**REPORT ON SERIOUS AVIATION INCIDENT, 19 MAY 2004 APPROX.  
20 NM WEST-NORTHWEST OF SANDEFJORD AIRPORT TORP, NORWAY,  
INVOLVING BOMBARDIER DHC-8-402, LN-WDA, OPERATED BY  
WIDERØES FLYVESELSKAP ASA**

Issued  
November 2007

Aircraft type: Bombardier Aerospace Inc. DHC-8-402  
Registration: LN-WDA  
Owner: HPA Leasing Limited, Don Street, St. Helier  
Jersey, UK  
Operator: Widerøe Flyveselskap ASA, Post Office Box 247,  
8001 Bodø  
Crew: 2 + 2  
Passengers: 27  
Incident location: Approx. 20 NM west-northwest of Sandefjord Airport Torp,  
Norway (ENTO)  
Date/time of incident: Wednesday 19 May 2004, at 0739

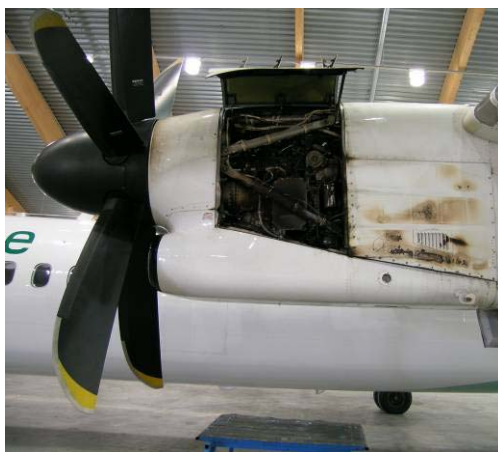
1.12.1.1 When the AIBN arrived at the Widerøe hangar, the airplane was cordoned off and only the forward access door on the left side of the left engine was open (see figure 3). Both access doors on the left side of the left engine were discoloured by heat on the outside. It was evident that the temperature inside the engine compartment had been high. In particular the rear door showed signs of having been exposed to high temperatures. On the right side of the engine, there was only a minor area where the white paint was discoloured. The underside of the nacelle from the landing gear backwards was soiled with engine oil.

Figure 3: Left side of left engine.

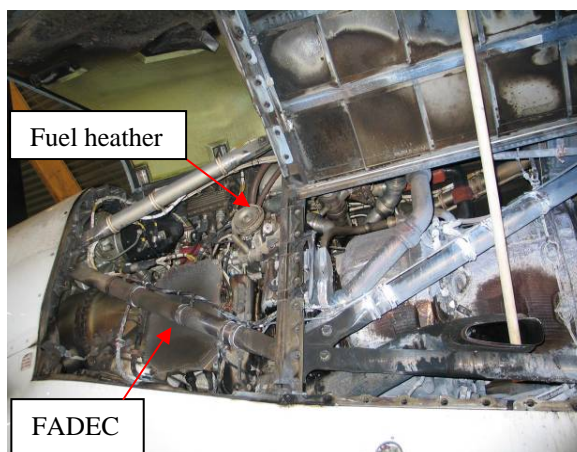
Figure 4: Visible heat damage once the rear left door was opened.

- 1.12.1.2 All engine access doors were opened. The support strut for the rear left door had partially melted,<sup>5</sup> and a rod had to be used to hold the cover open. On the top of the air intake section (the bottom of the engine compartment) were a number of remnants of rubber components from fixing brackets, small beads of melted metal and data plates etc. In addition, the top was covered with soot; partially mixed with oil. When the air intake section was to be lowered at the front, it was clear that the entire nacelle was distorted. The left front bolt had to be knocked out, and when the bolt did come out, the holes were displaced by 6 mm. When the section was lowered at the front, a number of metal parts from the engine's intake section and the compressor were found in the flow-through channel inside the air intake.

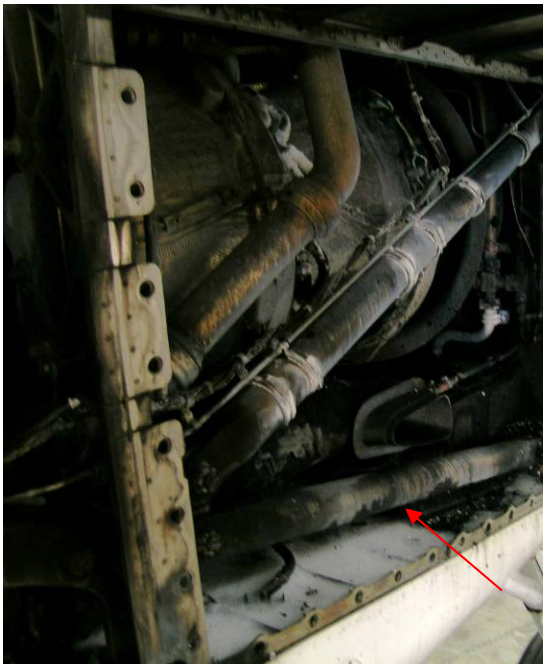
*Figure 5: Left side of the turbine section. The foam is still visible on the bottom of the engine compartment. The arrow points at the lower left engine mount strut which is bent upward.*

- The rubber padding in several wiring and hose fixings had burnt away.
  - The strut that constitutes the lower left engine mount was bent up in the middle by around 7-8 mm (see fig. 5).

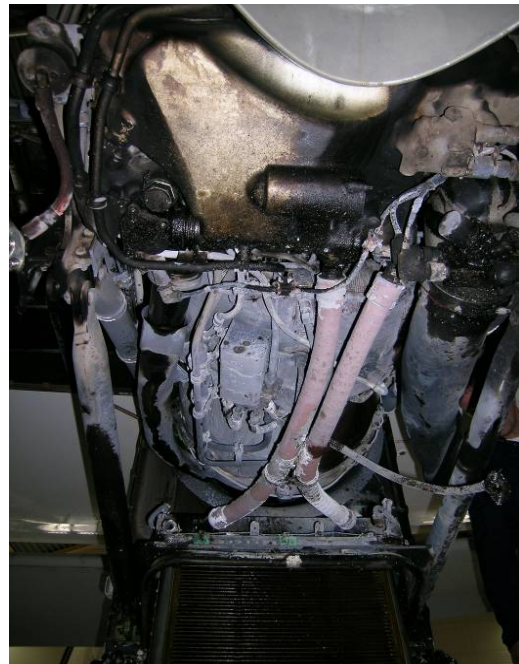
*Figure 6: The underside of the engine viewed towards the back once the air intake section was lowered.*

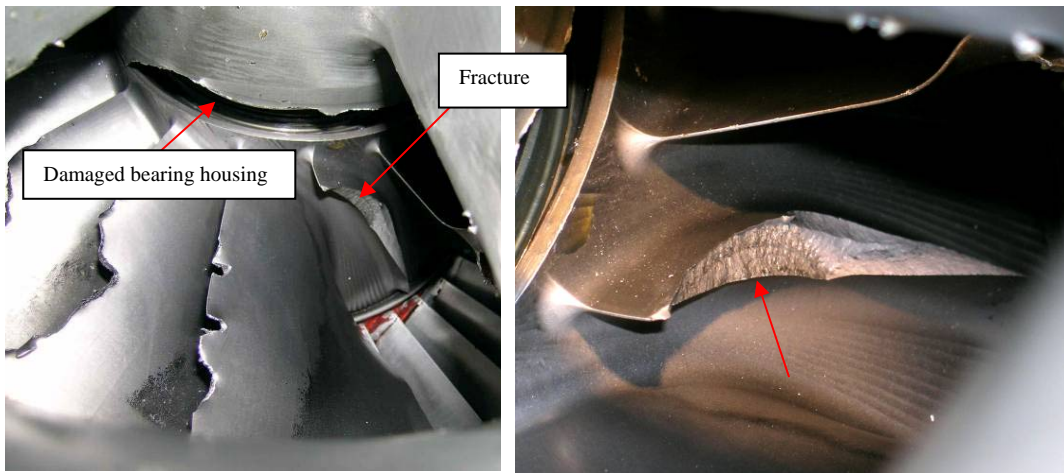
- 1.12.1.4 An inspection inside the air intake showed that there was major damage in the trailing edge of the supports for bearing nos. 2 and 2.5 (front inlet casing struts). Later examination revealed that cracks in the struts penetrated right in to the internal oil channels. There was also major damage to the bearing no. 2.5 housing. The low pressure compressor first stage had sustained major mechanical damage. On more detailed examination, fractures were detected in one of the compressor blades. The pattern in the fracture surface indicated that the fracture had been caused by metal fatigue. Internally, the air inlet was covered generally by a thin layer of engine oil. In addition, there were several small notches and dents in the parts of the air intake that are made of composite materials.

Figure 7: The air inlet with visible damage.

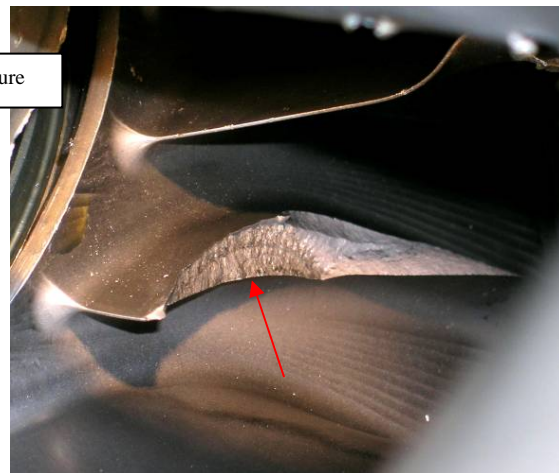
The investigation showed that the engine in flight shut down arose as a result of a fatigue fracture in one of the low pressure compressor first stage rotor blades. Vibrations due to the blade fracture led to major internal damage in the engine and caused an oil leak in the fuel heater. This oil flowed backward and was ignited by the hot exhaust gases at the rear of the engine. The fire caused major damage to the engine and caused the fire alarm to continue even after the engine had been cooled completely.

Figure 8: fracture in one compressor blade. The lines in the fatigue fracture are clearly visible.

The engine type concerned, Pratt & Whitney Canada PW150A, was relatively new and still maturing. The manufacturer was aware of problems in the leading edge of the blades concerned, and a new version of the low pressure compressor first stage was being developed at the time when the incident occurred. However, this Widerøe incident and a similar incident with an airplane belonging to SAS Commuter occurred due to cracking at the mid cord. A third version of the first stage compressor with a modified profile and a change of material was then developed and made available to production and PW150A operators under Service Bulletin (SB) 35191 in December 2006.

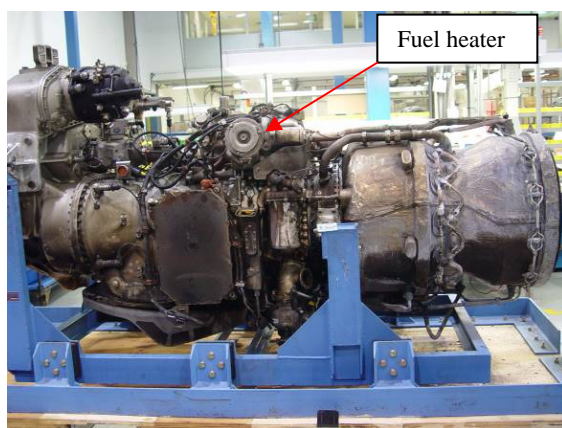
Figure 9: The left side of the engine before examination in Montreal started.

- The engine had fire damage, traces of high temperatures and soot in a number of places. The damage was particularly severe on the left side around the fuel manifold and the underside of the gas generator casing. Large areas of the engine were covered in a white powder.

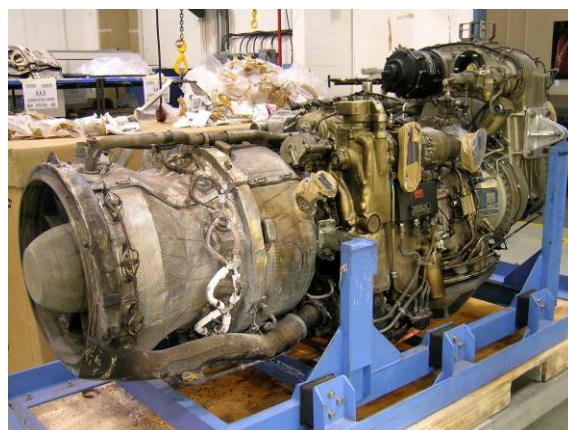
Figure 10: The right side of the engine before examination in Montreal started.

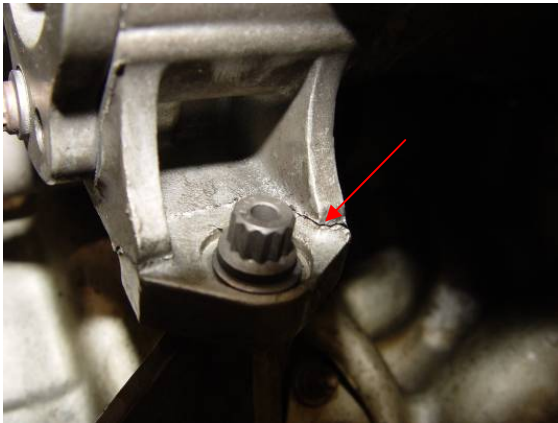
Figure 11: Fracture in the lower mounting lug on the fuel heater.

- The front, lower mounting lug on fuel heater was cracked (see figure 11). The other retaining bolts were found loose. After the fuel heater was removed, a crack was found running right through at the oil outlet left (see figure 13). A smaller external crack was also found in a re-inforcing web near the fuel port of the unit. During bench testing at an oil pressure of 100 psi, 5.7 kg of oil a minute leaked through the crack. The oil sprayed out through large parts of the crack and created a finely distributed spray of oil (see figure 14).

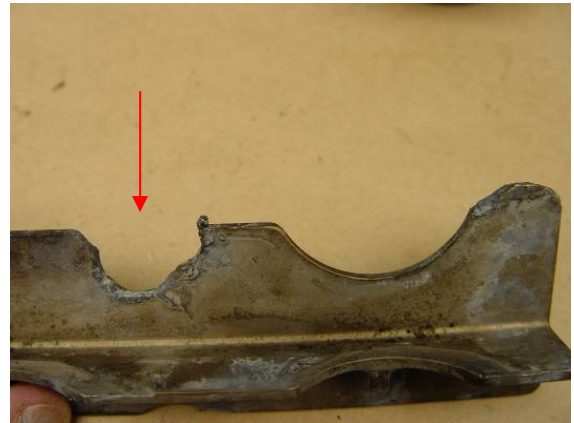
Figure 12: The bracket holding the oil transfer tubes. The arrow points at the fracture.

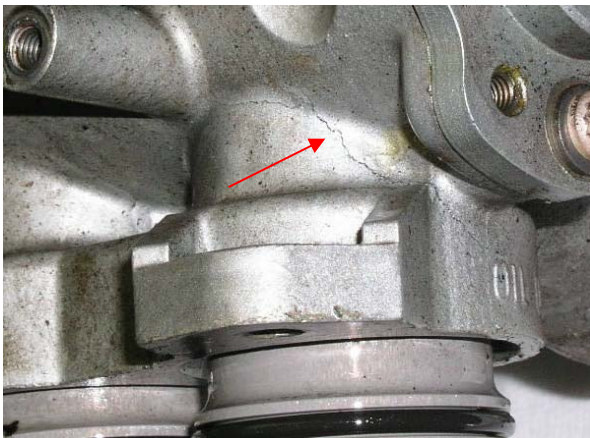
Figure 13: Crack going right through the fuel heater.

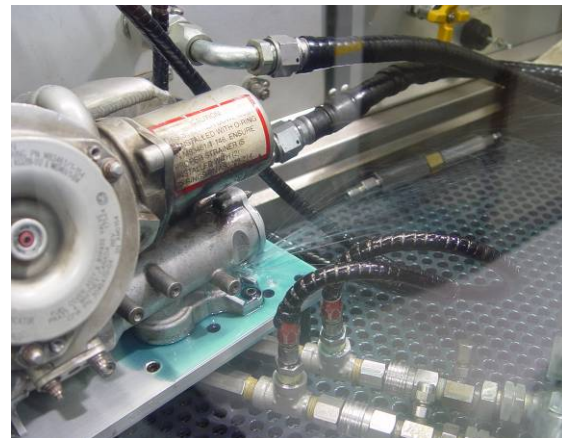
Figure 14: Fuel heater on the test bench.

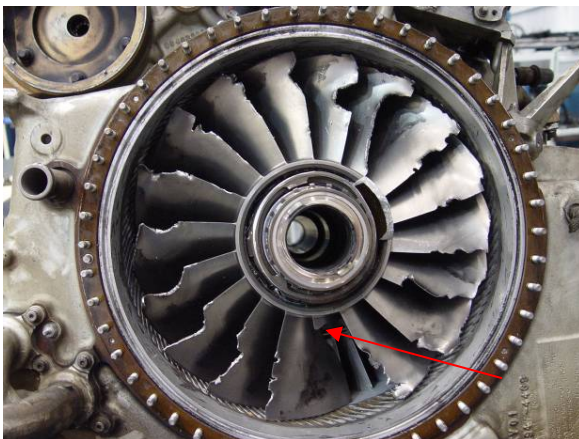
*Figure 15: The first stage compressor rotor after the inlet case was removed. The arrow is pointing at the blade root of the missing compressor blade.*

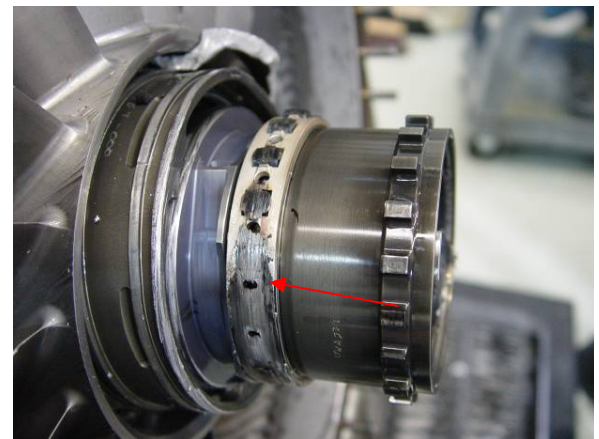
- Bearing no. 2.5 was totally damaged (see figure 16). The rollers were, to a varying degree, flattened and squeezed into the inner race. At the 3 o'clock position, the rollers were completely flattened.

*Figure 16: Bearing no. 2.5. The arrow is pointing at completely flattened rollers.*

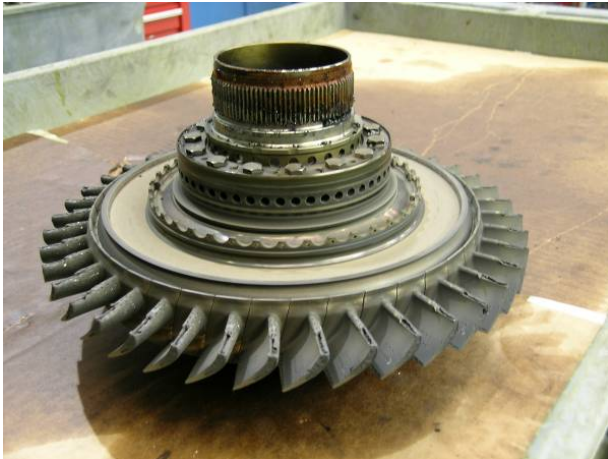
- The high pressure compressor had damage from contact with the compressor housing.
- The low pressure compressor, high pressure compressor, combustion chamber, high pressure stator and high pressure turbine all had damage from having been hit by foreign objects moving through the engine. The damage decreased towards the back of the engine. The same areas were also moistened by engine oil.
- The high pressure turbine had severe damage caused by carbon erosion. Pratt & Whitney Canada provided the information that this was caused by carbon deposits in the combustion chamber working loose and hitting the turbine blades on their way

back through the engine. (see figure 17 and 18). This evolved gradually before the actual incident and was not related to the compressor blade failure.

Figure 17: Carbon erosion on the first stage high pressure turbine (left engine).

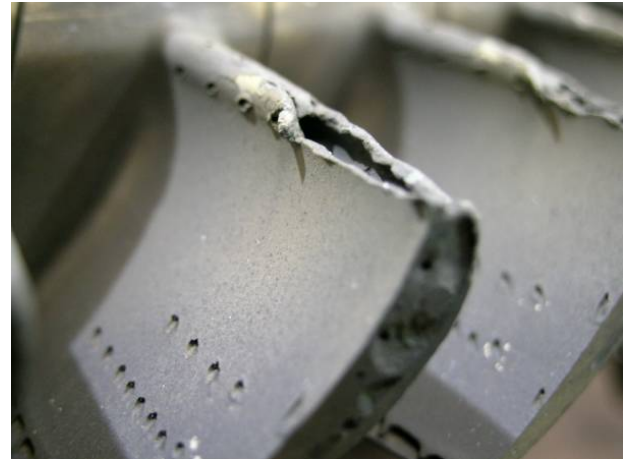
Figure 18: Close-up damage to turbine blade.

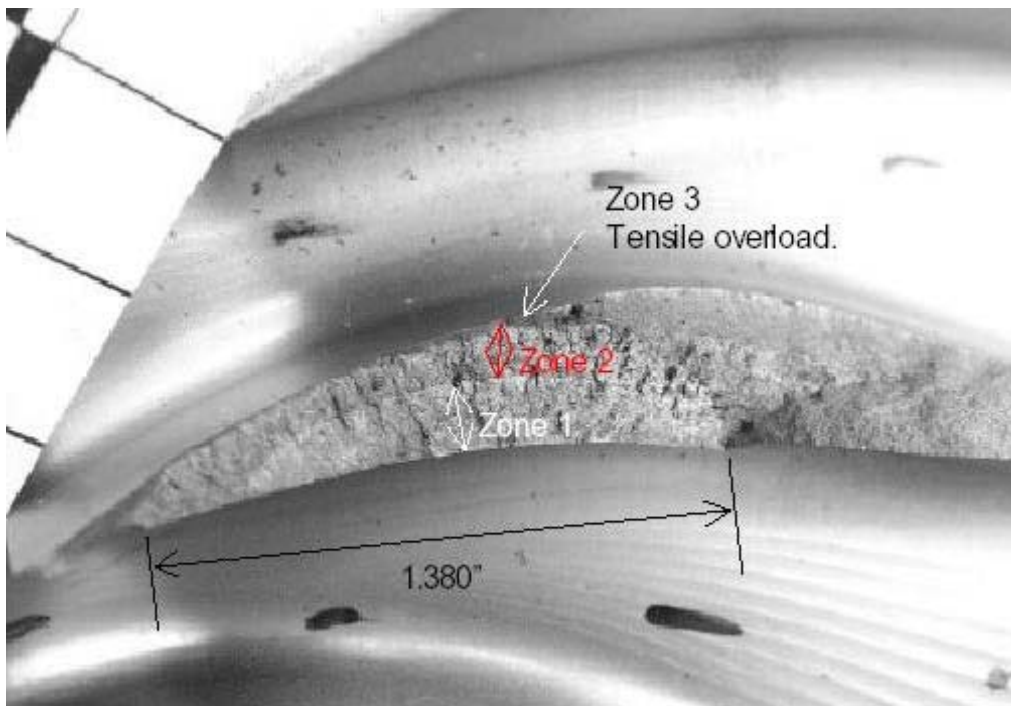
It then became clear that the fracture presented three distinct zones (see figure 19).

Figure 19: Picture of the three zones. The leading edge of the blade to the left. Zone 3 continues out of the picture to the right.

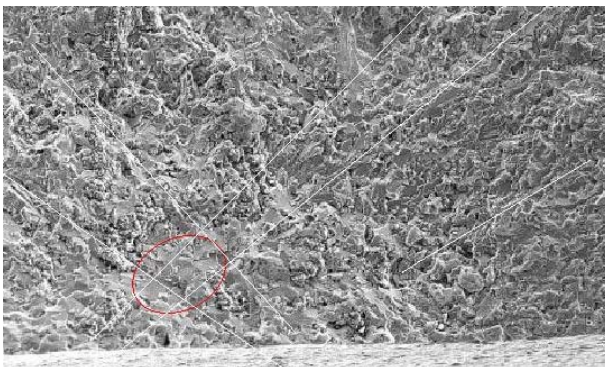
Zone 1 (see figure 20 and 21): Crystallographic nature. River lines were found starting from a point approx. 80  $\mu\text{m}$  (0.003 inch) from the surface. It was possible to use these river lines to determine the direction of crack growth on the fatigue fracture. More detailed examinations of the initiation area showed quasicleavage facets with no striations. The crack growth in Zone 1 was designated as very slow. Analysis of a material found in Zone 1 showed that this was primarily aluminium and oxygen (aluminium oxide). The material was deposited in a manner indicating that it had come there after the crack appeared.

Figure 20: Zone 1. Initiating area is within the circle just under the surface.

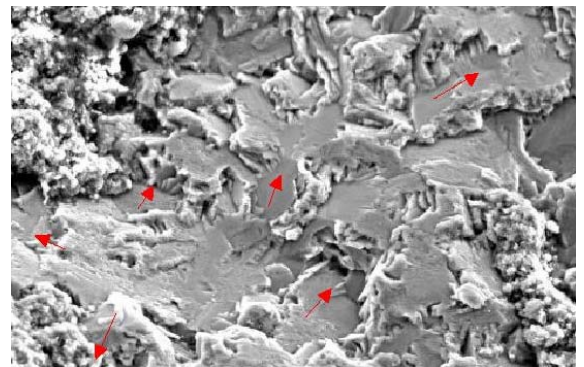
Figure 21: Zone 1. Close-up of area in figure 20. The arrows indicate the direction of crack growth.

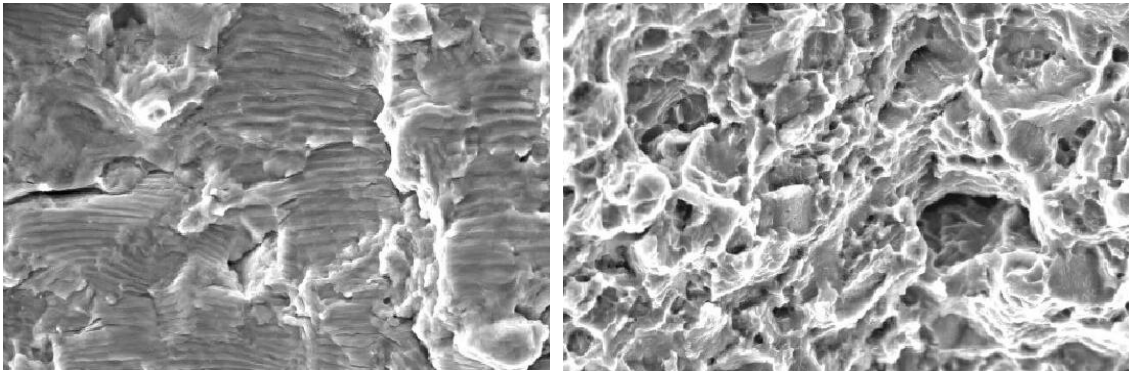
Zone 2 (see figure 22): This zone has clear fatigue striations. A count showed at least 1400 lines in the zone.

Zone 3 (see figure 23): The zone has dimples typical of overload fracture (residual fracture).

Figure 22: Clear fatigue striations in Zone 2. Figure 23: Dimples in Zone 3.

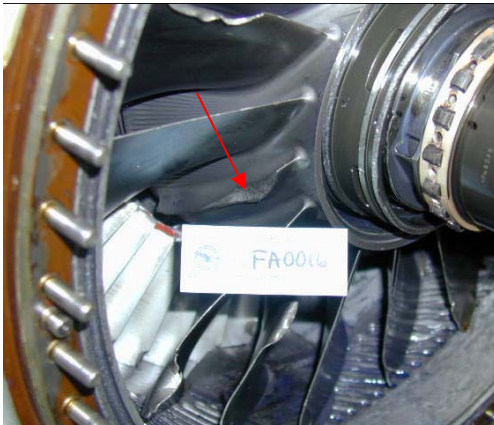
Figure 25: Fracture in compressor blade. Engine S/N FA0016.

- One first stage compressor blade had broken approx. 130 mm from the blade root. The loose part had wedged itself tightly between the compressor blades and the

compressor housing. All of the other blades had varying damage. A more detailed examination of the fracture surface disclosed that the fracture was caused by fatigue very like that found on engine no. FA0019 (see figure 19 and 28): Cracks were also evident on the leading edge of two other first stage compressor blades (see figure 27).

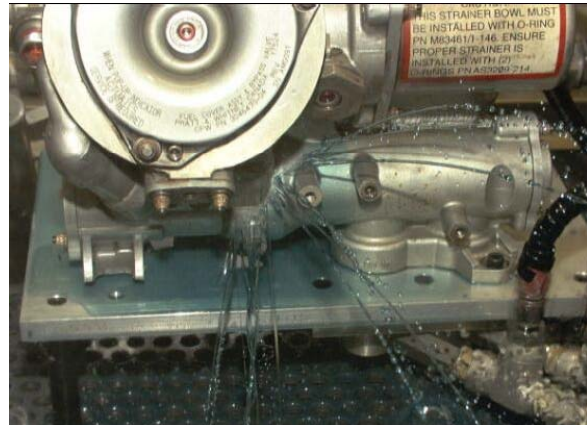
Figure 26: Leakage from the fuel heater at low pressure. Engine S/N FA0016.

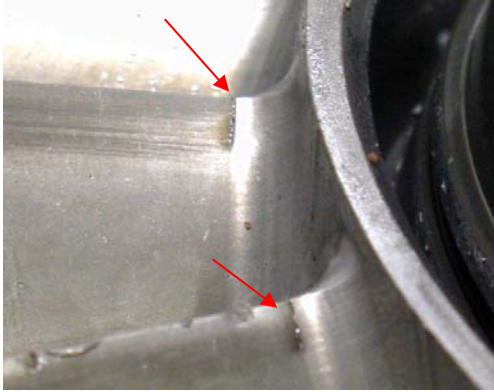
Figure 27: Cracks in the leading edge of two first stage compressor blades. Engine S/N FA0016.

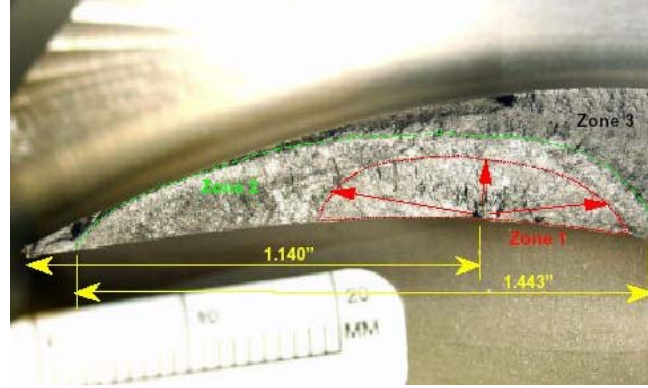
Figure 28: There are many common features in the fracture surfaces of the compressor blade from engine S/N FA0016 and the fracture surface from engine S/N FA0019 (see figure 19).
