RAPPORT

RAP: 29/2000

-type og reg.: Robinson Helicopter Company R-44, LN-OAM
-fabr. år: 1998
-motor: Lycoming O-540-FIB5

Type hendelse: Luftfartsulykke, tap av kontroll over helikopteret, etterfulgt av nødlanding på vei

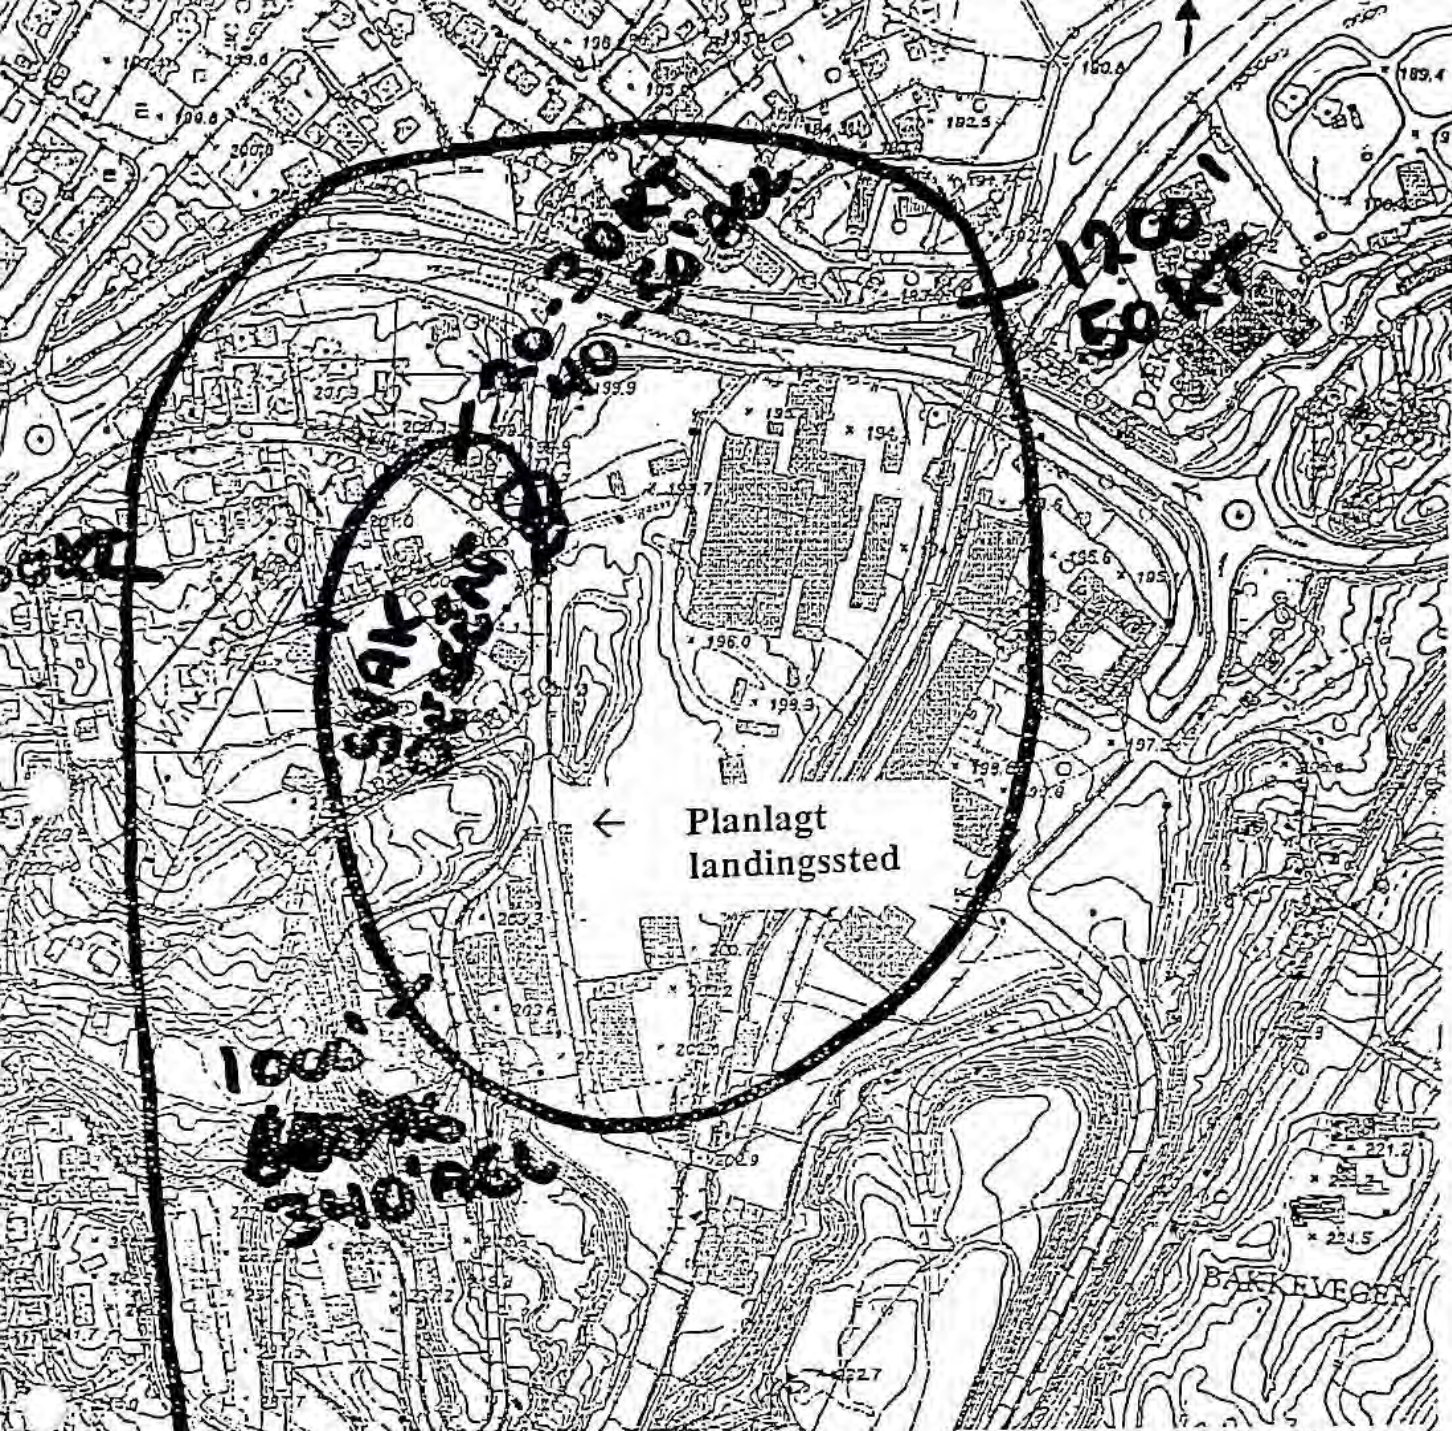
Innflygingsmønsteret

Flygingen forløp helt normalt frem til Gjøvik. Været var lettskyet med meget god sikt. Innflygingen til det planlagte landingsstedet startet med en rekognoseringsrunde over området ved Hunndalen (se vedlagte kart). På kartet har fartøysjefen beskrevet hastigheter og høyder på de forskjellige deler av innflygingen frem til ulykkesstedet. Her kan sees at høyden på medvindsleggen "abeam" landingspunktet var 300 ft AGL og ca. 50 ft over landingsstedet. Fra denne høyden skulle fartøysjefen gradvis senke helikopteret ned og lande.

Over ulykkesstedet, under utflatingen, i en høyresving med ca. 30° krenning og med en hastighet av ca. 20 kt, startet helikopteret plutselig en rask rotasjon om vertikalaksen mot høyre. Fartøysjefen trodde først at halerotoren hadde sluttet å fungere. Helikopteret tapte høyde og kom i en ny rotasjon (dette ble opplyst til HSL. I en høringskommentar til denne rapport uttrykker fartøysjefen at han ikke husker dette.). Fartøysjefen oppdaget da at han likevel hadde kraft fra halerotoren, men da var helikopteret så mye ut av kontroll at han fant det best å sette helikopteret på bakken. På dette tidspunkt befant helikopteret seg over en vei, ca. 100 m nord for det planlagte landingsstedet.

Innflygingsprosedyren i dette tilfellet var ikke velegnet. Skarp sving med gjennomsynking og reduksjon av hastighet med høy masse er en komplisert manøver som krever betydelig erfaring fra fartøysjef for å kunne gjennomføres. Det anbefales derfor ved en slik landing, en rettlinjert finale med en normal innflyging hvor gjennomsynkningen reduseres før reduksjon av hastigheten gjøres. Da får man tid til å forberede seg til en smidig "flare" eller stopp i "high hover out of ground effect", samtidig som man får kontroll over pedalbruk, og kan sjekke motorkraftuttak, airspeed og rotorturtall. Fartøysjefen satte seg altså i en situasjon som han ikke var forberedt på, og ble således overrasket over utfallet. HSL vil henviser til Pilot Operating Handbook siste del: "Safety Tips" hvor det behandles forhold der helikopterflygere erfaringsmessig kan komme i vanskelige situasjoner. Blant de mange emner som blir tatt opp sies det: "En privat helikopterflyger/eier er sin egen sjef, han har ingen til å overvåke hvordan flygingen utføres. Han vil derfor være avhengig av stor grad av selvdisciplin."

HSL anser at dersom det ikke er påkrevd, skal man unngå å lande med en-motors helikopter fra "high hover" over tett bebyggelse med mange hindringer. I alle fall skal man velge en hinderfri eller forsvarlig inn- eller utflygingstrasé. HSL anser at den valgte trasé frem til det planlagte landingsstedet ikke var særlig heldig. Videre må en fartøysjef påse at luftfartøyet har en slik masse at man har tilstrekkelig motorkraft til å bevare rotorturtall og retning i stoppfasen.

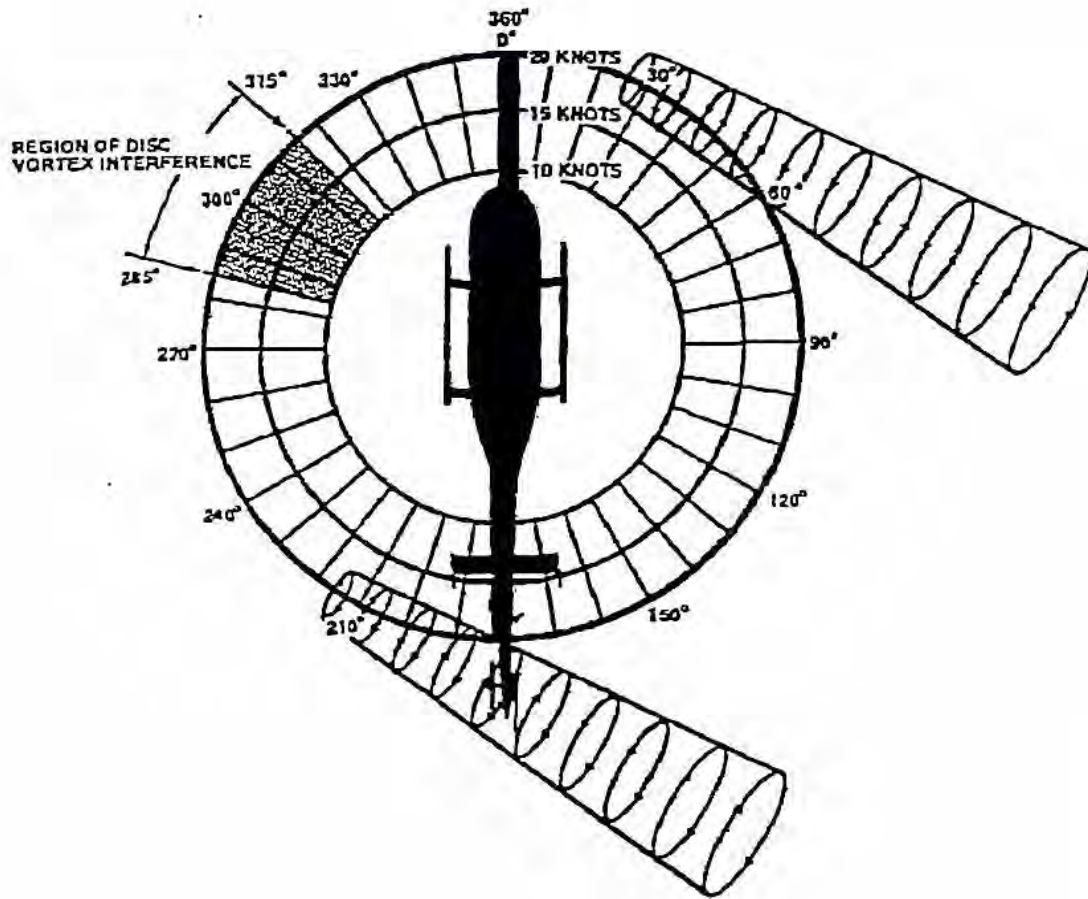
FIGURE 1. MAIN ROTOR DISC VORTEX INTERFERENCE

(1) Main rotor disc vortex interference (285° to 315°). (See figure 1.)

(a) Winds at velocities of about 10 to 30 knots from the left front will cause the main rotor vortex to be blown into the tail rotor by the relative wind. The effect of this main rotor disc vortex is to cause the tail rotor to operate in an extremely turbulent environment.

(b) During a right turn, the tail rotor will experience a reduction of thrust as it comes into the area of the main rotor disc vortex. The reduction in tail rotor thrust comes from the air flow changes experienced at the tail rotor as the main rotor disc vortex moves across the tail rotor disc. The effect

(d) As the main rotor vortex passes the tail rotor, the tail rotor angle of attack is reduced. The reduction in the angle of attack causes a reduction in thrust and a right yaw acceleration begins. This acceleration can be surprising, since the pilot was previously adding right pedal to maintain the right turn rate.

(e) This thrust reduction will occur suddenly and, if uncorrected, will develop into an uncontrollable rapid rotation about the mast. When operating within this region, the pilot must be aware that the reduction in tail rotor thrust can happen quite suddenly and the pilot must be prepared to react quickly and counter that reduction with additional left pedal input.

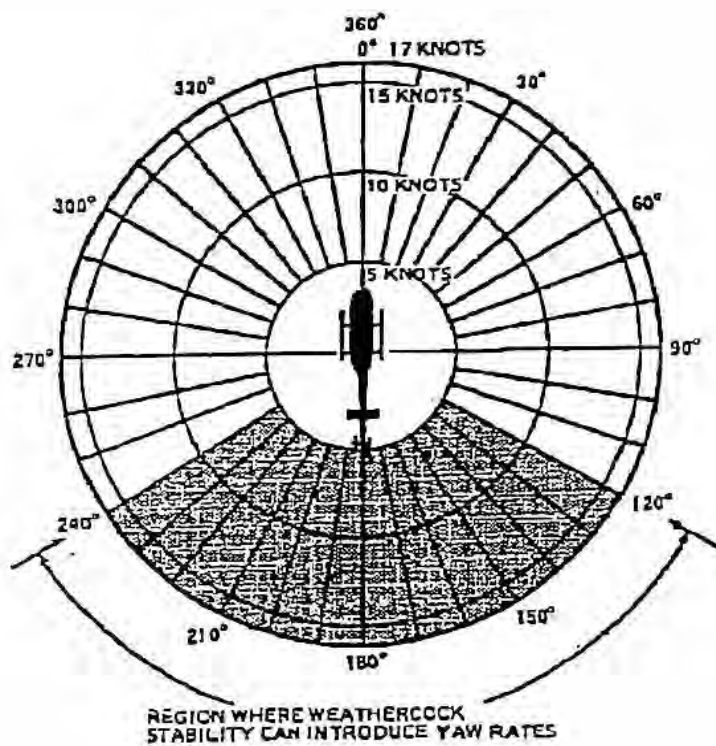
FIGURE 2. WEATHERCOCK STABILITY

(2) Weathercock stability (120° to 240°). (See figure 2.)

(a) Tailwinds from 120° to 240°, like left crosswinds, will cause a high pilot workload. The most significant characteristic of tailwinds is that they are a yaw rate accelerator. Winds within this region will attempt to weathervane the nose of the aircraft into the relative wind. This characteristic comes from the fuselage and vertical fin.

(b) The helicopter will make a slow uncommanded turn either to the right or left depending upon the exact wind direction unless a resisting pedal input is made. If a yaw rate has been established in either direction, it will be accelerated in the same direction when the relative winds enter the 120° to 240° area unless corrective pedal action is made.

(c) If the pilot allows a right yaw rate to develop and the tail of the helicopter moves into this region, the yaw rate can accelerate rapidly. It is imperative that the pilot maintain positive control of the yaw rate and devote full attention to flying the aircraft when operating in a downwind condition.

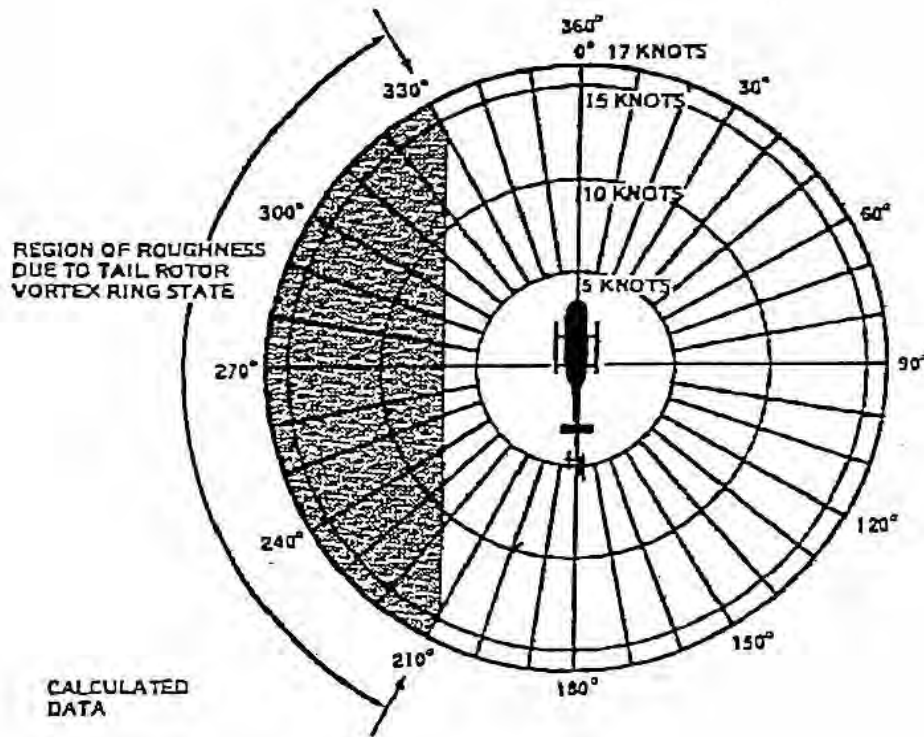
FIGURE 3. TAIL ROTOR VORTEX RING STATE

(3) Tail rotor vortex ring state (210° to 330°).
(See figure 3.)

(a) Winds within this region will result in the development of the vortex ring state of the tail rotor. As the inflow passes through the tail rotor, it creates a tail rotor thrust to the left. A left crosswind will oppose this tail rotor thrust. This causes the vortex ring state to form, which causes a non-uniform, unsteady flow into the tail rotor. The vortex ring state causes tail rotor thrust variations which result in yaw deviations. The net effect of the unsteady flow is an oscillation of tail rotor thrust. This is why rapid and continuous pedal movements are necessary when hovering in left crosswind.

(d) When the thrust being generated is less than the thrust required, the helicopter will yaw to the right. When hovering in left crosswinds, the pilot must concentrate on smooth pedal coordination and not allow an uncontrolled right yaw to develop.

(e) If a right yaw rate is allowed to build, the helicopter can rotate into the wind azimuth region where weathercock stability will then accelerate the right turn rate. Pilot workload during vortex ring state will be high. A right yaw rate should not be allowed to increase.
