REP 19/2003

**REPORT ON  
AIRCRAFT ACCIDENT AT LÅGHELLERNUTEN ON THE  
HARDANGER PLAIN IN THE MUNICIPALITY OF  
ULLENSVANG, HORDALAND ON NOVEMBER 6 1999,  
INVOLVING EUROCOPTER AS 350-B2, LN-OCF  
OPERATED BY AIRLIFT AS**

**ISSUED MARCH 2003**

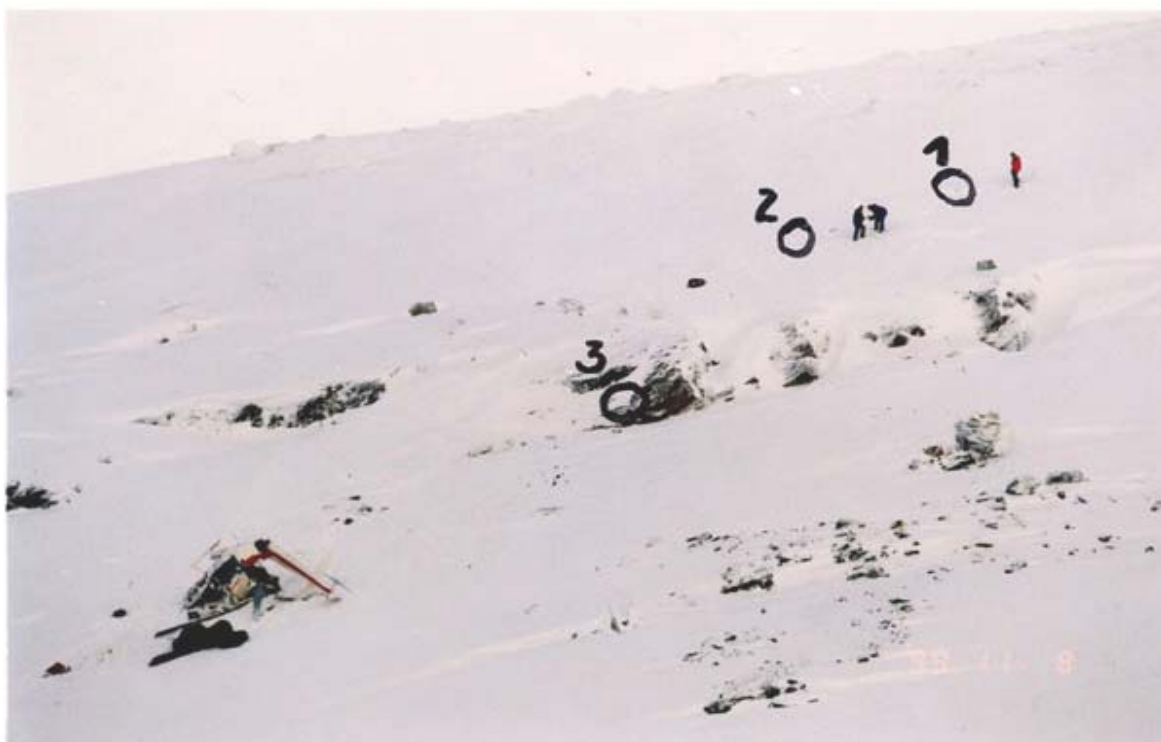
**The accident site**

The mountainside was covered in snow, varying between crusted snow and drifting snow, of varying depths. Large stones were sticking up out of the snow in the area, which meant that there was good reference to ground contours (it was not a “white out” condition). The helicopter touched the ground twice up on a slightly flatter part of the mountainside before descending a vertical drop of approx. 4 m. First impact was with a heading of 90° it bounced 14 m and impacted again, fell 4 m vertically before it continued 23 m downhill and came to a rest upside down.

- 1.12.1.2 The tracks in the snow up on the flatter part showed that the helicopter was on an easterly course when it first made contact with the ground. First contact was probably flat or with a slight nose up configuration (based on position to right hand landing skid remaining at the impact crater and the crater itself) After this contact, the helicopter was catapulted forward to the edge of the precipice and then went over it. It finally came to rest with its nose pointing in a direction of approx. 110°. Due to the winter condition with falling and drifting snow between the time of the accident and the AAIB/N arrival to the scene many details were gone.

- 1.12.1.3 Parts of the rotor blades and some of the right landing gear were found at the site of the first contact with the ground. The right-hand front door, some glass from the windshield and pieces of the glare shield were found at the second point of impact. The GPS was a little to the right, between these two points. The other detached parts were found between the helicopter wreckage and the vertical drop.

**1: First impact / 2: Second impact / 3: precipice**

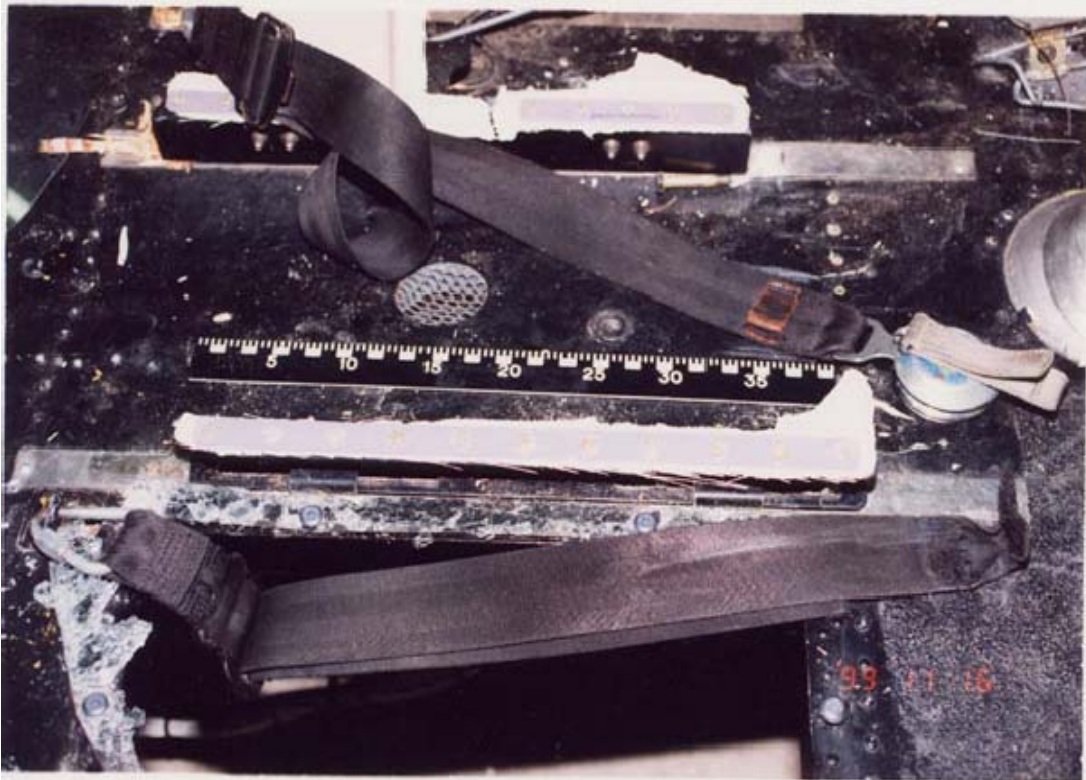
- 1.12.3.1 Both front seats had become detached because their glass fibre shell gave way. The pilot's seat (on the right) had virtually no damage to the sitting part of the seat shell, but the attachments had come apart on both sides, causing the seat to become detached from the helicopter floor. The seat back had also given way at the shoulder belt feed-through.

The stitching on the lap belts on both front seats had given way. The stitching on the pilot's belt had given way up near the buckle, while the stitching on the belt on the left seat had given way down near the snap hook. The lap belt used by the adult in the far right seat had come away at the webbing to the buckle.

**Right chairs anchorage and thorn lap belt**

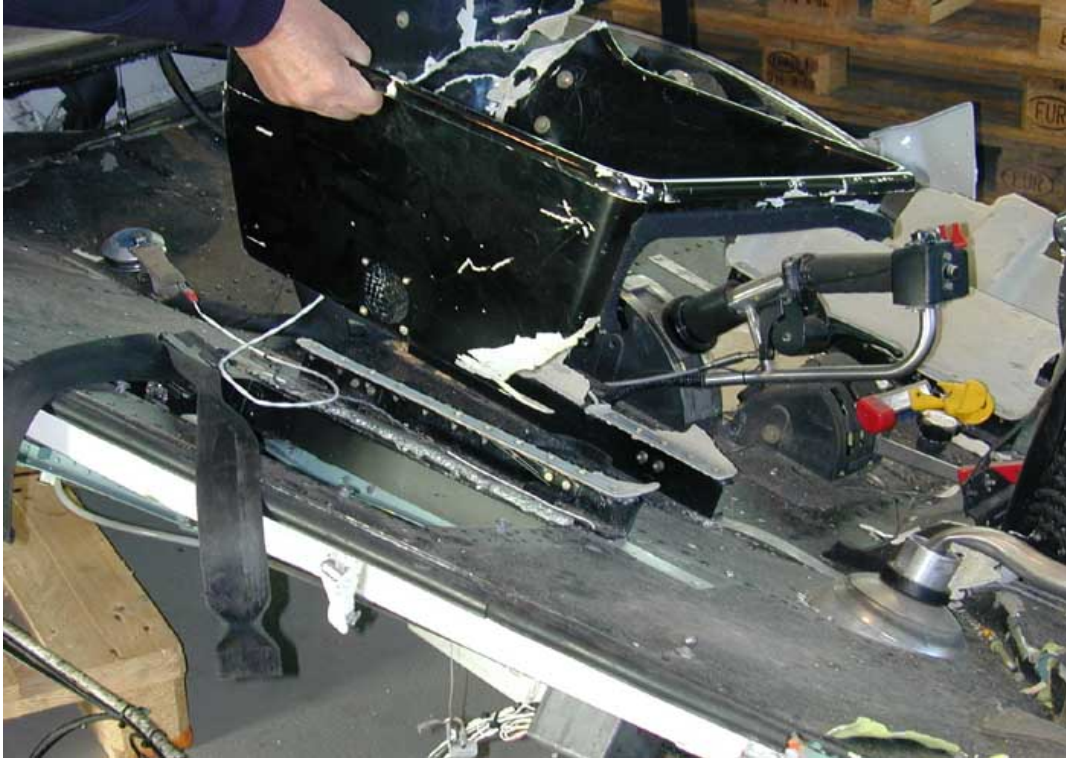
- 1.12.3.2 The left seat was more damaged in its sitting part. It had also become detached from the helicopter floor although bolts, attachment plates and parts of the seat shell were left on the floor. This seat was not damaged up on the seat back

**Left chair and details of the anchorage**

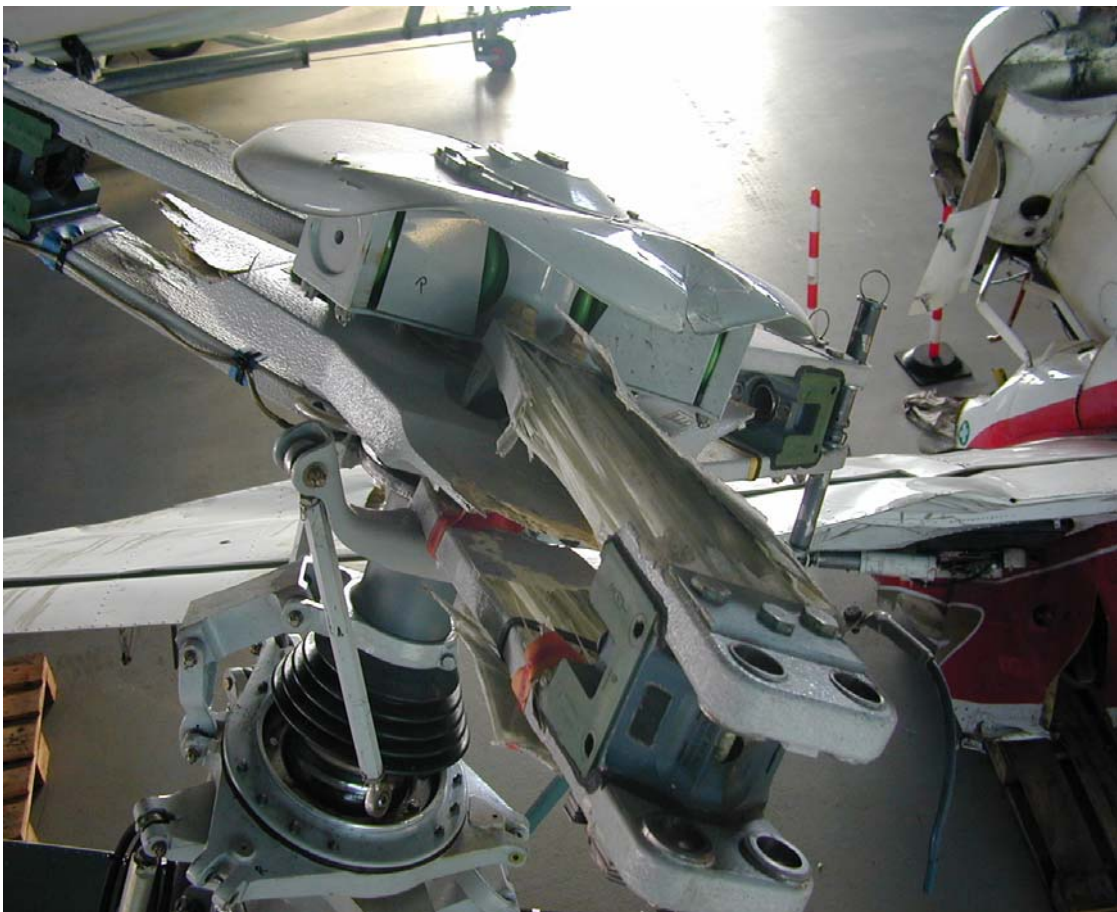
**The rotor head**

The main rotor blades were all damaged, but only the red blade had the outer part missing. The blue and the white blade remained in one piece, and all three (2,5) remained attached to the rotor head. All 3 arms of the Starflex fractured. Blue and yellow had a clear 45° fracture with the longest remaining part in direction of rotation. The red where more damaged, but also with a 45° fracture. This 45° fracture where in opposite direction, i.e. with the shortest remaining part in direction of rotation. The tail rotor blades were virtually undamaged.

- The Starflex and main rotor blades indicates that only one blade had serious impact with the ground. The red blade and Starflex are seriously damaged and with fracture pattern on Starflex indicating "contact". The yellow and the blue blade are less damaged and the yellow and blue Starflex has similar fracture pattern indicating that the blades continued while mast had stopped/lost rotational energy. This indicates that energy in the system was low at impact.
