SL REP: 27/2005

**REPORT ON THE ACCIDENT 17 NM SW OF STAVANGER
AIRPORT 5 NOVEMBER 2002 INVOLVING
AS 332 L2 LN-ONI
OPERATED BY NORSK HELIKOPTER AS**

**SUBMITTED
JUNI 2005**

**ACCIDENT INVESTIGATION BOARD NORWAY (AIBN)
P.O. BOX 213
N-2001 LILLESTRØM
NORWAY**

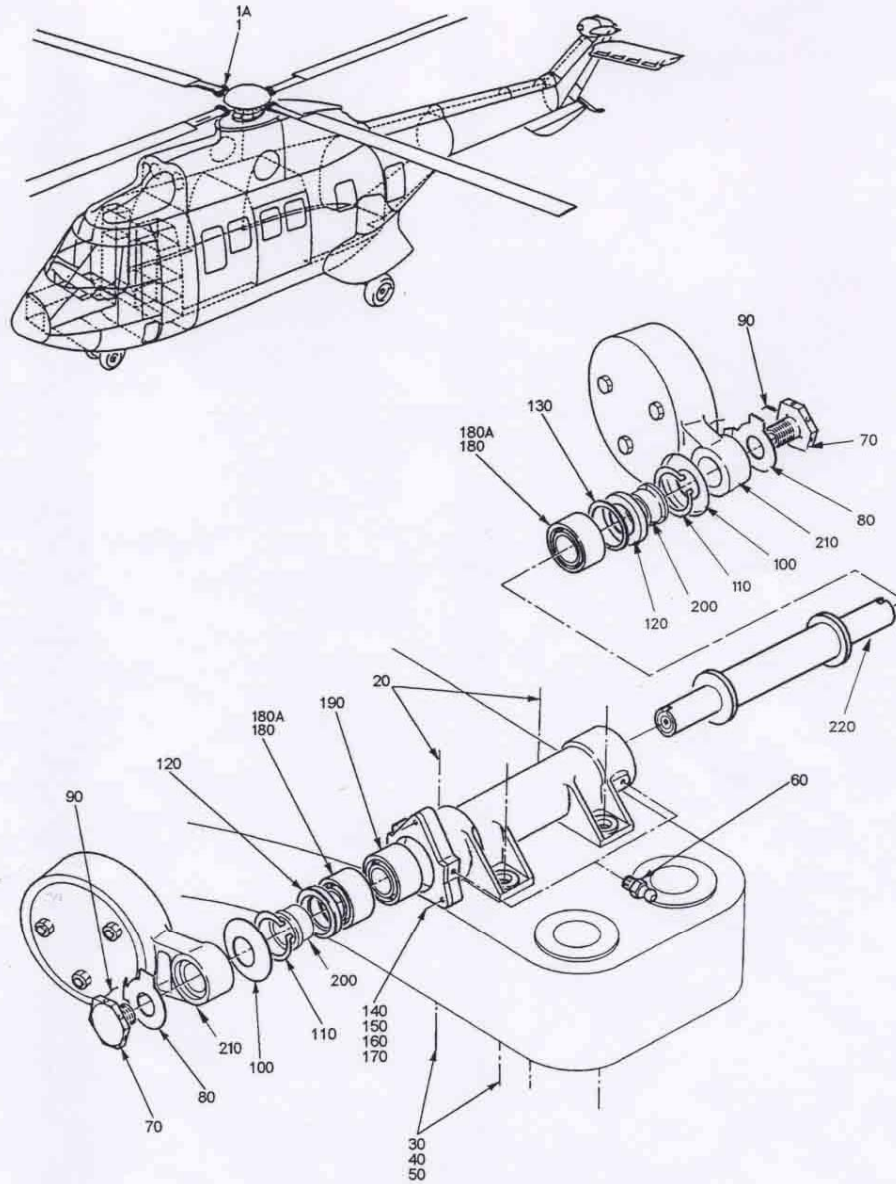
ABSORBER ASSY,VIBRATION
FIG. 02

During the investigations the AIBN has uncovered missing information in the AS 332 MK2 Illustrated Parts Catalogue (IPC). In Fig. 02 in IPC AS 332 MK2, 62-10-00, page 0, date 2000.09.30, Absorber Assembly, Vibration, item 130, Washer (P/N 332A11-0437-20), on one side of the absorber is missing from the drawing, and from the figure's itemised list. Cf. Appendices 1 and 2.

The AIBN's investigations have uncovered a missing item and part number in the AS 332 MK2 IPC. The missing item is the washer (spacer) involved in the accident. The missing item in the IPC was of no consequence in this accident, but the present investigations uncovered another occurrence in which a vibration absorber failed as a result of a missing spacer as mentioned above. The AIBN will not dismiss the possibility that the failure to install the washer may have been a result of the washer being missing from the IPC.

- 4.3 Eurocopter to revise the AS 332L2 IPC to include the missing washer (P/N 332A11- 0437-20) on the vibration absorber. (SL recommendation no. 33/2005)

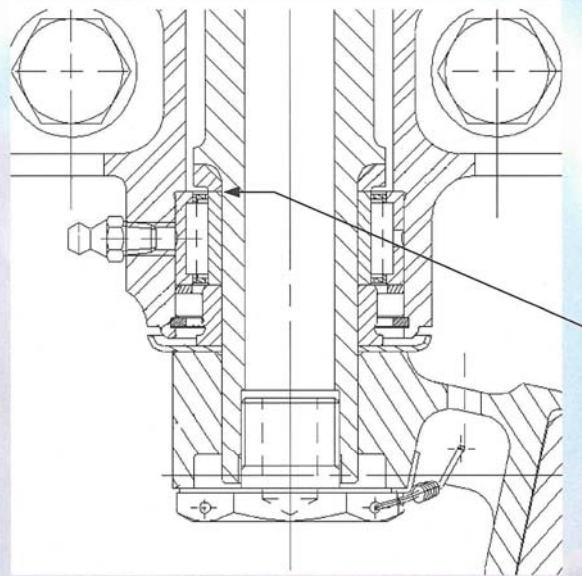
Failure area
of the shaft

EC's investigation of the failed shaft shows that the crack initiation on the shaft was at the contact with the inner washer, as a result of micro-cracks due to fretting. The fatigue failure was caused by rotational bending. There was no geometry or material defect involved. Fretting was observed on all contact areas. Cf. Appendix 7.

Crack initiation on the shaft at the contact with the inner washer (micro-cracks of fretting)

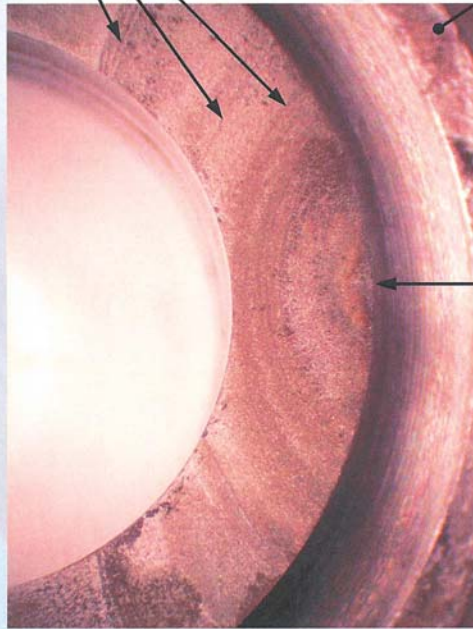
Macro-marks

Crack initiation point

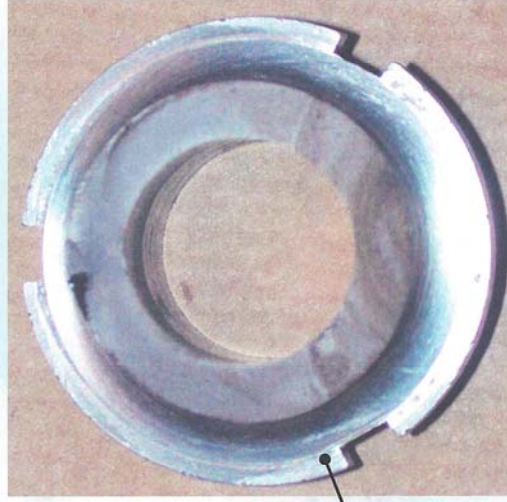
To be also specified, the fracture surface showed 50 main macro marks. If we accept that these stop lines represent the rotor stops and that the average between two rotor stops carried out by the aircraft is approximately 2 hours (value given by analysis of the aircraft log book), the propagation time of the failure is approximately 100 hours.

Quality Materials Laboratory investigation: 50 macro-marks

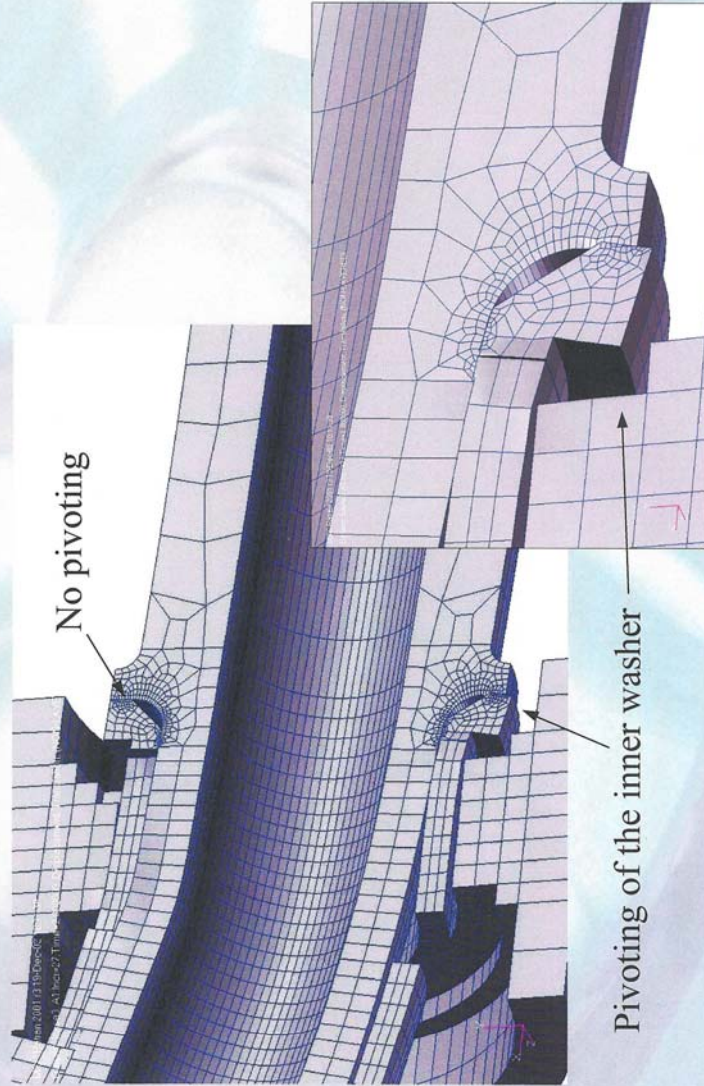
Model with loss of 80% of the tightening torque

EC calculated the shaft failure mode by using Finite Element Modelling. Cf. Appendix 8. It was shown that pivoting of the washer caused fretting wear. This resulted in loss of tightening torque. It was demonstrated that with the loss of 80% tightening torque, a fatigue failure could be simulated.

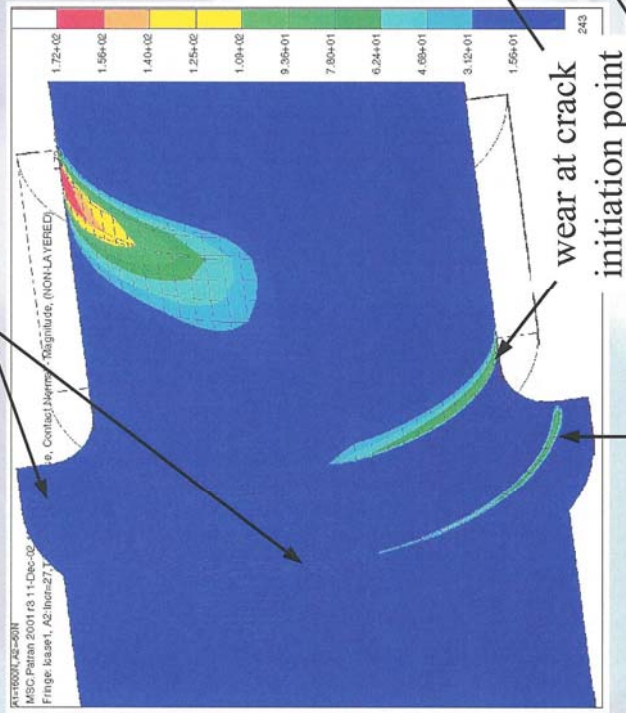
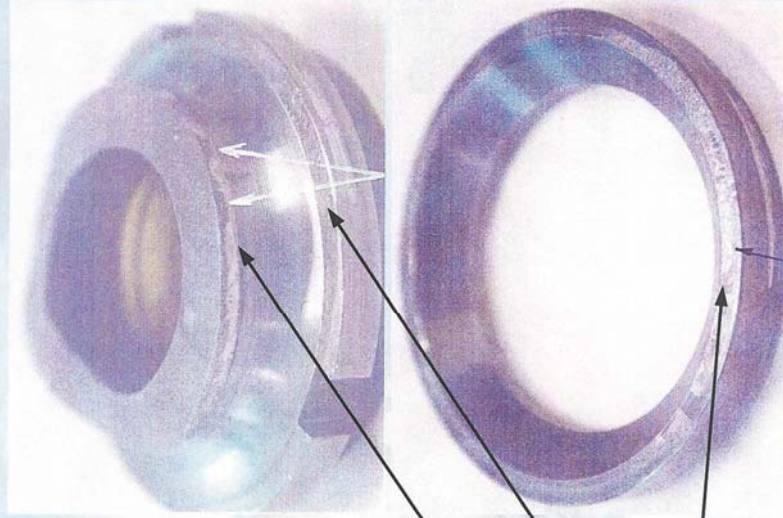
no contact (\Rightarrow no wear)

contact pressure area (\Rightarrow wear)

Results confirmed by observations on the shaft:
wear area on the shaft shoulder at the crack initiation level

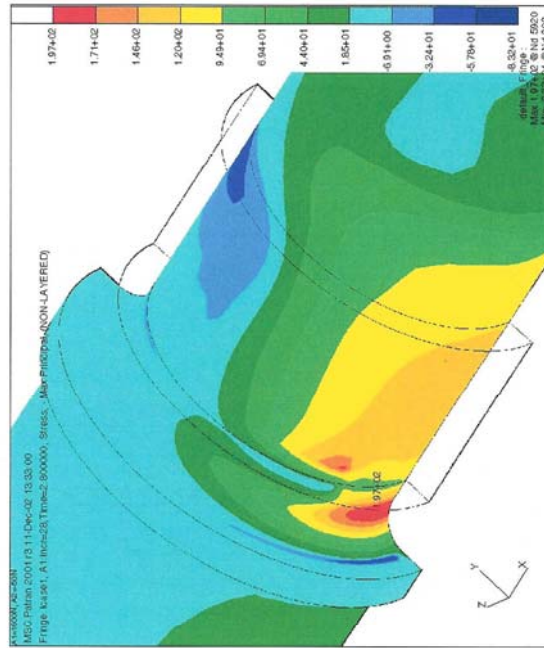
Maximum equivalent stress at the crack initiation point :

$\sigma_{eq} = \pm 171 \text{ MPa}$
 (tension + torsion at max flight loads)

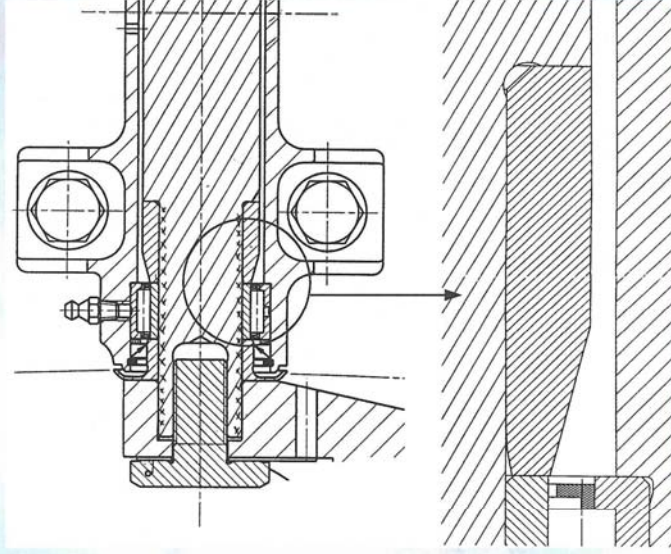
The Finite Element model done shows that even after a complete loss of tightening torque the stress level is low enough to guarantee the safety.

fretting prevention

- shrinking of inner washer on shaft
- optimised tightening torque
- bearing reliability improvement

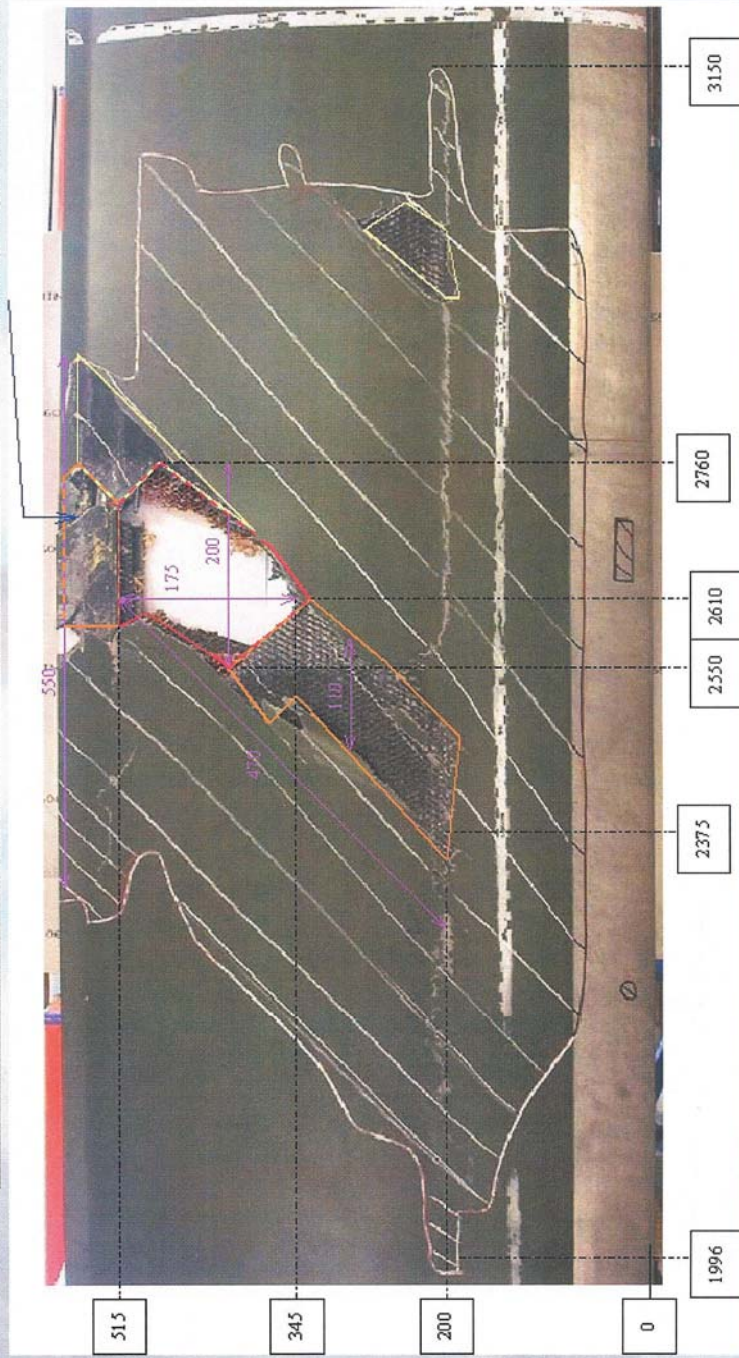
Investigation of the main rotor blade 332 A 11 0041 n°140

Trailing edge failure at ref. 2700

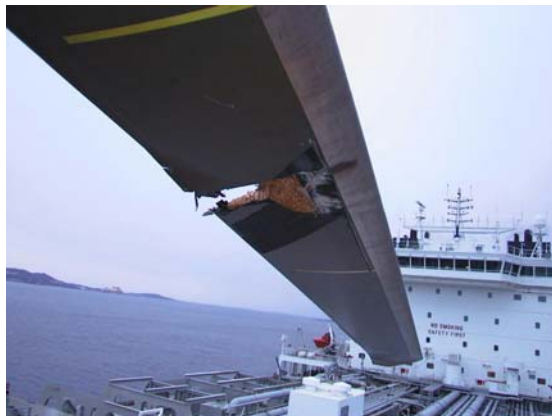
The Pendulum Support Weight had first made contact with the upper side of the black MRB (S/N 305). It then struck the following blue MRB (S/N 140) on the underside close to the leading edge. The black blade had strike damage on top of the blade just outboard of the blade root. The blue blade had been hit by the pendulum support weight under the leading edge at about 3/4 of blade length from the root, at blade station 2530. The pendulum weight made a dent in the stainless steel leading edge strip and then penetrated the blade structure aft of the main spar, leaving the spar intact. It had continued cordwise through the blade towards the trailing edge spar, which was cut. The MRB is built as a torsion box. With a cut trailing edge the MRB has lost its rigidity in torsion. Cf. Appendices 10-16. Through its path, the weight ripped out 280 g of blade mass. The total mass loss and the loss of built in rigidity in pitch and lead-lag resulted in severe rotor vibrations at 158 KIAS (Cf. §1.15.4.1). The speed reduction to 100 KIAS reduced the blade loadings and vibrations to approximately half of the initial values.

The damaged Blue blade observed from the helicopter

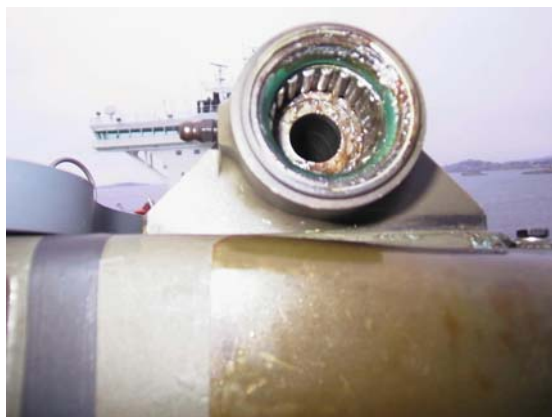
The remaining vibration absorber assy on Blue blade
