SL Report: 48/2005

**REPORT ON THE SERIOUS INCIDENT
AT BERGEN AIRPORT FLESLAND (ENBR)
ON 24 MARCH 2003,
INVOLVING SAS329, MD-81, LN-RMO,
OPERATED BY SCANDINAVIAN AIRLINES**

SUBMITTED
December 2005

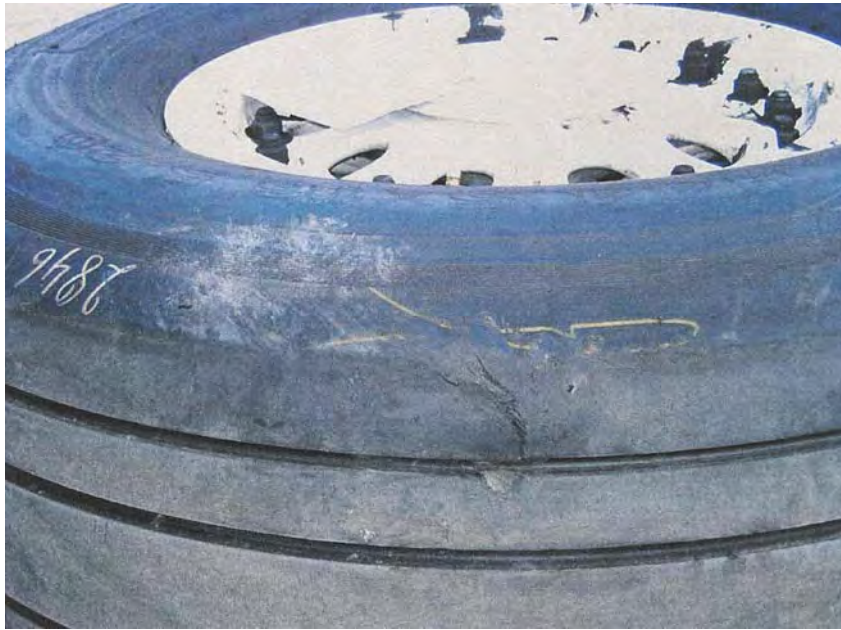
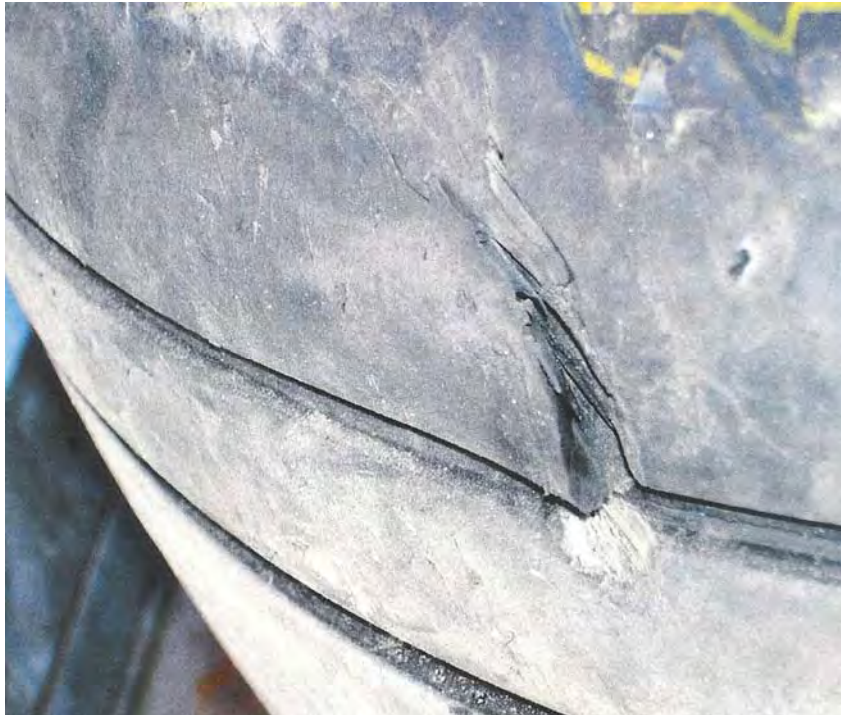
APPENDIX 1 LN-RMO

- 1.1.14 During this turn, the outer left main (no. 1) wheel tyre collided with a RWY edge light, which was broken.
- 1.1.15 The rest of the rollout and taxiing to parking was uneventful.

The damage to the aircraft was limited to a deep slash in the left outboard main wheel tyre (wheel no. 1). No further damage was found on the aircraft or its systems. The wheel was replaced at ENBR. Cf. Appendix 1.

Damaged aircraft tires

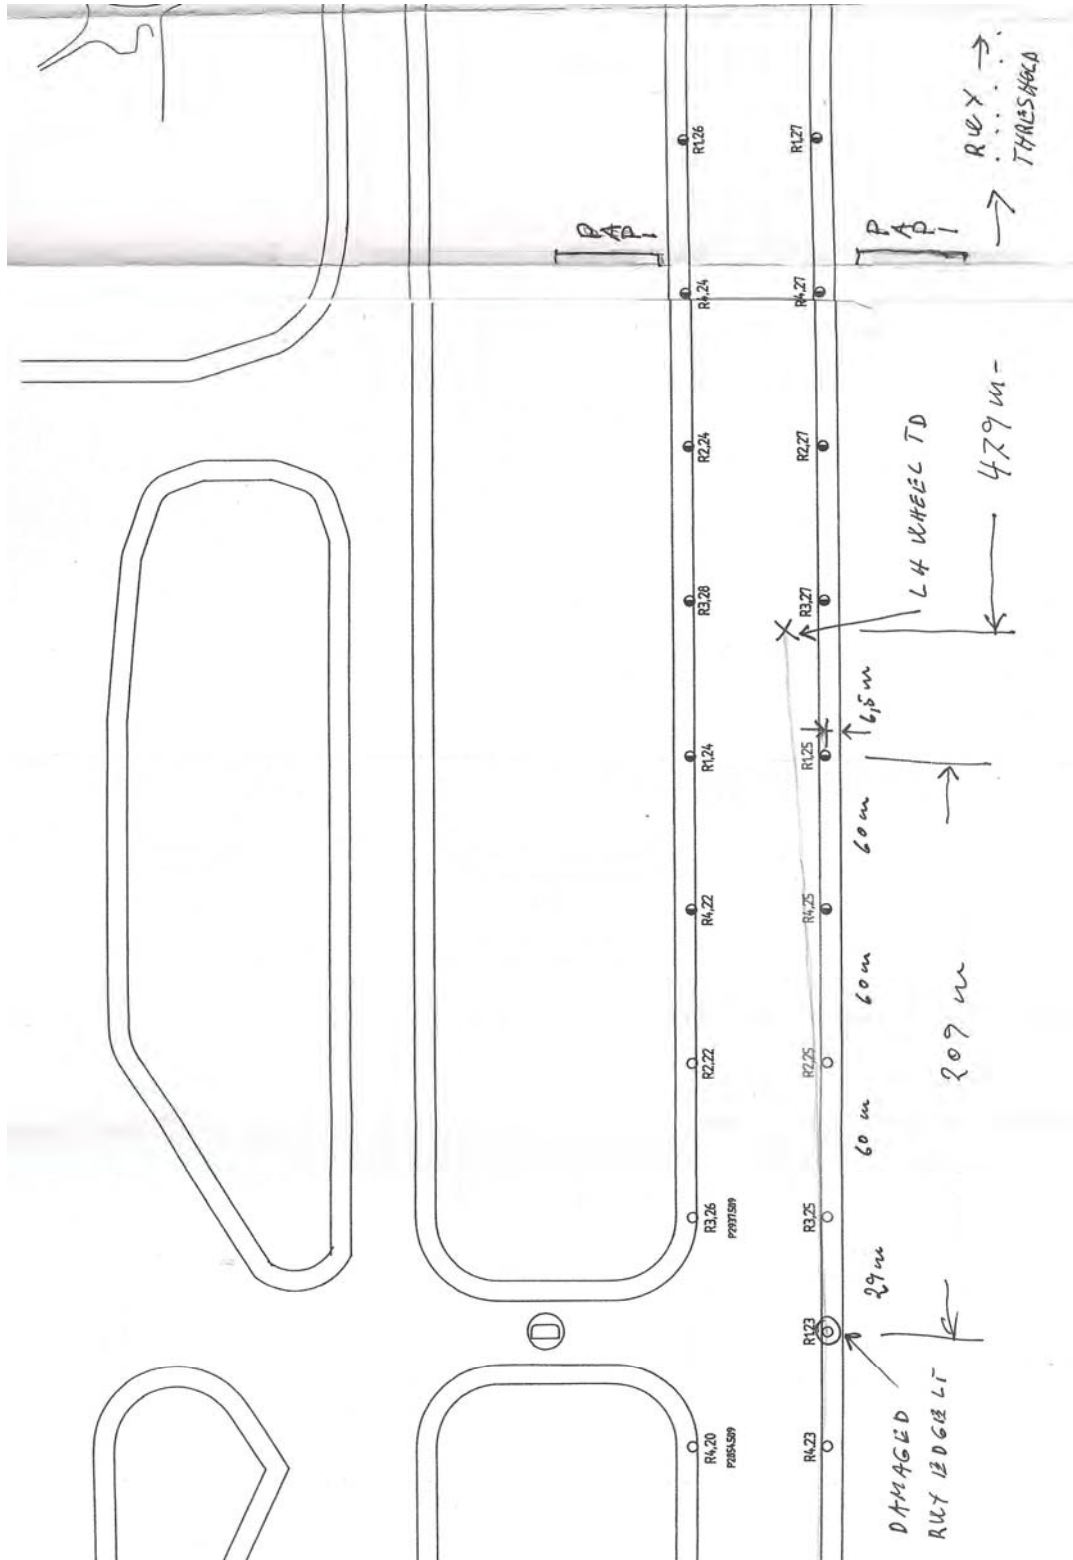
APPENDIX 3 LN-RMO

- 1.1.17 Shortly after that, damage to a left wheel tyre was reported to the TWR by the SAS maintenance crew. The Commander called the TWR and again requested a RWY inspection. This time the airport personnel did find a broken RWY edge light on the left side of RWY 35, just opposite the taxiway "D".

Touch down and aircraft ground track

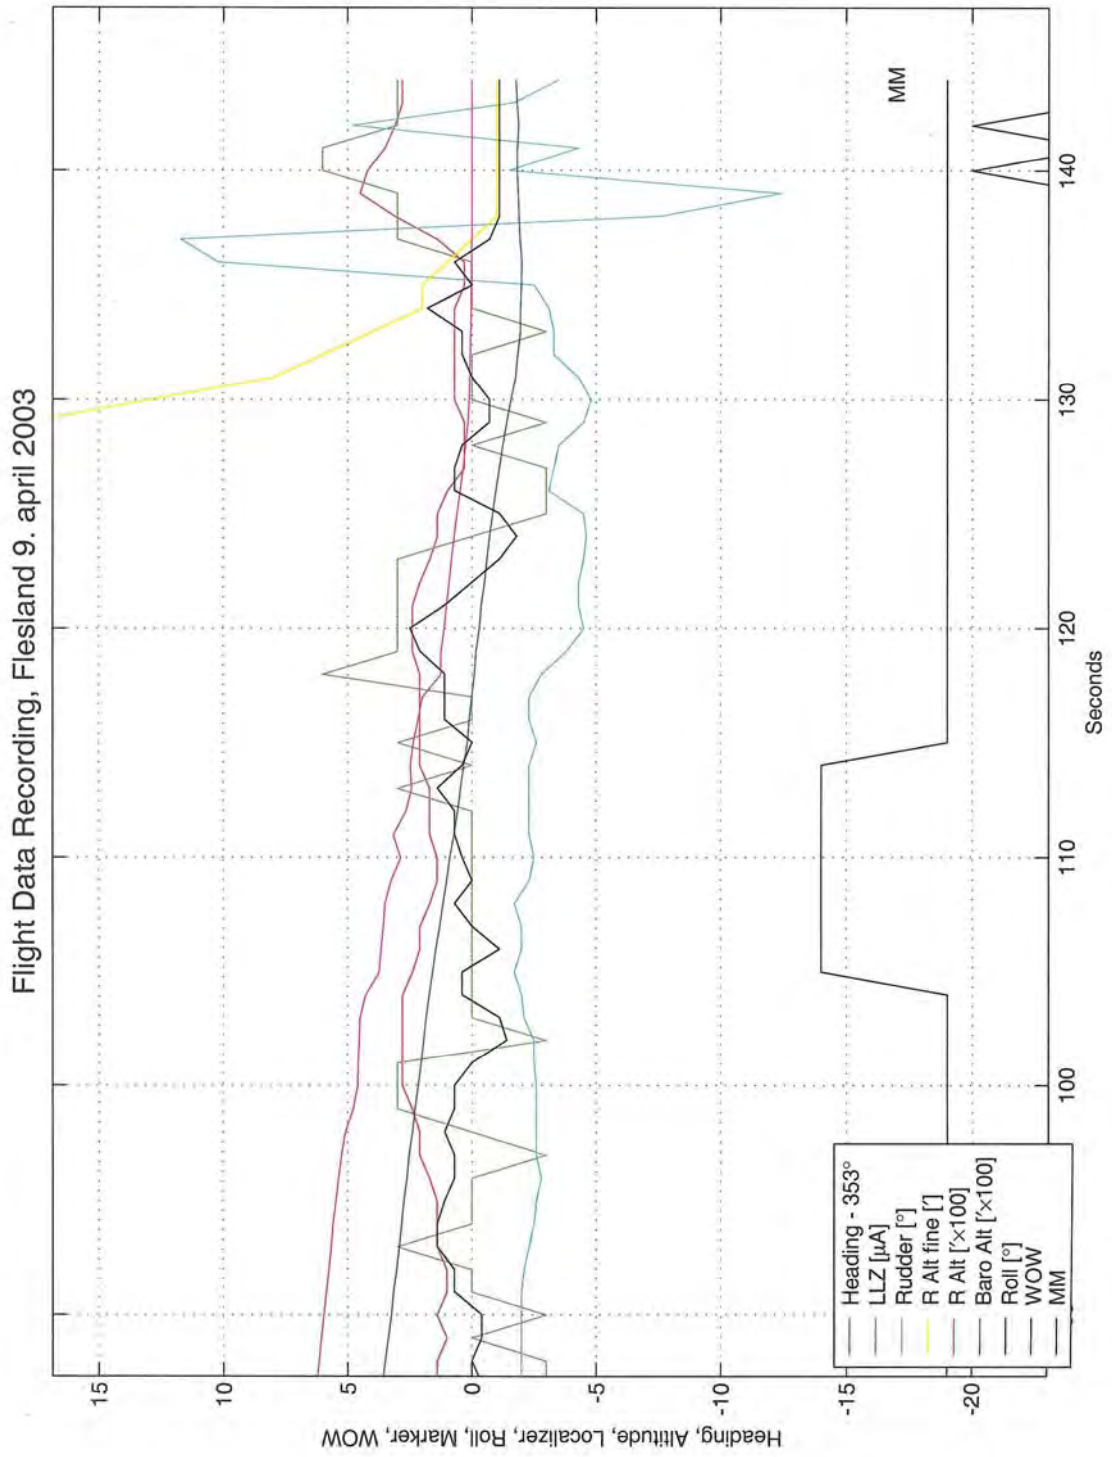
APPENDIX 4 LN-RMO

1.18.2.2 A closer look at the LLZ recordings show that there is a small deviation of the LLZ shortly before TD. There is a slight right deviation followed by a slight left deviation. This compares well with the incidents and may be the cause for the AP drift to the right at about 100 ft radio altitude. During autolandings the AP will correct back as the LLZ beam straightens out. Cf. Appendix 4.

2.7.4 After the incident on 24 March 2003, SAS made some evaluation flights on 9 April 2003, using AP and performed autolandings. The results indicated that the AP tracked the LLZ beam and steered the aircraft to a touch down slightly left of centre line, but within acceptable tolerances. Based on the evaluation, SAS revised the approach charts to include a note that autolandings are not recommended due to a dip in the GP. The evaluation recordings also indicate that there is a slight bend on the LLZ shortly before TD. This

SAS evaluation flight recordings
