REPORT

Sjø 2009/04

REPORT ON INVESTIGATION OF OCCUPATIONAL ACCIDENT ON BOARD MV NORDSTAR - LHXV NORTHWEST OF MÅLØY 7. OCTOBER 2008

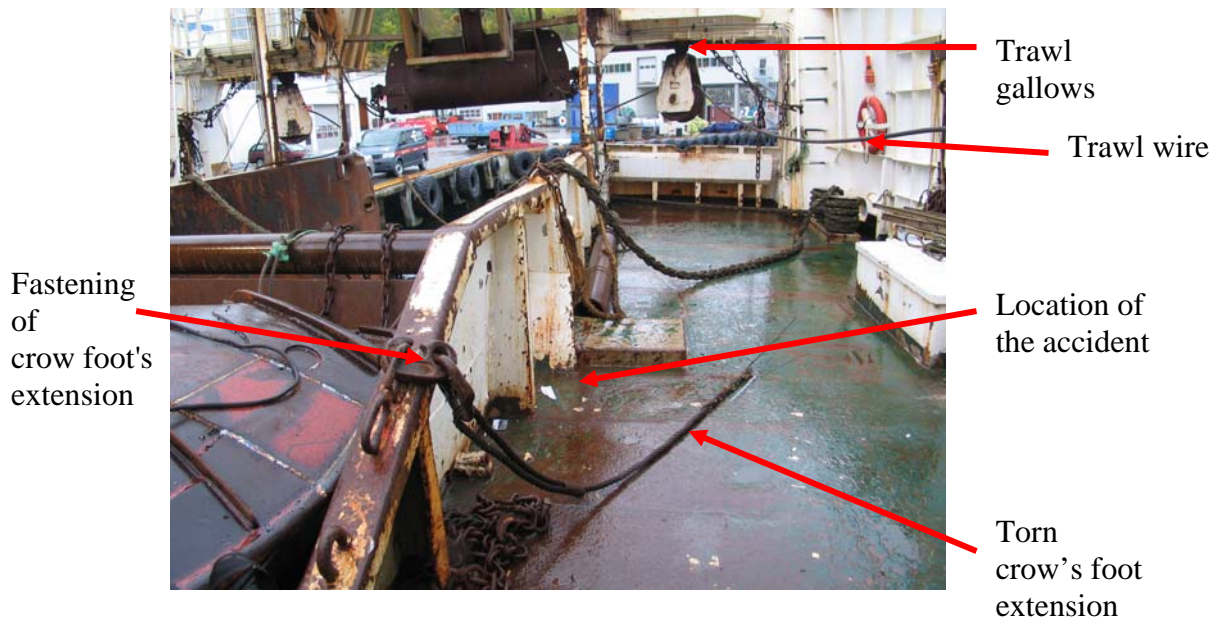
inner rail and the crow's foot extension, aft of the position where the crow's foot extension is fixed to the inner rail with a steel hook (see figure 1).

Figure 1: Port side of the trawler slip seen from the front.

When the crow's foot extension was tightened because the port side trawler door had fallen into the sea, one of the crew was squeezed between the crow's foot extension and the inner rail. However, he managed to get his right foot above the cable before his left leg was squeezed for a short time against the rail until the crow's foot extension broke. The deck chief managed to notify the skipper who stopped the starboard winch. The skipper understood that something was wrong, and saw that the trawler door had fallen overboard. He is of the opinion that he looked down on the control desk to see if the break was engaged. The skipper stopped the vessel and winched in the port side trawler door, before going down to the trawler deck. Here it was established that one of the crew was seriously injured in his left leg.

When the port trawl door went into the sea, the crow's foot extension, which is fastened to the trawl door, tightened up with severe force so that one of the crew on the deck was injured. On the MV Nordstar, the crow's foot extensions lie forward on the deck, and are fastened to the railing toward the trawl alley. The Accident Investigation Board Norway recommends that the shipping company consider implementing risk analyses of the arrangement with the crow's foot extensions in relation to work operations on the aft deck.

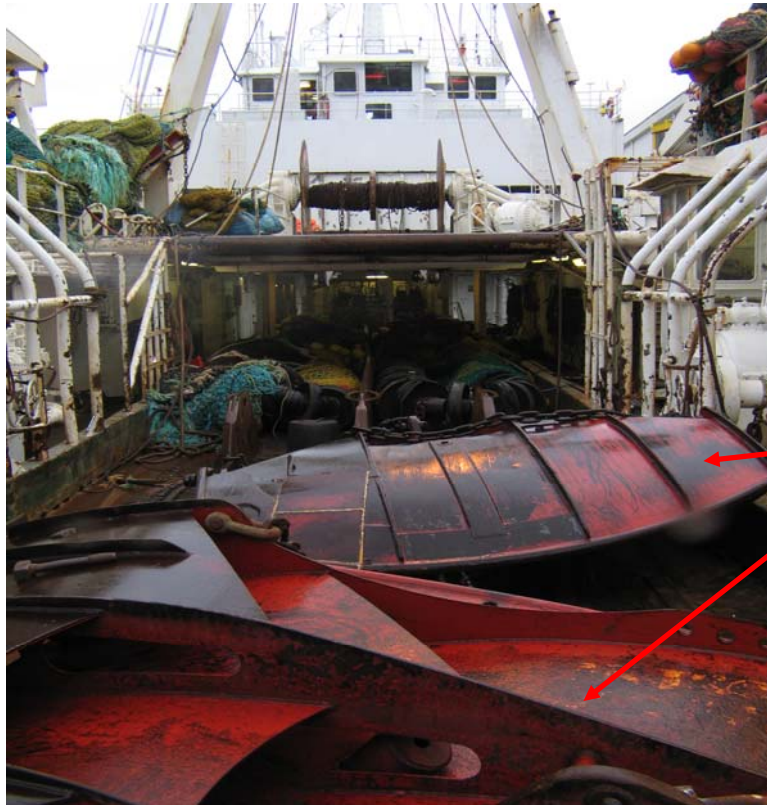
The vessel is equipped with two trawl doors. The doors cover an area of 9.5 m² and weigh 4.4 tonnes. Figure 2 shows the trawl doors lying in the trawl alley.

The trawl doors are taken on deck.

Figure 2: The trawl alley seen from the aft.

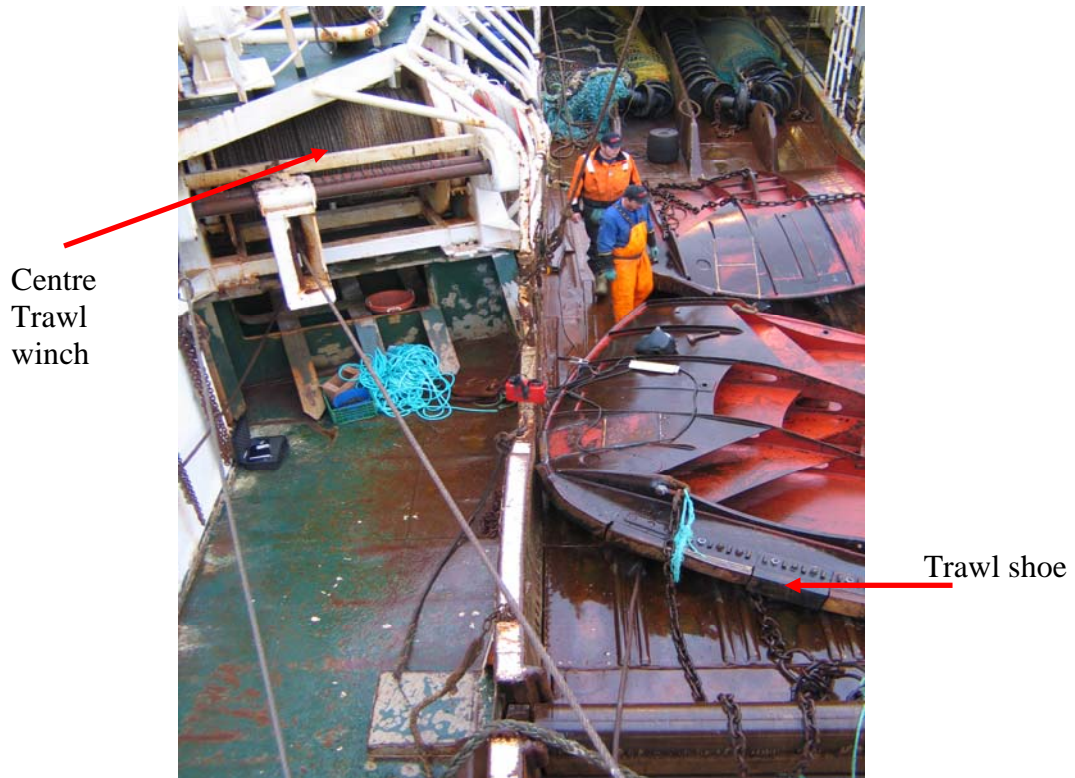
Figure 3: Port side centre trawl winch, Brattvåg type.

The trawl winch brakes were overhauled in July 2008. This included changing the brake pads. The brakes were also inspected following the accident on 7 October 2008 by the engineer on board, and were found to be in order. The brake lining was sufficient and showed no indication of damage.

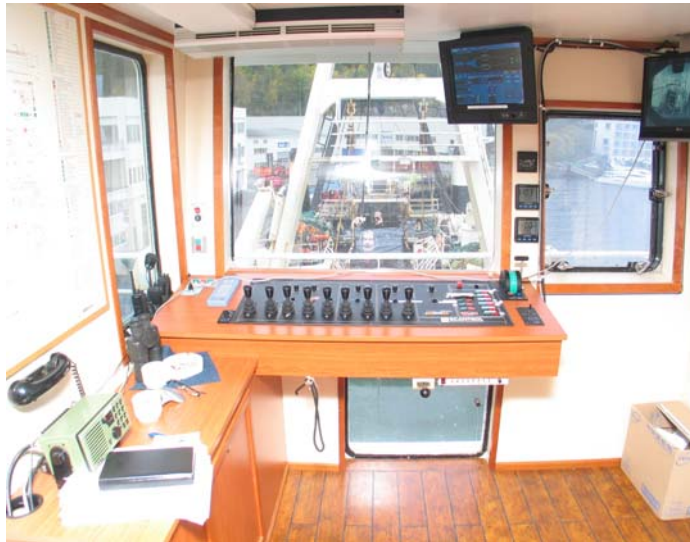
Figure 5: Operation panel aft in the wheelhouse.

The winch operator stands in front of the control panel located against the aft bulkhead. The control buttons for the winches are clearly marked with SB, S and BB respectively. The control buttons on the panel are placed in such a way that the buttons for controlling the starboard winch is in fact located on the starboard side of the button which controls the port side winch, and vice versa. As the operator is facing astern, the control buttons for the port side winch will be placed to the right of the control button for the starboard winch, and vice versa. The control buttons are placed 5-7 cm apart.

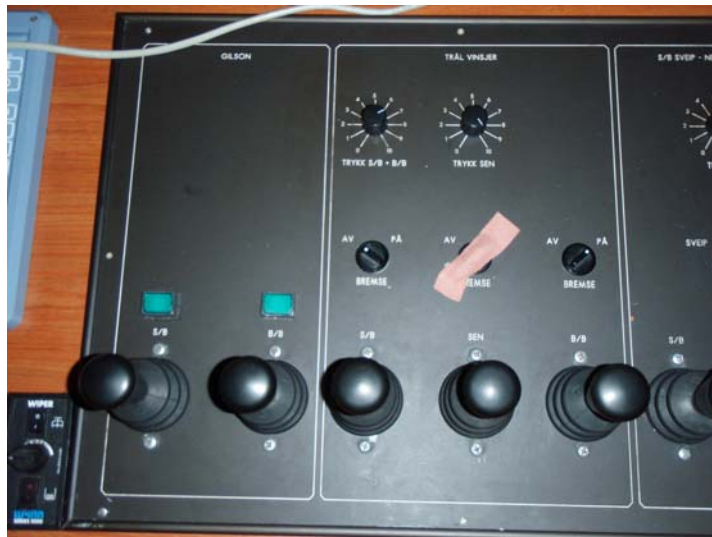
Figure 6: Operation panel for winches.

The pneumatic brakes are operated by an off/on button for each winch. In addition, the pneumatic pressure in the brake system is adjusted on a scale from 0 to 10. The pressure in the brake system for the centre winch is set separately, while the pressure for the starboard and port side winches is set with a joint switch. See Figure 6.
