Report on collision with a landslide at Finneidfjord between Bjerka and Mo i Rana on the Nordlandsbanen line on 24 October 2024

Railway report 2026/01

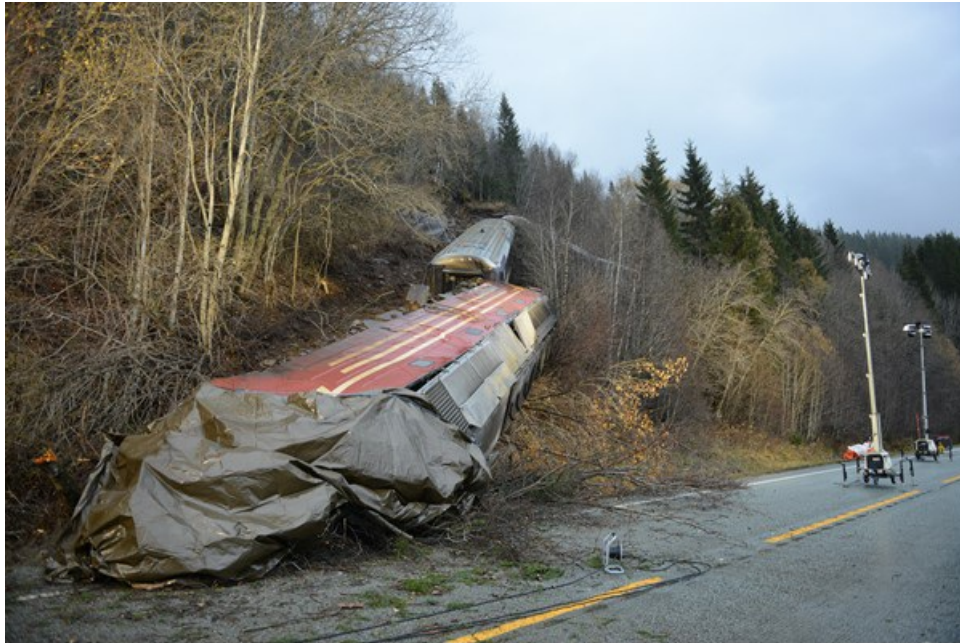
On Thursday, 24 October 2024 at 1414, train 471 collided with large landslide debris at km 472.398 near Finneidfjord on Nordlandsbanen. In the collision, the locomotive derailed, overturned, and continued down an embankment together with passenger carriage 1 and 2 before striking the roadside shoulder and coming to a stop. Carriage 3 derailed, while the remaining two carriages remained on the track. The locomotive driver was killed in the accident, and five passengers sustained minor injuries.

The accident site. Photo: NSIA

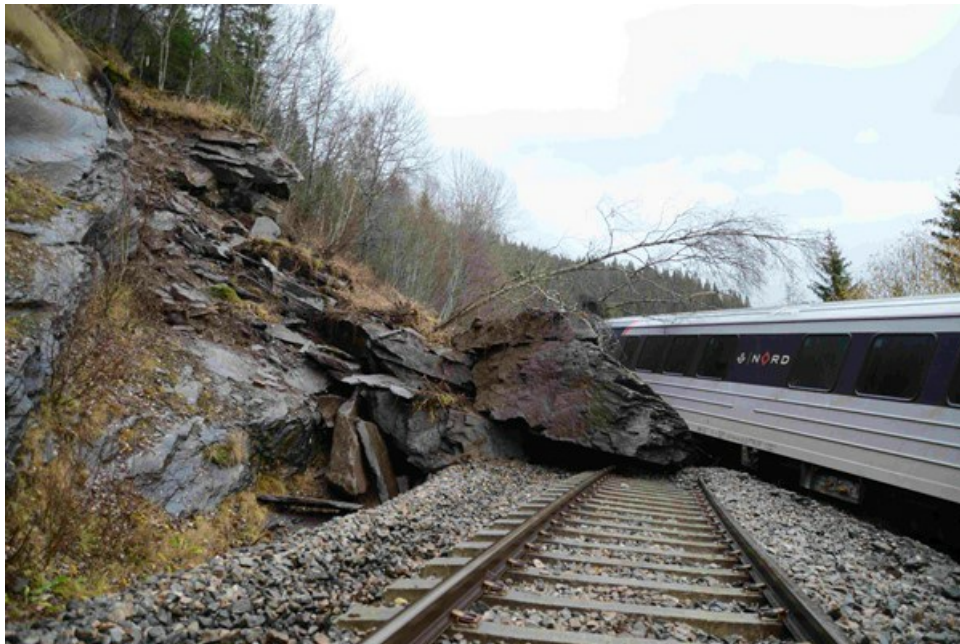
The cause of the accident was a landslide of between 100 and 150 m³, of which approximately 30 m³ blocked the line when the train arrived. The largest rock the train struck was about 15 m³. Prior to the accident, the train was traveling at the line speed of approximately 90 km/h, and its speed had been reduced to about 60 km/h at the moment just before the collision.

- Heavy rainfall before the accident contributed to the landslide.
- The landslide remained undetected from the time it occurred until the train arrived.
- Previous rock protection measures were insufficient to prevent the landslide.
- Previous rock protection measures were not assessed or implemented in accordance with

Rock slide at Finneidfjord. Photo: NSIA
