THE AIRCRAFT ACCIDENT INVESTIGATION BOARD / NORWAY

HAV 02/93

**REPORT ON THE CONVAIR 340/580 LN-PAA AIRCRAFT
ACCIDENT NORTH OF HIRTSHALS, DENMARK, ON
SEPTEMBER 8, 1989**

SUBMITTED FEBRUARY 1993

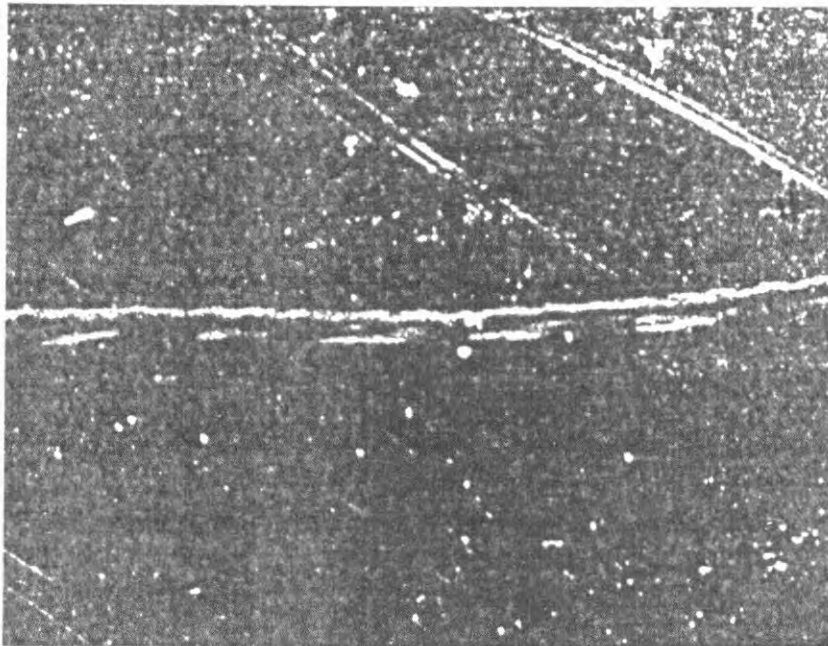
PHOTO 1 (FOTO) Typical double trace due to stylus resonance causing multiple alternative knife edge indentations on altitude parameter of Flight #2. Photo magnified 32 X.

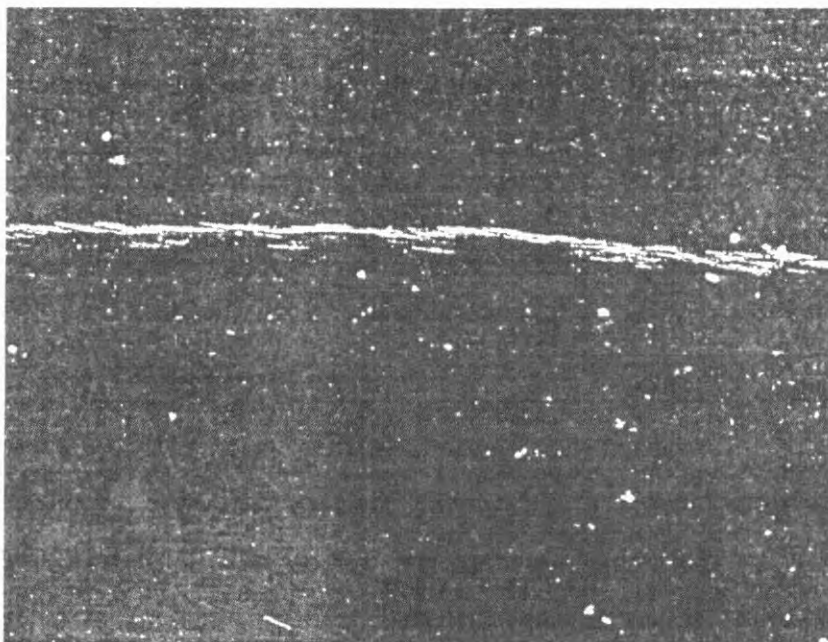
PHOTO 2 (FOTO) Typical double trace due to resonance on altitude parameter of Flight #16. Photo magnified 32 X.

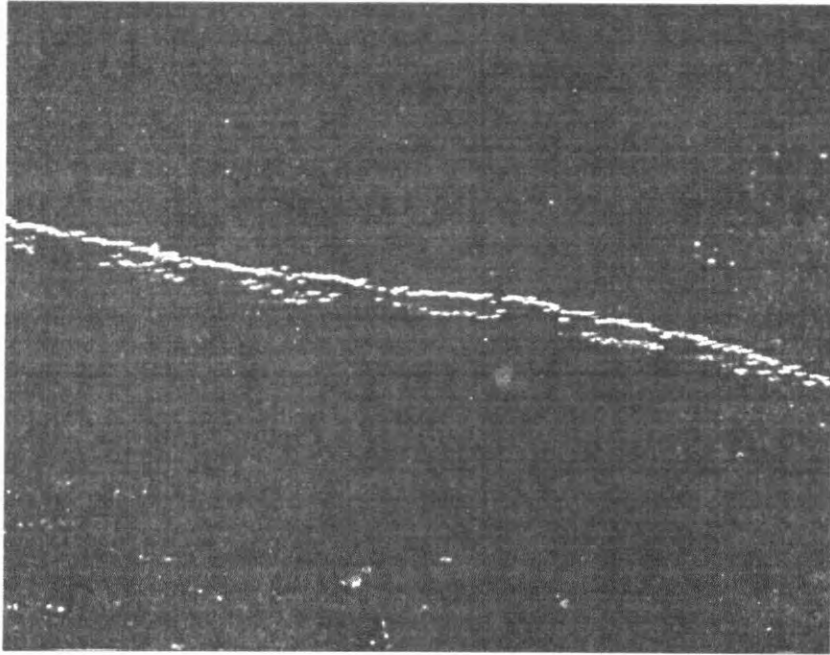
PHOTO 3 Typical double trace due to resonance on altitude parameter of (FOTO) Flight #28. Photo magnified 32 X.

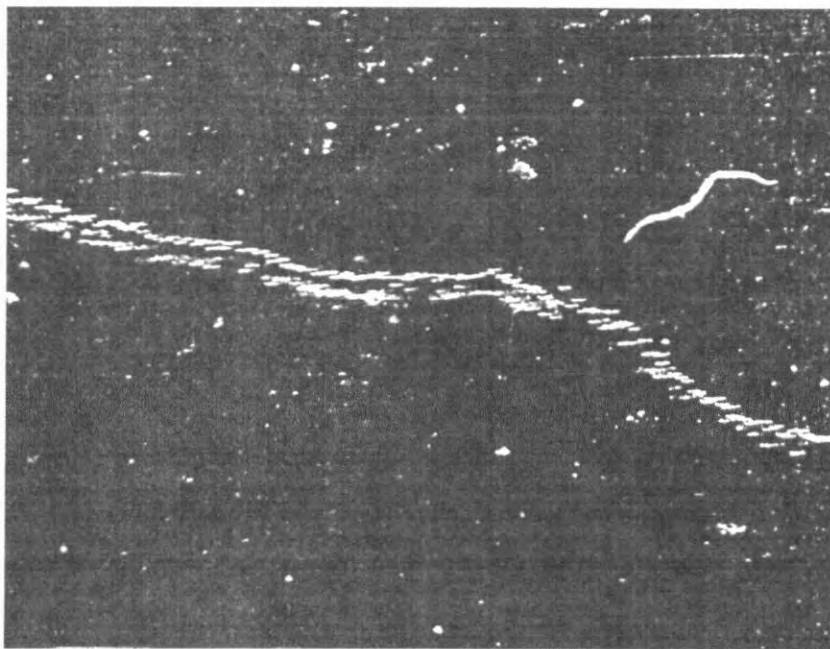
PHOTO 4 Typical double trace due to resonance on altitude parameter of the (FOTO) accident Flight #33. Photo magnified 32 X.

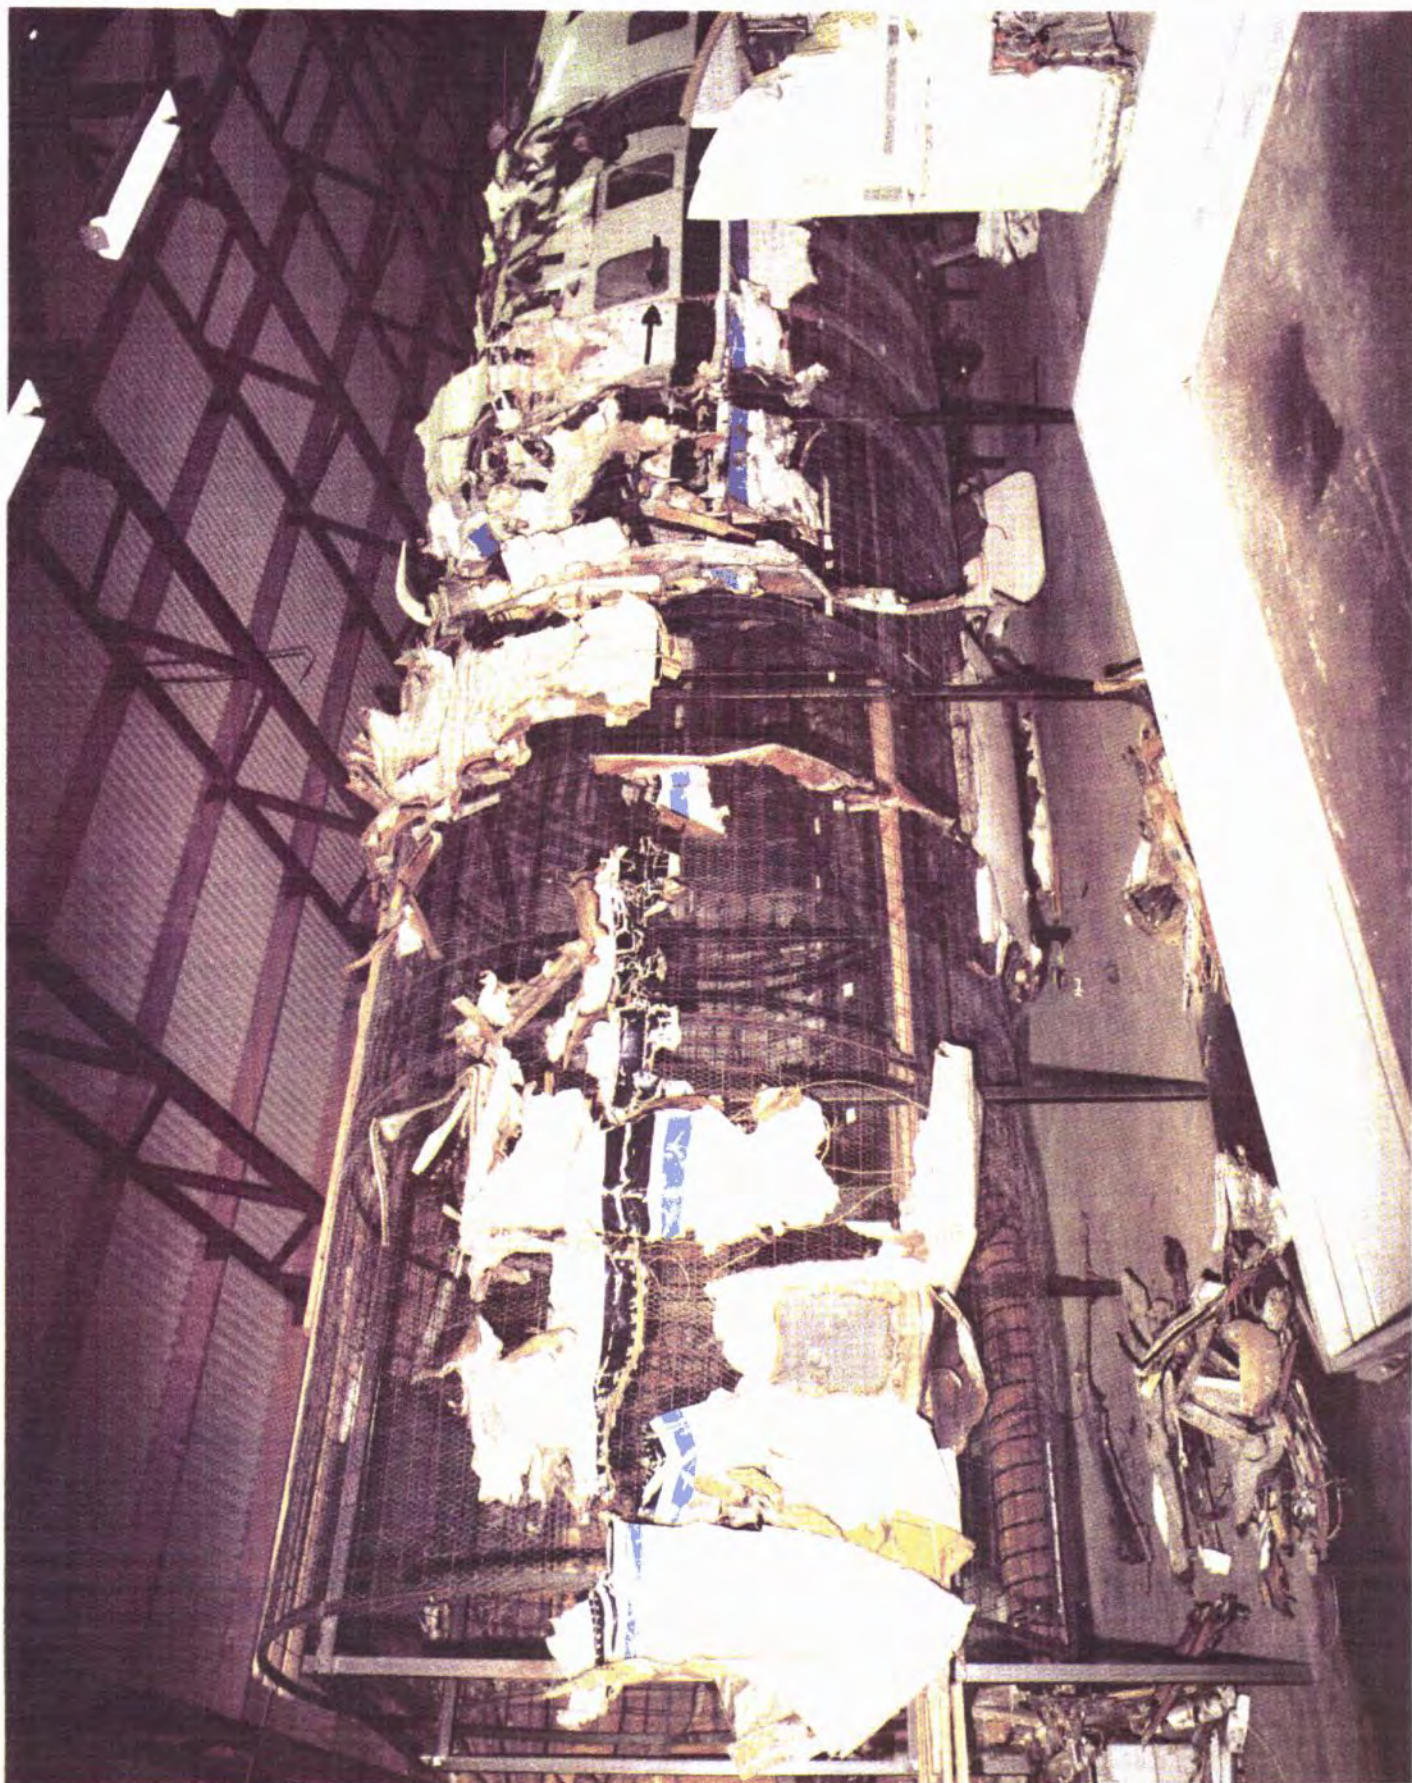
PHOTO (FOTO) 5A

The most extensive damage to the fuselage was to the forward left side. Practically the entire construction of this part of the fuselage broke up into small pieces in a

FORWARD, LEFT SIDE OF THE FUSELAGE
ARROWS POINT AT STA 261
(VENSTRE SIDE AV SKROGET, FREMRE DEL
PILENE VISER STA 261)

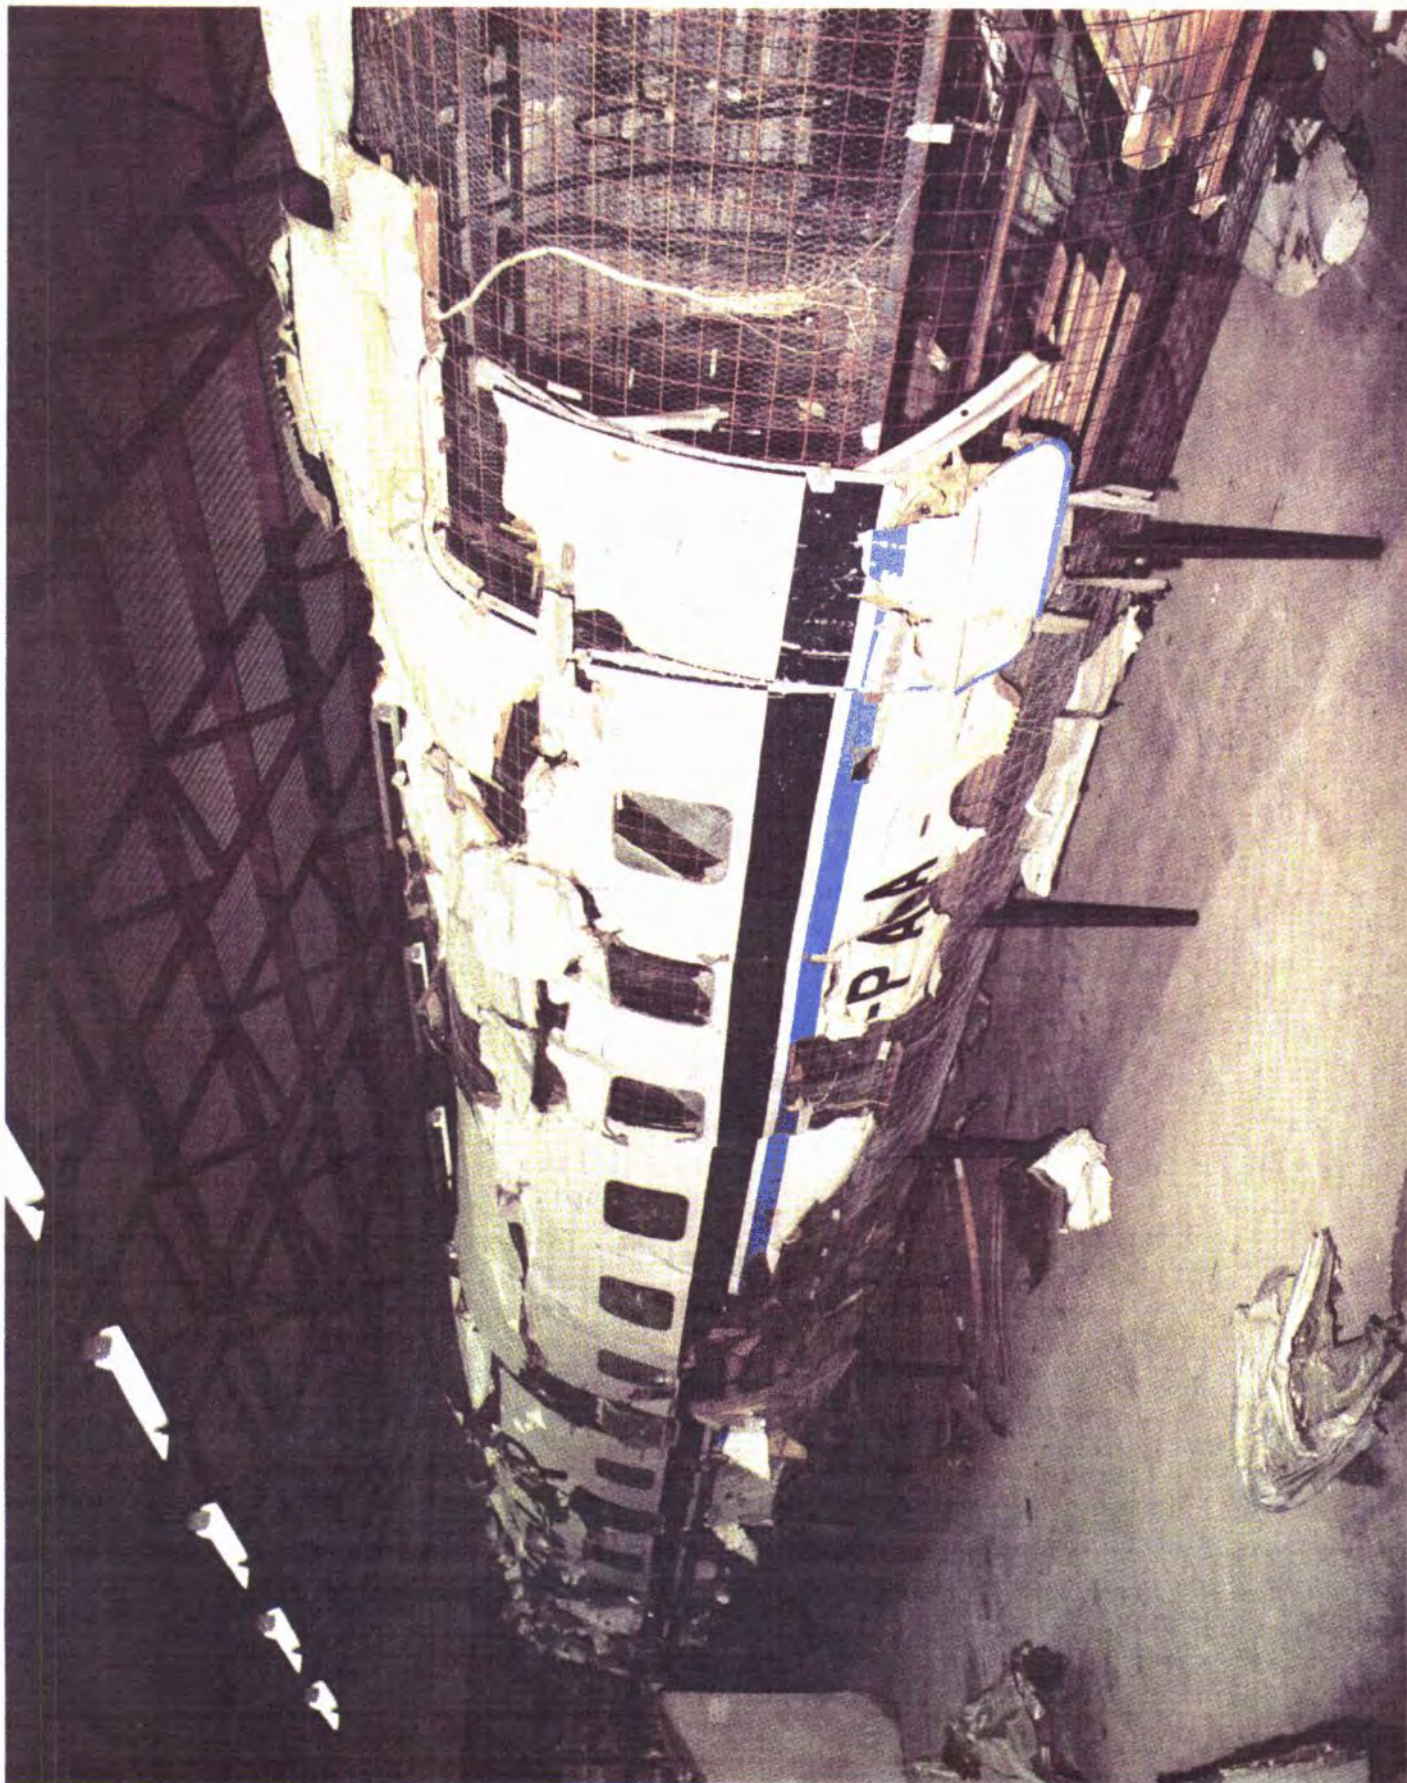
PHOTO (FOTO) 5B

AFT, LEFT SIDE OF THE FUSELAGE
(VENSTRE SIDE AV SKROGET, BAKRE DEL)

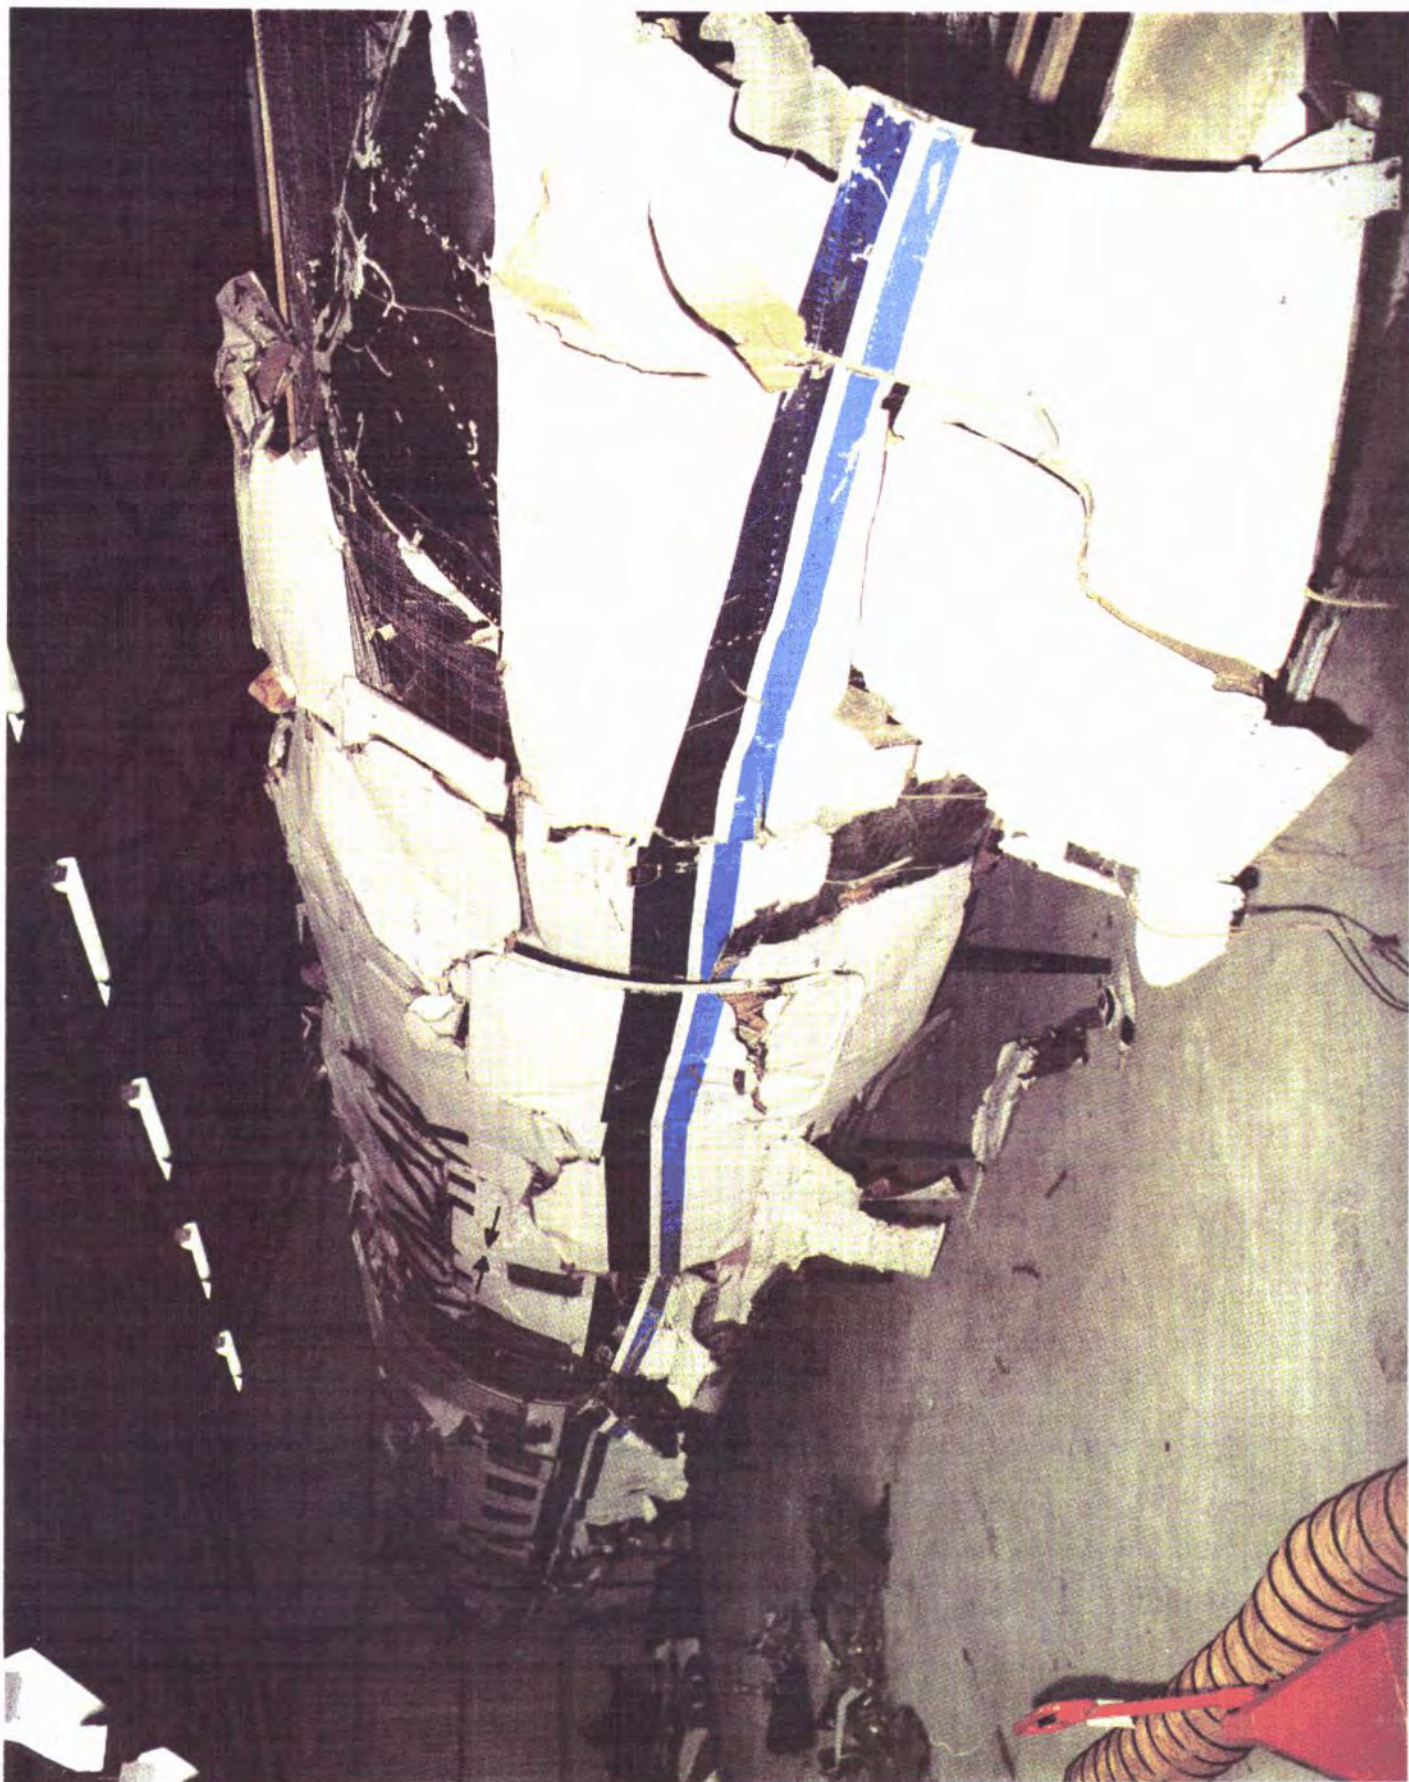
PHOTO (FOTO) 6

FORWARD, RIGHT SIDE OF THE FUSELAGE
ARROWS POINT AT STA 261
(HØYRE SIDE AV SKROGET
PILENE VISER STA 261)

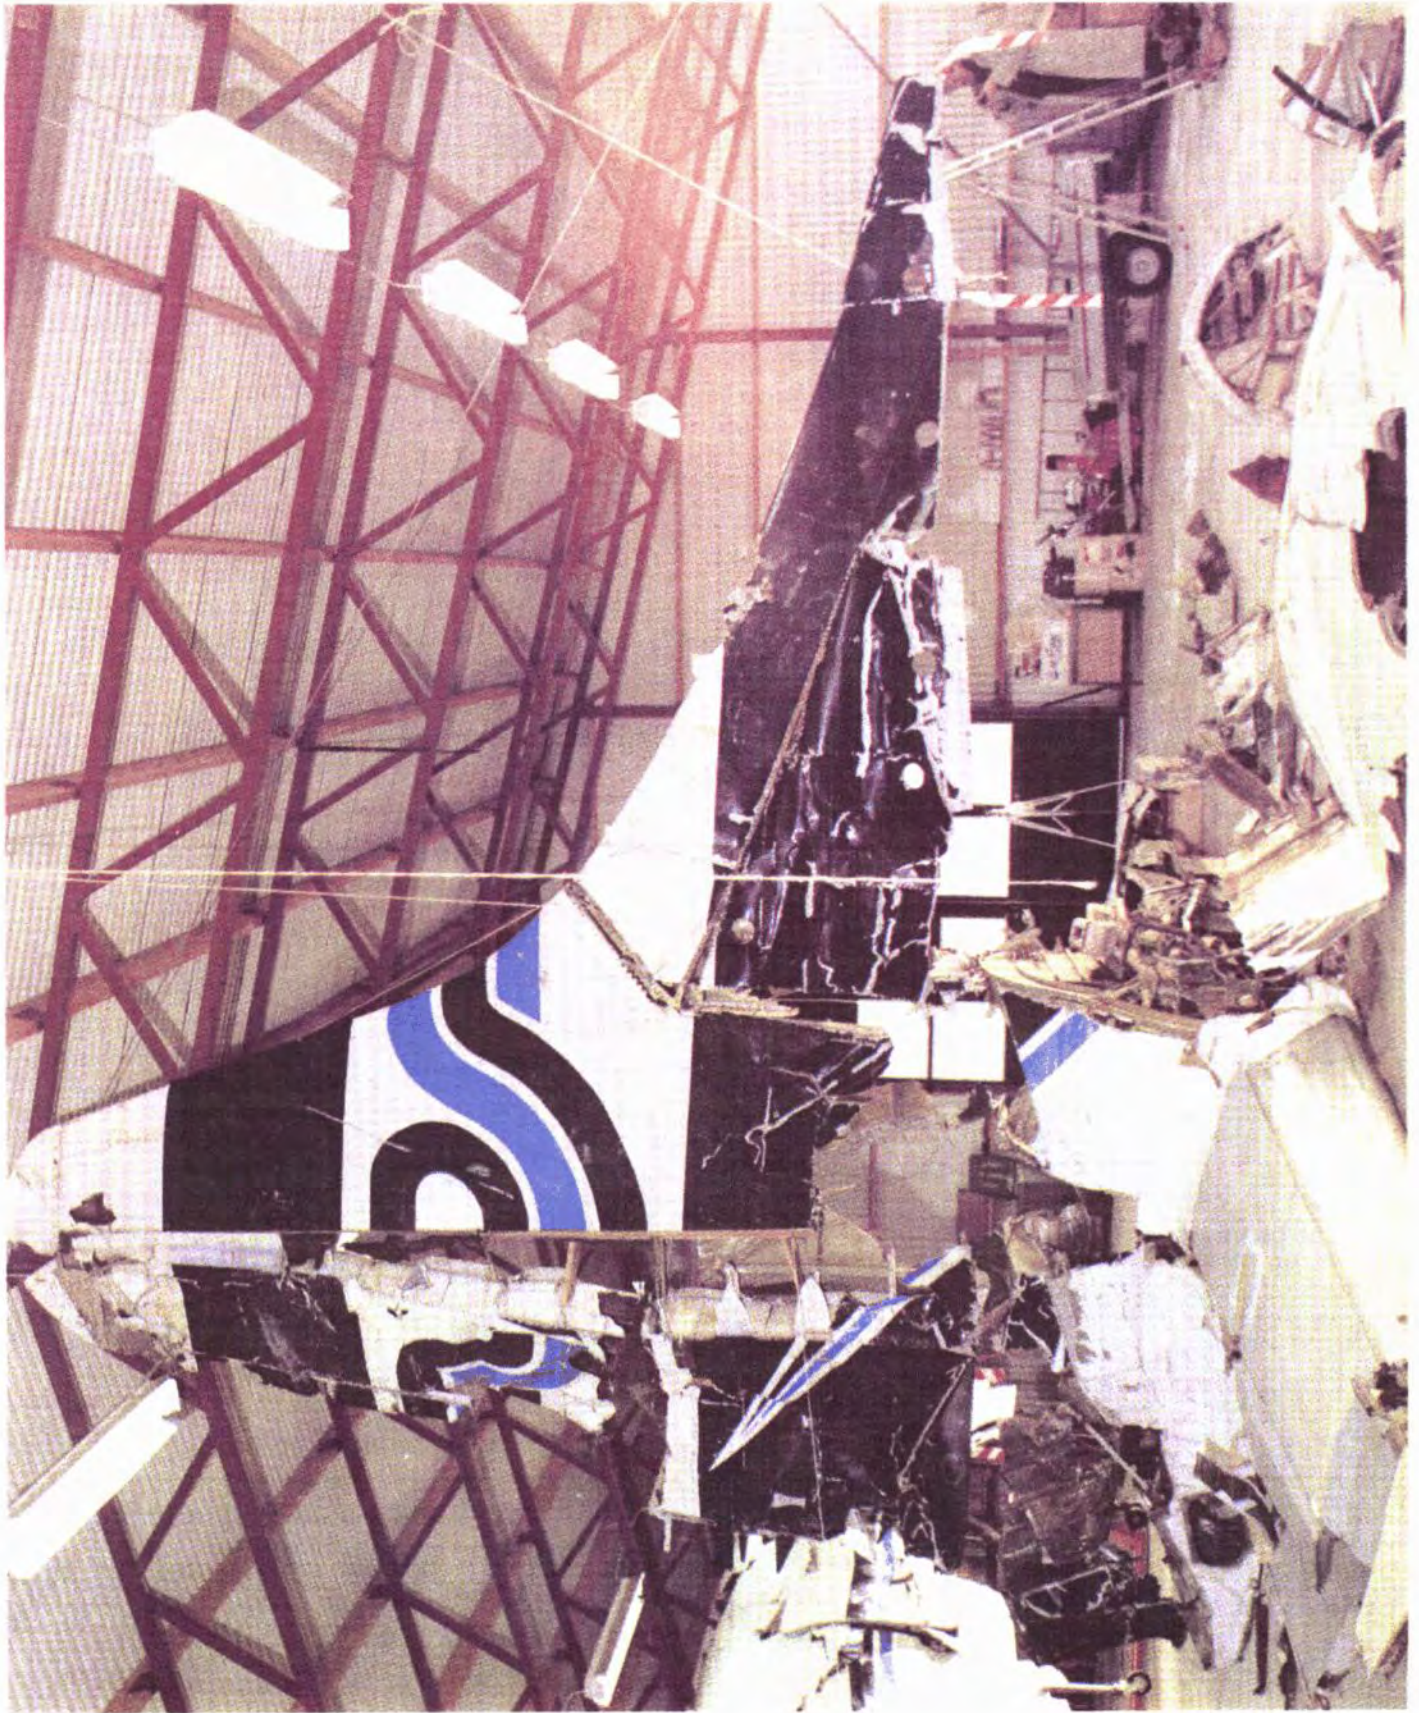
PHOTO (FOTO) 7

RIGHT SIDE OF THE TAILSECTION
(HØYRE SIDE AV HALESEKSJONEN)

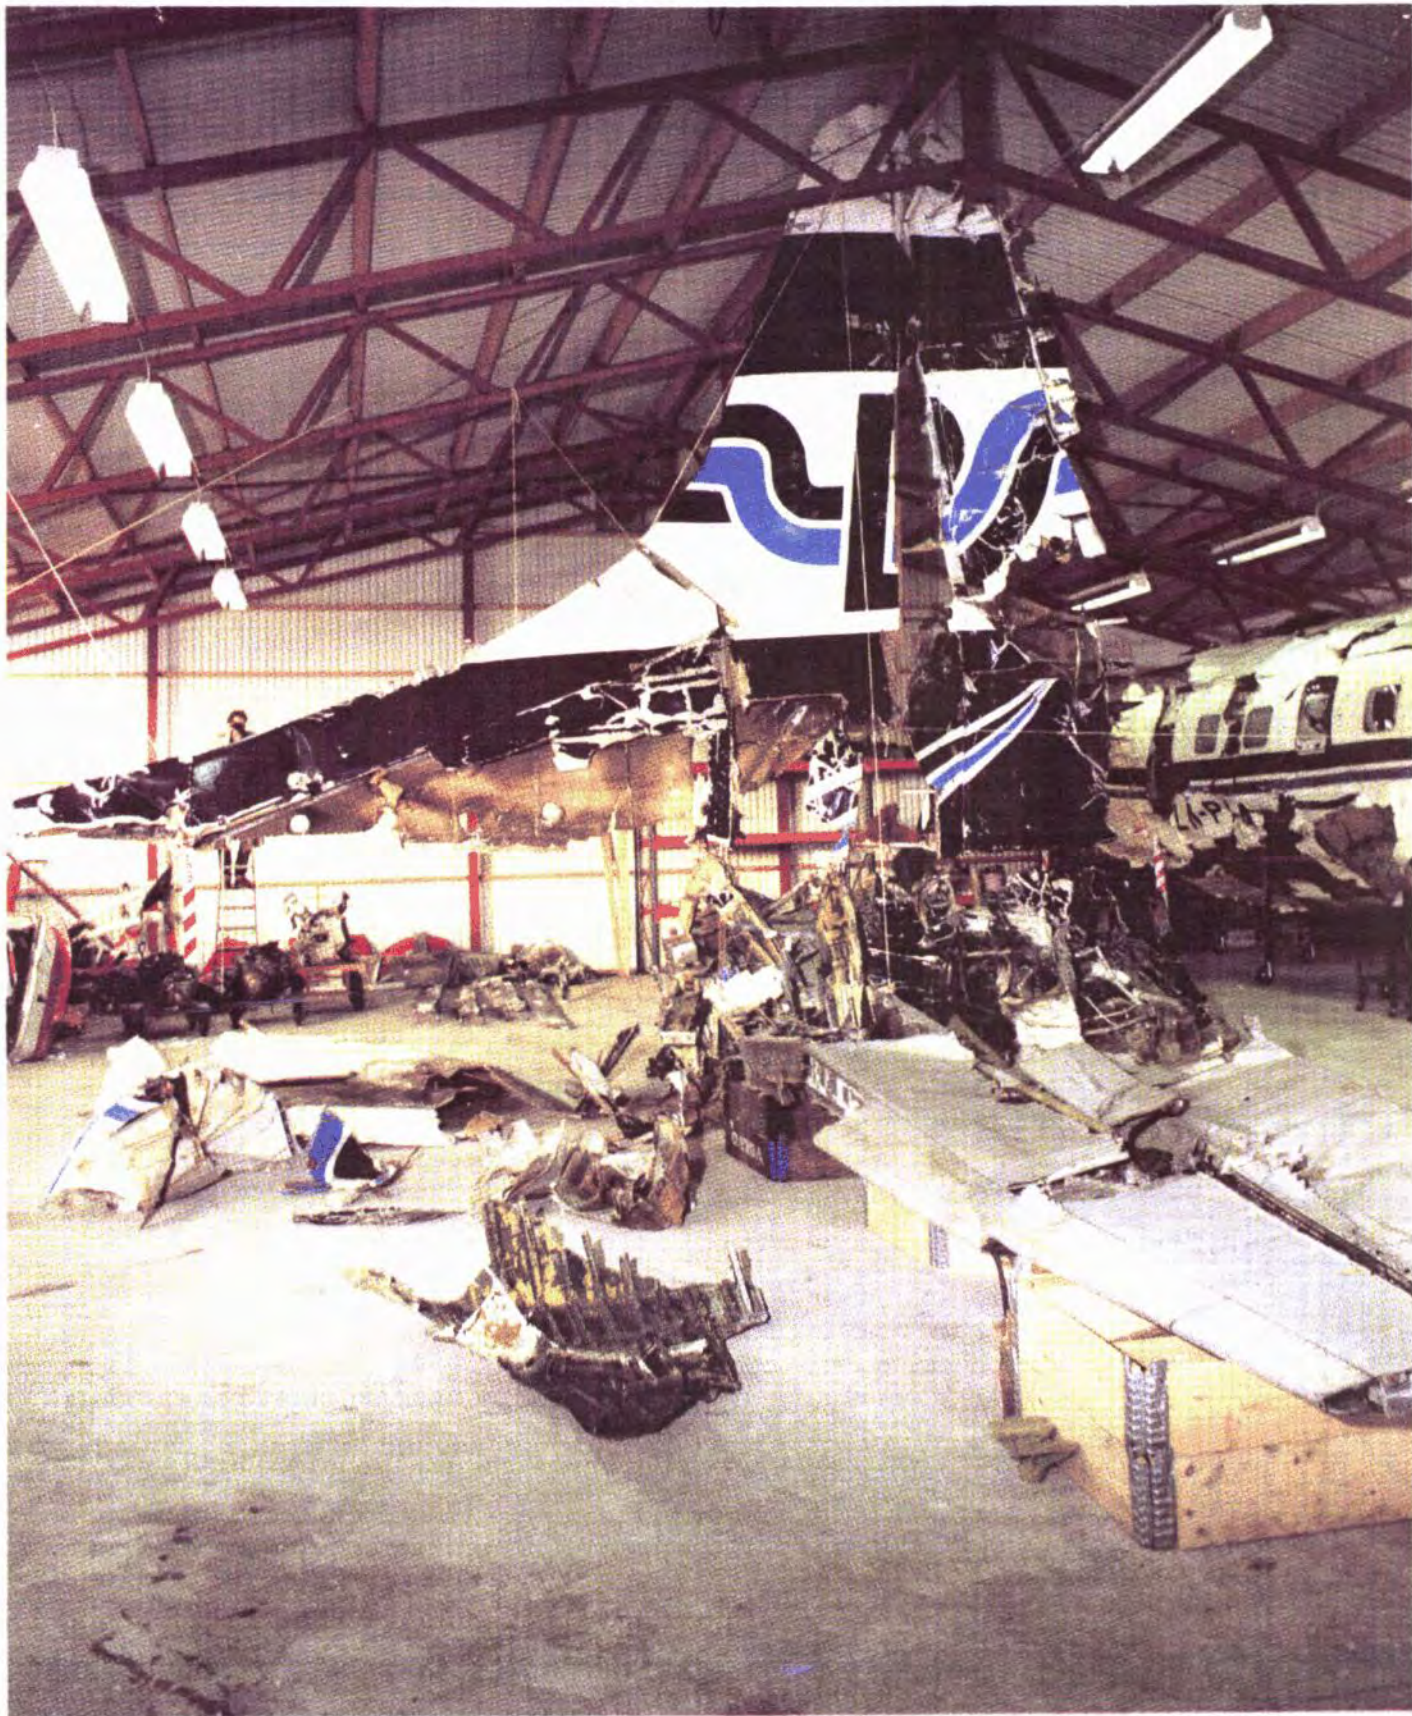
PHOTO (FOTO) 8

LEFT SIDE OF THE TAILSECTION
(VENSTRE SIDE AV HALESEKSJONEN)

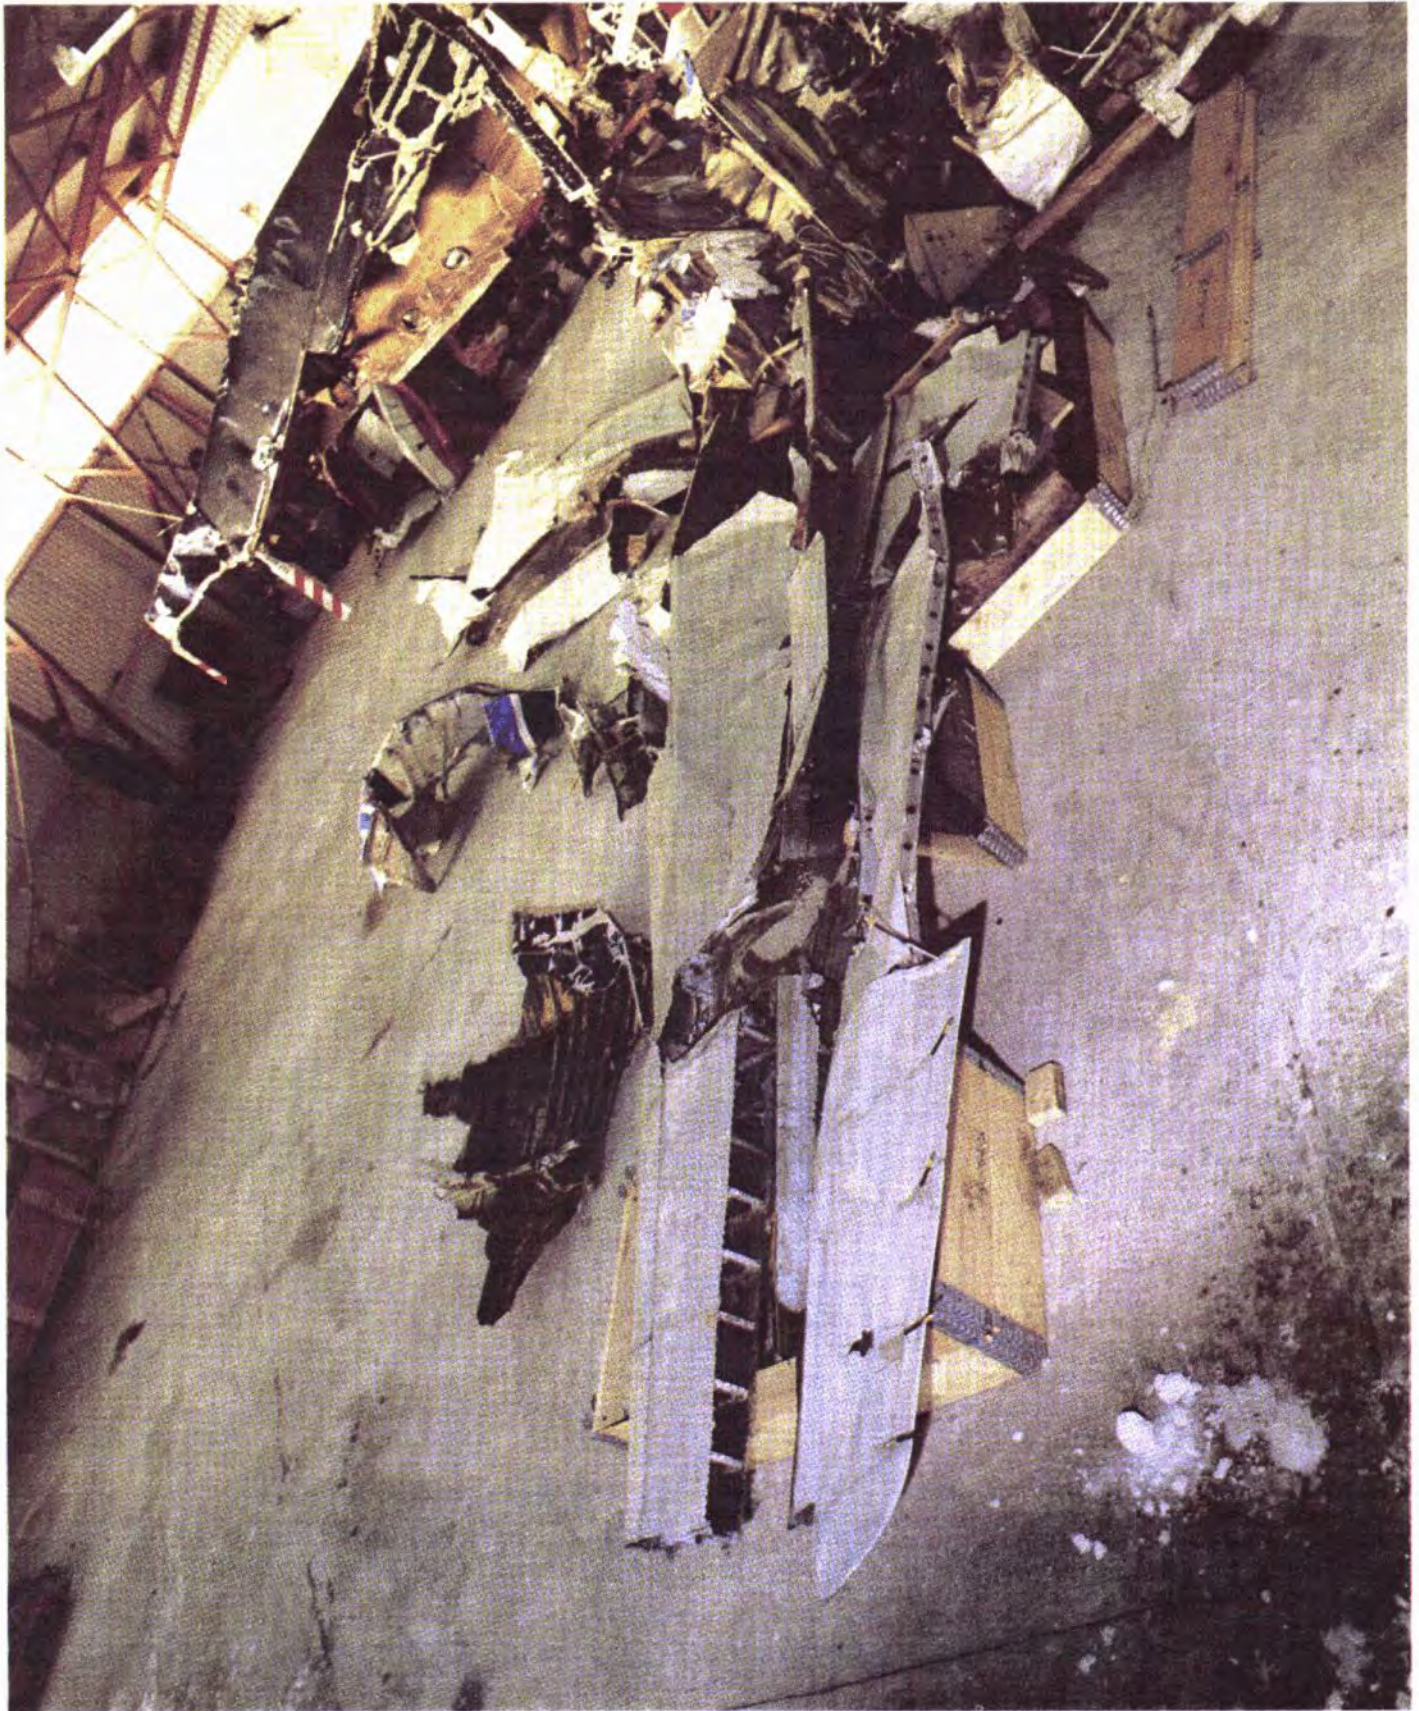
PHOTO (FOTO) 9

LEFT TAILPLANE INCLUDING ELEVATOR
(VENSTRE HALEFLATE M/HØYDERØR)

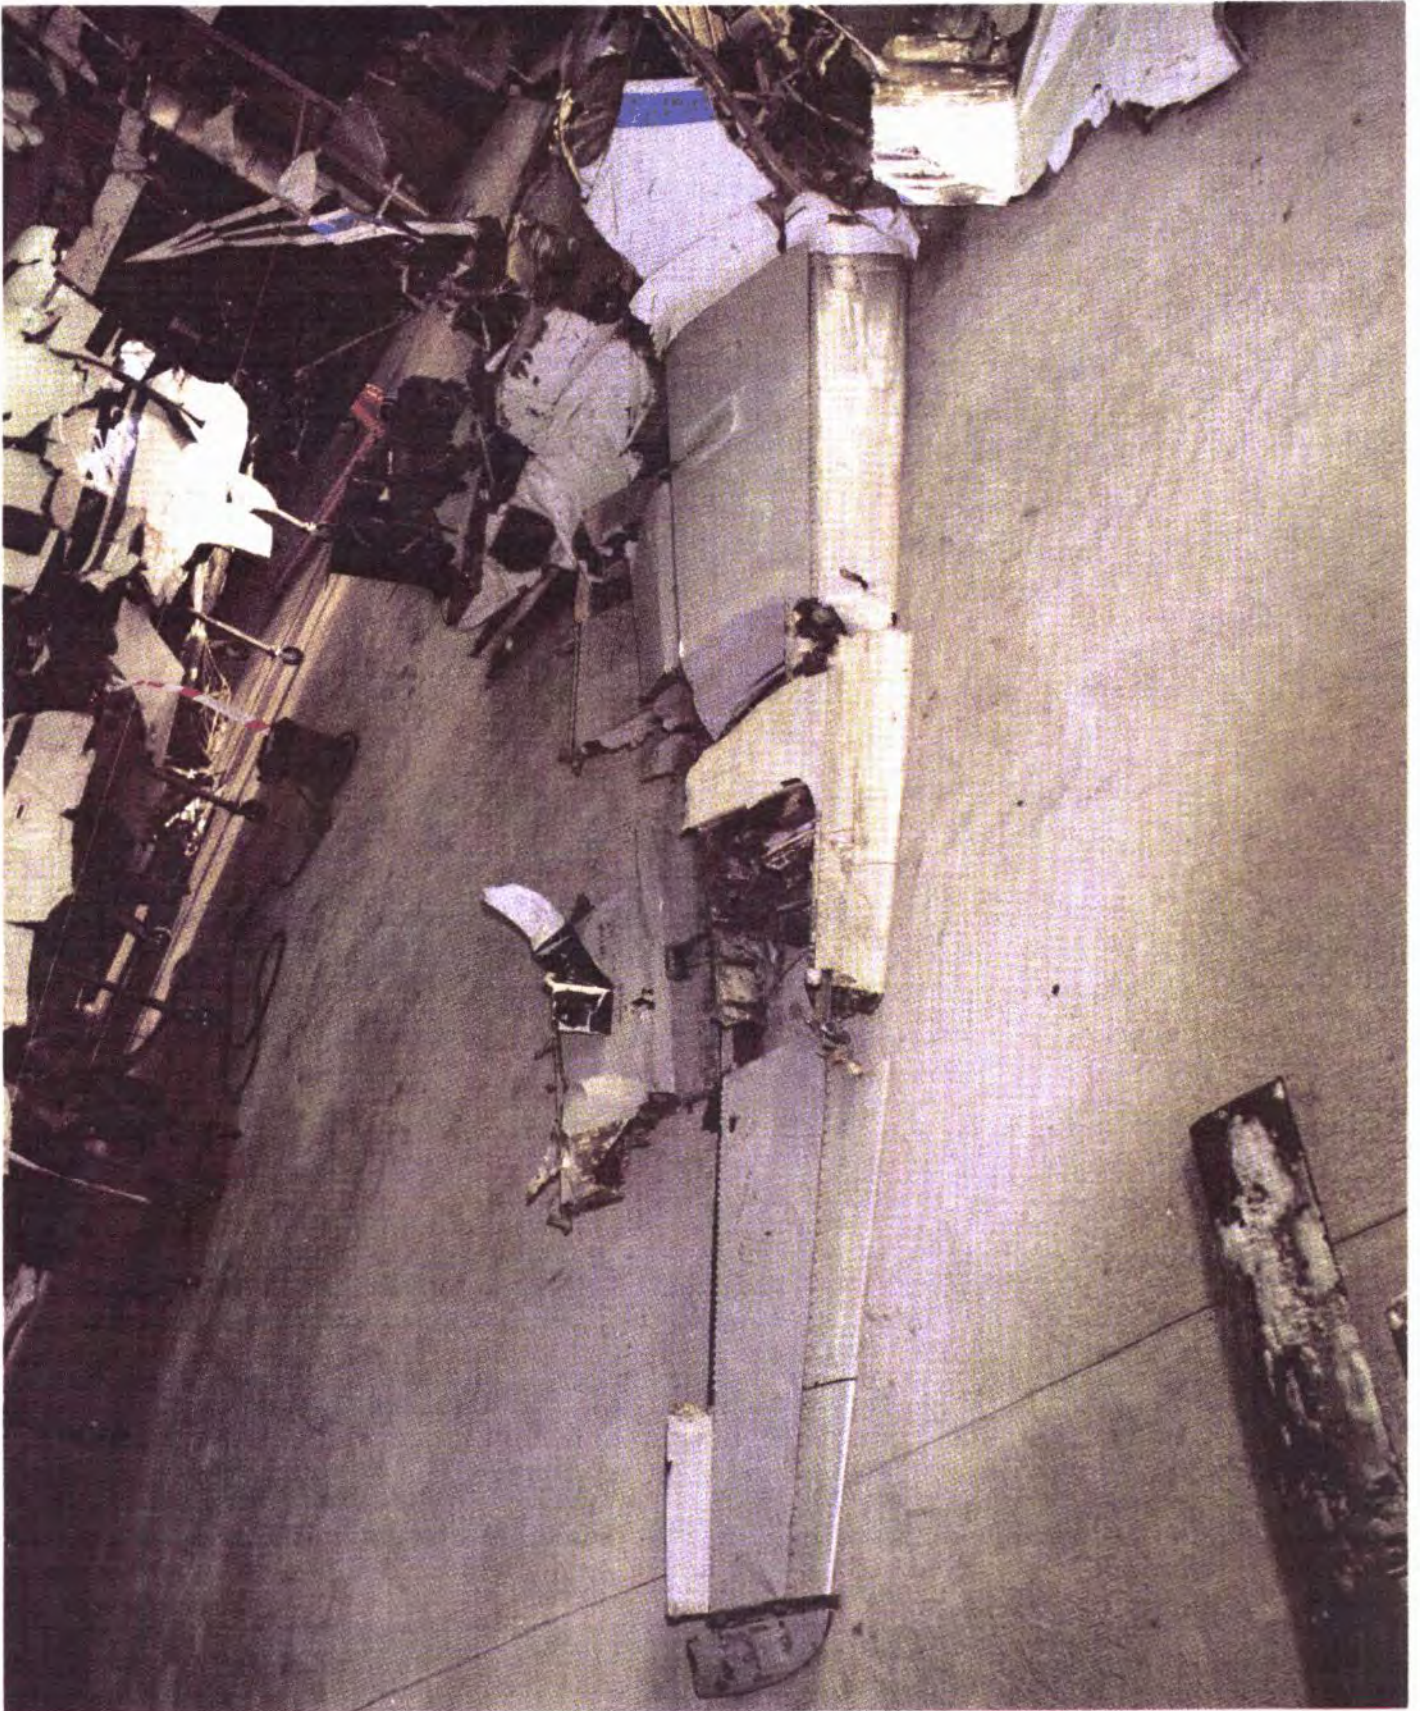
PHOTO (FOTO) 10

RIGHT TAILPLANE WITH PIECES OF ELEVATOR
(HØYRE HALEFLATE M/RESTER AV HØYDERØR)

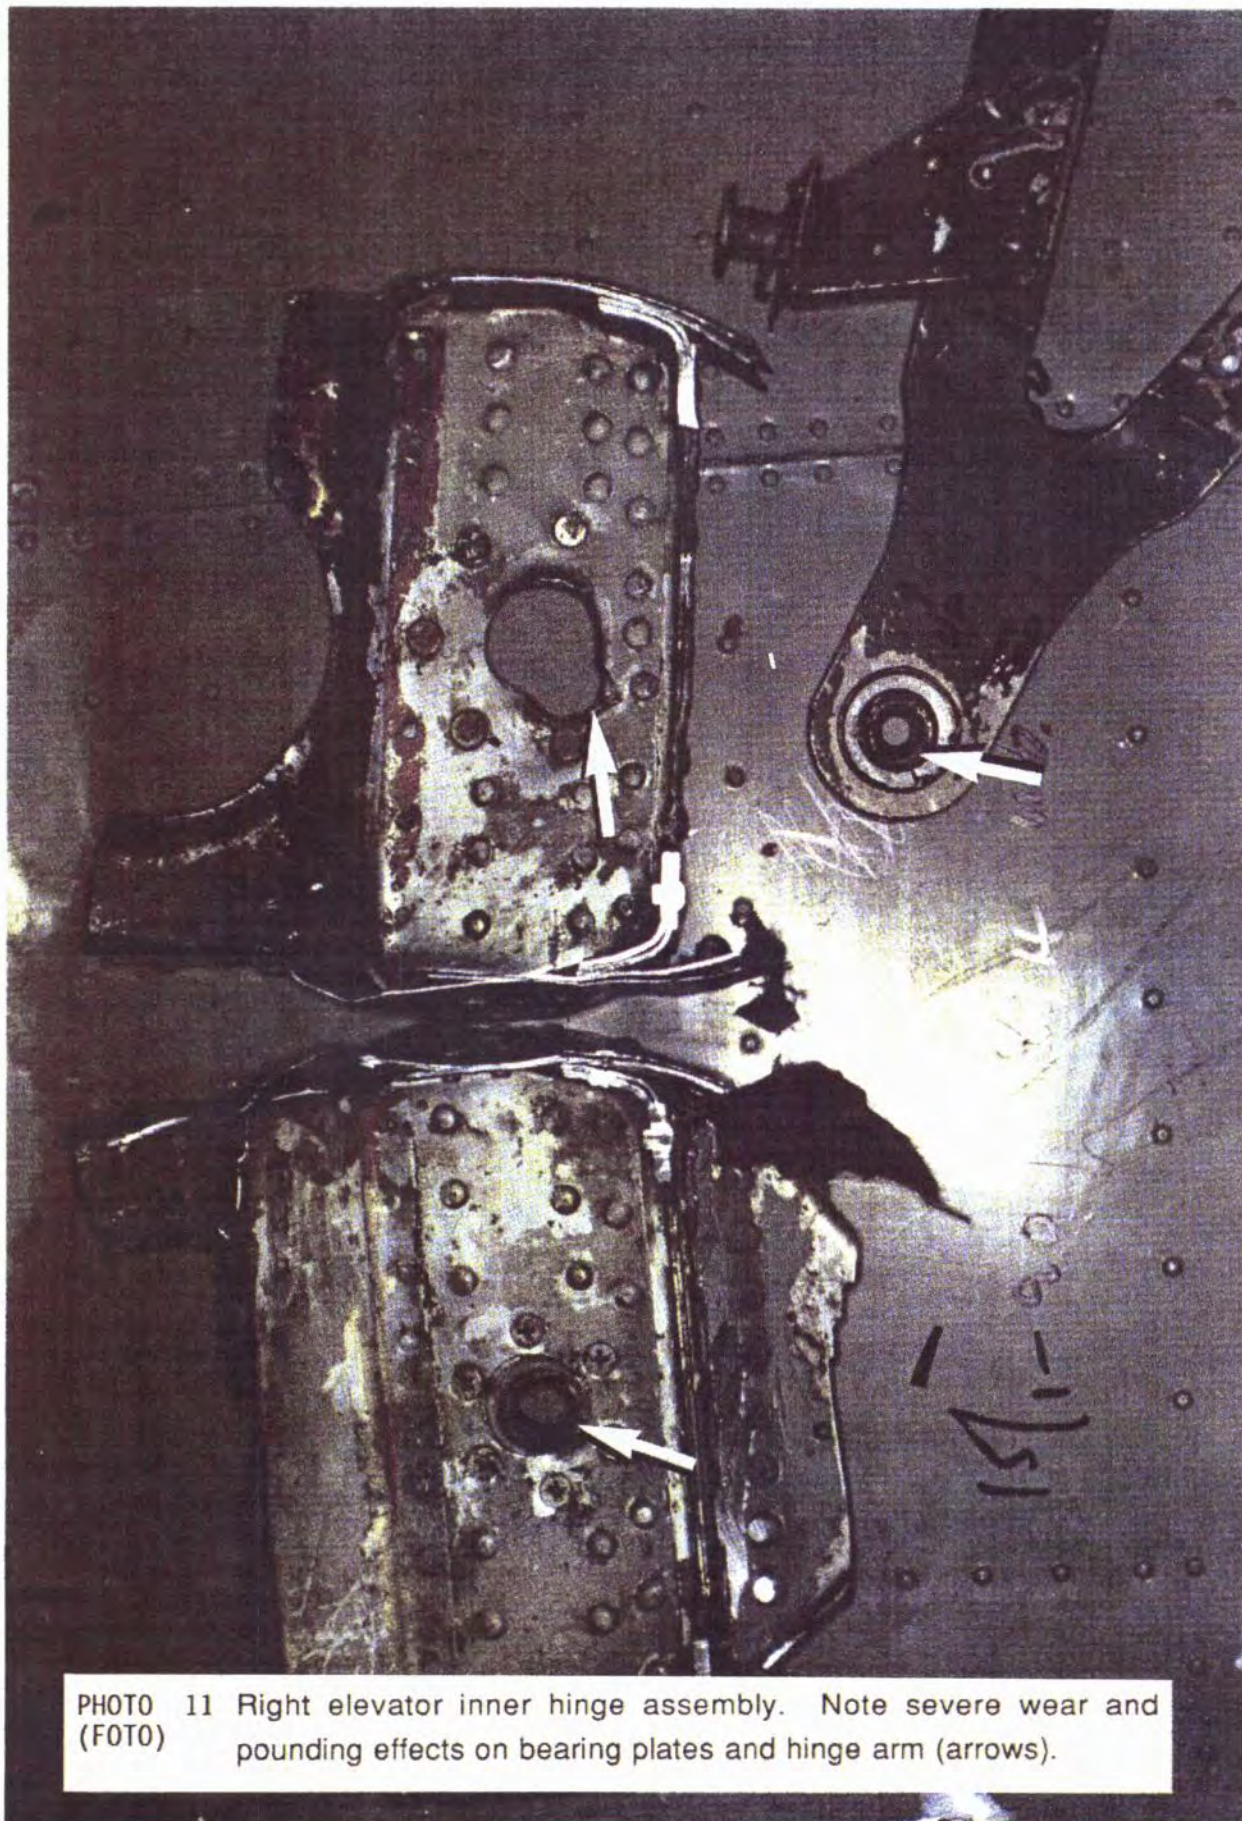
Technical investigations revealed that the inner right-hand elevator hinge was severely damaged. The hinge pin was not found. The anchor nut the pin had been screwed into was torn off in such a way that the threaded portion had disappeared with the pin. The hinge bracket was examined in detail at the Veritec laboratory. There were signs that the bracket had been exposed to strong vibrations in both holes since the hinge pin bushing holes were severely deformed. The material had been substantially compressed in such a way that the holes had changed to an oval shape towards the end of the deformation process (See photo 11).

PHOTO 11 Right elevator inner hinge assembly. Note severe wear and (FOTO) pounding effects on bearing plates and hinge arm (arrows).

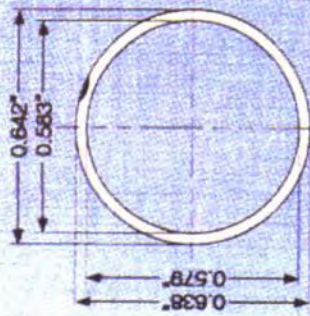
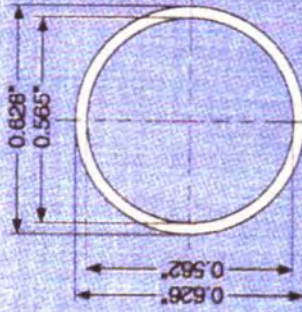
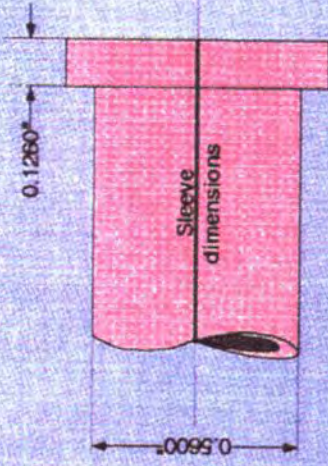
MEASURED DIMENSIONS OF THE AFT RIGHT VERTICAL STABILIZER ATTACHMENT BUSHINGS AND SLEEVE FROM LN-PAA

A check carried out on the bushings installed in the aluminum lugs on the rear right-hand attachment bracket showed a considerable discrepancy between the dimensions in the front and rear bushings. The difference between the outer diameters was approximately 0.013 inches while the difference between the inner diameters was approximately 0.018 inches (figure 4). In the production of these bushings the maximum allowable deviation is 0.001 inches.
