THE AIRCRAFT ACCIDENT INVESTIGATION BOARD / NORWAY

HAV 02/93

**REPORT ON THE CONVAIR 340/580 LN-PAA AIRCRAFT
ACCIDENT NORTH OF HIRTSHALS, DENMARK, ON
SEPTEMBER 8, 1989**

SUBMITTED FEBRUARY 1993

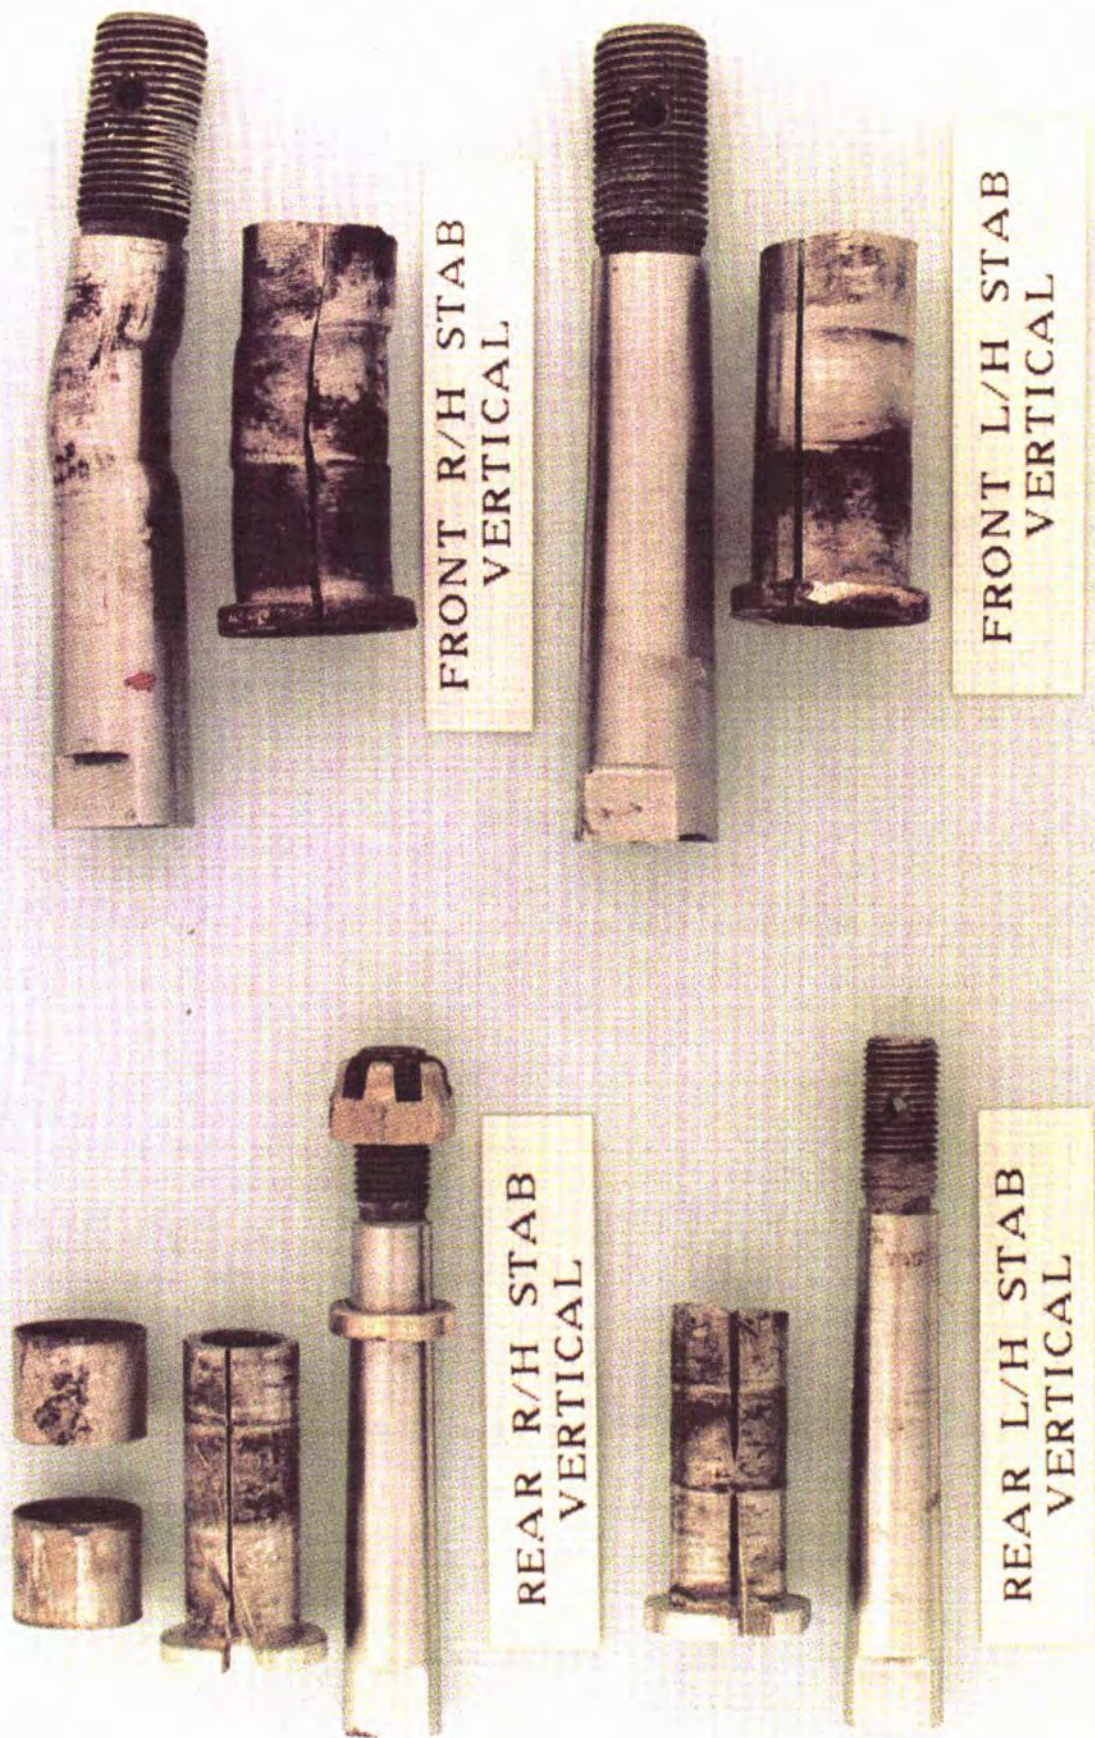
PHOTO (FOTO) 12

Later examinations by AIR also revealed that the two front attachment pins, as well as their respective sleeves, did not satisfy the specifications. The hardness was between 200 and 230 (HV5). A hardness of 200 - 230 corresponds to a tensile strength of approximately 100,000 psi. Convair's specification for hardness corresponds to a tensile strength of 160,000 to 180,000 psi.

SHEAR PINS, SLEEVES AND BUSHINGS FROM LN-PAA FOR VERTICAL STABILIZER ATTACHMENT (BOLTER, HYLSE OG FORINGER FRA LN-PAA FOR FESTE AV VERTIKALFINNEN TIL SKROGET)

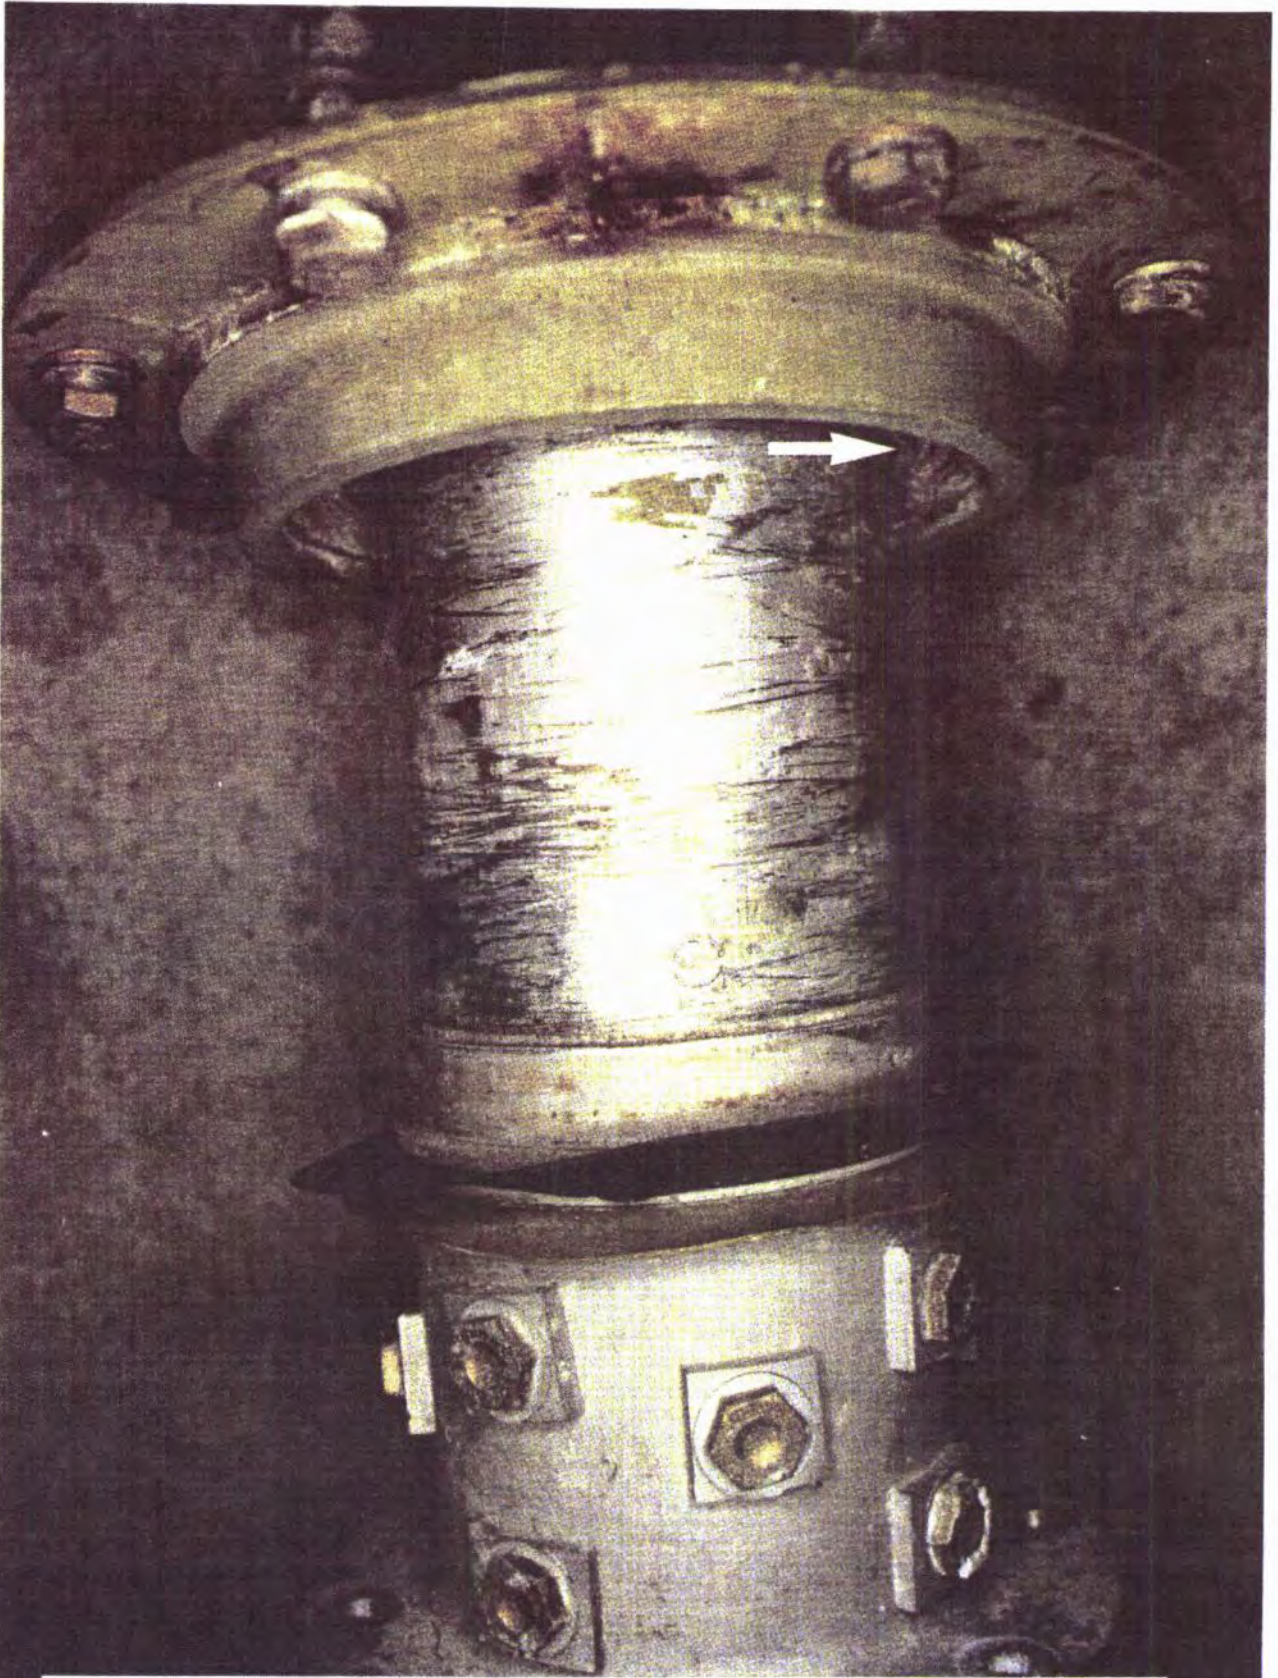
PHOTO 13 Fully displaced (outboard) retainer collar reveals 3" zone of severe scoring on torque tube. The scoring was caused by abnormal rotation of the retainer collar inner land (arrow) against the tube.

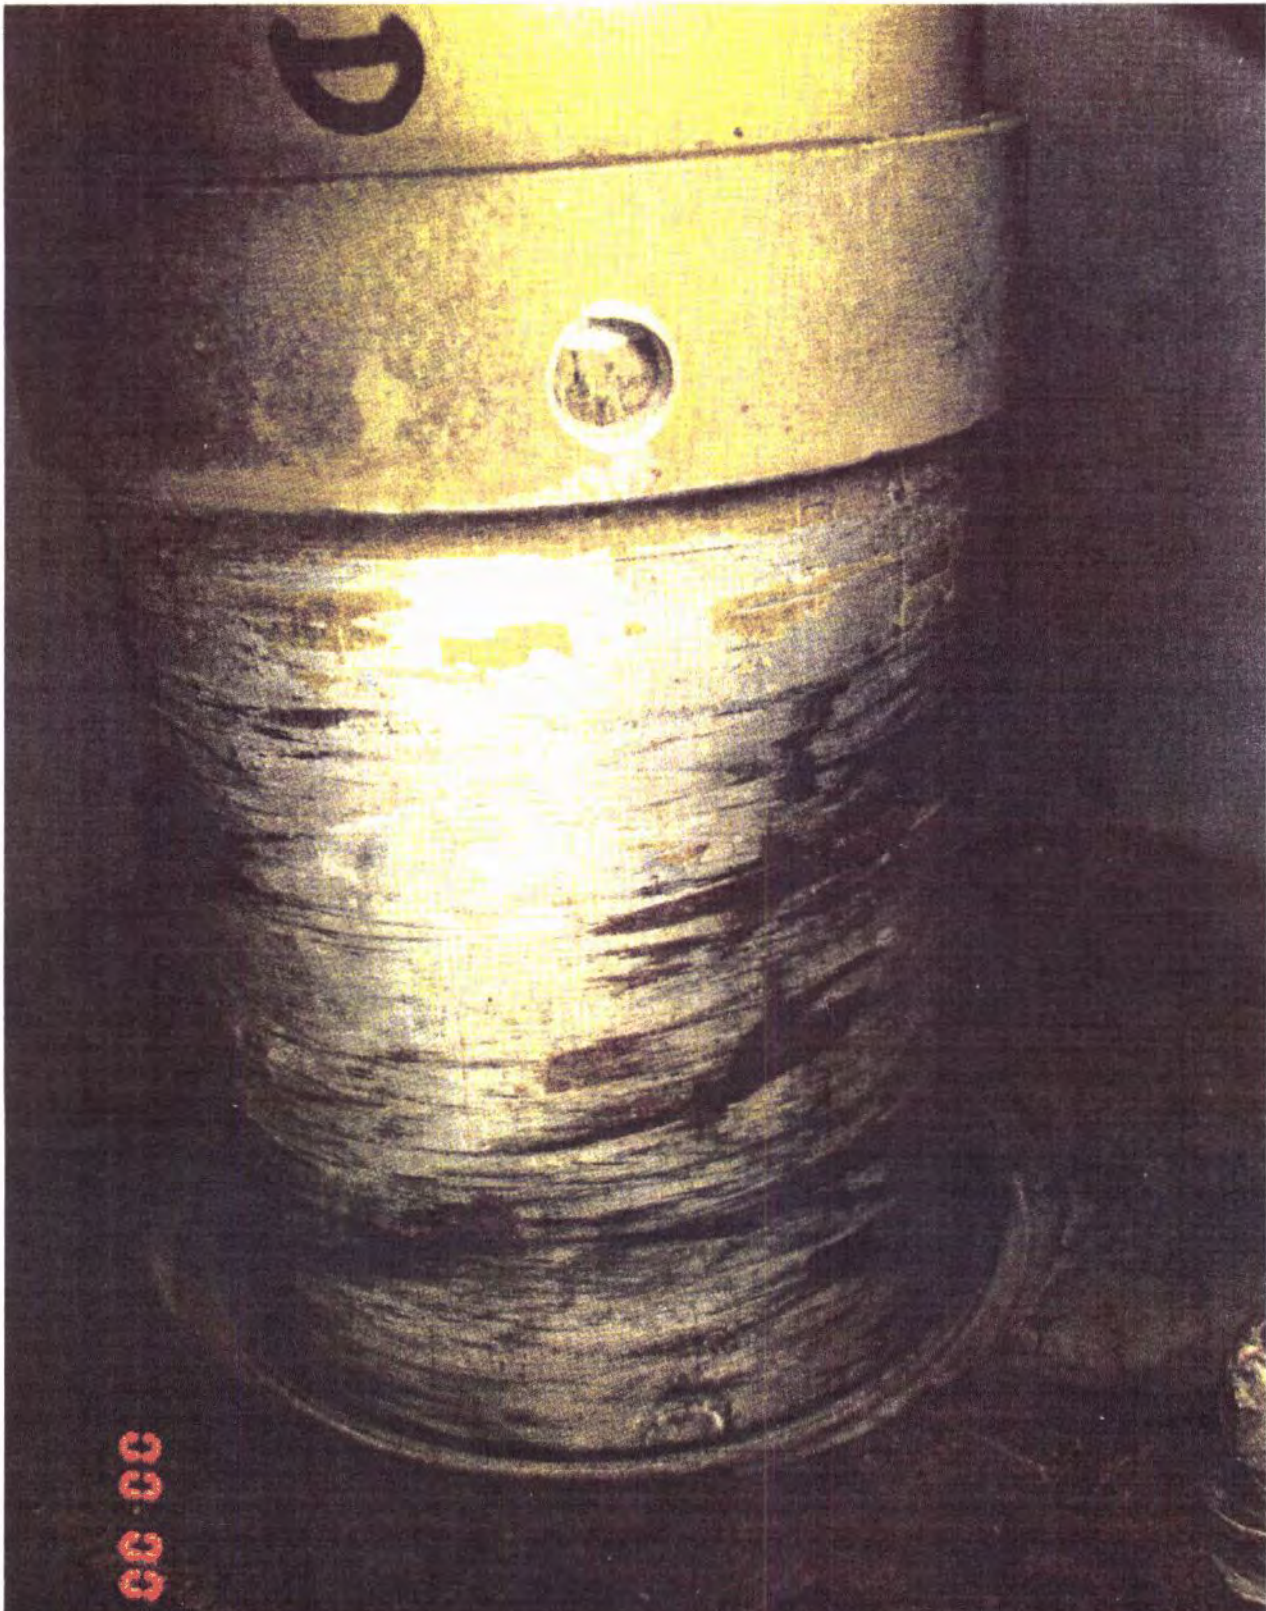
PHOTO 14 (FOTO) Clearly exhibits the extensive scoring. Note the circumferential length and angles of the score marks well in excess of the normal 35° of elevator travel. Some marks are up to 90° of the circumference.

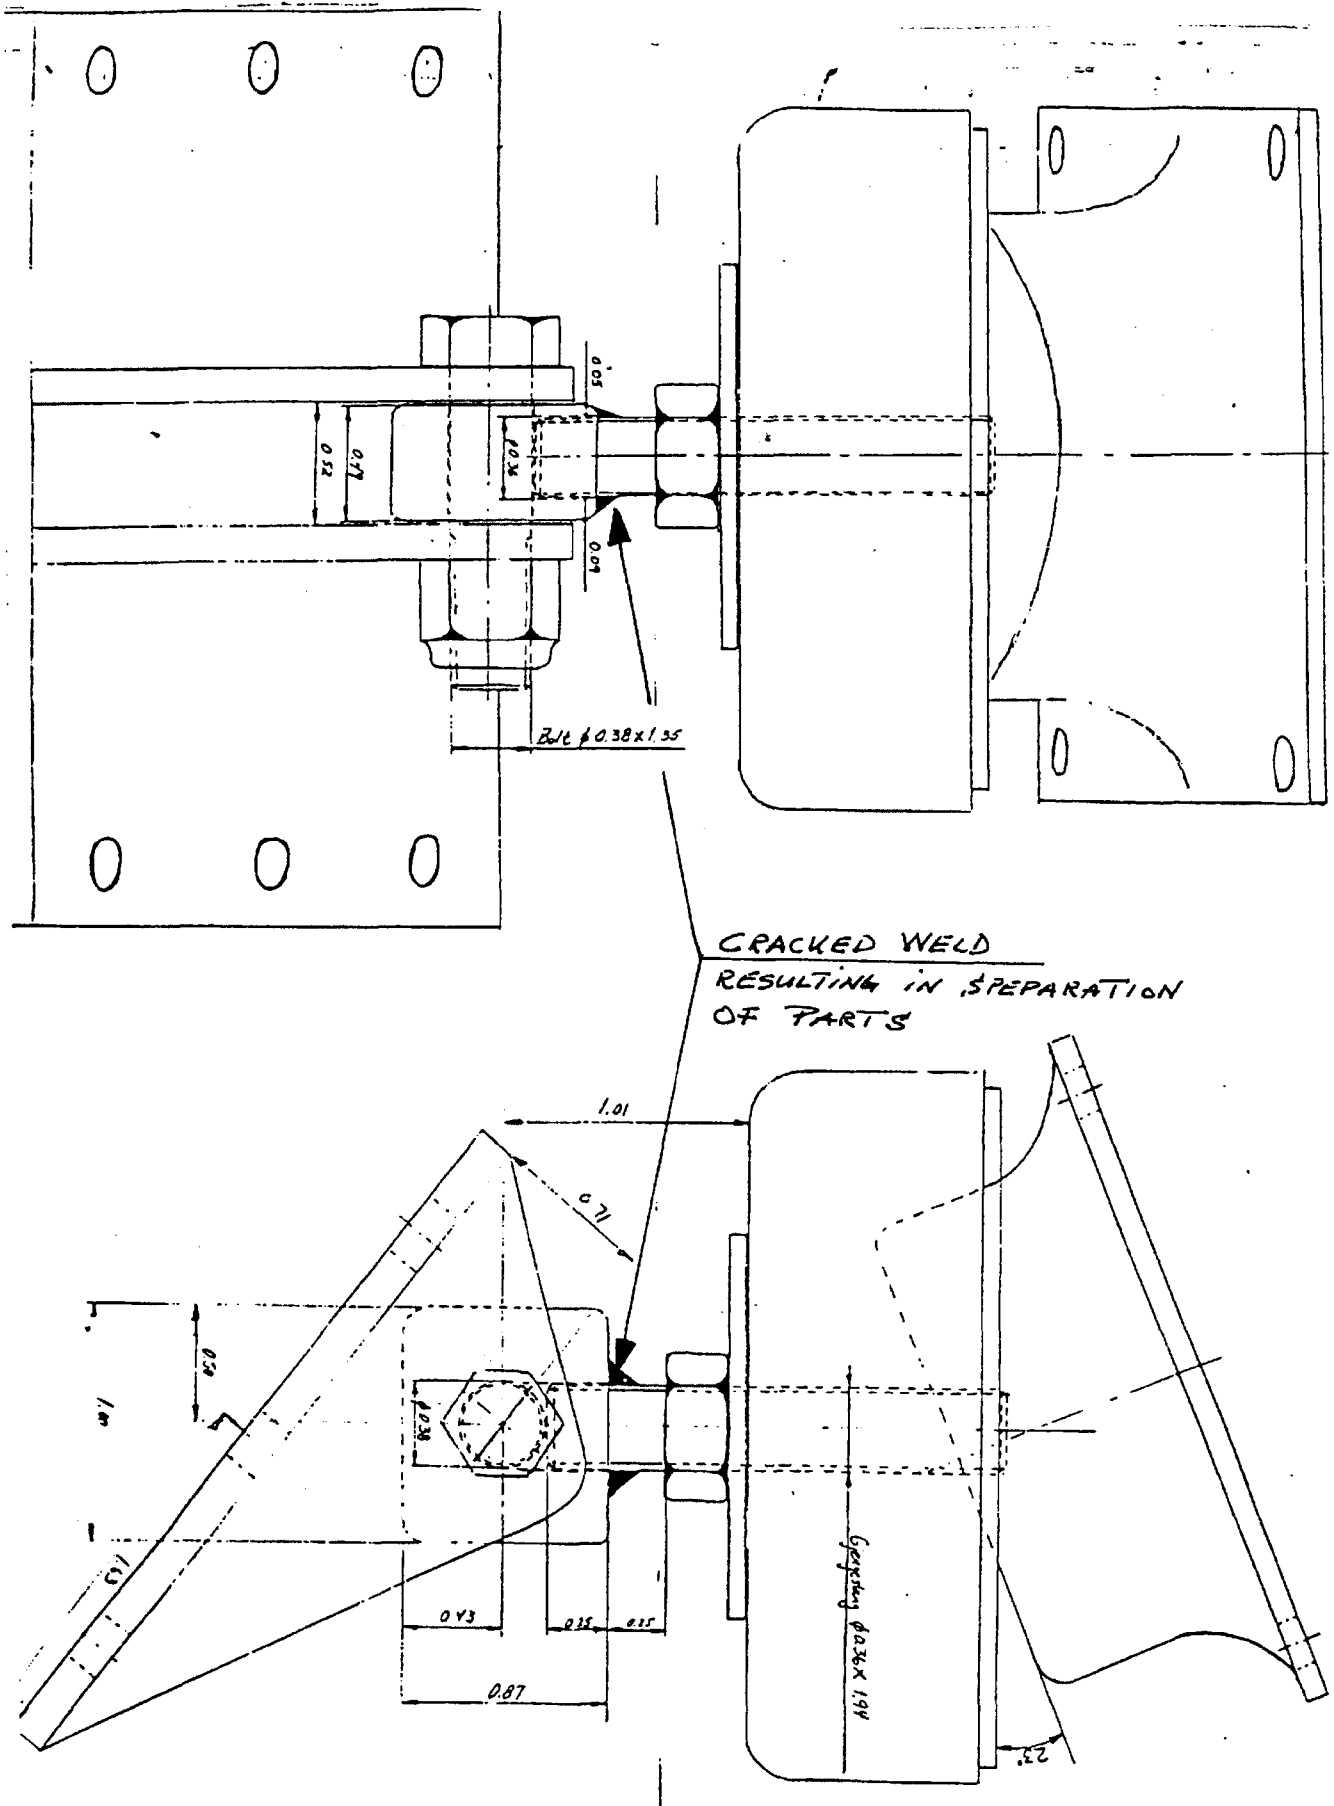
FIG. 5

1.16.6.2 The APU had a total of four attachments to the aircraft structure. The two main supports were intact. The other two were fractured. Metallurgical examinations revealed that the rear support had failed in overload while the front support showed signs of fatigue failure. The front support was of a design and manufacture which did not conform to the manufacturer's specifications. The support end fitting, which is normally a rod end with an internal spherical bearing, had been replaced by a locally-manufactured design. This consisted of a square piece of iron and a threaded rod which had been welded together (figure 5). The quality of the welding was poor and the wrong type of material had been used. The fatigue fracture was caused by a fault in the welding. The method used to make the support and the choice of material did not conform to the standards used in aircraft parts. The support had signs of repeated loads having been applied to it after the fracture took place (photos 15 and 16).

**FORWARD MOUNT FOR THE APU (AS FOUND)
FREMRE MONTERINGSFESTE FOR APU (SOM FUNNET)**

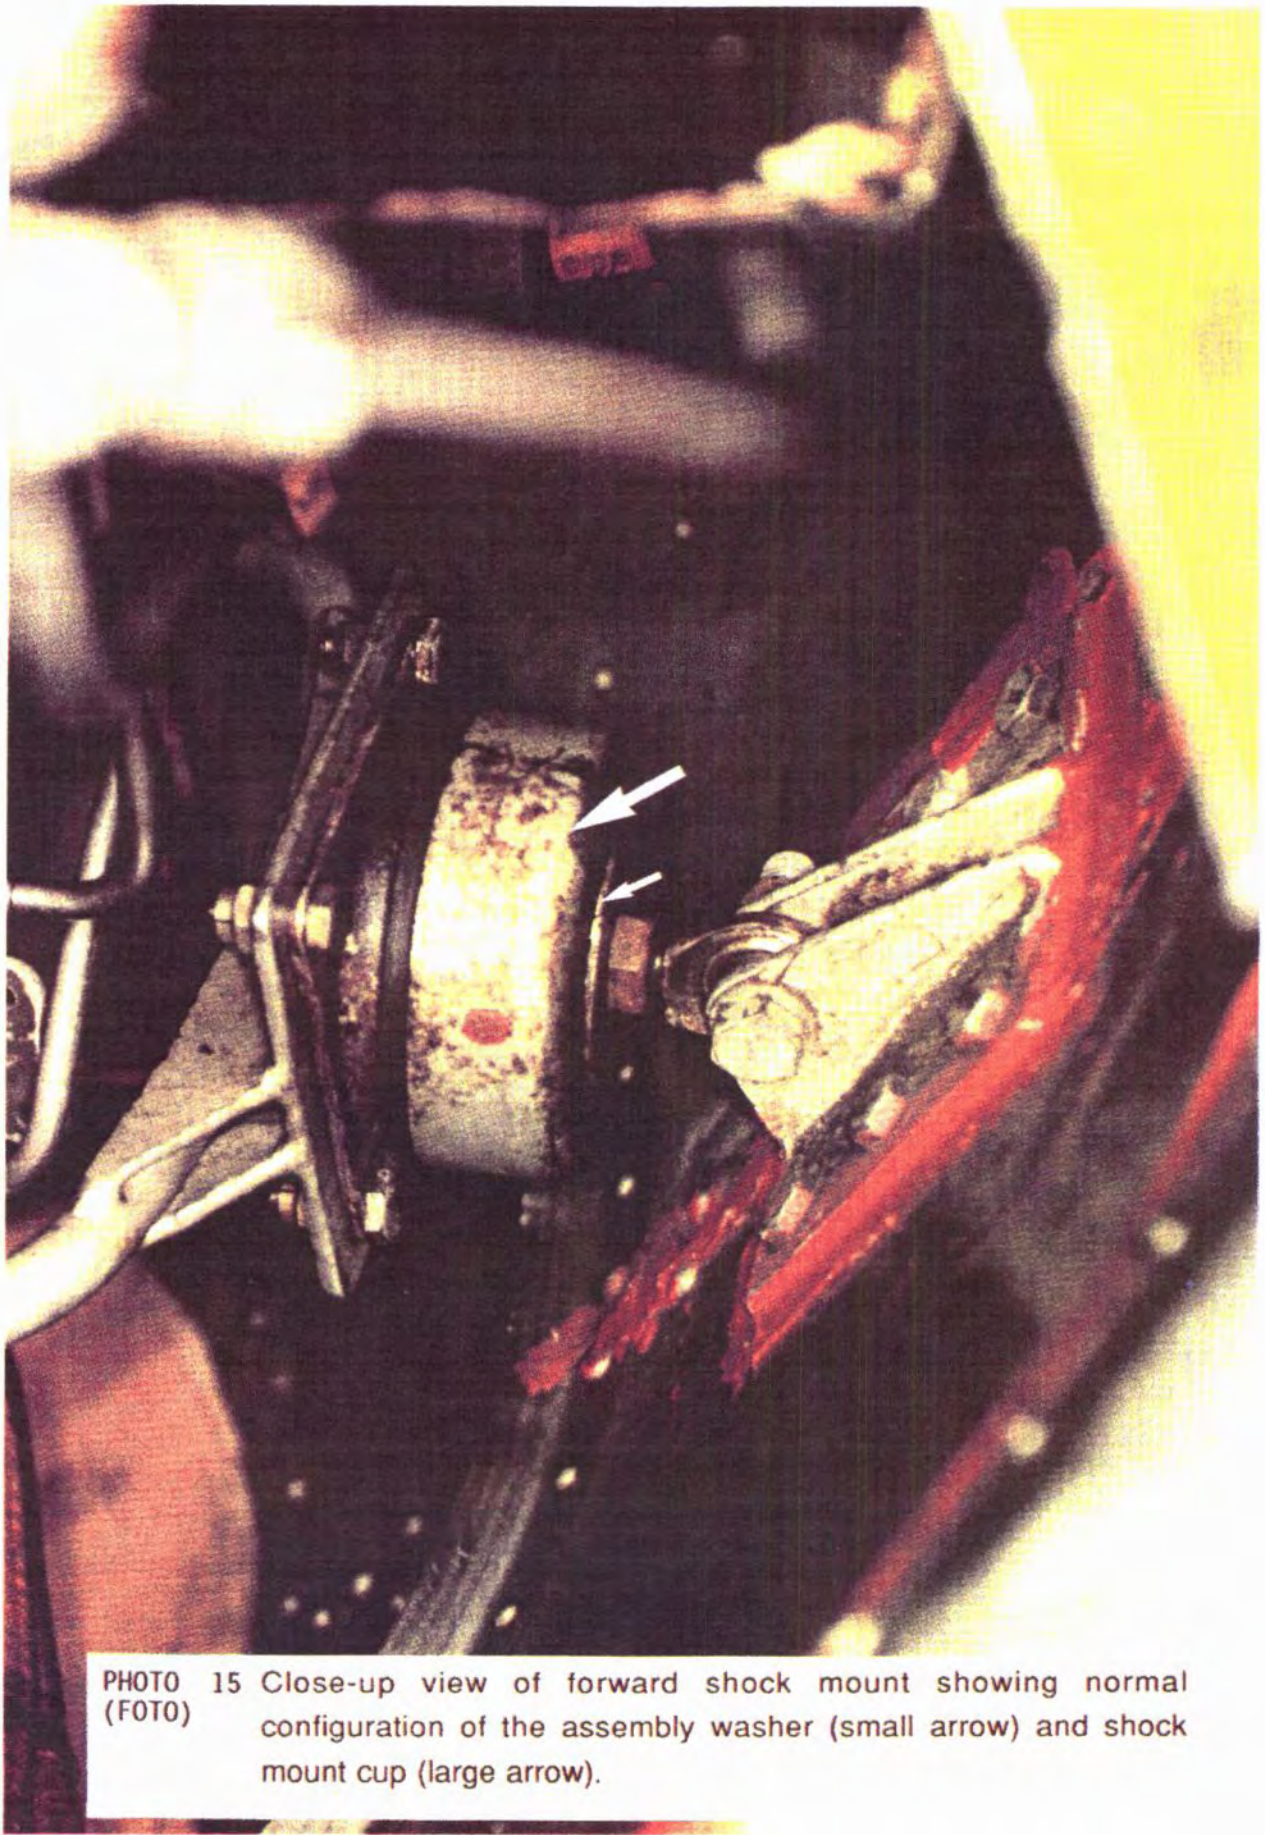
PHOTO 15 Close-up view of forward shock mount showing normal configuration of the assembly washer (small arrow) and shock mount cup (large arrow).

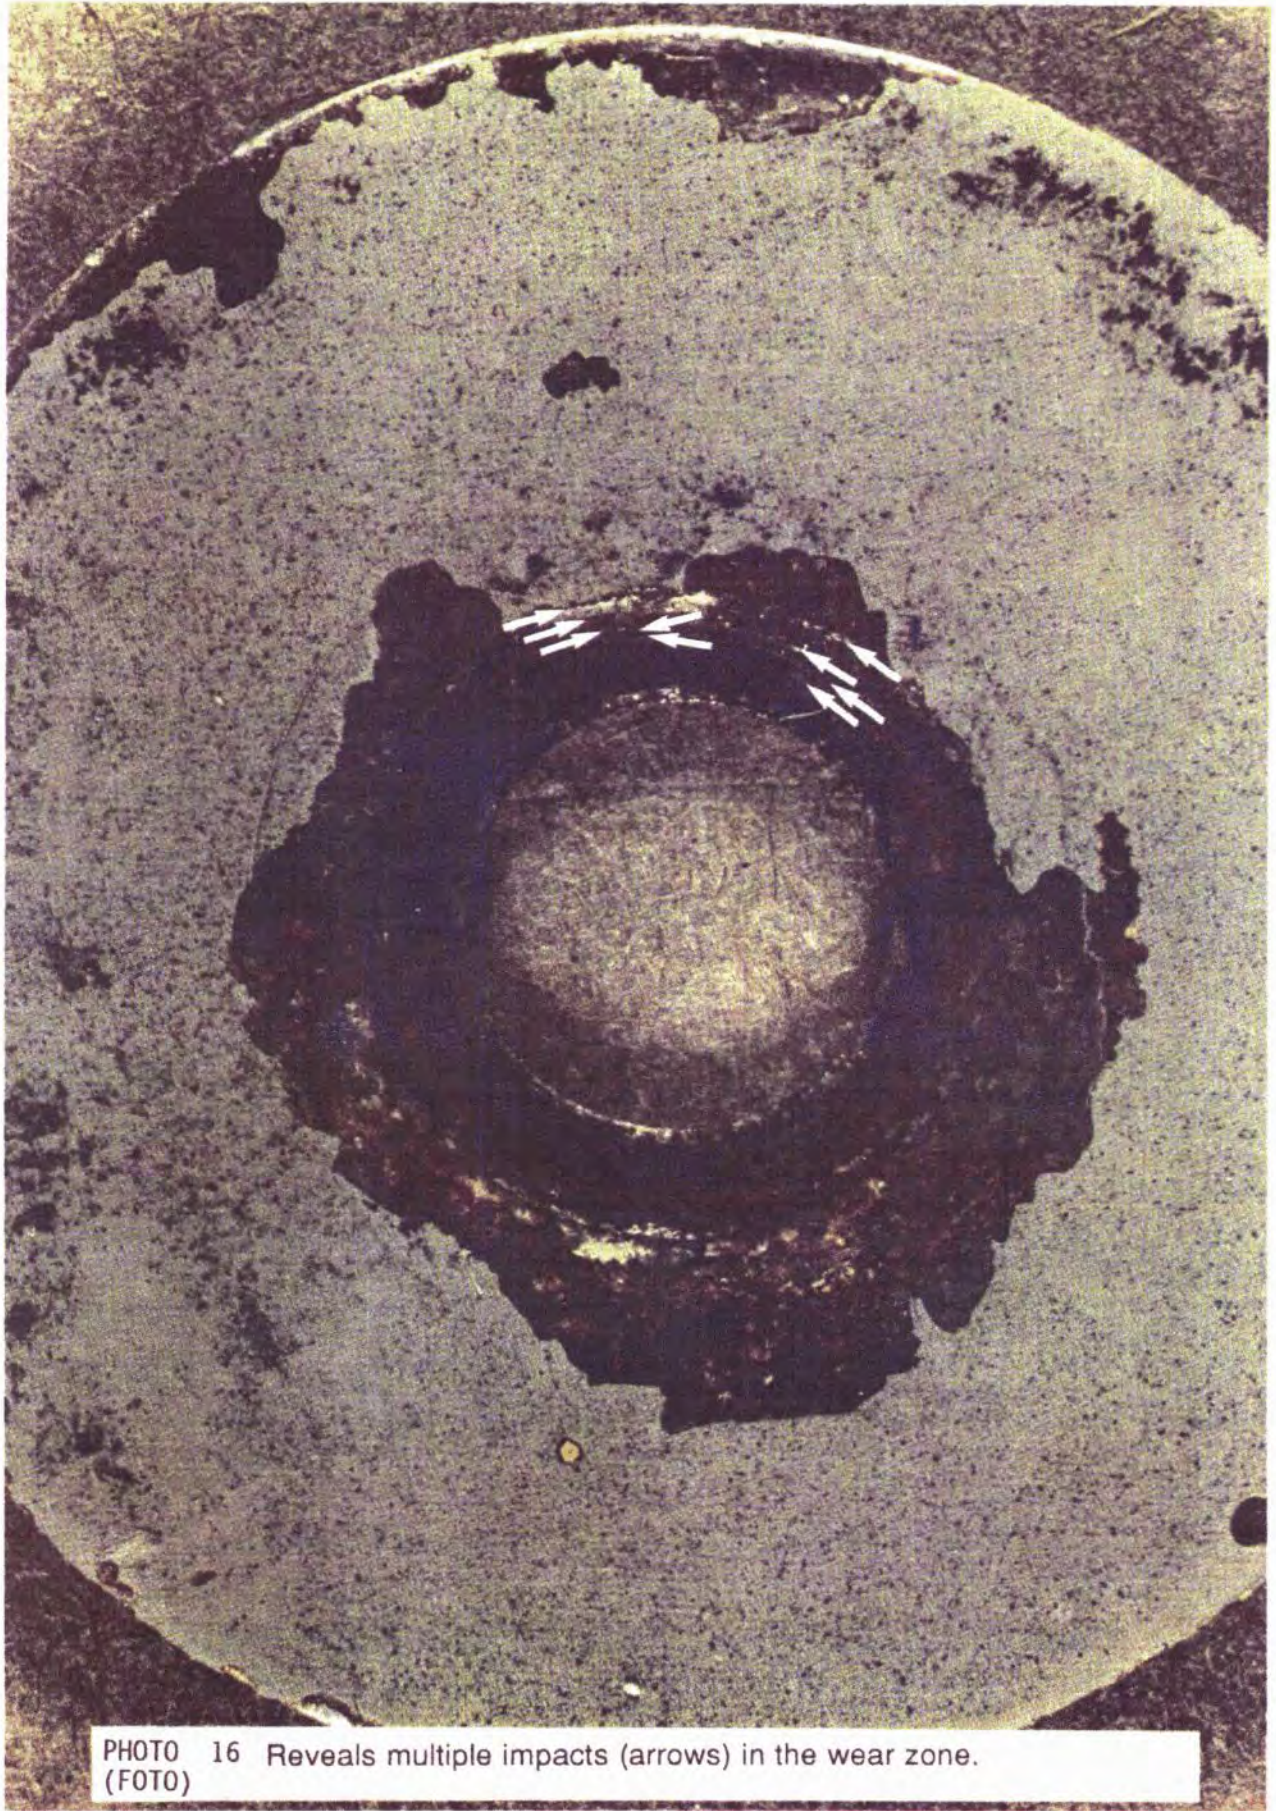
PHOTO 16 Reveals multiple impacts (arrows) in the wear zone.
(FOTO)
