**THE AIRCRAFT ACCIDENT INVESTIGATION BOARD/NORWAY
(AAIB/N)**

REP.: 06/96

**REPORT ON THE AIR ACCIDENT AT TROMSØ AIRPORT,
NORWAY, 20 APRIL 1995 WITH BEECH SUPER KING AIR B200
LN-MOE**

SUBMITTED JUNE 1996

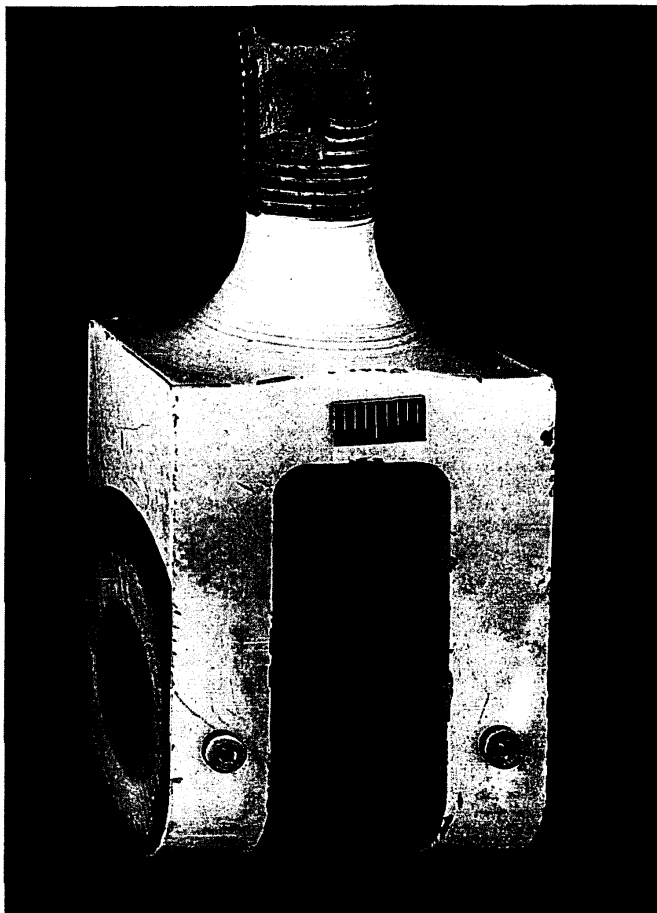
1.16.1.2 The findings from the testing and examination were compiled in DNVI report No. 95-3340. The investigation found the threaded portion had fractured in a complex manner in the area of threads No. 5 - 14 as seen from the "fork-end" (see Appendix 2). In the photograph in Appendix 3, it can be seen that the fracture has followed the

machined groove on one of the "sides" of the part. The fracture may be divided into three main zones:

- a crescent-shaped radial zone in the same level as thread No. 14
- an axial wall "down" to thread Nos. 5 - 7
- a crescent-shaped irregular fracture covering the area around thread Nos. 5 - 7

Fig. 3 General view of the broken L/H clevis rod from the aircraft reg. LN-MOE. The machined groove in the one side of the threaded portion is seen at the top of the photo.

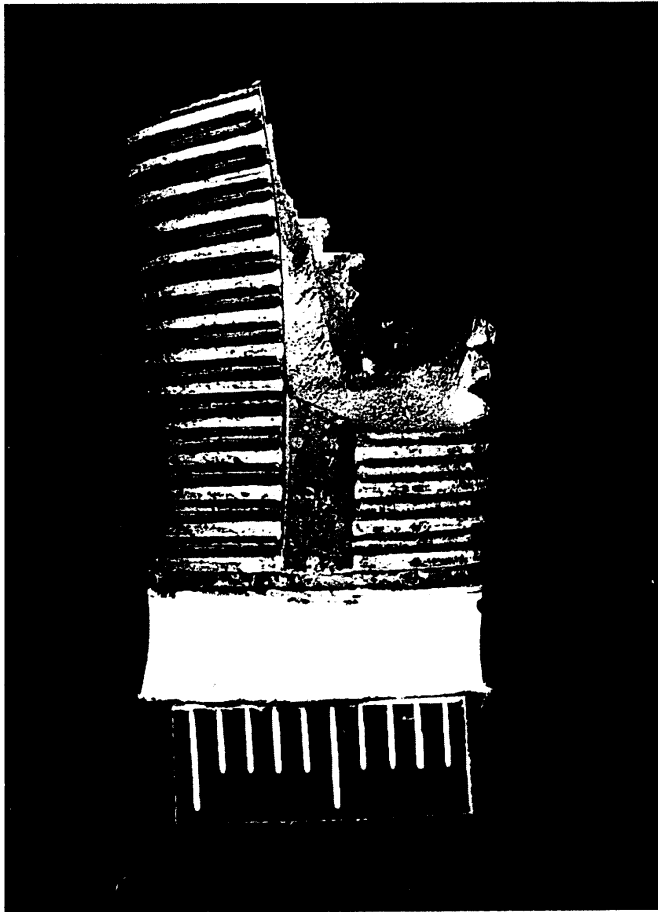
From the photograph it also can be seen that the upper part of the fracture surface has been bent to the left. (as seen in the photograph)

Fig. 4 Close-up photo of the broken clevis rod revealing the side profile of the fracture surface. The machined groove has obviously influenced the axial section of the fracture. It is also seen that the threaded section is slightly bent towards the left side (ref. photo only).

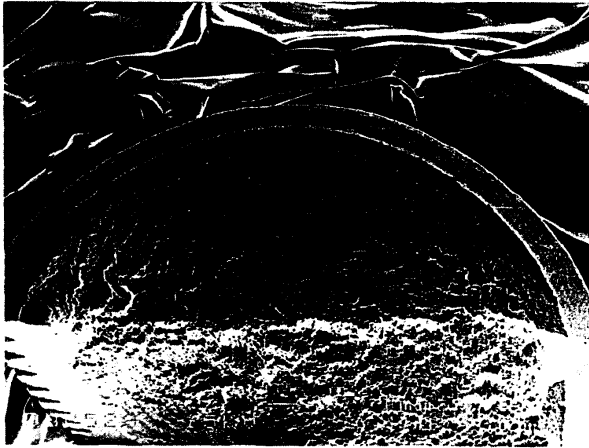
- 1.16.1.3 SEM examination found the fracture zone at thread No. 14 level to have a narrow edge zone covering approximately half the circumference. The edge zone was about 0,3 mm wide near the machined groove, and about 0,5 mm wide 90° away from the groove (see Appendix 4, Fig. 5). Large portions of the microstructure in the fracture surface had been distorted when the surfaces had been pressed against each other again in the process of widening the crack (see Appendix 4, fig. 6). Still it was possible to find parallel lines (striations) in the edge zone (see Appendix 5, figs. 5 and 6). These are lines characteristic of a fatigue crack. The edge zone also has radial lines (brak-over marks) which indicate that the fatigue cracking has started at different levels, and at a later stage run together. In the microstructure within the edge zone, "dimples" can also be found (see Appendix 6, fig. 9). The dimples are characteristic of a fracture caused by overload in a ductile material.

Fig. 5 General SEM view of the upper semi-circular section of the fracture. A narrow edge zone of a somewhat different (darker) appearance is noted. Magnification 10 X

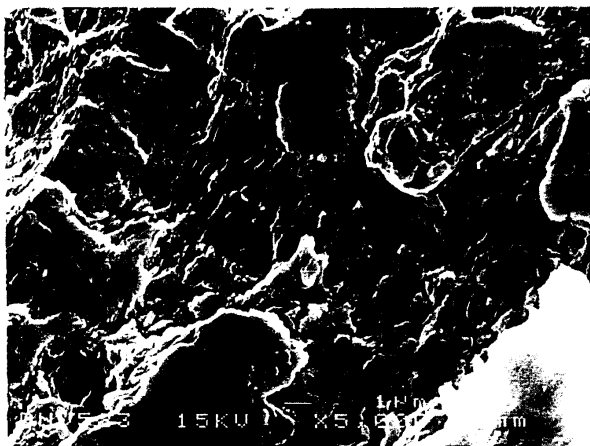
Fig. 7 SEM photo representing the intact micropattern of the narrow edge zone at a location close to the machined groove (ref. Fig 5). Fatigue striations and parallel microcracking is noted. Magnification 5000 X

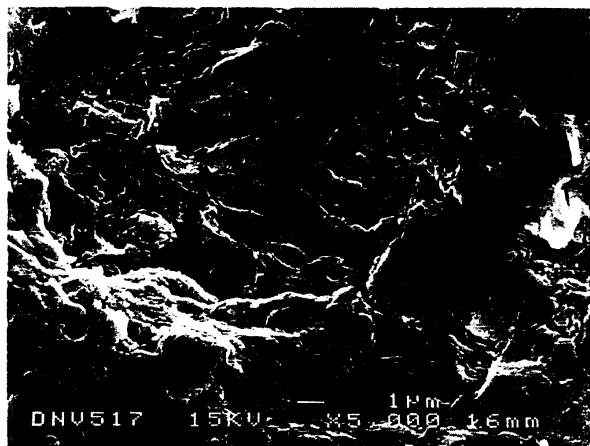
Fig. 8 SEM photo representing intact micropattern of the narrow edge zone at a location nearly 180 degrees opposite to the machined groove (ref. Fig. 5). Fatigue striations and parallel microcracking is indicated. Magnification 5000 X

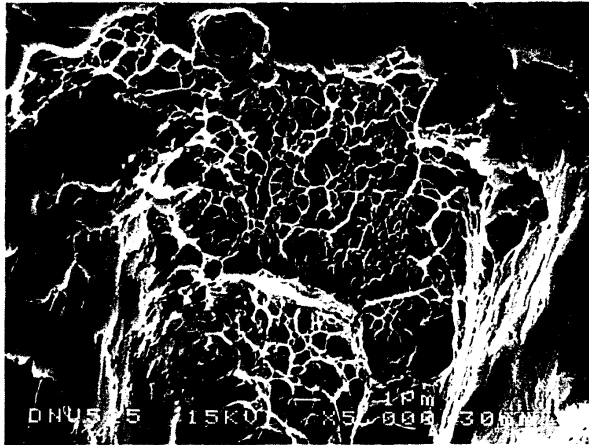
Fig. 9 SEM photo showing the micropattern of the fracture outside the narrow edge zone, representing so-called "dimples" which are characteristic for a ductile material overload. Magnification 5000 X

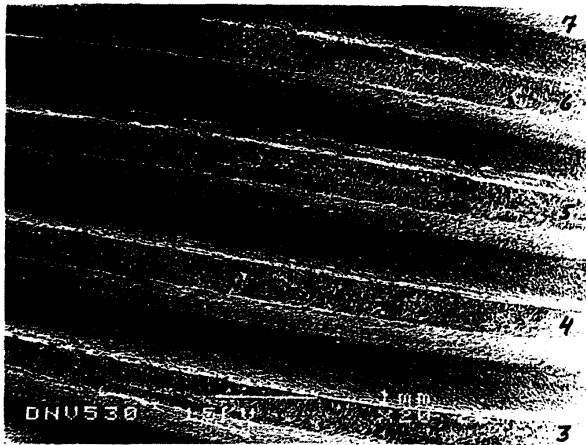
- 1.16.1.4 SEM examination of the thread bottom surfaces "below" the fracture found cracks in this area (see Appendix 6, fig. 10). The cracks are found in two different areas of the circumference. One is near the machined groove, and the other is 180° opposite the groove. One of the cracks was forced open and examined, and the microstructure had a pattern similar to what was found in the edge zone of the fractured surface.

Fig. 10 SEM photo representing the threads No. 3 to 7 from the fillet area. Base area cracking is seen between all the threads in question. Magnification 20 X

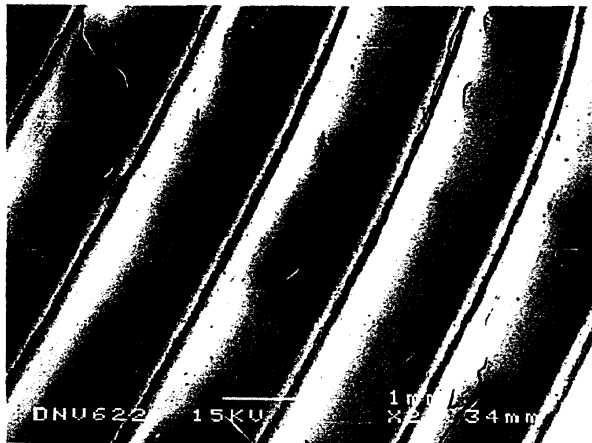
2.1.4 One of the DNVI-reports concludes that "improper machining" is evident in the thread bottoms on some of the rods. Furthermore it is reported large variations in thread profiles and surface quality. The photograph in Appendix 9, fig. 43, is indicating a surface which, in the opinion of AAIB/N, does not correspond with the requirement in the blueprints to manufacture the threads by rolling. However, due to the lack of information, it can not be determined whether the cracks in the rod ends are initiated by the manufacturing process or not.

Figure 4 SEM photo showing the threads of the clevis rod marked "A". Due to improper cleaning of the specimen, some particles are present on the surface. Magnification: 20X

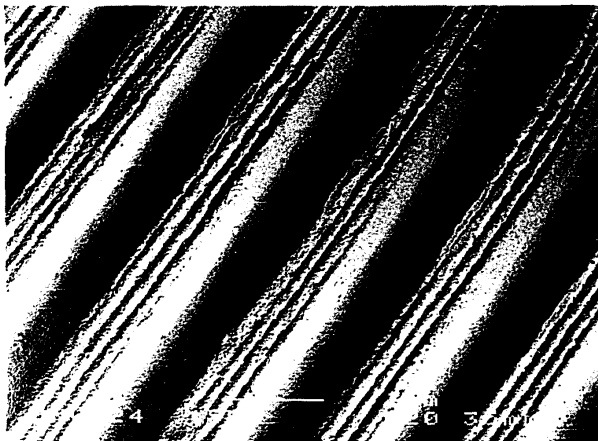
Figure 5 SEM photo showing the threads of the clevis rod marked "B". Magnification: 20X

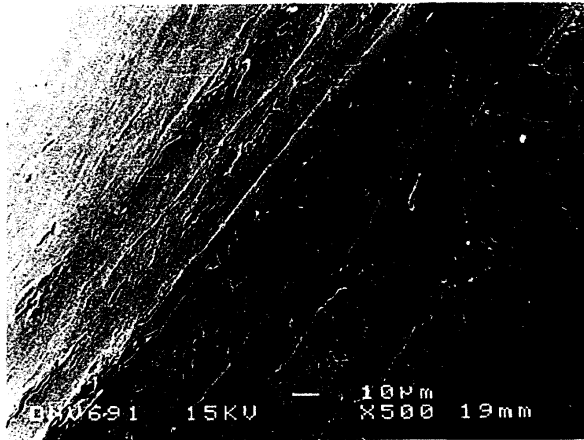
Figure 39 SEM detail photo of the base area No. 1 from the fillet area of the L/H clevis from the aircraft LN-MOG. Score marks, most likely caused by some improper machining, can be observed. Magnification: 500X

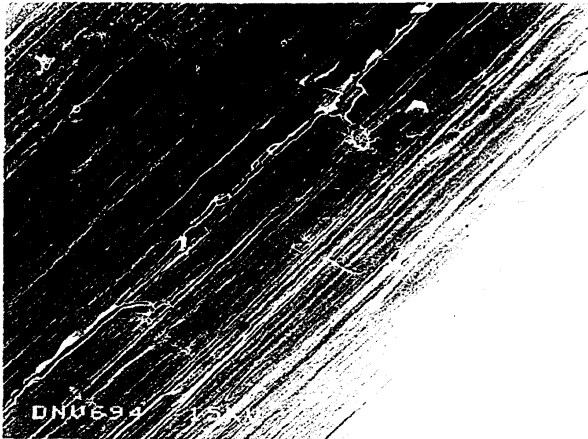
Figure 42 SEM detail photo of the crack shown in Fig. 41. Magnification: 500X

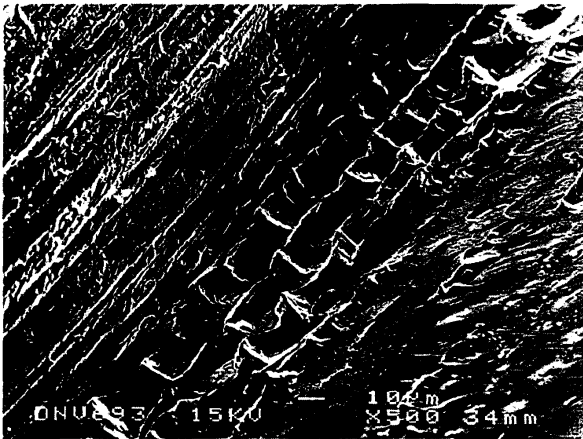
Figure 43 SEM detail photo showing score marks from improper machining in the base area No. 1 from the fillet area of the R/H clevis rod for the aircraft LN-MOG, seen after a HCl cleaning. Magnification: 500X
