REPORT

JB 2009/03

REPORT ON LEVEL CROSSINGS

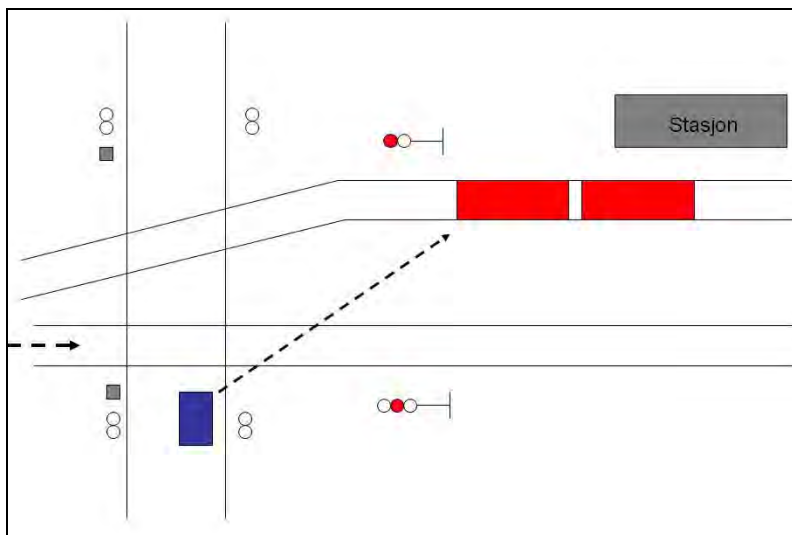
If a motorist focuses on the stationary train (Figure 19) while the barriers begin to descend, there is a risk that the motorist will think that it is the stationary train at the station that is about to depart rather than a train approaching from the left. In the worst case, the motorist may reverse in order to clear the track nearest the station (Figure 20) and thus end up on the approaching train's track.

Figure 19: The problem at Ranheim, part 1.

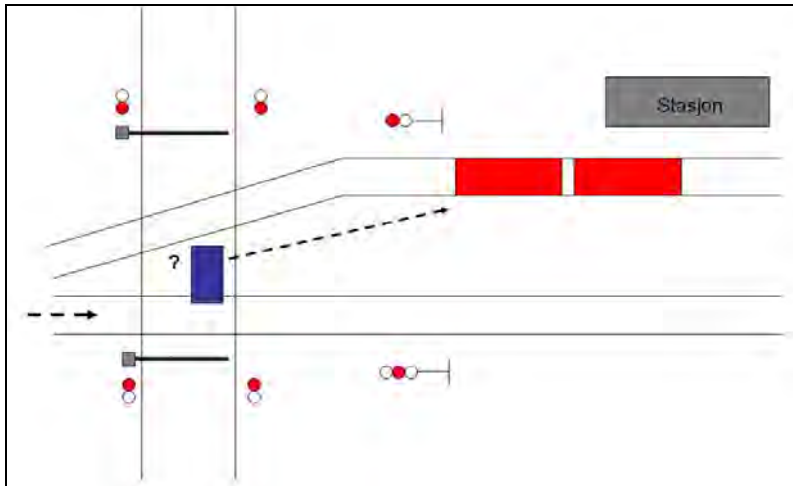
Figure 20 – The problem at Ranheim, part 2

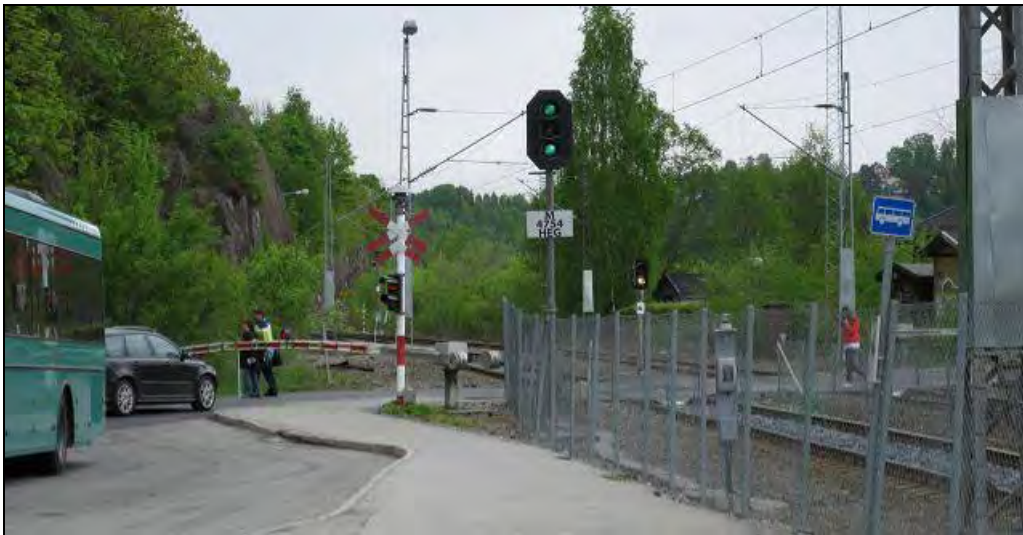
During the inspection, three persons who were going to catch the train to Oslo were observed bypassing the barriers. When asked directly why they broke the rules, one of them answered as follows: ‘The barriers are always down for approx. two and a half minutes before the train leaves. I often run across the track after the barrier has descended. A train has never approached unexpectedly from the other side. Everyone in the area does this.’ (Woman, approx. 20-25 years old)

A motorist, a learner driver true enough, had to reverse in order to prevent the barrier from hitting the car (on the Heggedalsvei side) The road was recently asphalted and it is therefore unknown whether it is normally marked with a stop line in accordance with the recommendations in the NPRA Manuals.^{9,10} Furthermore, since the barrier is not correctly installed (i.e. perpendicular to the road), an inattentive driver can be caught on the crossing or the car could be hit by the descending barrier.

Figure 33: Three people crossed the level crossing while the barriers were down. A motorist had to reverse in order to avoid collision with the barrier.

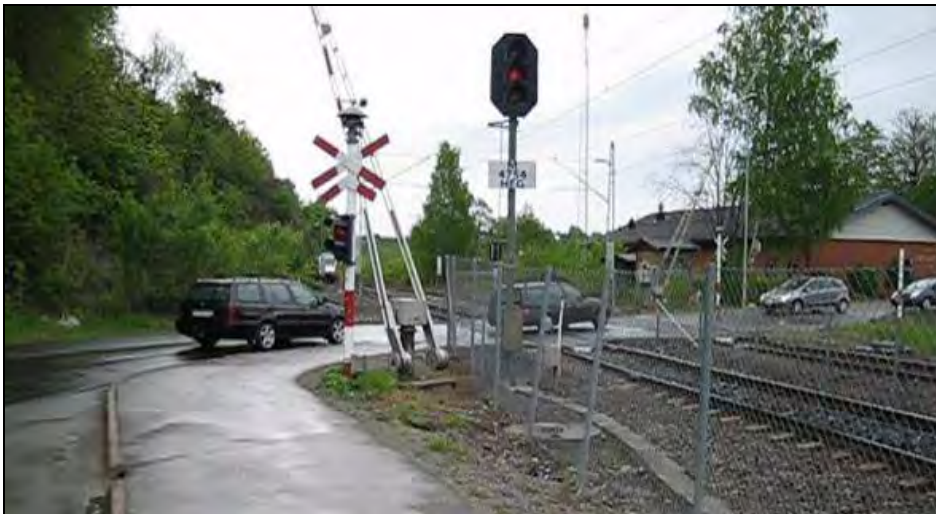
Figure 34: Several cars drove through the level crossing before the barrier was fully raised.

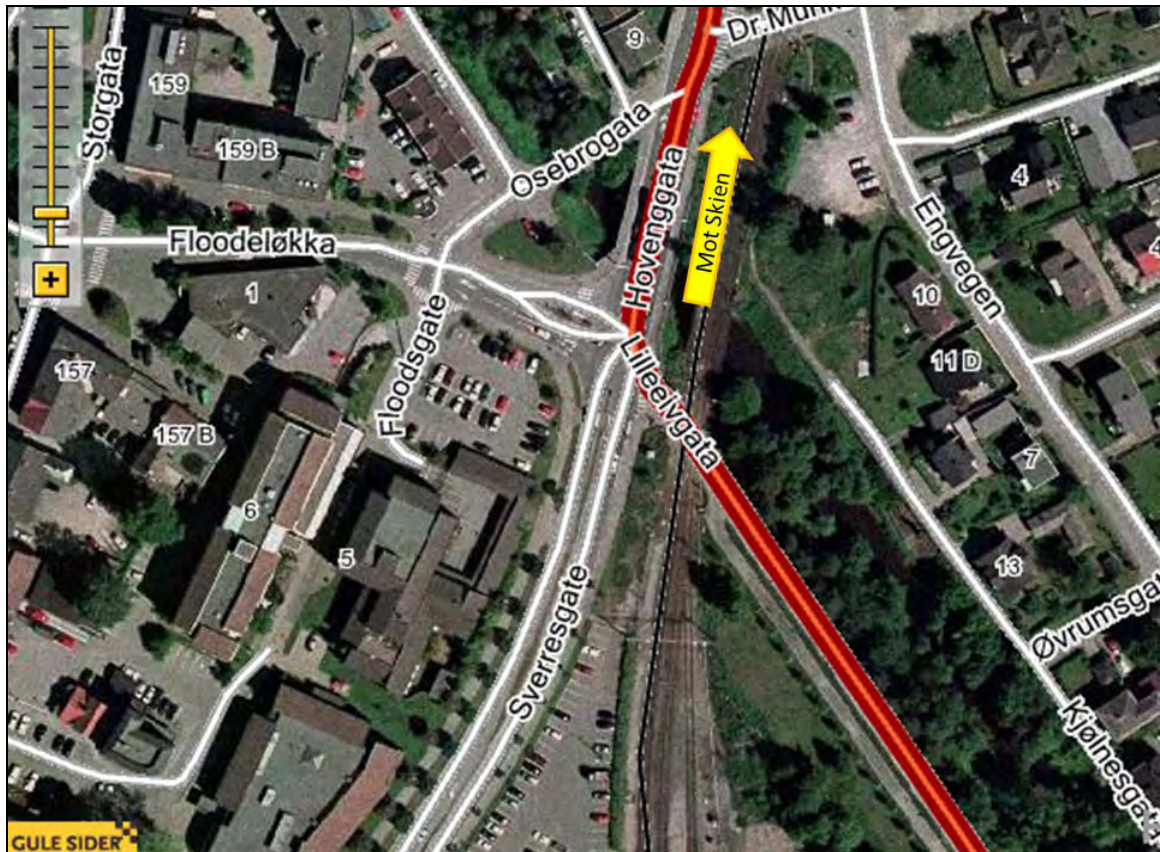
Figure 35: Porsgrunn LC (Lilleelvgata).

The design of the junction invites incorrect behaviour. Very many instances were observed in which motorists were forced to take unnecessary chances in order to make it across the junction from Hovengata to Lilleelvgata during the brief interval when the light was green.

It was noted that the road signals and railway signals are not synchronised with each other. When trains are approaching, the traffic lights start flashing yellow. In a road traffic context that means that the junction is out of operation but motorists may proceed through the junction with particular caution.

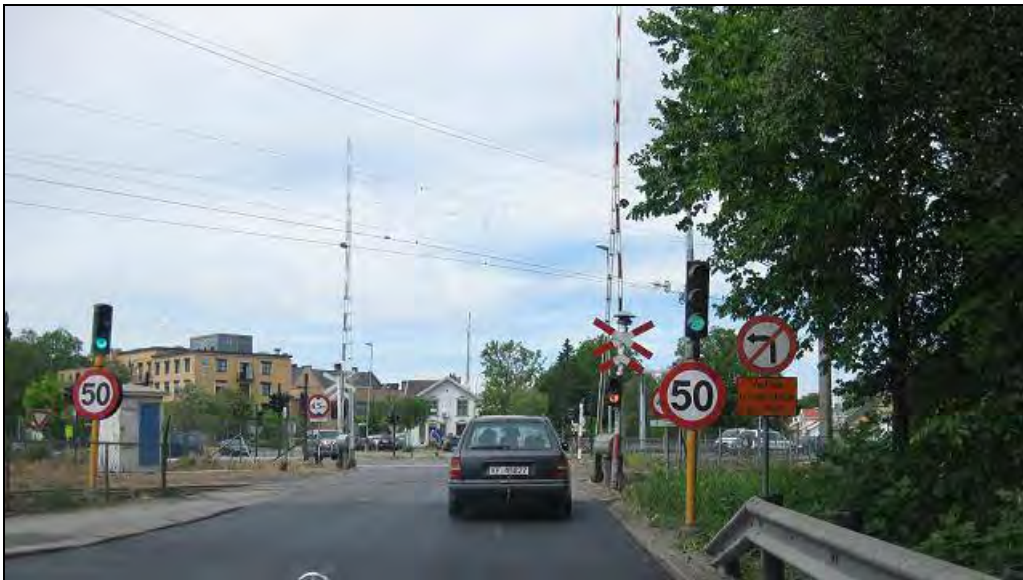
Figure 36 below shows a combination of road traffic lights and railway signals. The combination of the two types of signal creates confusion and it can be difficult to decide which signal applies in different situations. The complicated and dense signage makes it challenging to drive correctly in the junction for a person who is not familiar with the area.

Figure 36: A combination of different types of signs and light signals is very demanding for motorists.

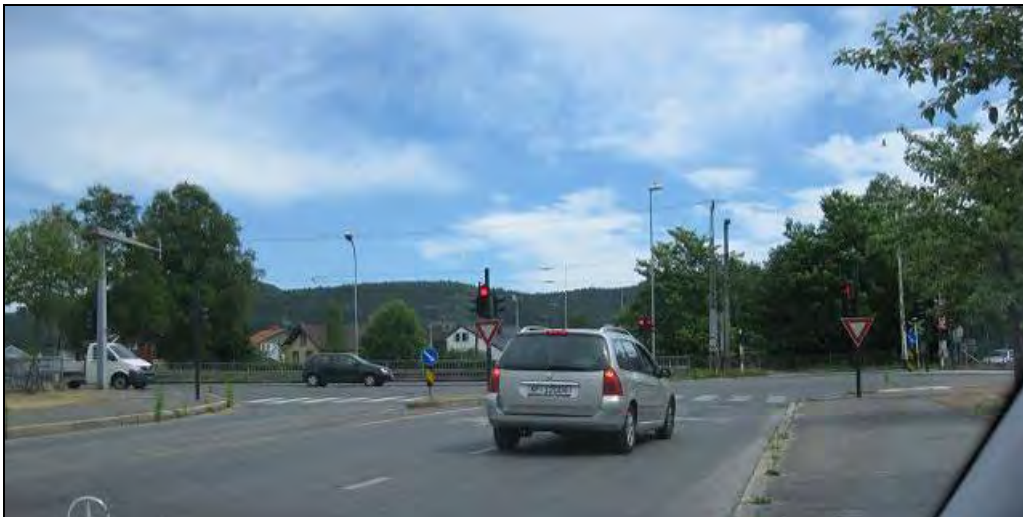
The photograph below shows the distance between the road junction and the level crossing. At the level crossing, one has a stronger sense of being in a road junction than on a level crossing.

Figure 37: The junction with the level crossing in the background.

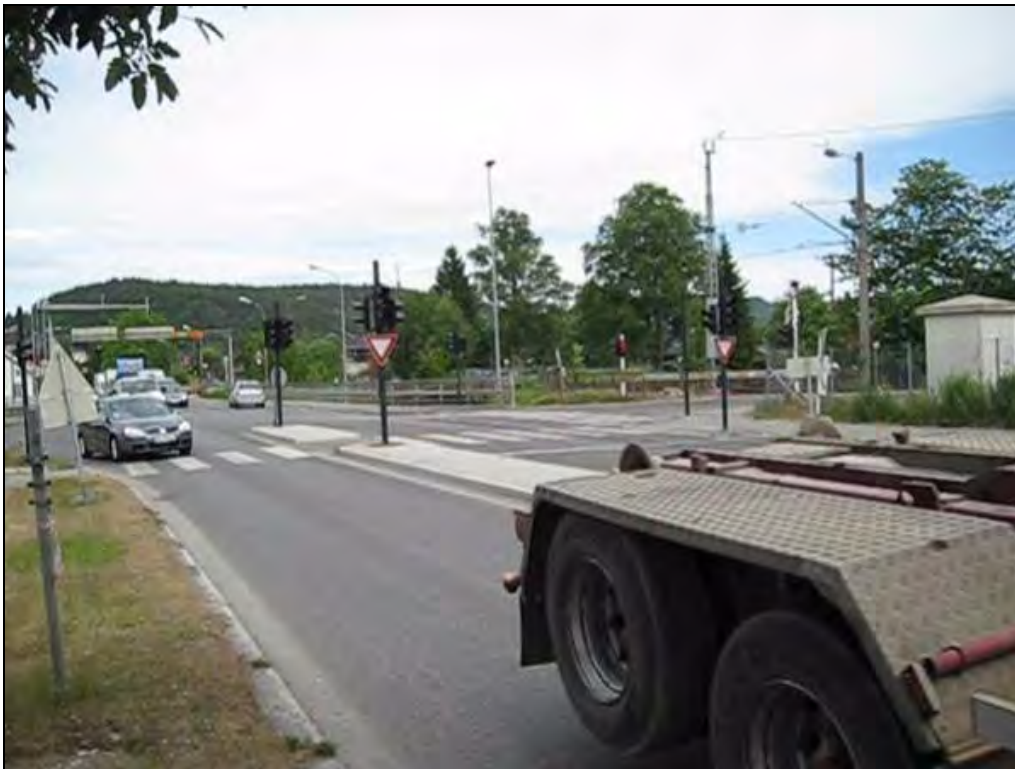
The photograph below shows the level crossing when the barriers are down. In this instance, the traffic lights are flashing yellow. Long queues build up in every direction when the barriers are down.

Figure 38: The barriers are down and the traffic lights are flashing yellow.

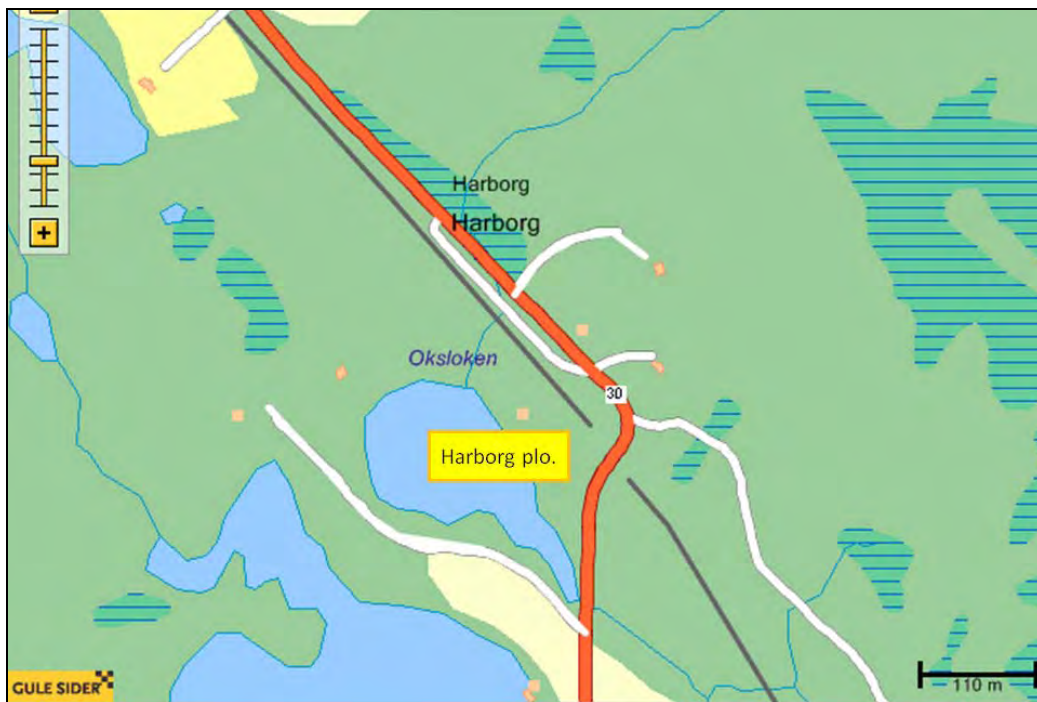
Figure 43: Harborg LC.

Barriers and light signals at Harborg LC and Nesvoll LC are often damaged in collisions with vehicles. The two level crossings have largely the same design. The incidents occur on the side of the level crossing where the road goes from being a relatively long, straight stretch and curves before the level crossing.

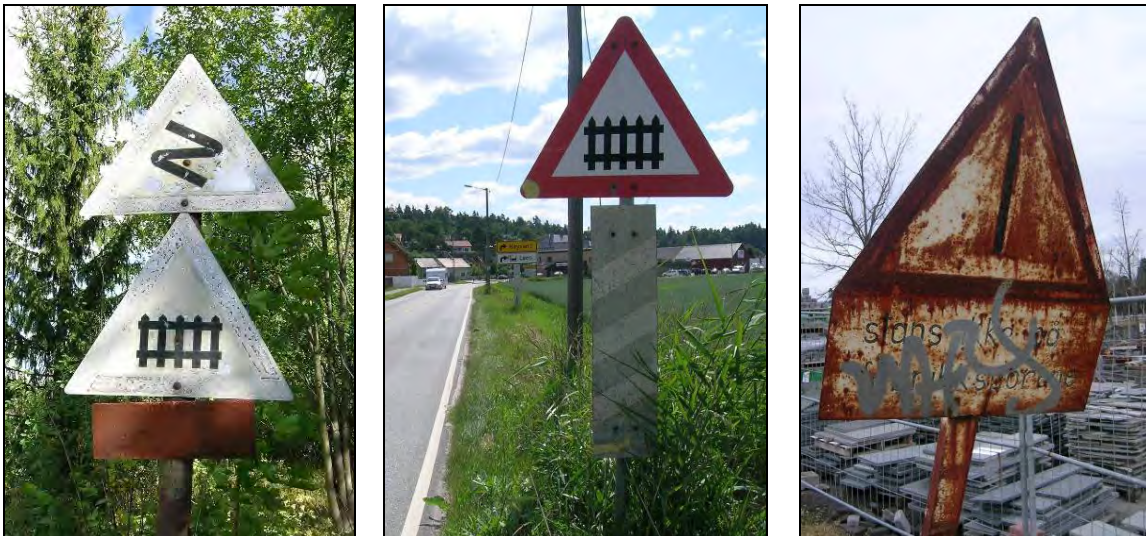
Figure 49: Worn-out signs.

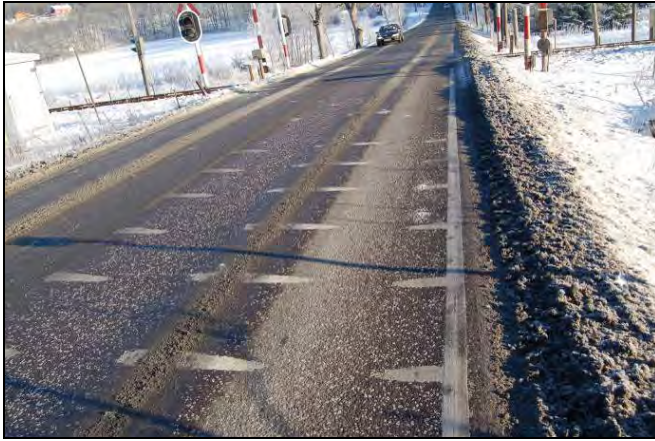
Figure 50: Example of poorly maintained rumble strips (Tomsbakken LC).

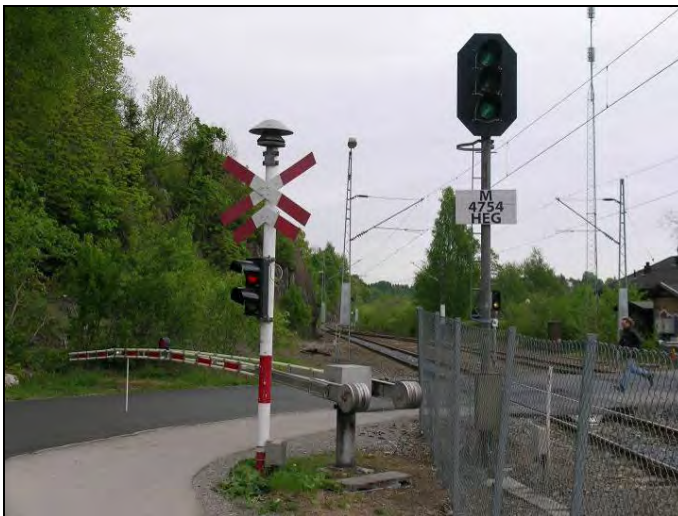
Figure 51: Would a stop line here have helped motorists to ascertain where the barrier comes down?

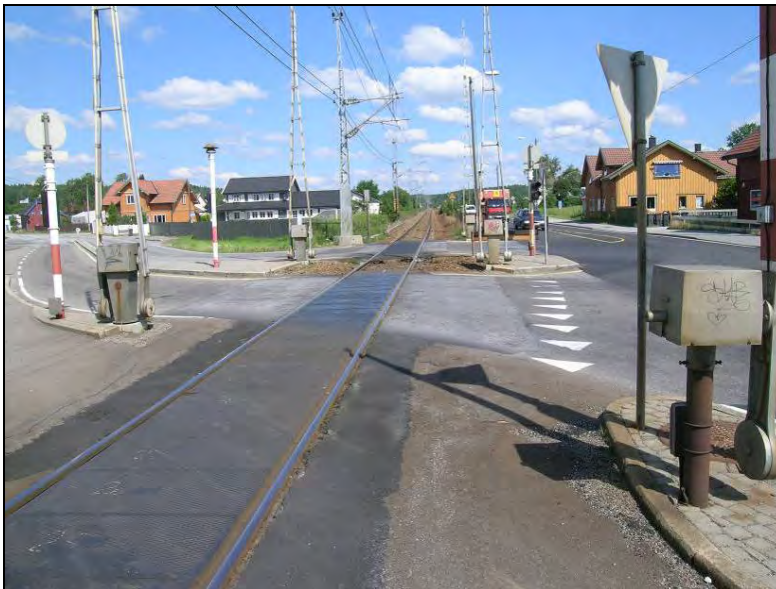
Figure 52: The give way line can mislead motorists into stopping too close to the track.

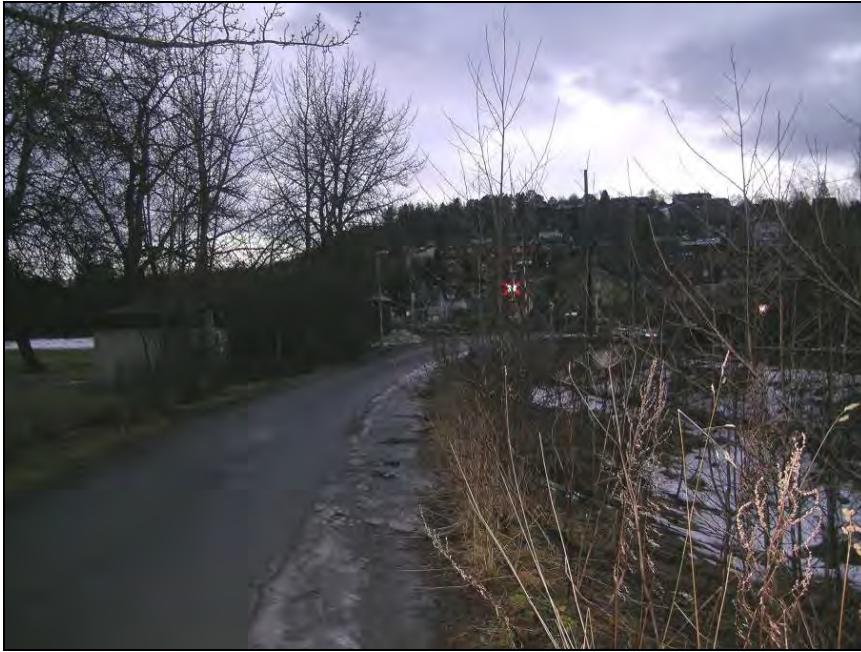
Figure 53 - Vegetation blocking sight lines to the level crossing (Stavne LC).

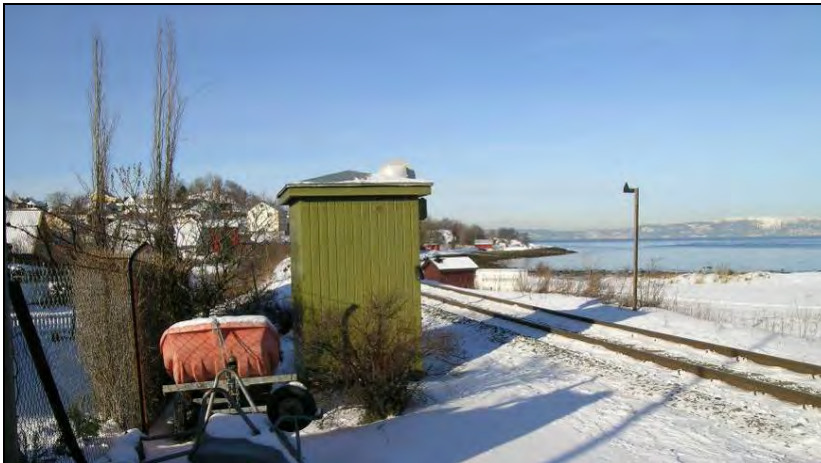
Figure 54: A cabin blocking sight lines at Grytbakkstranda.

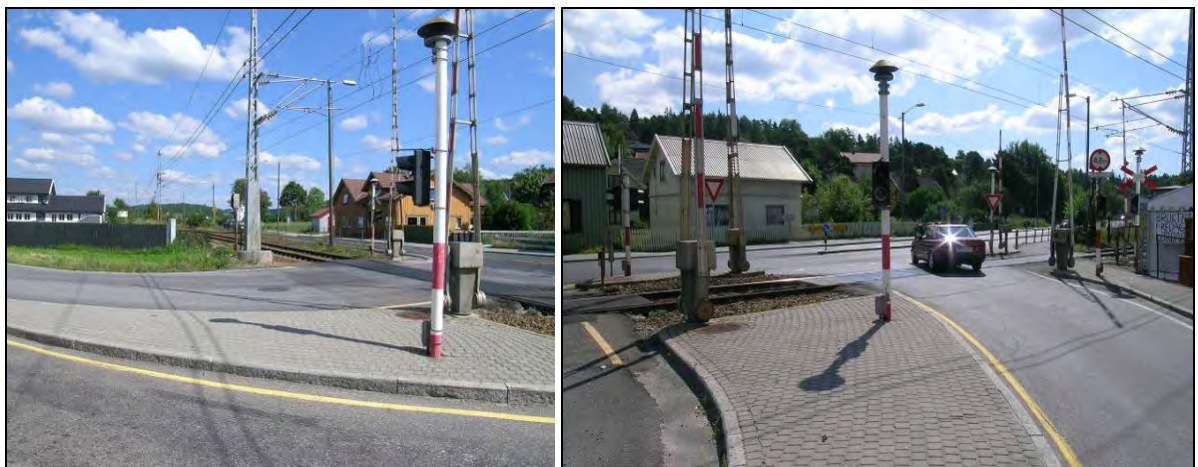
Figure 56: Poor sight lines to road traffic on the priority road (Skjeberg LC).

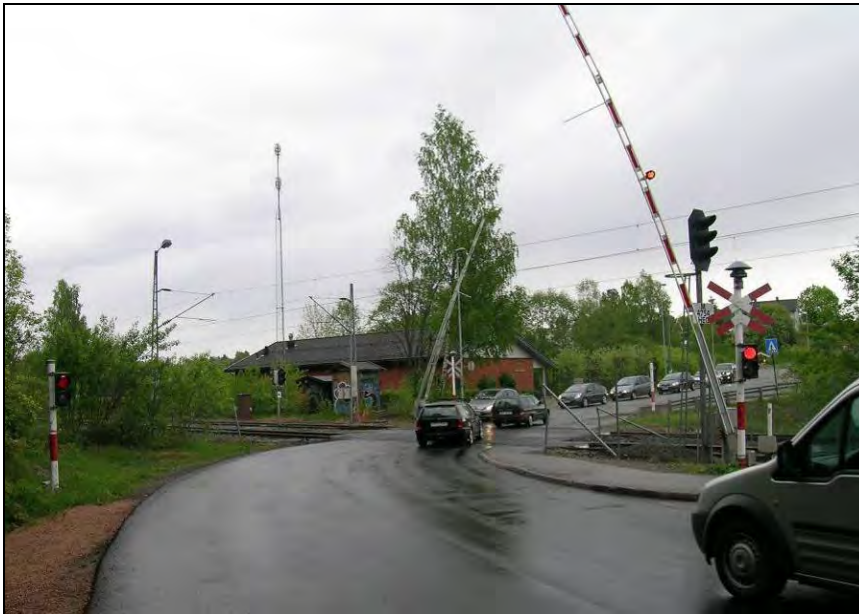
Figure 57: Example of poor traffic behaviour - two cars have managed to cross the level crossing before the light changes to white and the barriers have been fully raised
