SL REP.: 11/2005

**REPORT ON THE AIR ACCIDENT ON 30 NOVEMBER 2001 AT SKIEN AIRPORT  
GEITERYGGEN NORWAY, INVOLVING BRITISH AEROSPACE JETSTREAM 31, SE-  
LGA, OPERATED BY EUROPEAN EXECUTIVE EXPRESS AB**

SUBMITTED APRIL 2005

ACCIDENT INVESTIGATION BOARD - NORWAY  
PO BOX 213  
2001 LILLESTRØM  
NORWAY

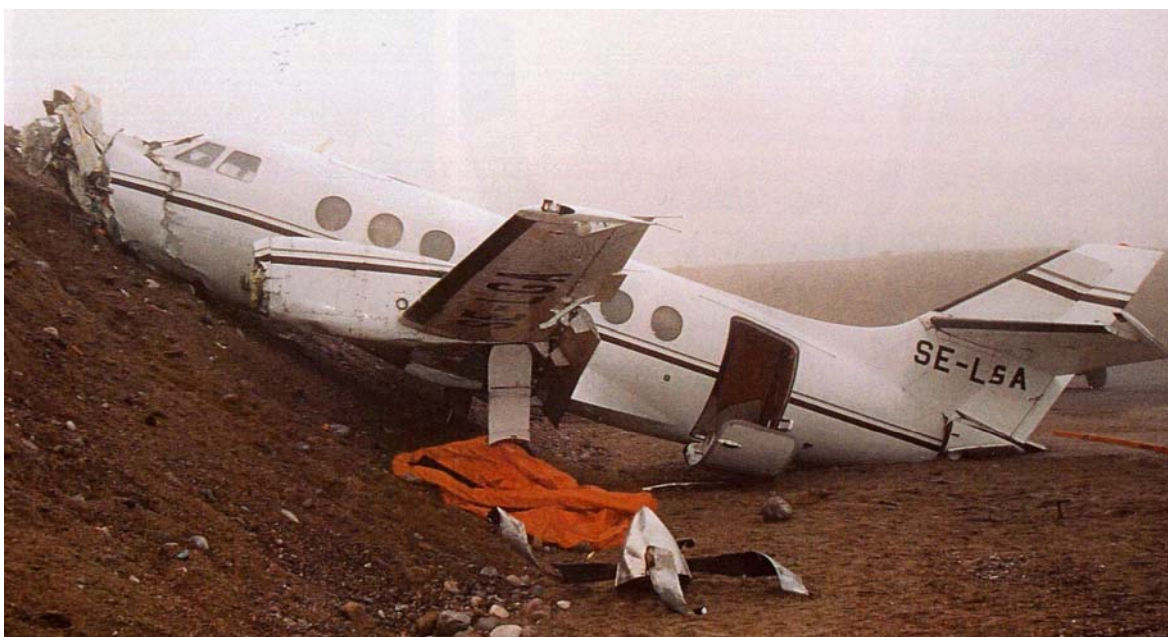
The landing led to permanent deformation of the left wing on the forward wing beam. As a result of this deformation, the left landing gear leg was bent backwards, with the engine and propeller pointing obliquely downwards. The left propeller touched the runway and the crew lost directional control so the aircraft skewed out to the left and left the runway (see diagram in subparagraph 1.12.1.3). It continued, skidding in an arc to the left, crossed a taxiway twice and hit a gravel bank with great force. The gravel bank was hit by the nose of the aircraft and the left propeller at an assumed angle of 45° in the horizontal plane. The aircraft continued up the gravel bank in a virtually horizontal attitude while the tail was thrown out to the right. Then the aircraft fell so that it was resting on its tail and main wheels with the nose up on the gravel bank.

*Photograph taken looking south the day after the accident. Note the unusual position of the wing, engine and landing gear*

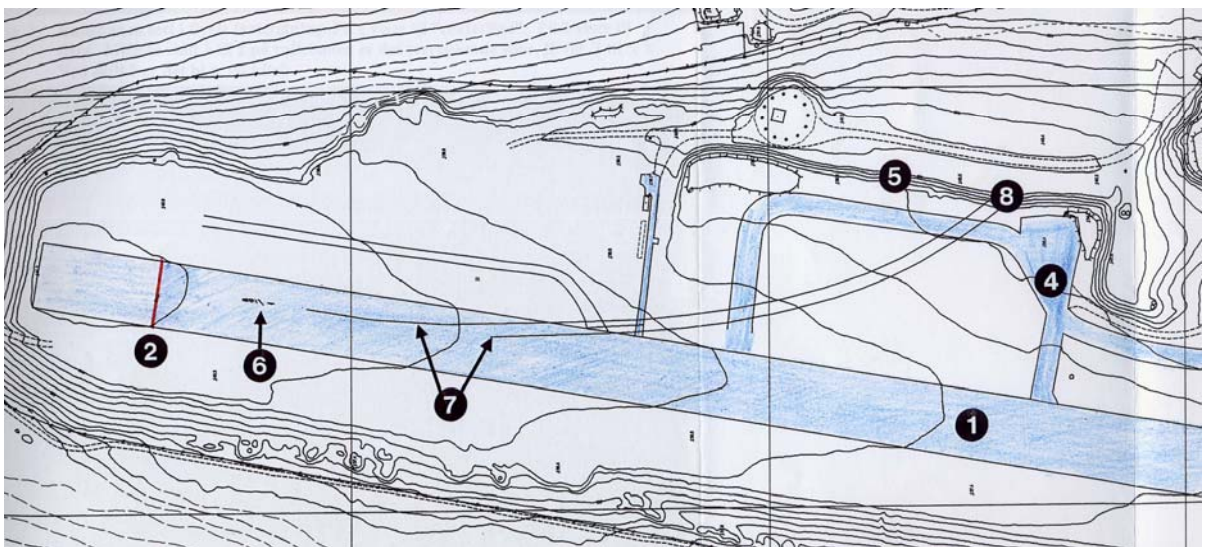
- 1.12.1.1 The first trace of the landing is a mark on the runway caused by the left propeller. This mark was 41.7 m into the runway, measured from the middle of the threshold marking lines and 3.75 m to the left of the runway's centre line. 13 lateral strike stripes from the propeller blade were found, with a distance of 46 cm between the 1<sup>st</sup> and 2<sup>nd</sup> strike. After this strike, the distance shrank by 1 cm per strike until the 7<sup>th</sup> strike where the distance once again increased. After the 13<sup>th</sup>, the marks in the asphalt become longitudinal and irregular, and there were small pieces of paint and plastic in the vicinity. Apart from a few short stretches, it was possible to follow the trail of the aircraft along a 371-metre trail from the place that the propeller touched the runway to the place where the aircraft came to rest.

- 1.12.1.2 After the aircraft left the runway, it continued around 220 m over a grassy flat area. There are several paved roads/taxiways crossing this area, but the transition between these and the grass is even and in good condition. 100 metres before the aircraft hit the gravel bank, the distance between the right main wheel and the nosewheel was 3.55 m, which indicates that the aircraft had 7° skid to the left with regard to the direction of movement. The aircraft then hit an approx. 5-metre high gravel bank that sloped steeply upwards. The bank, which consists of loose gravel mixed with stones, had earlier been even steeper, but some time before the accident some of the material had been removed so the angle is now around 35°. As a result of this work, the bank was not covered by vegetation. The aircraft struck the bank at an angle of approx. 45°, but the tail was thrown to the right so that the aircraft finally came to rest at an angle of around 100° in relation to the bank (seen in the horizontal plane). The aircraft stopped with its nose 3 m up the bank (see picture under subparagraph 1.1.11).

*1 runway, 2 threshold marking, 4 paved road/taxiway, 5 gravel bank, 6 marks from the left propeller, 7 wheel tracks, 8 collision point*
