SL Report 12/2006

**REPORT ON THE AVIATION ACCIDENT AT GÅSVASSRYGGEN,  
STORE GÅSVATN, SKJERSTAD IN NORDLAND COUNTY,  
2 SEPTEMBER 2003, WITH A HUGHES 369D SE-HSI OPERATED  
BY FJELLFLYGARNA AB**

SUBMITTED  
May 2006

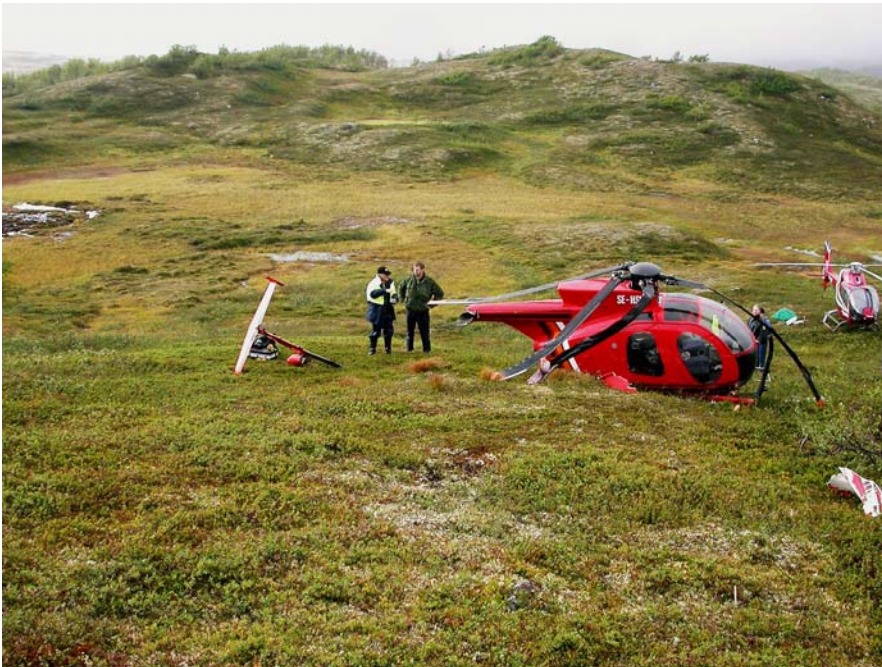
*Fig. 1 Crash site seen from the east*

The main part of the helicopter with the cabin, main gearbox and the forward part of the tail boom exhibited structural damage (cf. Fig.1).

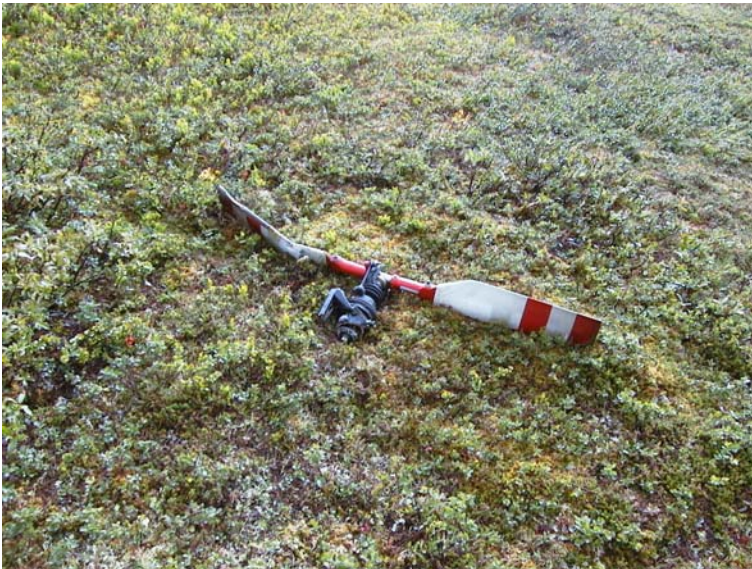
The tail rotor with the remainder of the tail rotor gearbox (Output section) lay 15 metres southeast of the severed tail (cf. Fig. 2 and Appendix 2).

*Fig. 2 SE-HSI Tail rotor with Output section of gearbox*

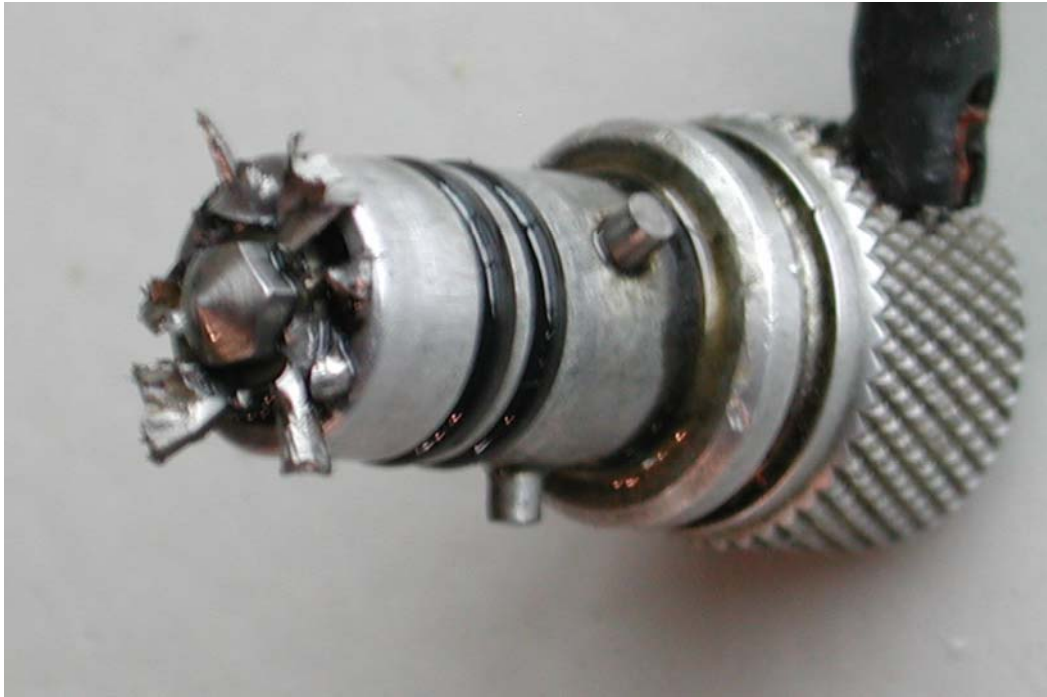
- 2.4.5 When the Input Gear fractured and a tooth and piece of the gear detached, the gearbox was split in two. Immediately before the residual fracture, metal particles detached from the gears, and metal particles on the magnetic plug triggered the caution light (T/R XMSN CHIPS) in the cockpit (cf. Appendix 1).

Tail rotor gearbox magnetic plug

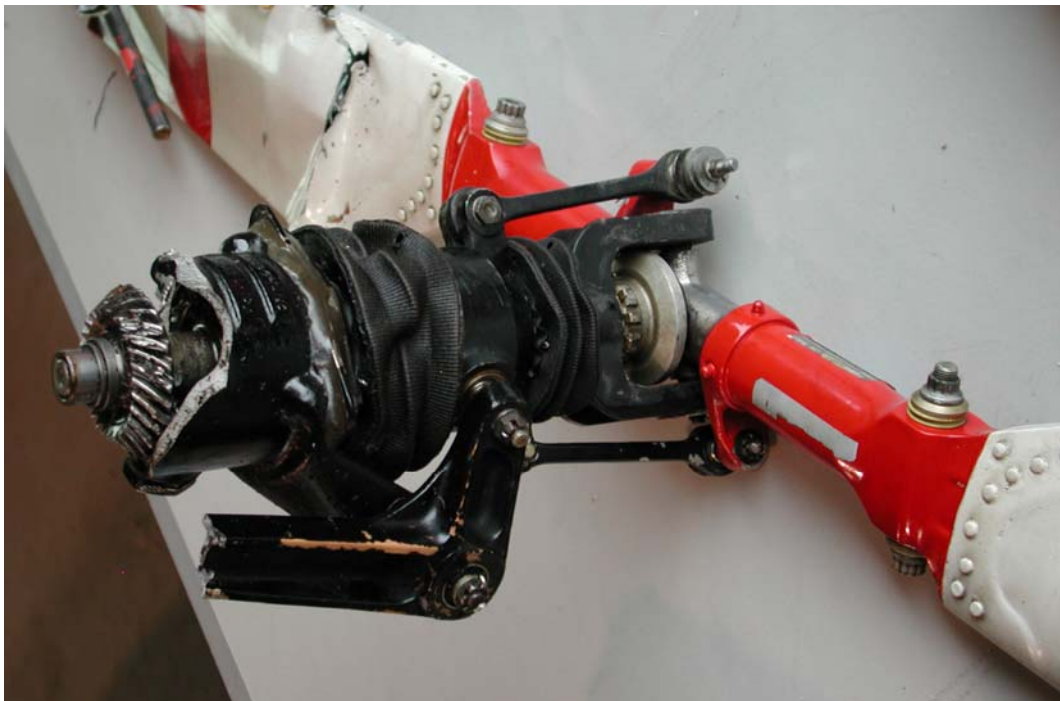
Tail rotor with Output section of the gearbox

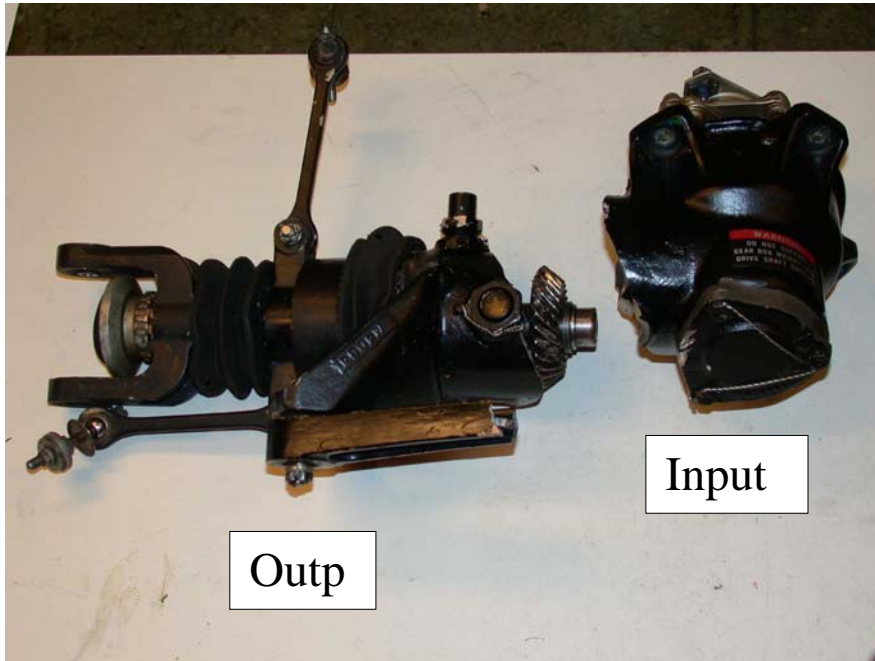
FOLAT, chemistry and materials technology, received a damaged helicopter tail rotor gearbox. The gearbox had detached, Figure 1, and a fracture could be seen in one of the gears on the power input side of the gearbox, Figure 2. The client wanted an assessment of possible root causes.

Figure 1 Photograph of the damaged gearbox.

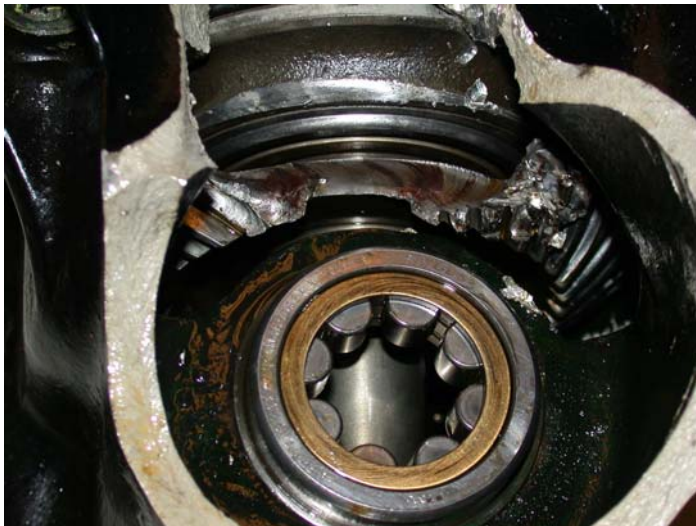
Figure 2 Photograph of fractured gear as observed in input side of the gearbox ref. Figure 1.

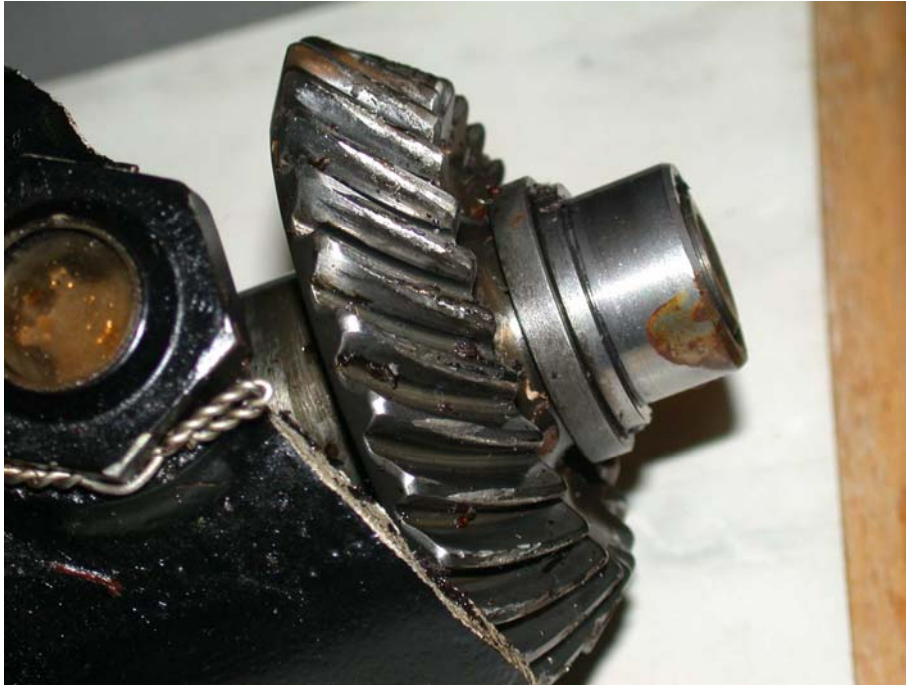
Preliminary examination was conducted with the stereo microscope. No abnormal wear could be observed on the gear on the output side of the gearbox. The damage observed showed clear indication of being secondary damage that was caused when fragments from the gear have been trapped, Figure 3 and 4

Figure 3 Photograph of output section gear. Examination using the stereo microscope concluded that the damage observed was secondary damage.

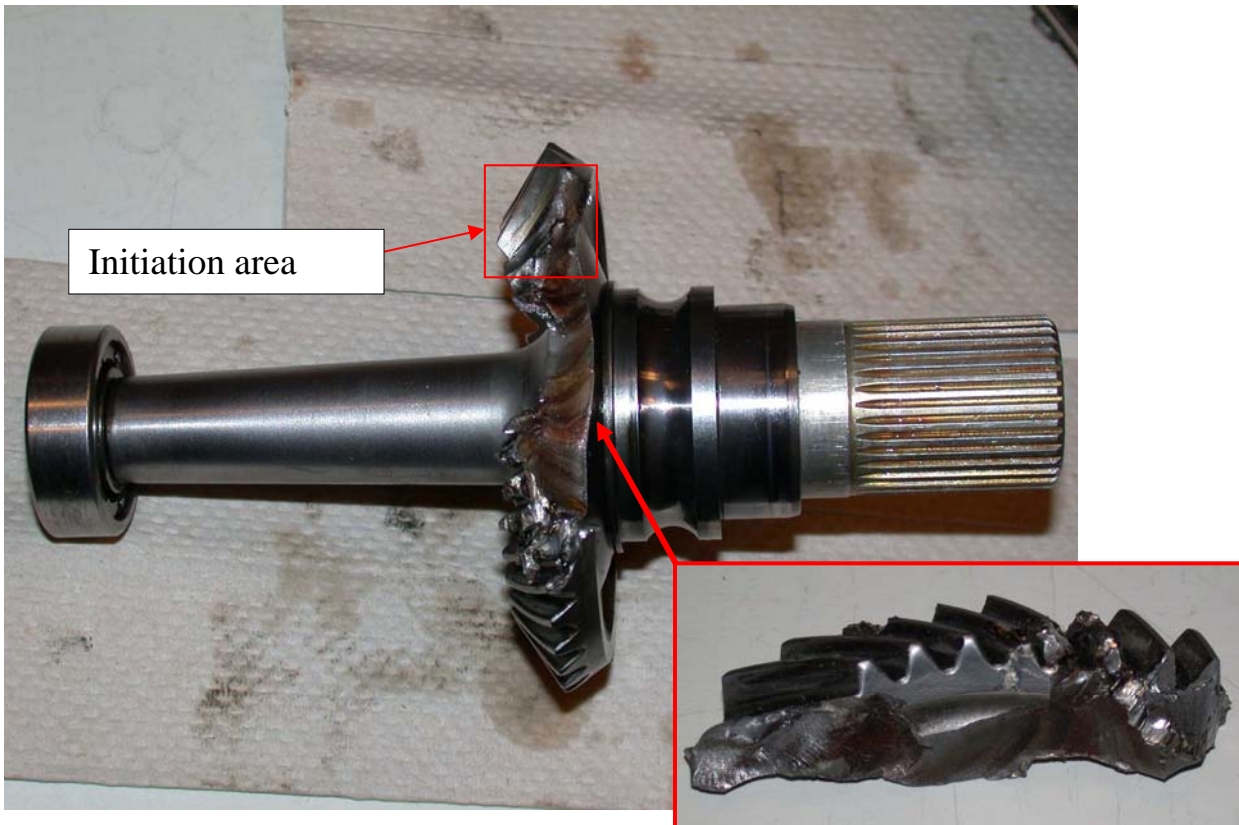
The gear on the input side was separated as shown in Figure 4. No indication of abnormal wear could be observed apart from the secondary damage that occurred when the gear detached. It can be seen when the separated part is fitted (integrated in Figure 4) into the gear in Figure 5, that a tooth is missing.

Observation through the stereo microscope reveals clear static lines in the fracture surface, which indicates fatigue. In order to confirm the fracture mechanism, a fractography was carried out in SEM. Further examination was concentrated around the crack initiation area, marked in Figure 4.

Figure 4 Photograph of fractured gear. The probable crack initiation area is shown at the top of the photograph. The separated part (ref. red arrow) has been integrated in the photograph.

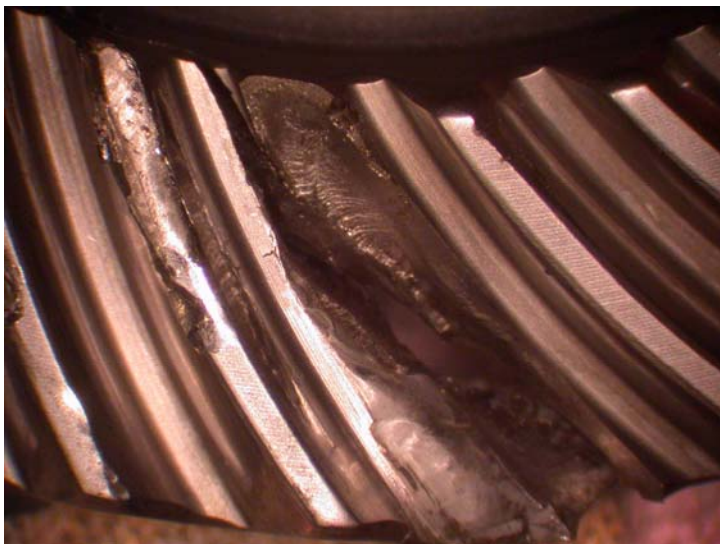
Figure 5 Photograph of the separated part sat into the gear. Shows that a tooth is missing.

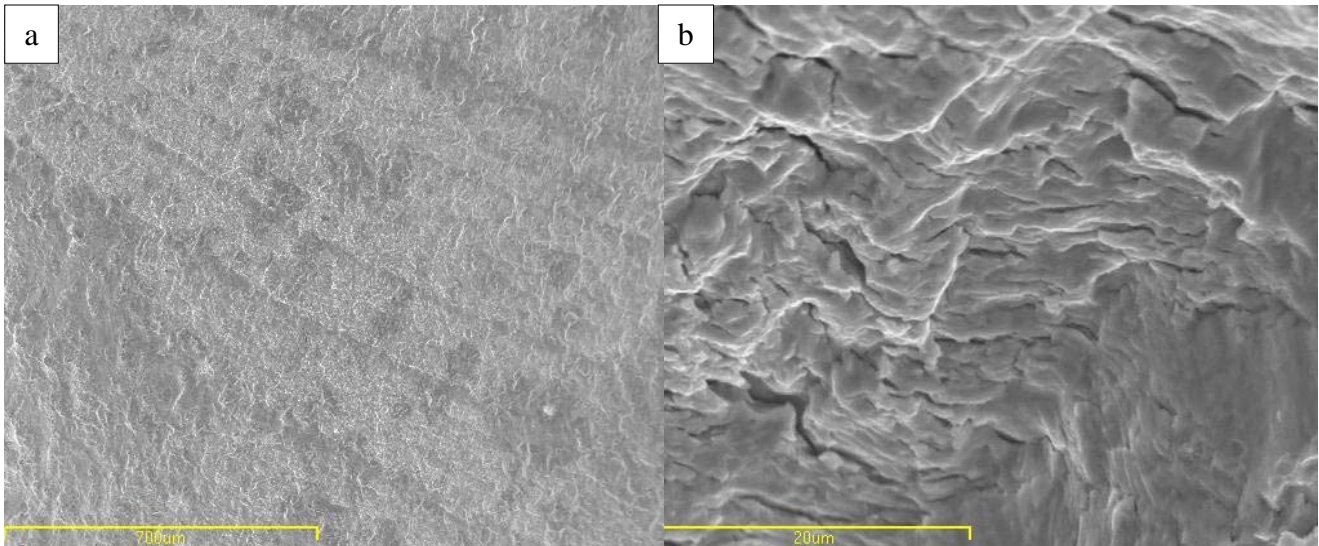
Fracture surface shown in Figure 4 was examined in SEM. Characteristic photographs of the fracture surface are shown in Figure 6, and it can be seen from the photographs that the fracture growth has taken place as a result of fatigue. It was not possible to conclude what the mechanisms in the initiation area were, as the area was oxidised and spread/secondary damage as shown in Figure 7.

Figure 6 Characteristic photograph of the fracture surface in two enlargements. a: Shows clear static lines in the fracture surface, b: Shows microfractures consistent with fatigue.

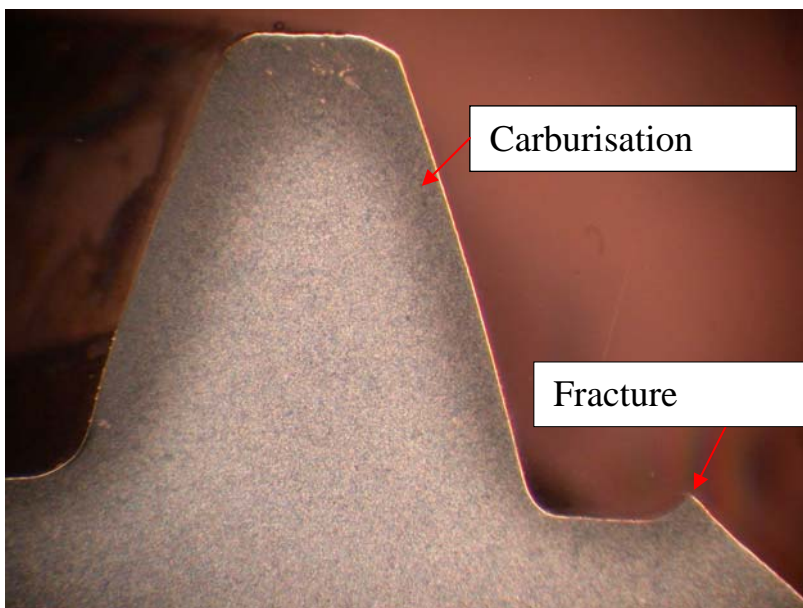
A section through the fracture initiation area (see Figure 4) was extracted for metallographic examination. Figure 8 shows a photograph of the test following etching in Nital, and it can be seen from the photograph that the gear has a carburisation layer. Representative photographs of the microstructure are shown in Figure 9 a and b for the carburisation layer and base material respectively.

Figure 8 Photograph of the section grind following etching in Nital show that the gear has a carburisation layer.

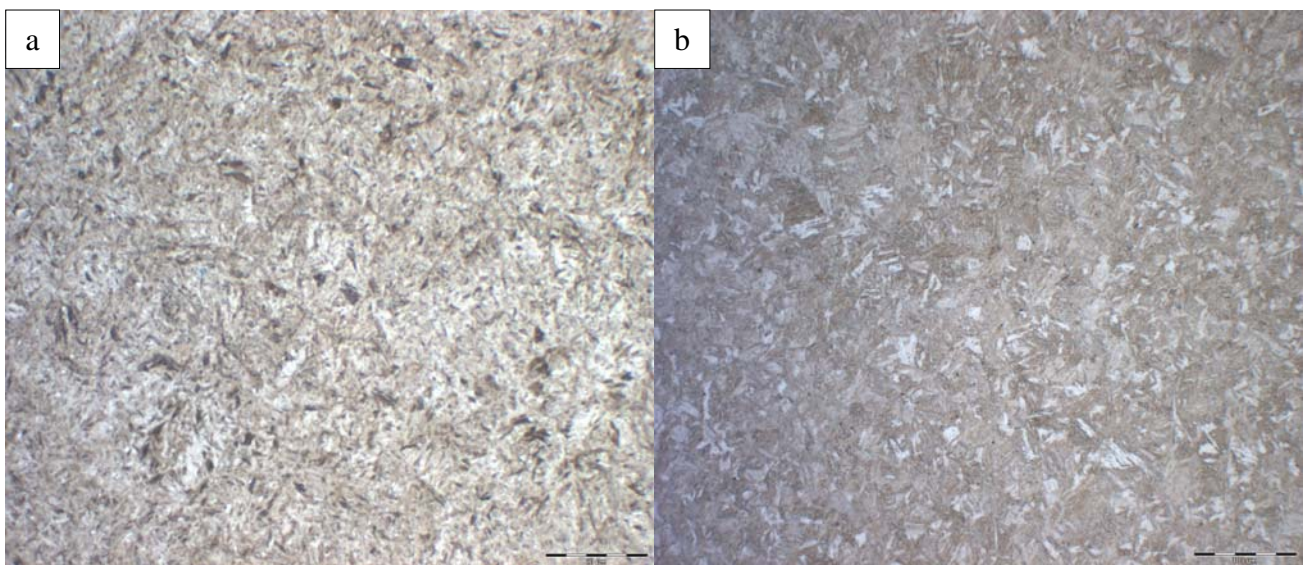
Figure 9 a: Microstructure photograph shows a carbonised annealed martensitic structure. b: Microstructure photograph from the base material shows an annealed martensitic structure.

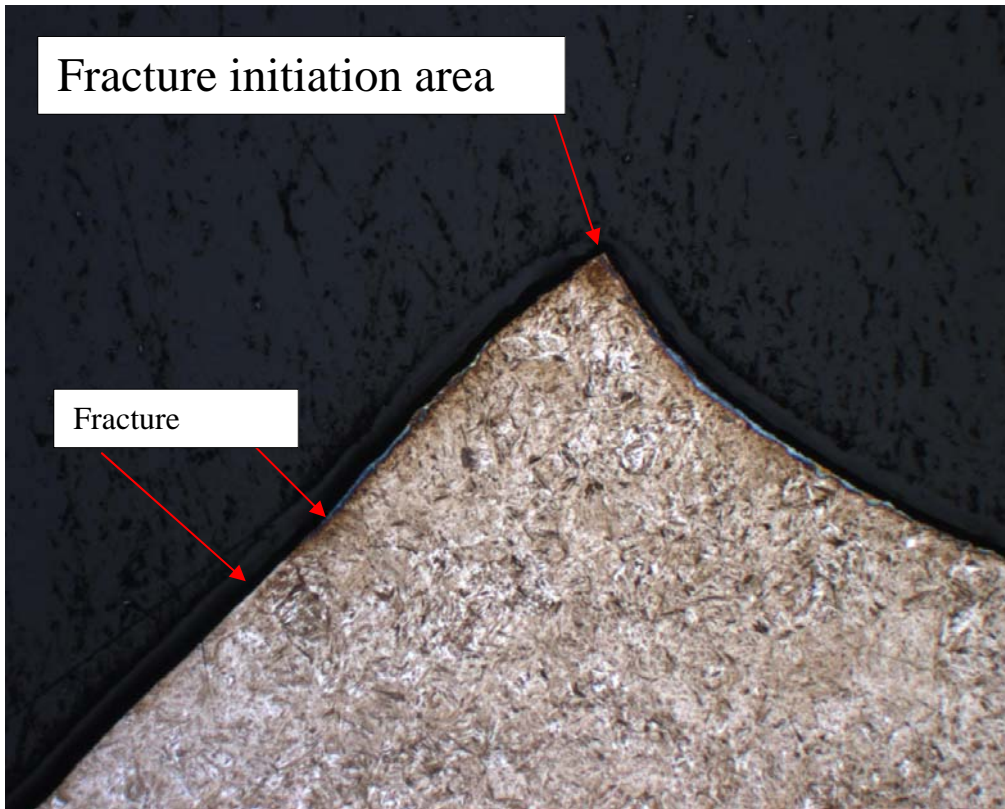
A series of grinds and repolishes were carried out in order to reveal potential microstructure deviations in fracture initiation area, but it was not possible to reveal deviations as occlusions or visible plastic deformation, Figure 10.

Figure 10 Representative photograph of section grind in fracture initiation area.
