FINAL REPORT

Date: 26.07.2006
SL Report: 20/2006

- Type and reg.:	Boeing 737-800, TC-APH
Operator:	Pegasus Airlines
Radio call sign:	PGT872
Date and time:	Sunday 23 October 2005, at time 2110
Incident site:	Oslo Airport Gardermoen (ENGM) Norway
ATS airspace:	Gardermoen CTR, class D
Type of occurrence:	Air traffic incident, attempted take-off from a taxiway
Classification:	Class 3. Major incident, according to Norwegian Aviation Regulations BSL A 1-10
Type of flight:	Commercial, non-scheduled.
Weather conditions:	Gardermoen METAR 2050 hrs.: 36006KT 9999 FEW019 SCT025 BKN130 00/M01 Q1008
Light conditions:	Dark
Flight conditions:	VMC
Flight plan:	IFR
No. of persons on board:	Unknown
Injuries:	None
Aircraft damage:	None
Other damage:	None
Crew:	Commander

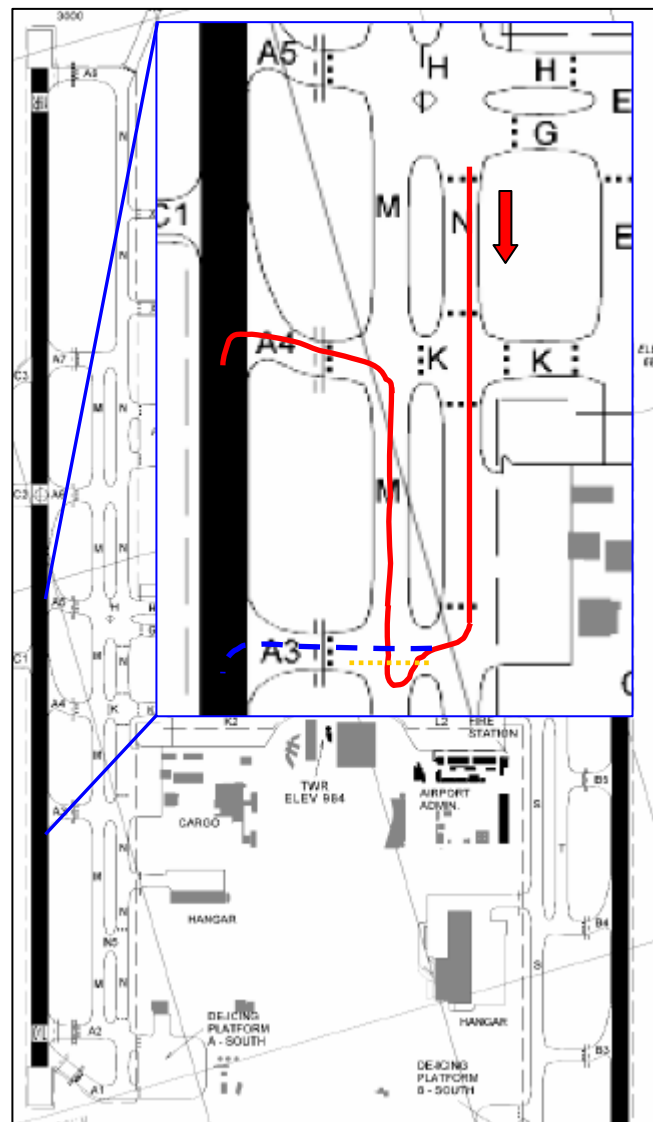
The crew taxied, in accordance with their clearance, in a southerly direction on taxiway (TWY) N (see map). The commander was pilot flying (PF) and the first officer was responsible for radio communication with Air Traffic Services. There was also a third pilot in the cockpit who had newly joined the airline and was being trained. He had no other tasks than to observe. While taxiing in a southerly direction on TWY N the crew was given clearance for take-off on RWY 01L via intersection A3. The first officer acknowledged this with the flight's radio call sign, and the air traffic controller followed up with clearance to taxi in a southerly direction on RWY 01L, if necessary. The crew had calculated that the runway available from A3 was sufficient for take-off. The stated TORA in AIP for RWY 01L from A3 is 2,696 metres. The red line on the map shows the aircraft's movement. The data source is the airport ground radar.

In her report, the commander says that when they were given clearance for take-off and turned to the right towards A3 she increased the engine rpm slightly and lit the landing lights. She then saw the yellow dashed line across TWY M, south of A3 which marks the intermediate holding point. The commander writes:

"When I saw the yellow dash lines on the left on taxiway, because of the notam, I misinterpreted the lines as if I am aligning on the runway centreline".

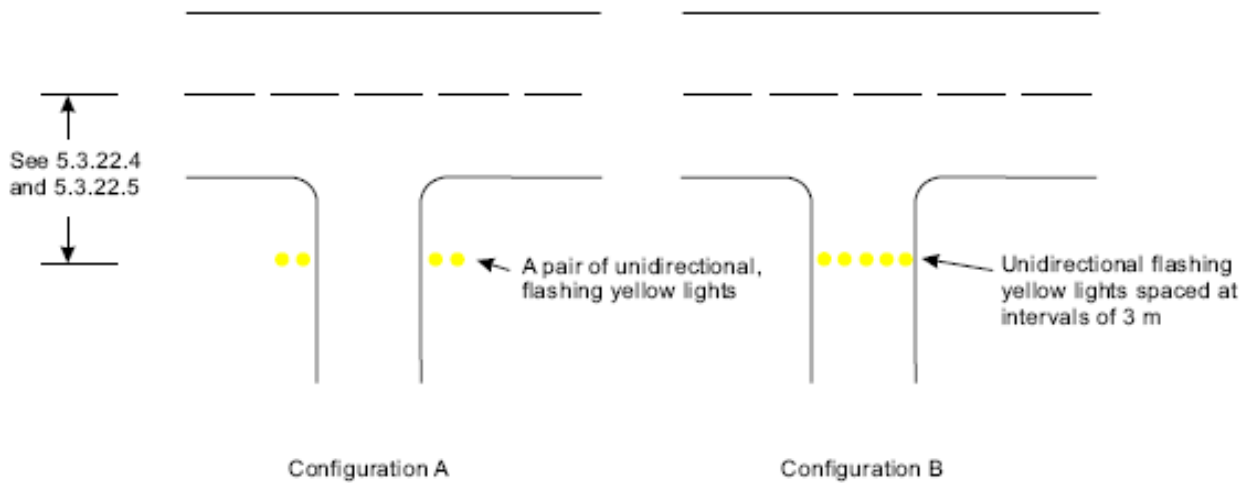
Figure 5-27. Runway guard lights

Note – The purpose of runway guard lights is to warn pilots, and drivers of vehicles when they are operating on taxiways, that they are about to enter an active runway. There are two standard configurations of runway guard lights as illustrated in Figure 5-27

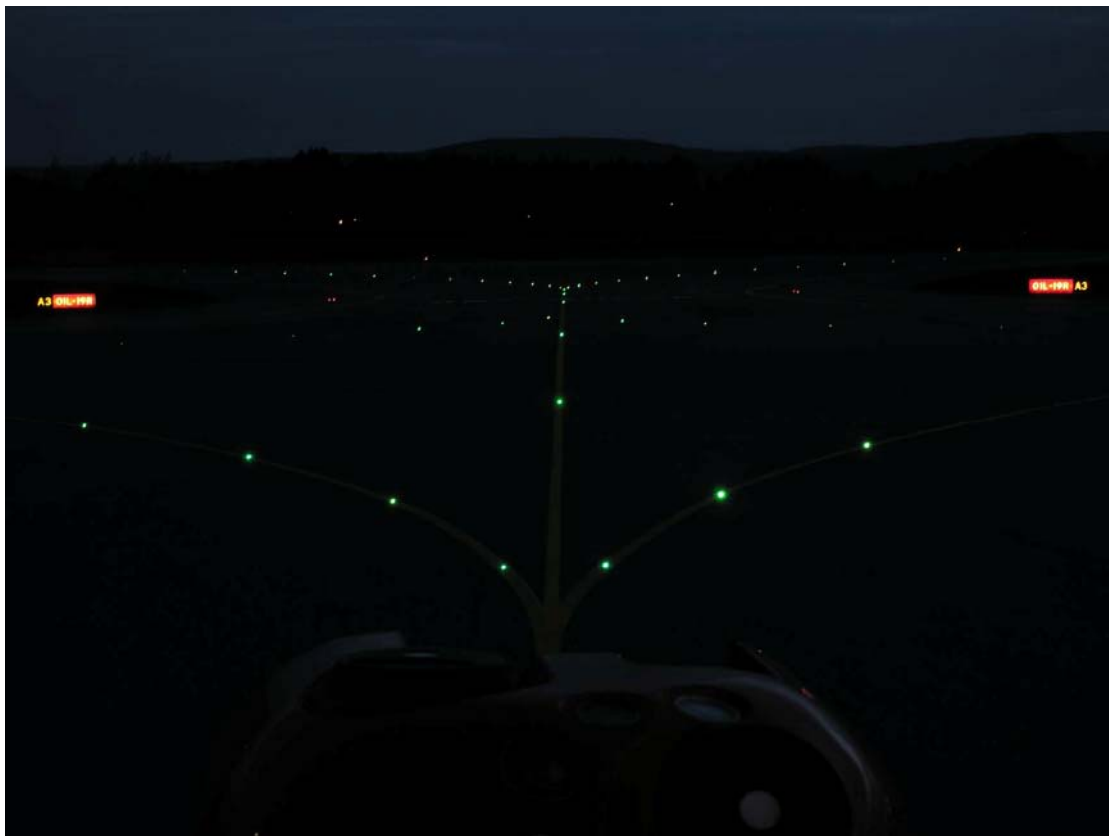
On TWY A3 at intersection TWY N.

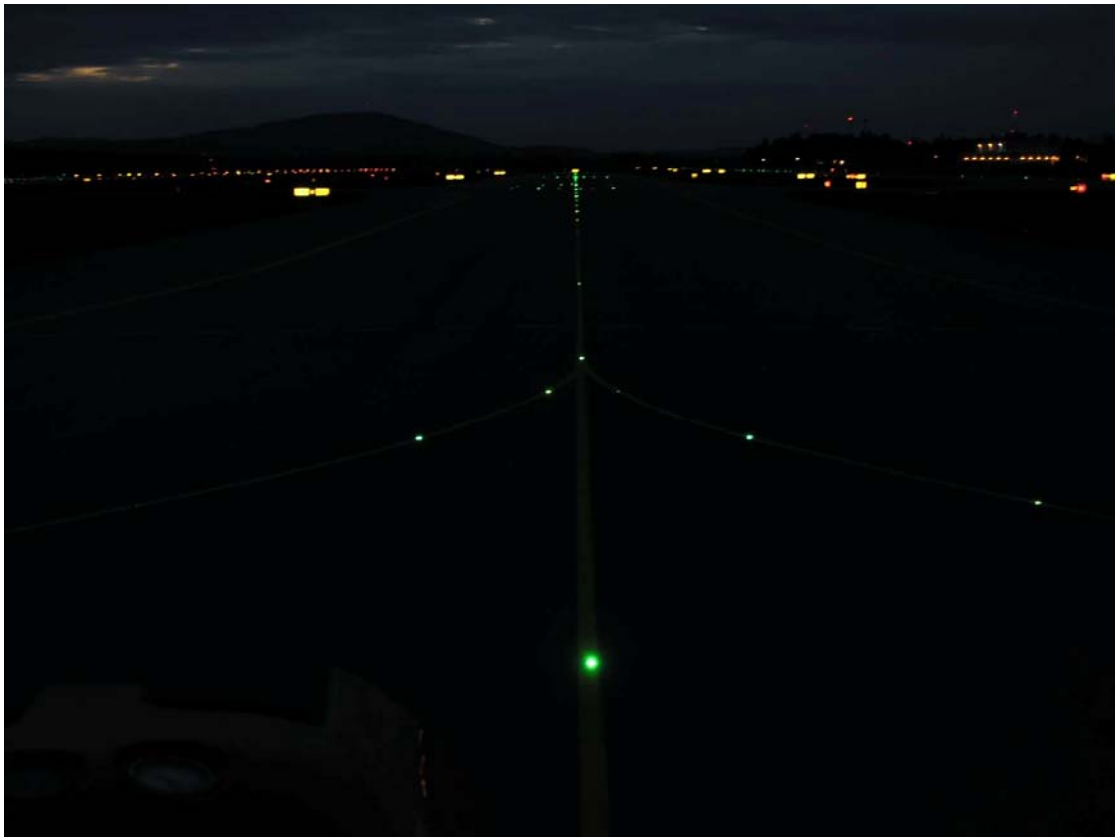
On TWY M at intersection TWY A3.

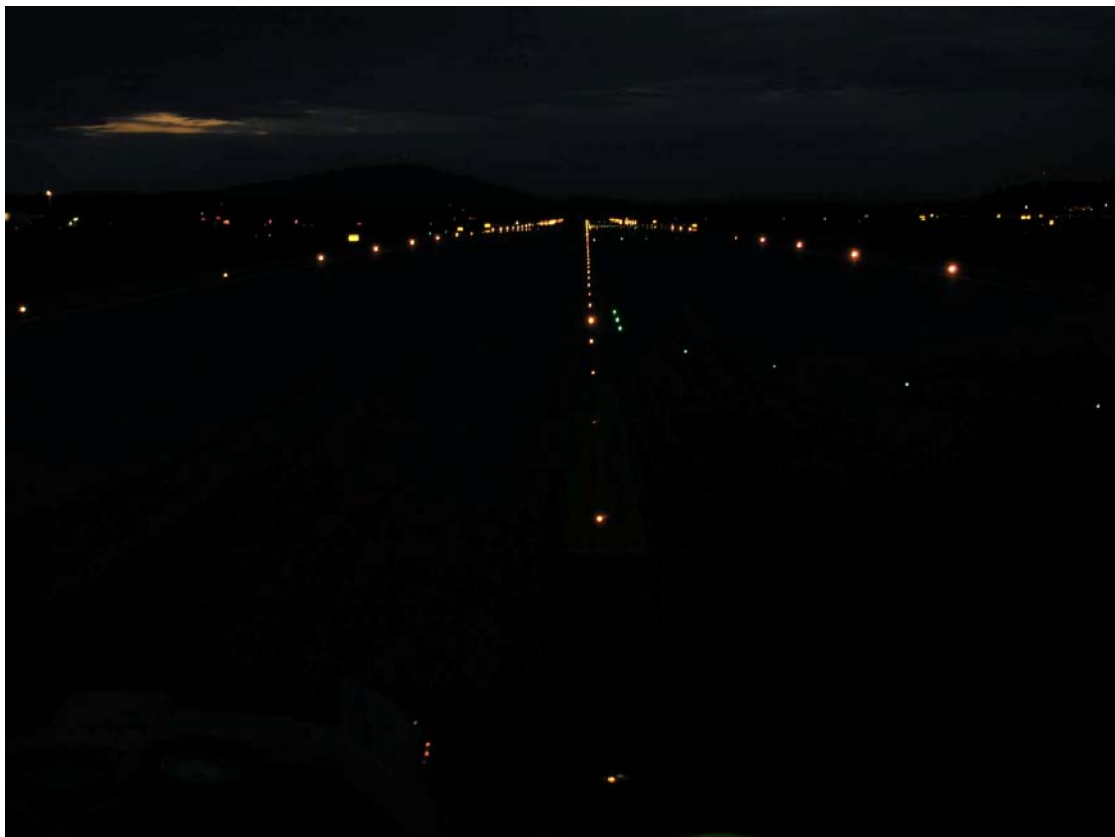
On RWY 01L at intersection TWY A3.
