SL 2009/12

REPORT ON AIRCRAFT ACCIDENT AT ØSTRE
ÆRA, HEDMARK, NORWAY ON 16. JULY 2004
INVOLVING ANTONOV AN-28 YL-KAB, OPERATED
BY A/C RIGAS AEROKLUBS

Date: 18.06.2009
SL Report: 2009/12

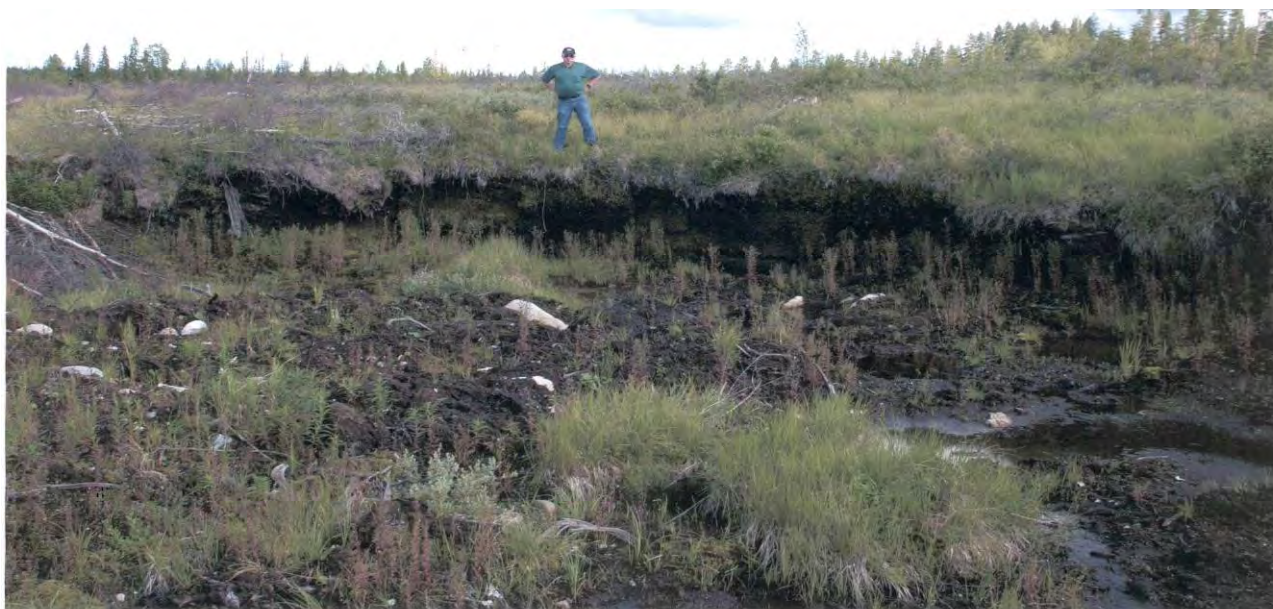
The PF first positioned the aircraft on downwind on a southerly course west of the airfield, in order then to make a left turn to final on runway 01. The landing took place around halfway down the runway, at a faster speed than normal - according to the Commander's explanation approximately 160-170 km/h. The PF braked using the wheel brakes, but when he realized that he would not be able to stop on the length of runway remaining, he ceased braking. He knew that the terrain directly on the extension to the runway was rough, and chose to use the aircraft's remaining speed to lift it off the ground and to alter course a little to the right. The aircraft passed over the approx. 2.5 m high embankment in the transition between the runway level and the higher marshy plateau surrounding the northern runway area, see Figure 1.

Figure 1: Embankment approx. 60 m beyond the end of the track in the extension of runway 01. The picture has been taken in the direction of travel.

The AIBN believes that the crew, after having entered this difficult situation, carried out a satisfactory emergency landing under very demanding conditions. The fact of the parachutists being within the approach sector made the scenario more complex, and a landing ahead of the threshold had to be avoided. With the flaps non-functional, it is understandable that the speed was high and the touchdown point not optimal. The fact that the Commander got the aircraft into the air again and landed on the higher marshy plateau, was probably crucial to the outcome. Continued braking would have resulted in the aircraft running into the earth embankment at relatively high residual

speed, and it is doubtful whether the crew would have survived. A safety recommendation is being put forward in connection with this.

The terrain in the extension to runway 01 at Østre Æra, with an approx. 2.5 m high earth embankment around 60 m from the threshold, could inflict severe damage to aircraft and injury to onboard personnel in the event of a potential high-speed overrun. The AIBN recommends that the CAA-N should assess whether it needs to order the owner of Østre Æra airstrip to smooth out the terrain in the extension to runway 01.

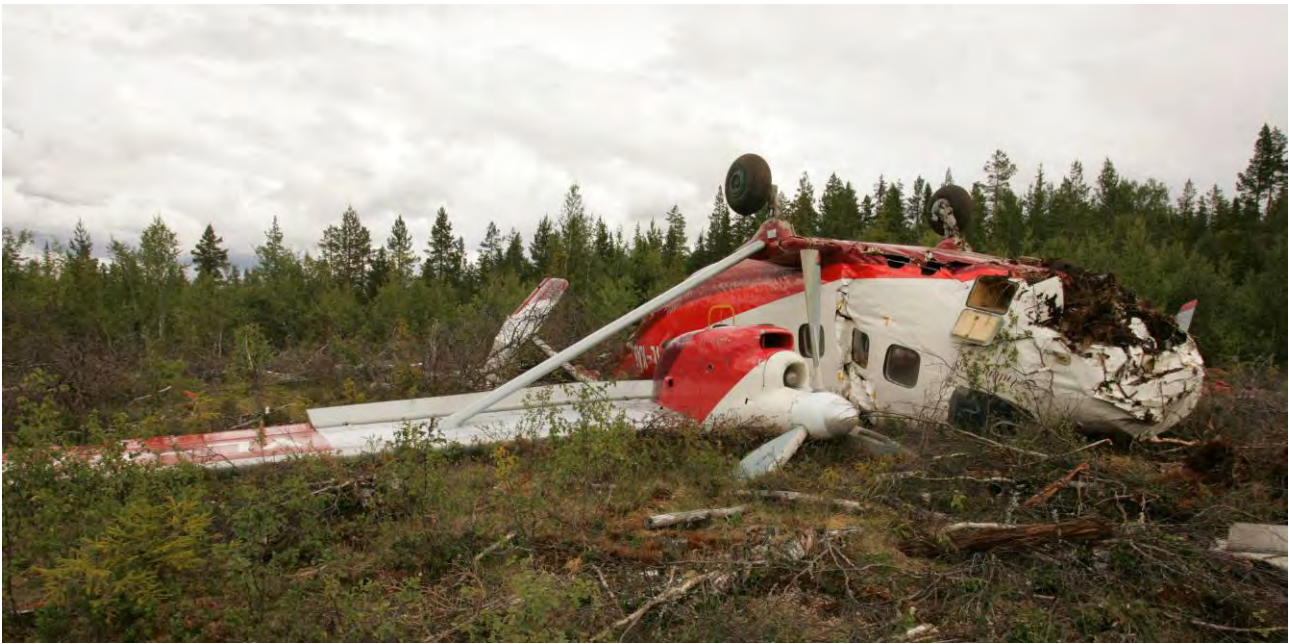
The aircraft ran approx. 230 m in ground effect before landing on its wheels in the flat marshy area north of the airfield. After around 60 m of roll-out, the nose wheel and the aircraft's nose struck a ditch and the aircraft turned over lengthways. It came to rest upside down with its nose section pointing towards the landing strip, see Figure 2. The floor of the cockpit was pushed up so that the nose wheel came through the floor and partially into the cockpit (Figure 3).

Figure 2: Aircraft wreckage after the accident.

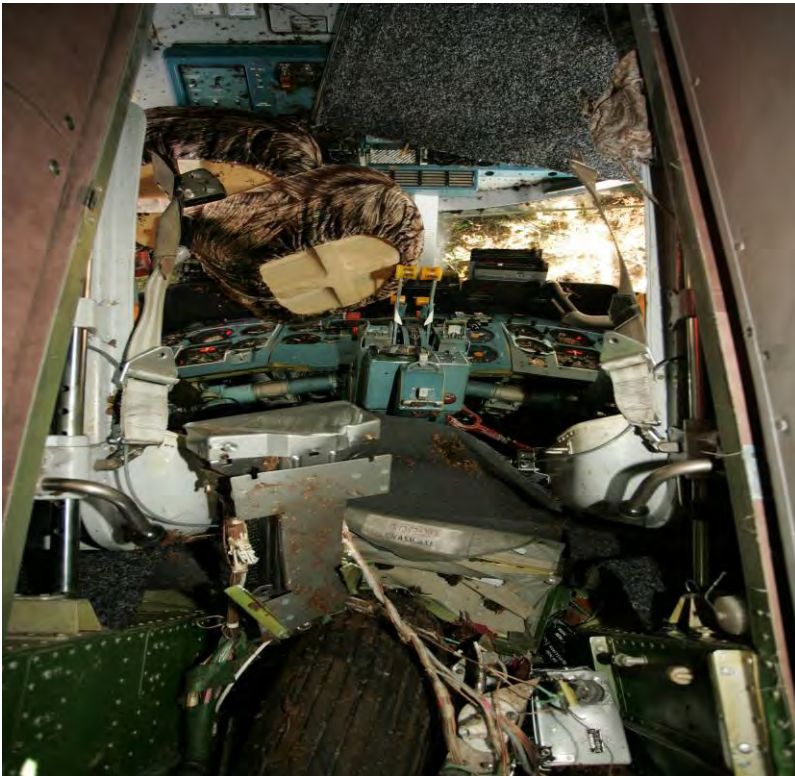
Figure 3: Cockpit with floor pushed up and the nose wheel penetrating through the floor.

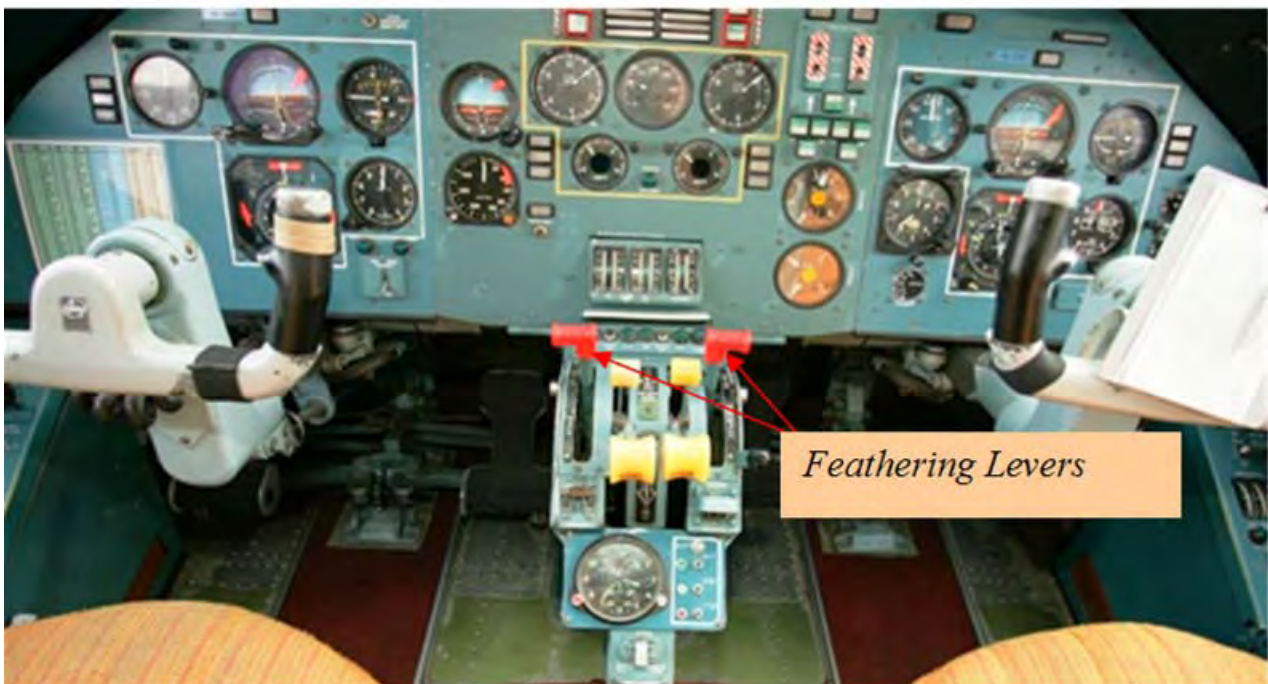
Two red-painted handles (Feathering Levers), one for each engine, are located on either side of the pedestal, between the pilots (see Figure 4). With the handles in the forward position, the automatic feathering system is armed for both engines. According to the aircraft manual, automatic feathering and shutdown of the engine's fuel supply will occur if the combination of compressor rpm and pressure gradient are lower than the set values, 56 % and 2.6 respectively. To avoid this, during a descent no air should be tapped from the engines to the anti-icing system if the compressor rpm is reduced below 72 %.

Figure 4: AN-28 Flight Deck with instrument panel, central console and red Feathering Levers.

In the folder in the cockpit there was a procedure for starting engines in the air. The procedure contained an item about verifying that the Feathering Lever is in the forward position, but did not mention that, after automatic feathering of the propeller, it is first necessary to re-arm the system. According to the explanation given by the crew of YL-KAB, both Feathering Levers were in the

The experienced Commander assessed the distance to the cumulonimbus cloud as sufficient to allow the drop to be carried out, and expected that they would then rapidly make their way out of the exposed area. It appeared, however, that problems arose when the aircraft was exposed to turbulence and icing from the cloud. The AIBN believes the limits of the engines' operational range were exceeded since the anti-icing system was switched on while the power output from the engines was low, in combination with low airspeed, turbulence and sudden manoeuvring. At that, both engines stopped, and the propellers were automatically feathered. The AIBN believes the engines would not restart because the Feathering Levers were not moved from the forward to the rear position and forward again, as is required after automatic feathering.
