REPORT

Vei 2012/01

THEMATIC REPORT CONCERNING SAFETY IN CARS

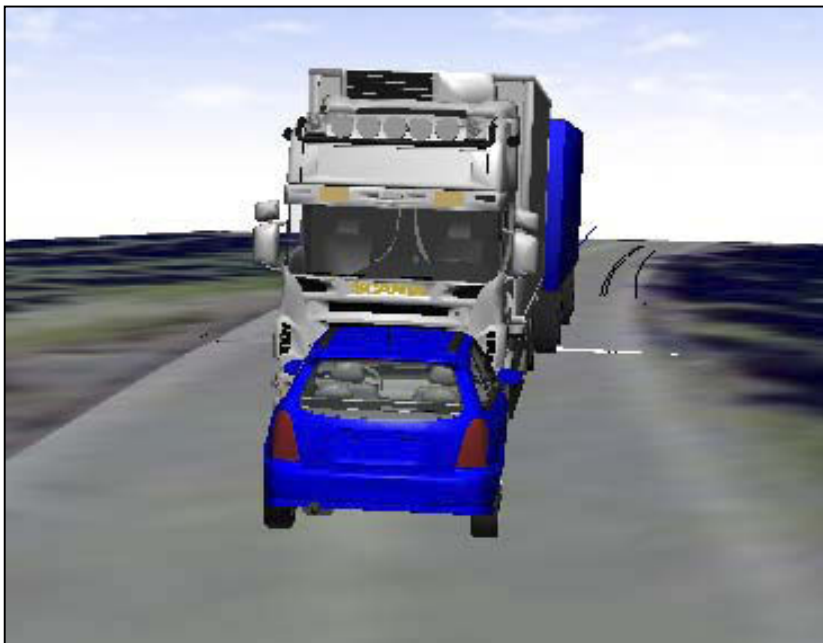
The simulation shows a collision speed between 24 and 36 km/h for the lorry and between 42 and 69 km/h for the passenger car. The passenger car was exposed to a speed change of between 71 and 93 km/h with the force direction approximately directly backwards in relation to the car. The lorry's speed change in the collision was minimal.

Figure 8: Collision position - Accident 1.

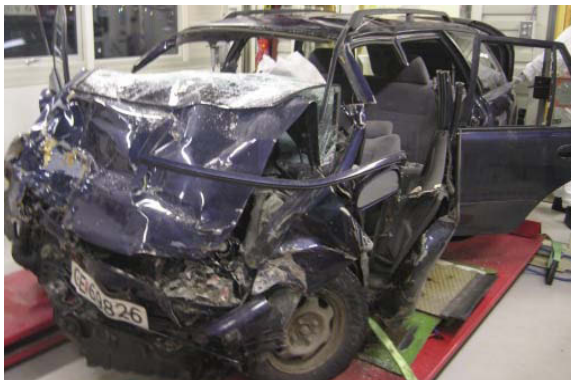
Seen together, the internal damage to the back of the driver's seat (cranial impression and pushed forcefully forward) and the final positions and injuries of the backseat passengers (passenger with head injury found on the floor behind the driver's seat), indicate that one of the passengers sat unsecured in the boot.

Figure 9: Damage to the front of the Mitsubishi Lancer. Survival space for all seats in the car except the driver's seat.

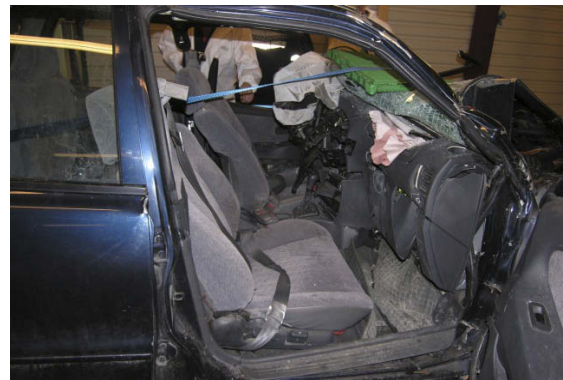
Figure 10: Restricted survival space for the driver's seat.

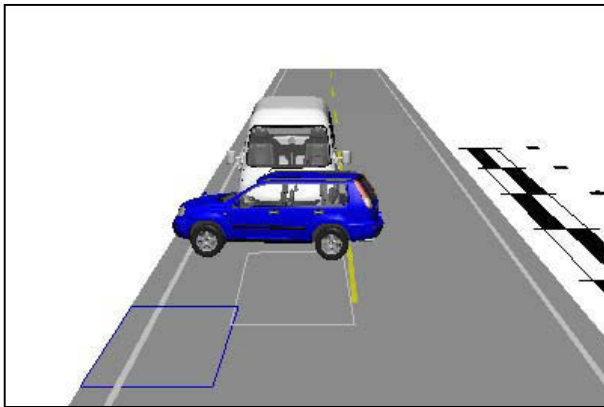
backwards in relation to the car. The Nissan was exposed to a speed change of 65-76 km/h with an angle of approximately 90 degrees to the left in relation to the car.

Figure 15: Collision position - Accident 3.

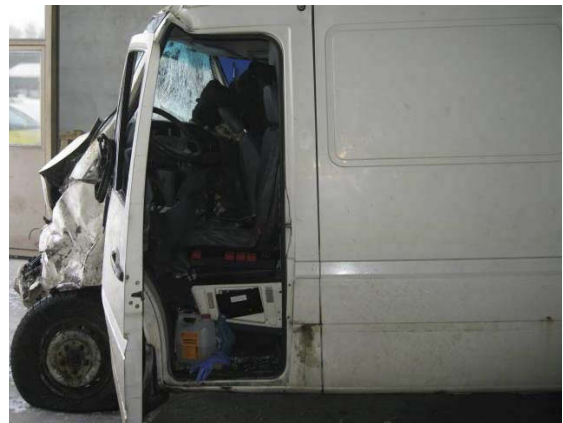
Figure 17: Damage to the front of the Mercedes Sprinter van. Survival space for the driver's seat.

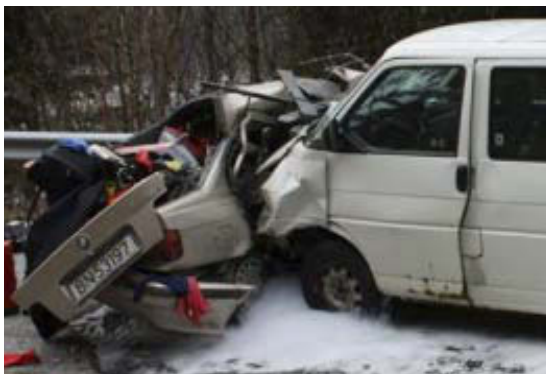
Figure 19: The BMW 325i collided sideways into the front of a VW Caravelle. (Photo: the Police)

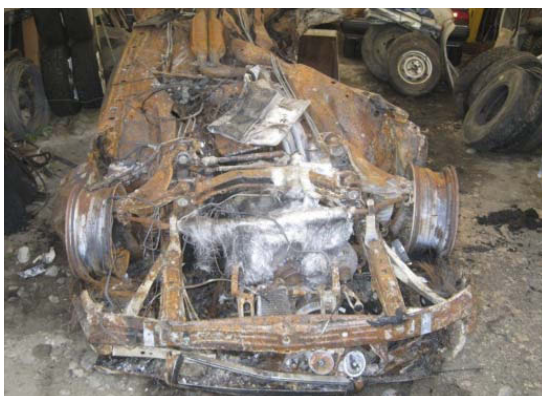
The passenger car was burnt out, making it impossible to describe movement or impact points in the car. Both persons in the back seat probably used seat belts as the belt buckle was in the lock. In front, everything was deformed/burned out making it impossible to ascertain whether seat belts were used.

Figure 22: Mercedes E220 completely burned out, no survival space in the car.

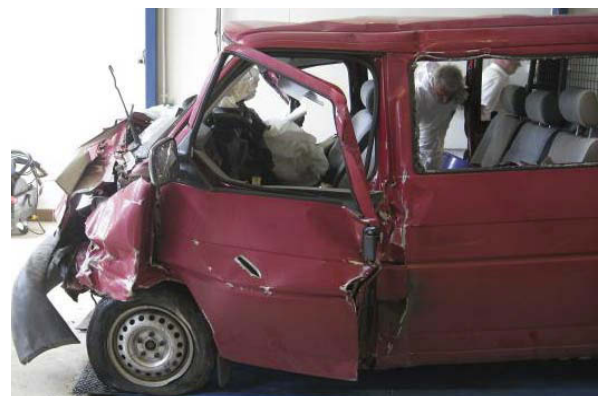
Figure 23: Damage to the front of the VW Caravelle. Survival space for the driver's seat.

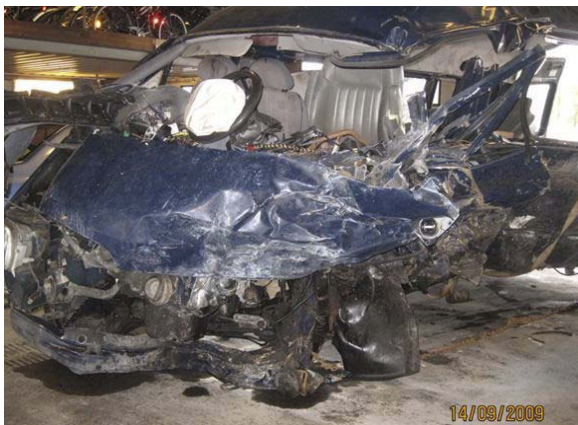
Figure 25: Damage to the front of the Ford Transit (photograph: Norwegian Public Roads Administration). Survival space for all seats in the car, limited space for the driver's seat.

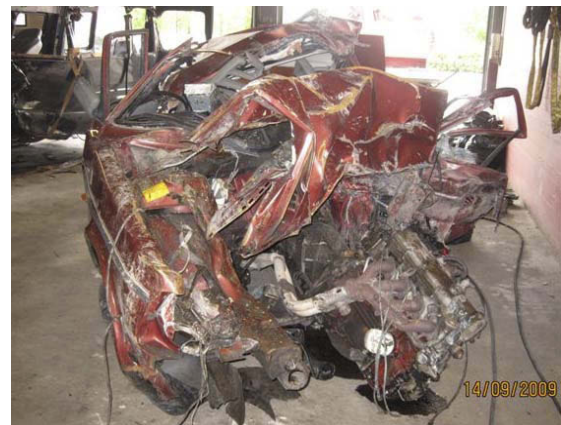
The Volvo 240 passenger car 1984 model is listed with medium safety in the Folksam list. The car has not been tested by EuroNCAP. The car was not equipped with air bags, seat belt pretensioners or force limiters. The passenger car hit the minibus at high speed and was totally destroyed. The driver of the Volvo used the seat belt, but there was no survival space in the car.

Figure 26: Totally destroyed Volvo 240 (photograph: Norwegian Public Roads Administration). No survival space for the driver's seat.

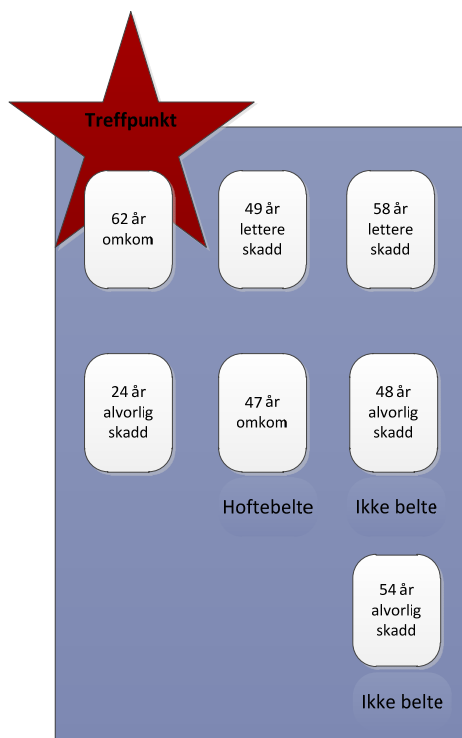
The Ford had an intrusion of 55 cm at the left front. This car was equipped with airbags in front and both had been triggered. The car had also had seat belt pretensioners in the front, but no force limiters. There were seven people in the car, three in front, three on the second row and a person on the right in the third row. Figure 25 shows the passengers' location in the car, degree of injury and use of seat belts.

Figure 27: The passengers' location in the Ford Transit, use of seat belts and degree of injury.

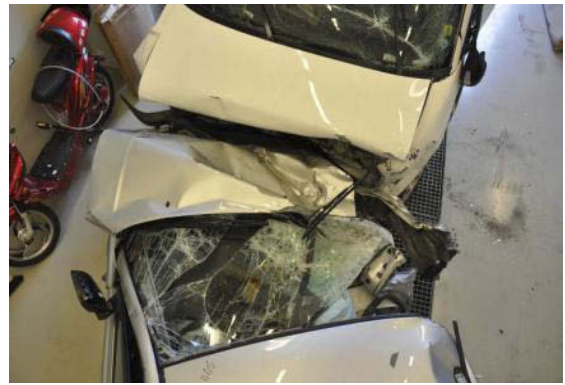
Figure 30: Reconstruction showing the vehicles' positions in relation to each other at the moment of impact.

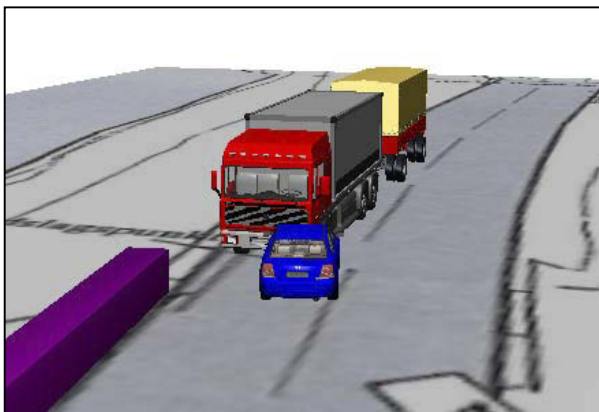
For the lorry, the speed change was between 3.3 and 4.0 km/h and the rotation speed between -0.6 and -0.7 rad/sec. The rotation speed was maintained at the same level for about 1 second for the Toyota due to the simulation of secondary collisions with the lorry, but is reduced to 0 after only approx. 0.2 seconds for the lorry.

Figure 33: Collision position - Accident 8.

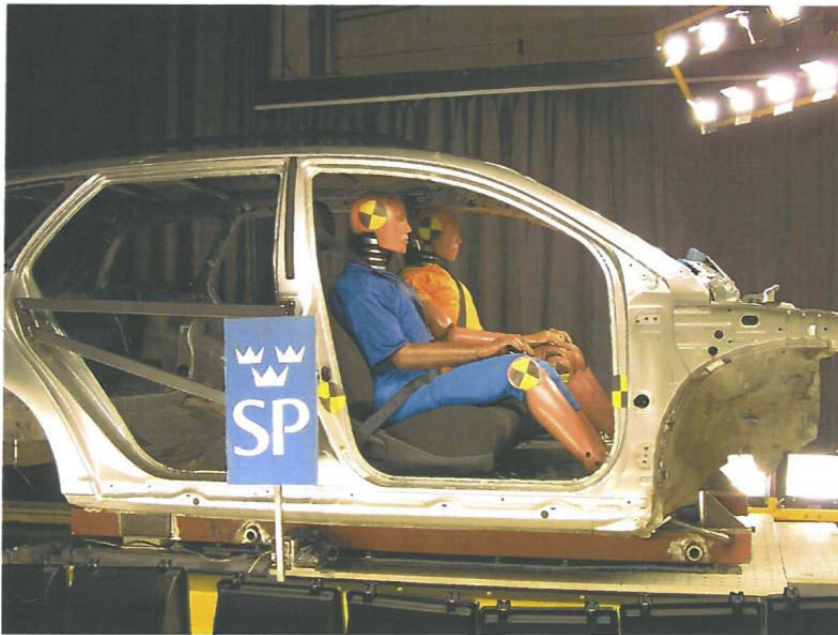
Figure 38 show the test chassis with the two crash test dummies before the dynamic tests were carried out.

Figure 37: Chassis with dummies before the tests were conducted.

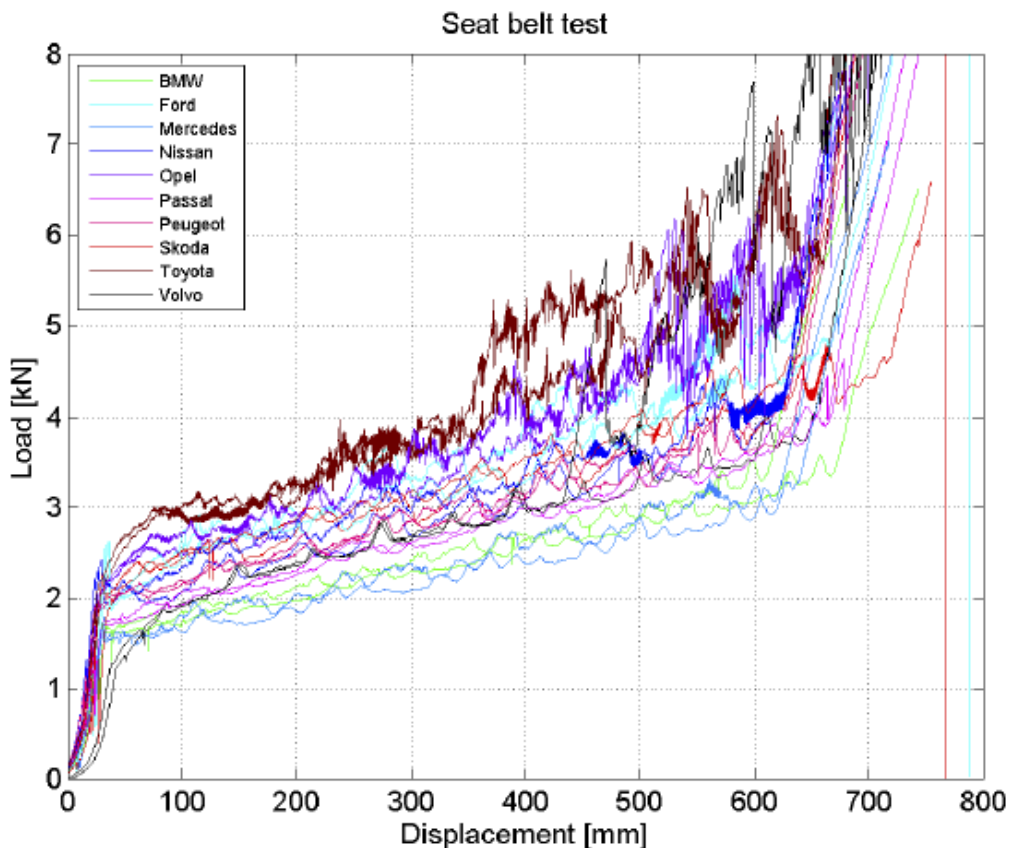
significant degree. The tests also showed that none of the belts had any limitations on the length that could be pulled out, as all belts could be pulled out until the spool was empty.

Figure 39: Overview of the load and pull development for the tested seat belts. (Source: SP)

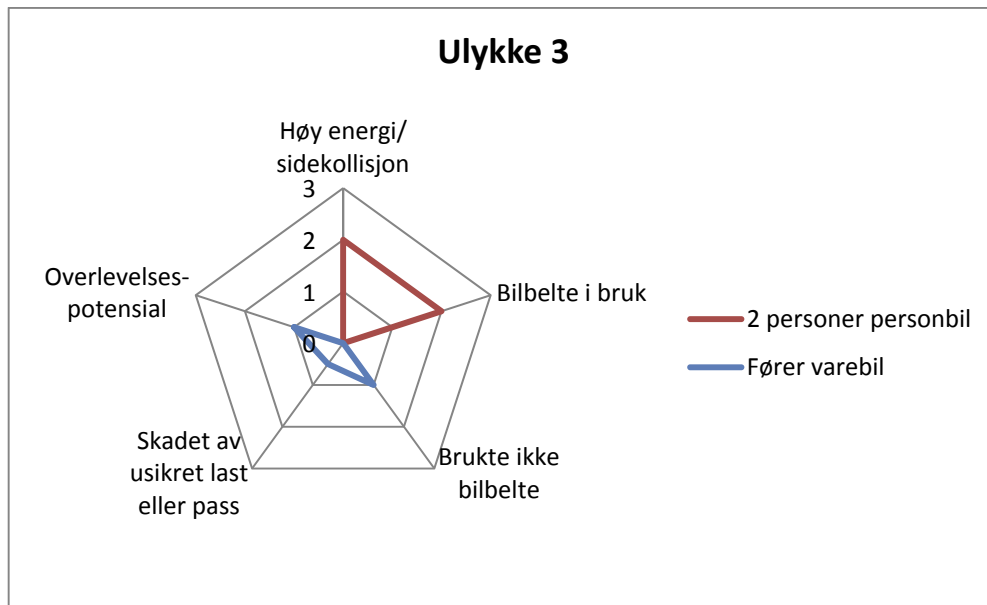
Figure 42 shows the survival potential for the driver of the van, but that he did not use a seat belt and was hit by unsecured cargo in the seat back. For the driver and passenger in the passenger car, there was no survival potential as a result of high energy/side collision, although both of them used seat belts.

Figure 42: Survival potential - Accident 3.

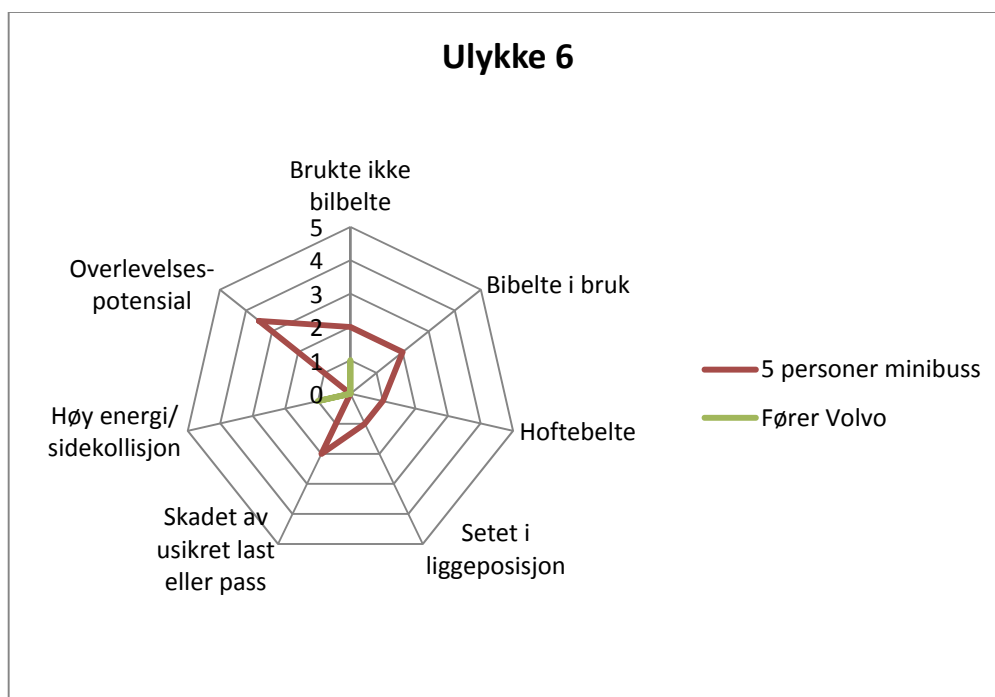
Figure 45: Survival potential - Accident 6.

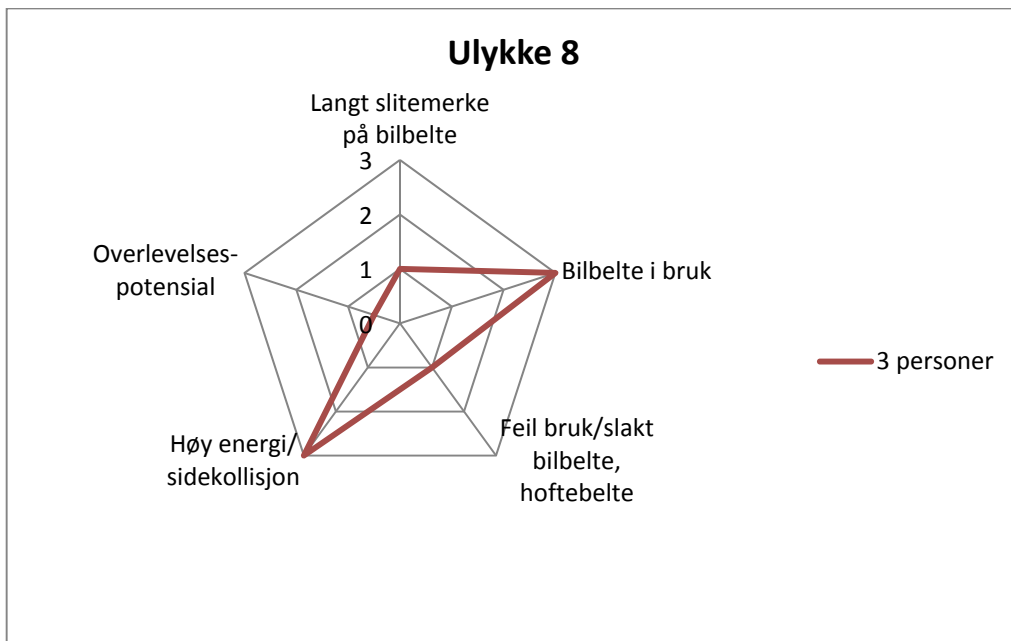
Figure 47: Survival potential - Accident 8.
