REPORT

JB 2013/01

REPORT ON RAILWAY ACCIDENT AT DOMBÅS STATION 13 JANUARY 2012, TRAIN 5701

Date of issue: 11.01.2013
RW Report: 2013/01

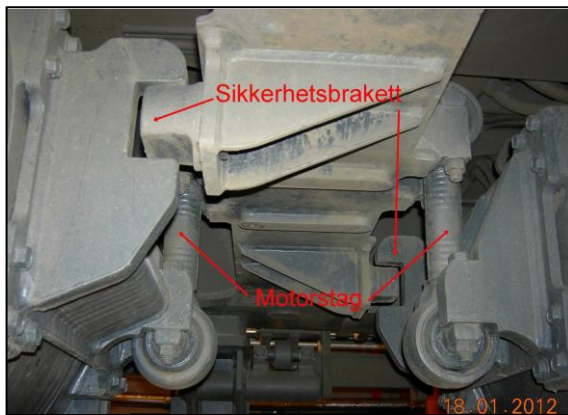
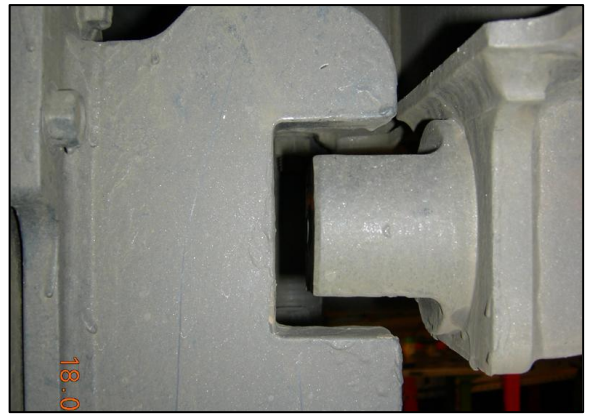
There are no standards or regulations specifying how to design and inspect emergency supports. Bombardier has informed the AIBN that ascertainment of whether the emergency support was in use, was based on the assumption that such use would cause the emission of loud, unpleasant noise that would be detected by the driver. The derailment at Dombås showed that this was not the case.

Figure 14: Torque links and emergency supports [5]. Figure 15: Emergency support [5].

After the derailment at Dombås, CargoNet AS has introduced more frequent and detailed inspections of torque links and emergency supports. This is described in more detail in section 3.

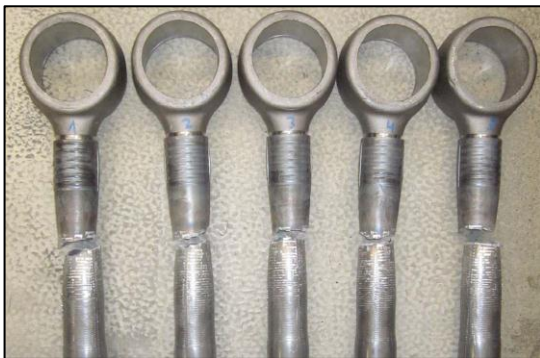
Five static tensile tests were carried out on torque links until they broke; see Figure 16. Each time, the break occurred in the torque link's tube, and not in the area around the bearing eye, which is where the break occurred in the derailment at Dombås in 2012 [10]. The loads used to break the torque link are in line with the calculated loads it is designed to tolerate.

Figure 16: Static tests [10].

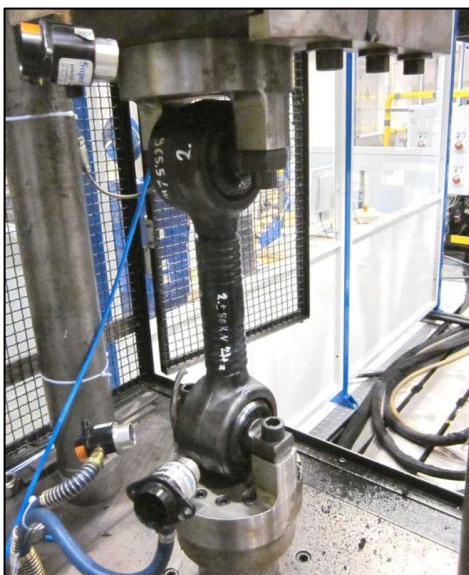
Seven fatigue tests were carried out on torque links [10], during which none of the test samples failed in the same way as during the derailment at Dombås on locomotive number 119-003 in 2012; see Figure 18. This means that none of the samples suffered equivalent damage or breakage after running the same distance as locomotive 119-003. In five of the tests, cracks were observed in the area around the cut-in to the snap-ring of the rubber bearing in the torque link's bearing eye; Figure 19. This type of fault is a functional fault, and not a total failure of the torque link. It is a visible fault which has been covered in previous reports, and is expected to be discovered during maintenance. In two of the tests in which the torque link failed, the break was in the tube and not in the area around the bearing eye; see Figure 17. Calculations of the expected service life (in kilometres) of the torque link are based on fatigue tests and load measurements carried out on tracks in Switzerland [11]. These show that the kilometres travelled by locomotive number 119-003 were well within these values when it derailed at Dombås in 2012. Based on the Swiss track measurements, it is estimated that functional faults can be expected after 8.28 million kilometres, and total failure after 51 million kilometres.

Figure 18: The test rig [10].

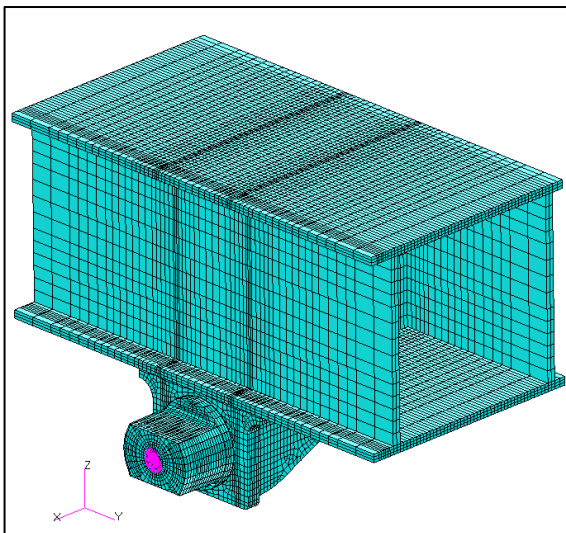
The emergency support was plotted into a finite element method⁶ (FEM) analysis, and strength analyses were performed [13][14]. The results of these showed that the weakest point on the emergency support was the bolt and the washer behind the bolt [15]. The design of the rest of the emergency support was considered to be adequate.

Figure 20: Emergency support bogie-side[13].

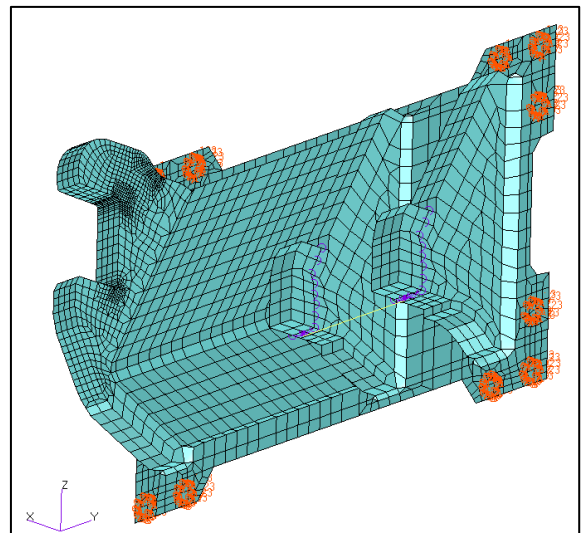
Figure 21: Emergency support engine-side [14]

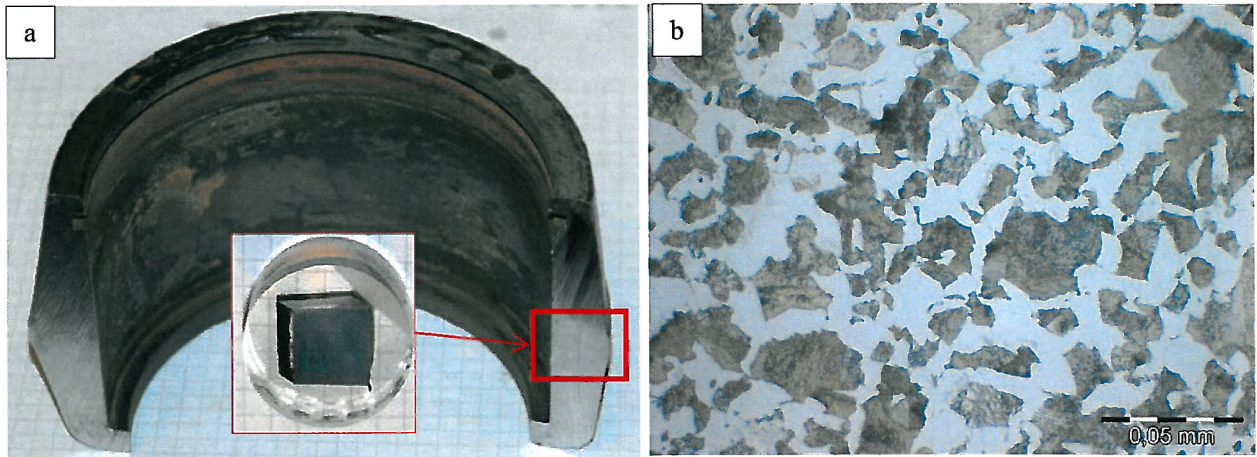
A metallographic sample was cut out from the component as shown in Figure 7a. The microstructure of the base material is shown in Figure 7b and reveals a ferrite perlite structure. Pictures of the sample towards the component surface reveal an irregular surface with micro cracks most likely originating from the forging process.

Figure 7a Overview picture of location for the metallographic sample. b: Microstructure of base material showing a ferrite, pearlite structure, specimen etched in 10% Nital.

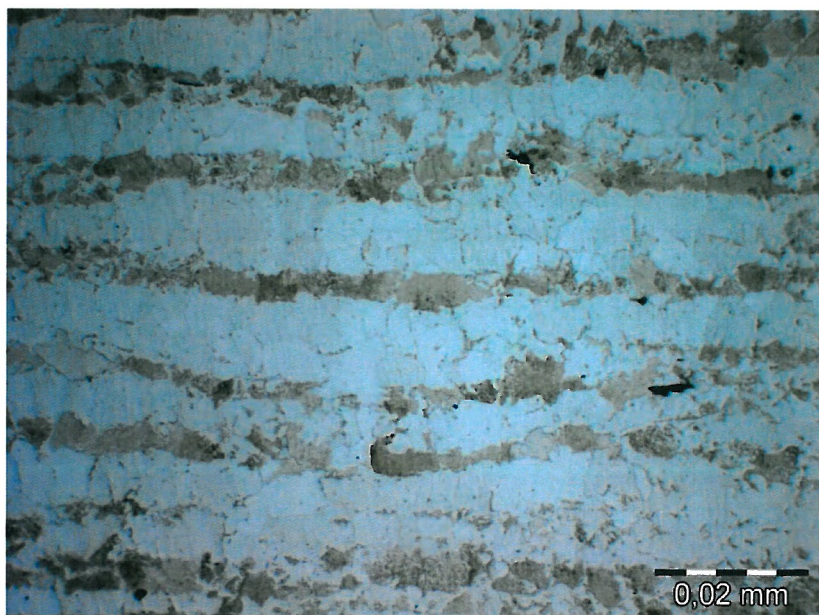
A metallographic sample from the engine side panel base material was obtained to establish the base material microstructure. The structure is shown in Figure 11 and reveals a ferrite perlite structure.

Figure 11 Picture in light microscope of material microstructure consisting of perlite and ferrite, specimen etched in 10% Nital.
