# REPORT

## JB 2019/04

## REPORT ON RUNAWAY WORK MACHINE AT ENSJØ METRO STATION, 7 JUNE 2018

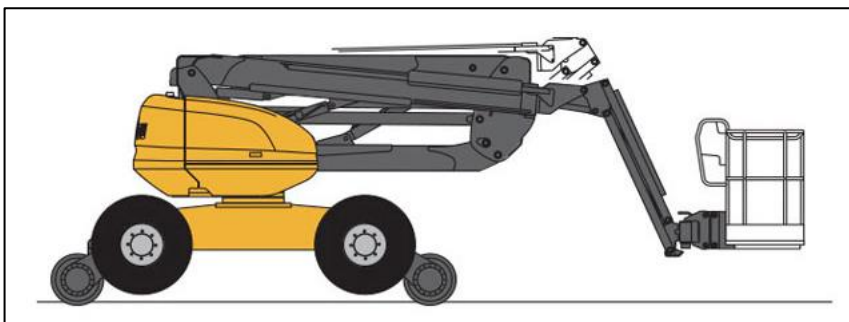
Figure 3: Schematic drawing of the machine involved. Source: Rail Products UK

The AIBN examined and tested the MEWP several times to determine how the brake system worked and whether the machine was defective. The machine was first tested at Hesselberg in Oslo on 13 June, and subsequently on 21 June and 6 July. A closer examination of the oil leakage from the machine revealed that it came from the slewing rim and not from the brake system.
