THE AIRCRAFT ACCIDENT INVESTIGATION BOARD/NORWAY

REP.: 07/96

**REPORT ON THE ACCIDENT TO DHC-6-300 TWIN OTTER,
LN-BNM NEAR NAMSOS, NORWAY ON 27 OCTOBER 1993.**

**REPORT ON THE ACCIDENT TO DHC-6-300 TWIN OTTER, LN-BNM
NEAR NAMSOS, NORWAY ON 27 OCTOBER 1993**

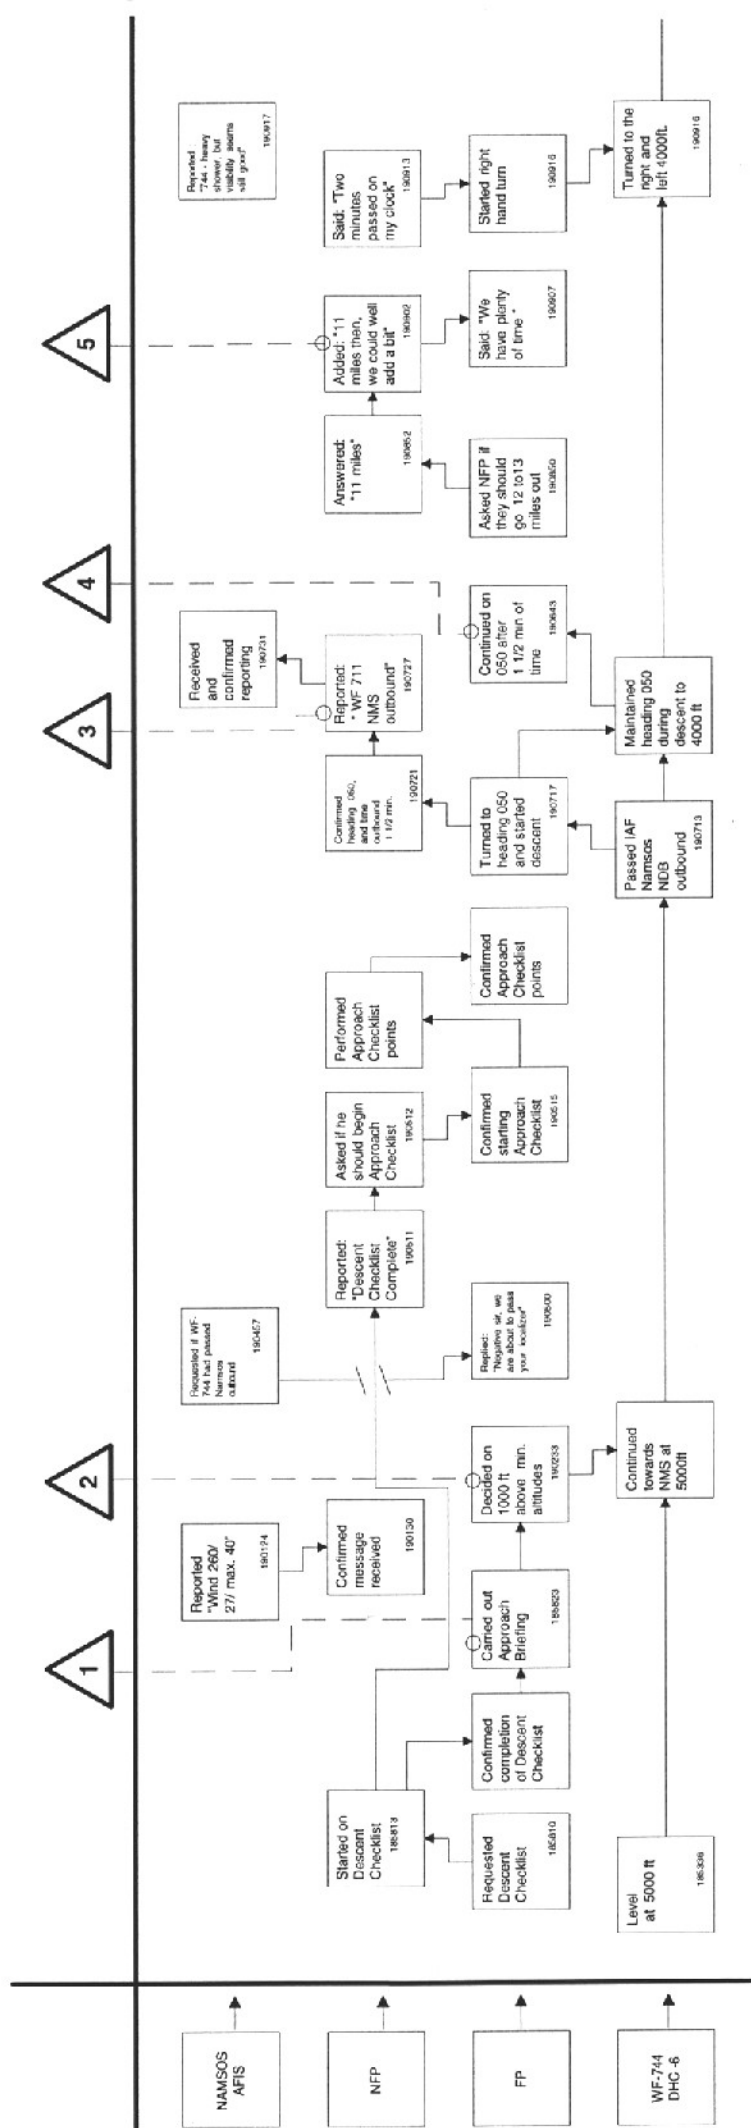
STEP ANALYSIS OF ACCIDENT TO LN-BNM

- 1.19.1.3 By systemising the material from the accident the AAIB/N has decided to begin with the active failures, as these are the keys to any sources of failure within the system supporting the flight operations. These failures and their accompanying safety problems have been highlighted using a STEP (Sequentially Timed Events Plotting) analysis.

- Δ 7 The crew failed to report to the AFIS that the aircraft had left 4,000 ft (ref. FOM section 9.1 paragraph 17.3).
 - Δ 11 The crew failed to report the Final Approach Fix (FAF) = Namsos NDB inbound with the actual altitude reading (ref. FOM section 9.1 paragraph 17.2).

- Δ 14 The crew failed to report to the AFIS regarding FOM section 4.2 paragraph 1.3 and section 9.1 paragraph 17.3 that they had changed to visual flying.

Δ 5 The recommended distance (DME 11) for commencing the inbound turn to the localizer had been exceeded, and the aircraft continued flying on track QDR 050⁰ for a total of 2 minutes (calculated from the IAF).

- 2.3.8 Δ 10 The crew started reducing altitude after passing the inbound FAF without having planned a rate of descent and time for the Missed Approach Point (MAPt) (ref. Δ 1 and FOM section 9.5, paragraphs 1.2.5 and 2.4, and FTM paragraph 10.2.4) Both stop clocks were found in the zero position i.e. they had not been started.
