THE AIRCRAFT ACCIDENT INVESTIGATION BOARD/NORWAY
(AAIB/N)

REP.: 02/98

AIR ACCIDENT INVOLVING EUROCOPTER SUPER PUMA 332L,
LN-OBP, IN THE NORTH SEA ON 18 JANUARY 1996, APPROX. 40
NM SOUTH-WEST OF SOLA, NORWAY

SUBMITTED MARCH 1998

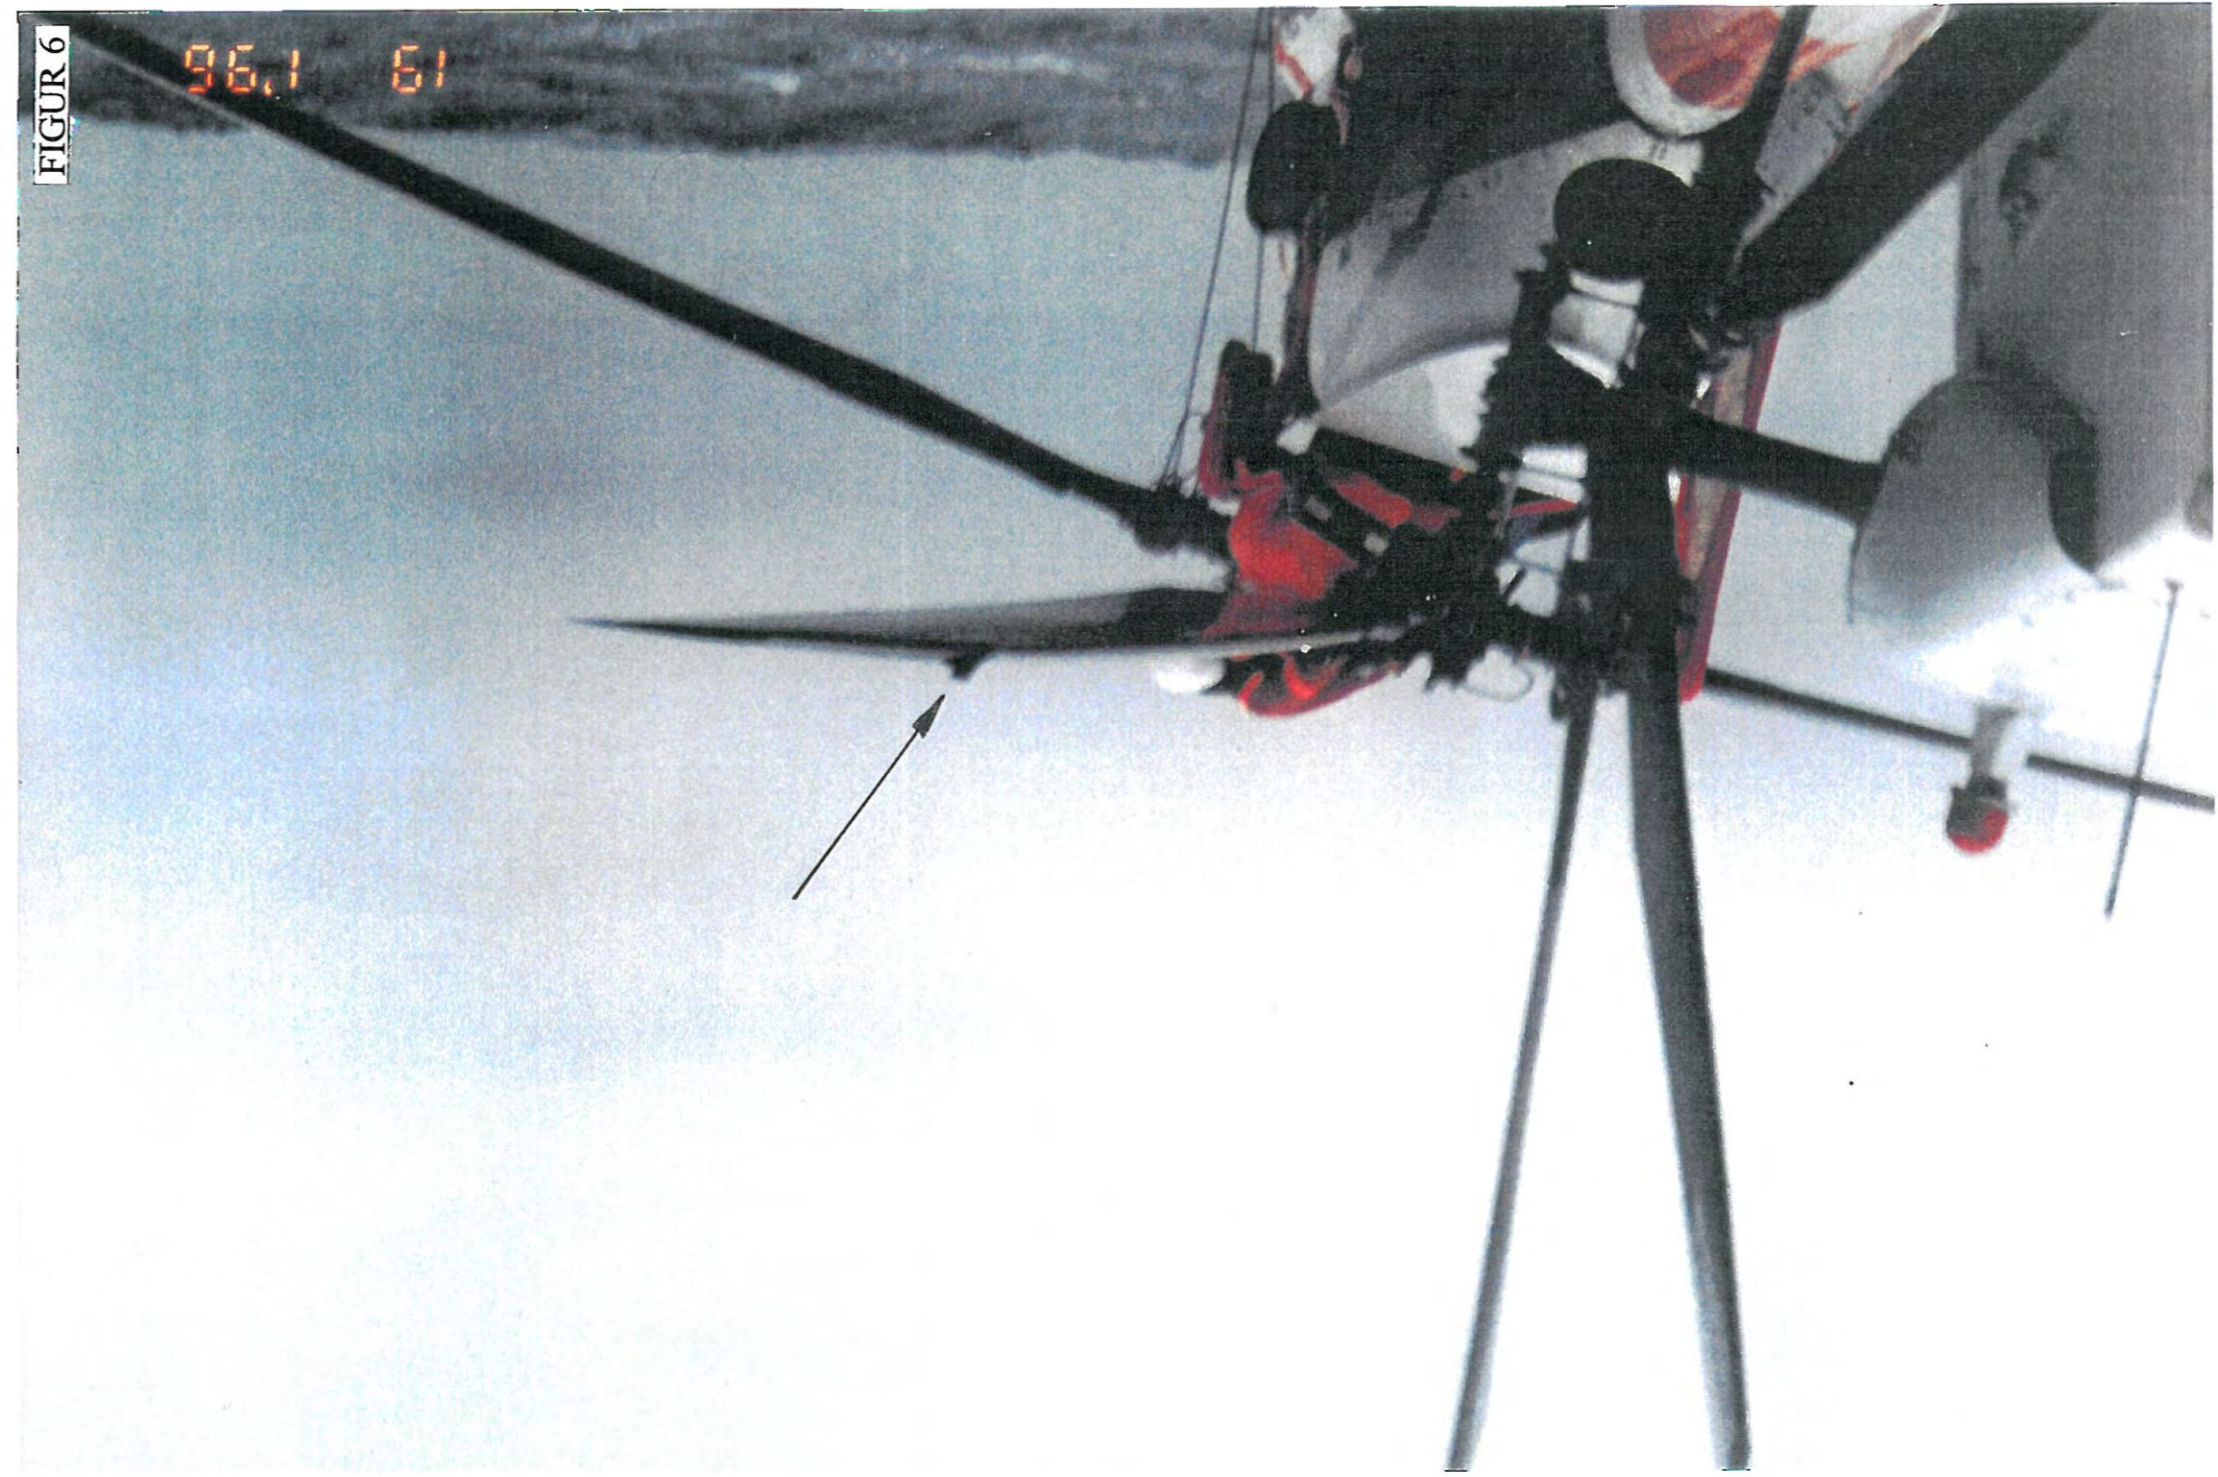
FIGUR 6

- 1.12.2.1 After the evacuation, the helicopter remained floating on the sea. The Coast Guard vessel KV Farm and a rescue cutter went to the scene of the accident, and work began on securing and making the helicopter ready for salvaging. Personnel from HS who arrived on the boat via helicopter and the Coast Guard used an outboard dinghy to place two inflated floats inside the cabin and to fit winching straps to the main rotor head. During this operation, the helicopter was photographed and it was determined that the "black blade" (S/N 617) was damaged (see Figure 6).

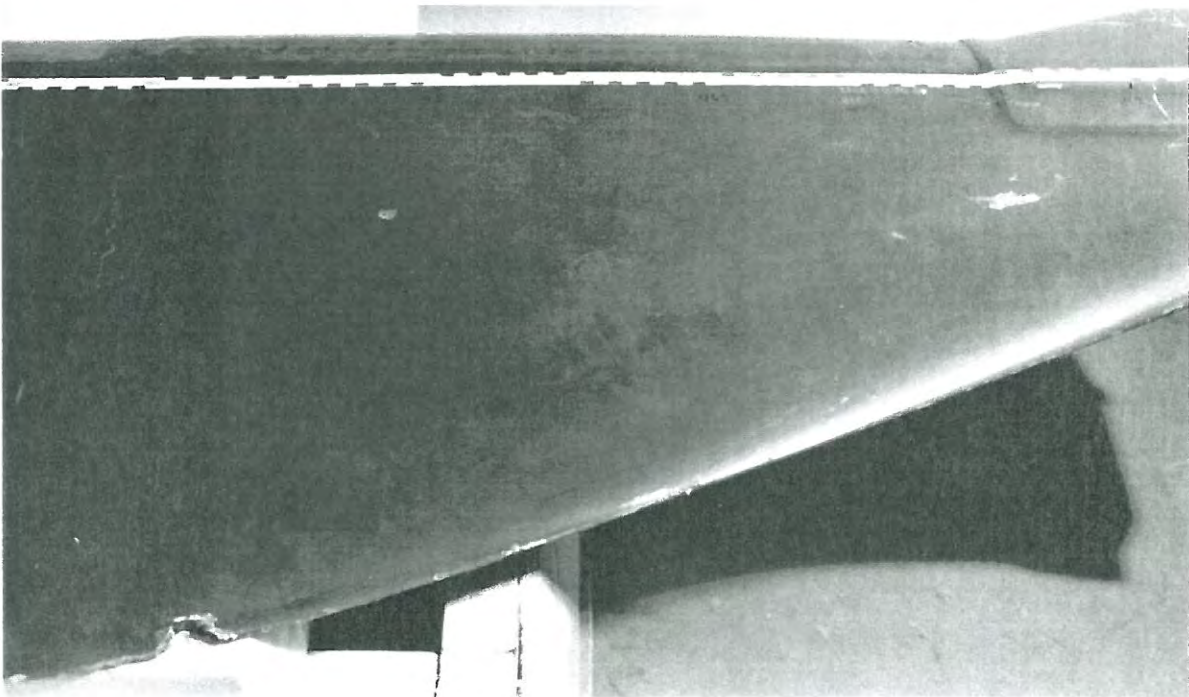
MRB upper surface 5.4. - 6.2. m from the "zero line", seen towards the leading edge.

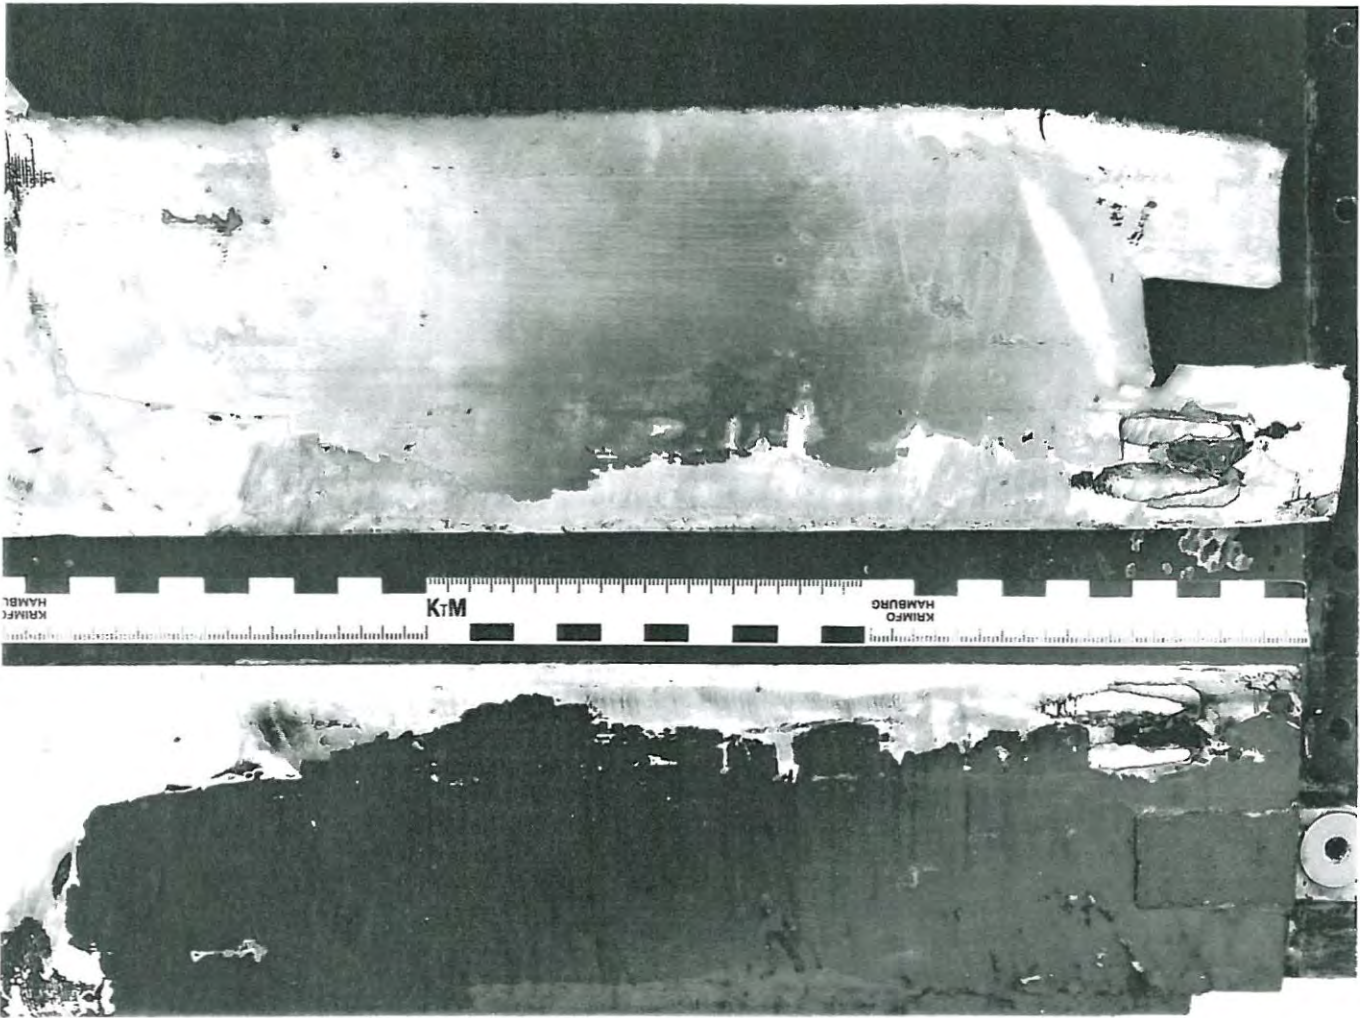
Photo showing the bonding surface of the protective Ti-strip (top) and the mating bonding surface of the blade structure (below). The geometry of the adhesive bonding for the upper blade surface should be compared with the borderline photo shown in Fig. 19A.

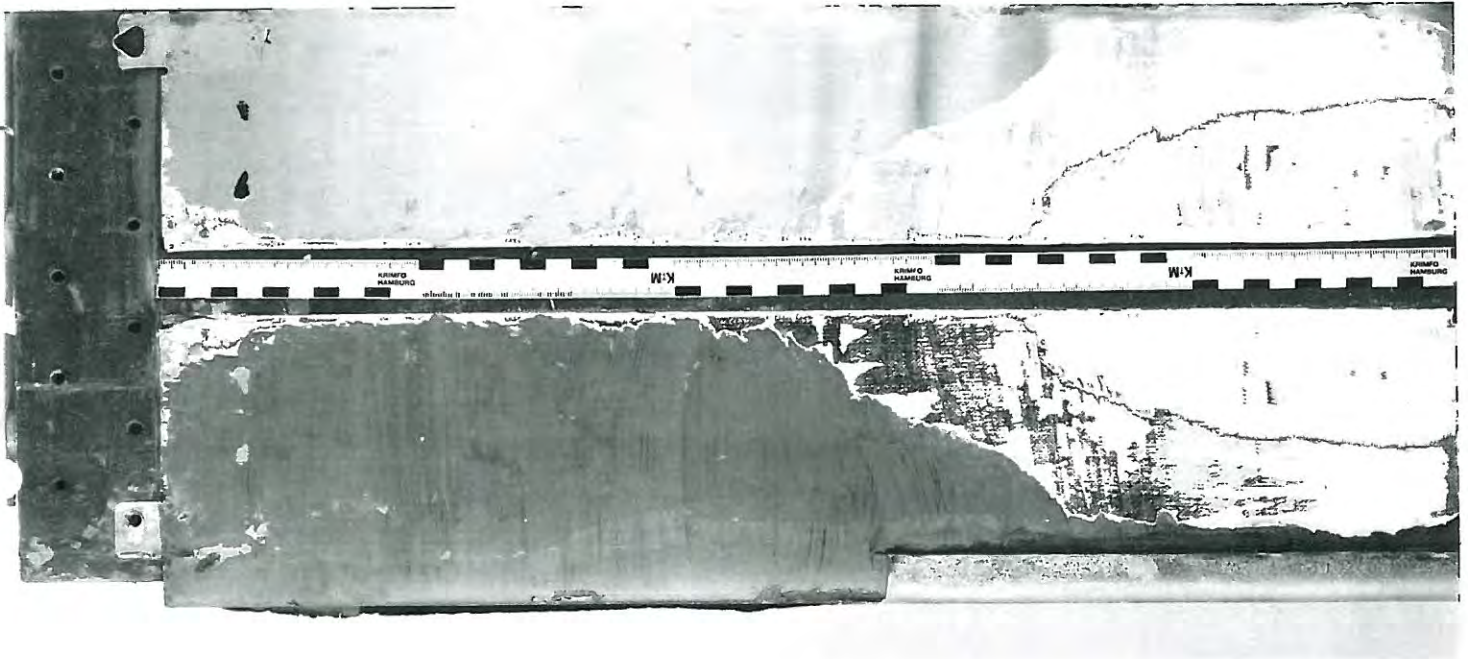
Photo showing the bonding surface of the protective Ti-strip (top) and the mating bonding surface of the blade structure (below). The geometry of the adhesive bonding for the lower blade surface should be compared with the borderline photo shown in Fig. 19B.

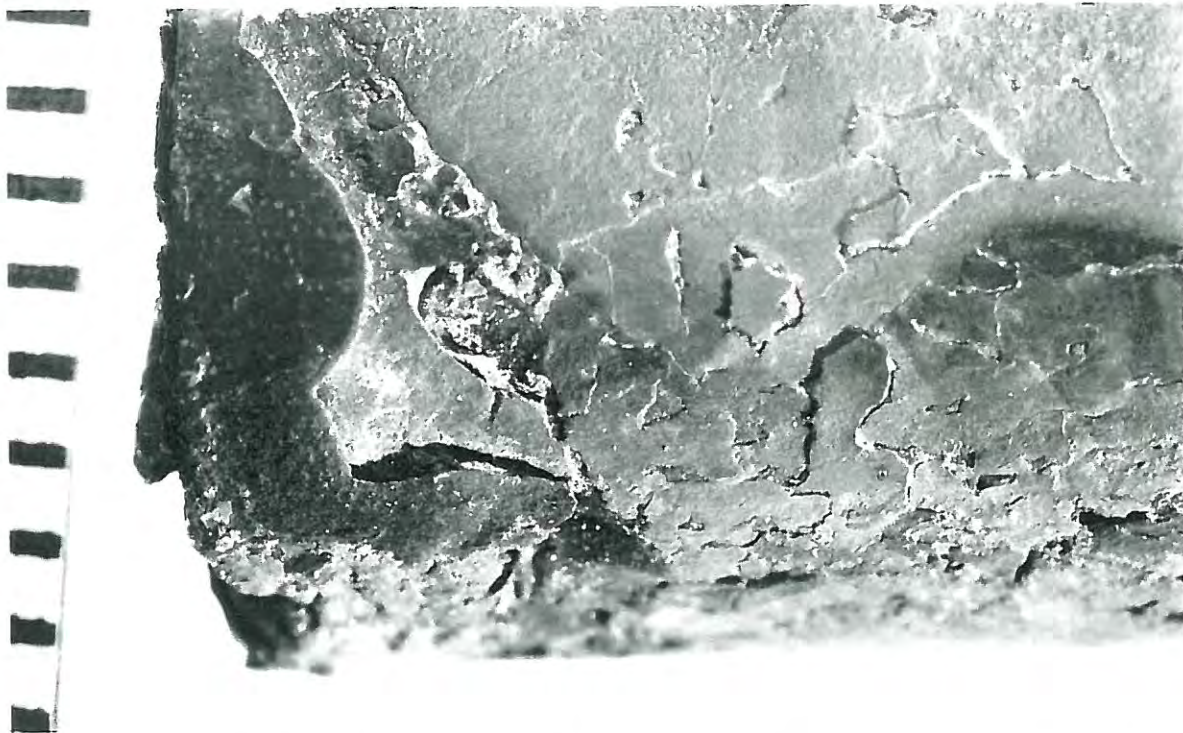
Close-up photo showing surface details of the blade structure of the leading edge.

After the sample, which represented a section into the blade, was excised, the blade structure and the de-icer element came loose from the leading edge strip. Impressions from the leading edge strip in the primer/neoprene, however, indicated that the materials did have good contact even within the smallest radius on the leading edge strip.

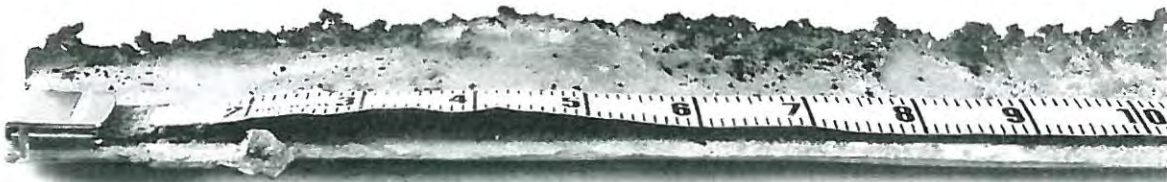
Photo illustrating the fracture profile in the outer portion of the protective Ti-strip. The interior (bonding) surface 0 - 0,1 m from the "zero line" (left) is seen.

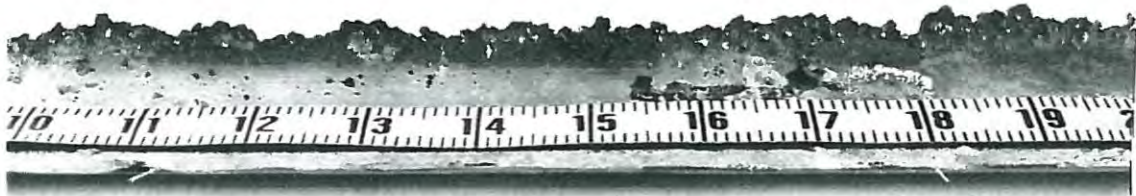
Photo illustrating the fracture profile in the outer portion of the protective Ti-strip. The interior (bonding) surface 0.1 - 0.19 m away from the “zero line” is seen.

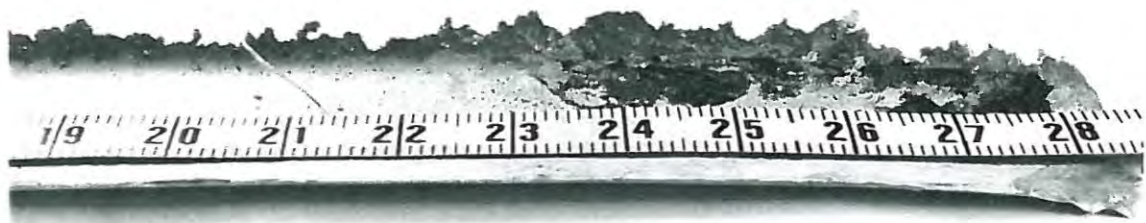
Photo illustrating the fracture profile in the outer portion of the protective Ti-strip. The interior (bonding) surface 0.19 - 0.285 m away from the “zero line” is seen.

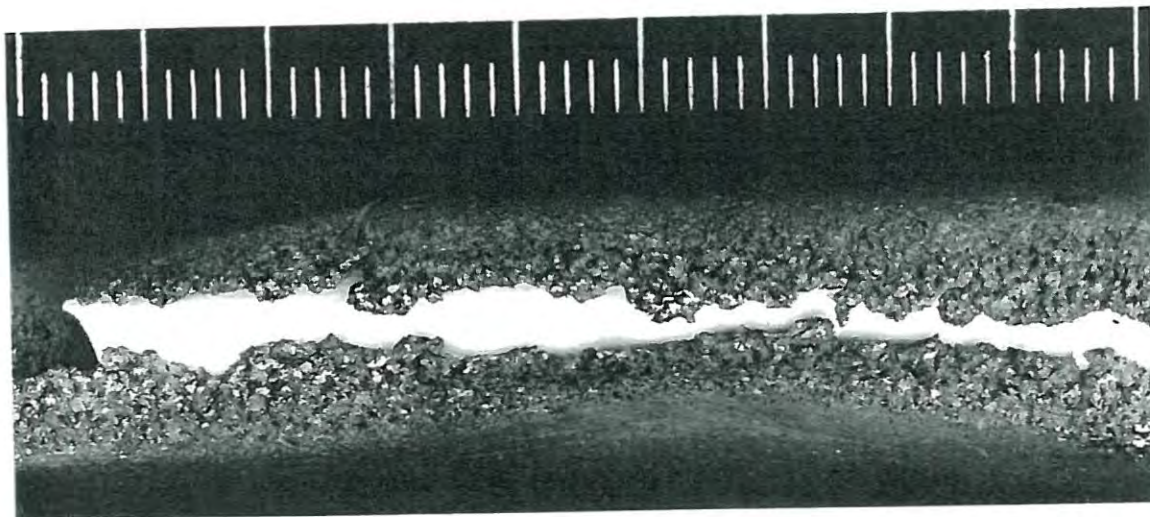
Detail photo showing the fracture profile and the leading edge wear of the second cut section from the outer end of the protective Ti-strip.

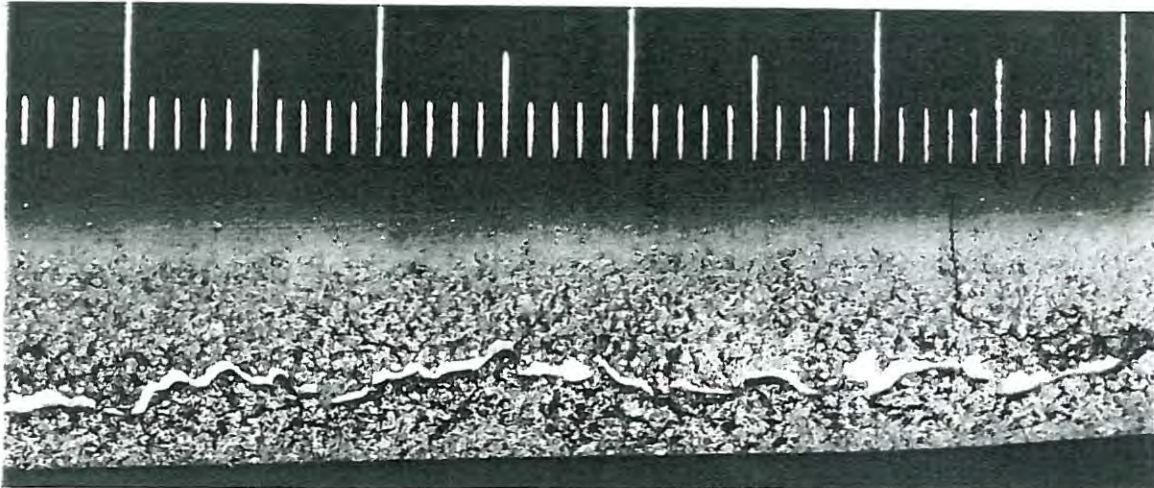
Detail photo showing the fracture profile and the leading edge wear of the third cut section from the outer end of the protective Ti-strip.

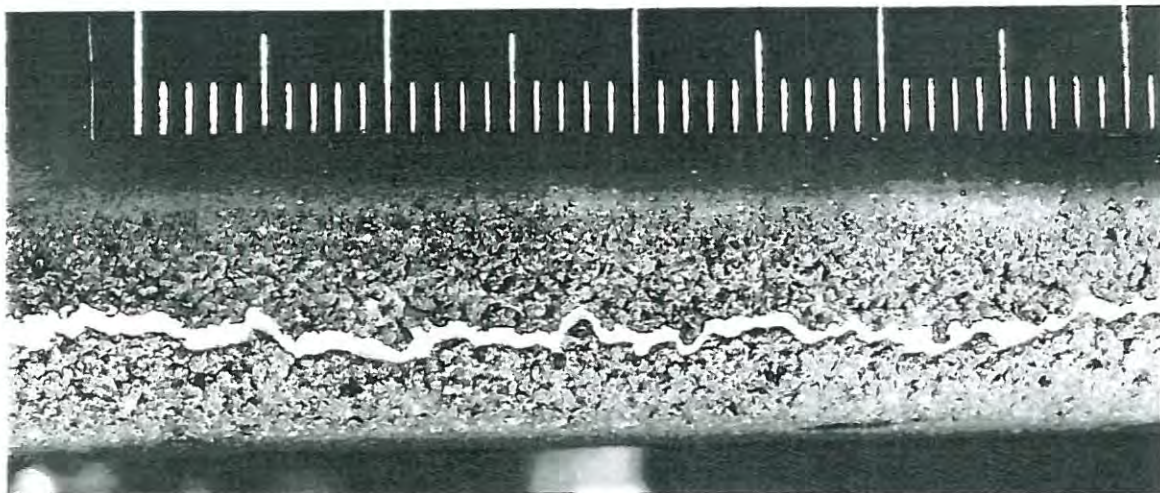
Detail photo showing the fracture profile and the leading edge wear of the fourth cut section from the outer portion of the protective Ti-strip.

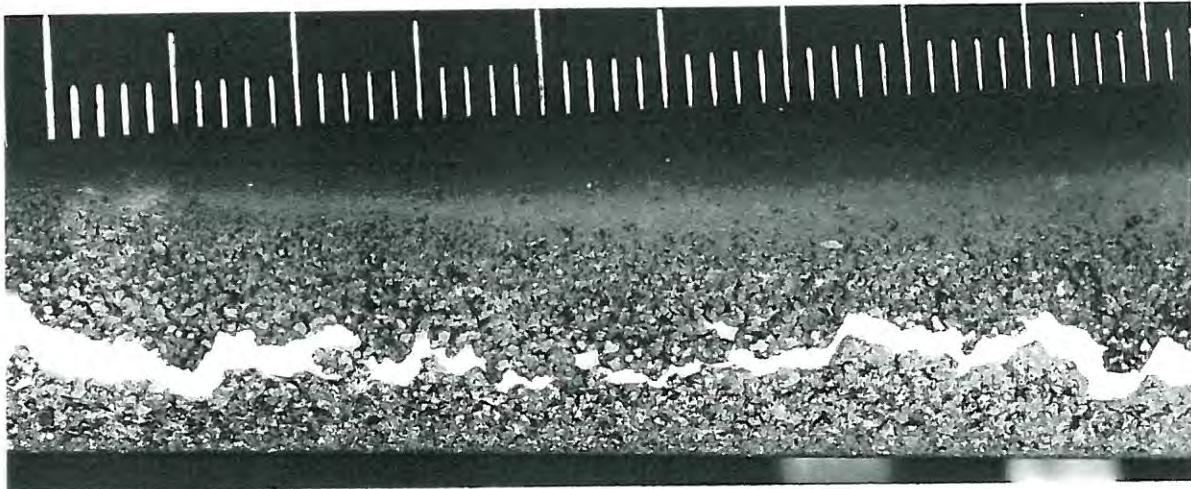
Detail photo showing the fracture profile and the leading edge wear of the fifth cut section from the outer portion of the protective Ti-strip.

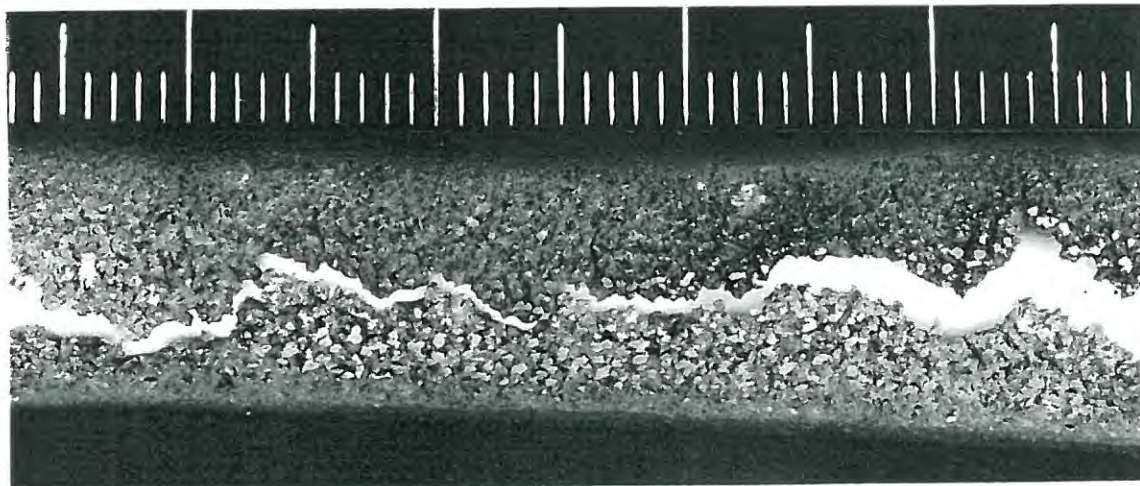
Detail photo showing the fracture profile and the leading edge wear of the sixth cut section from the outer portion of the protective Ti-strip.

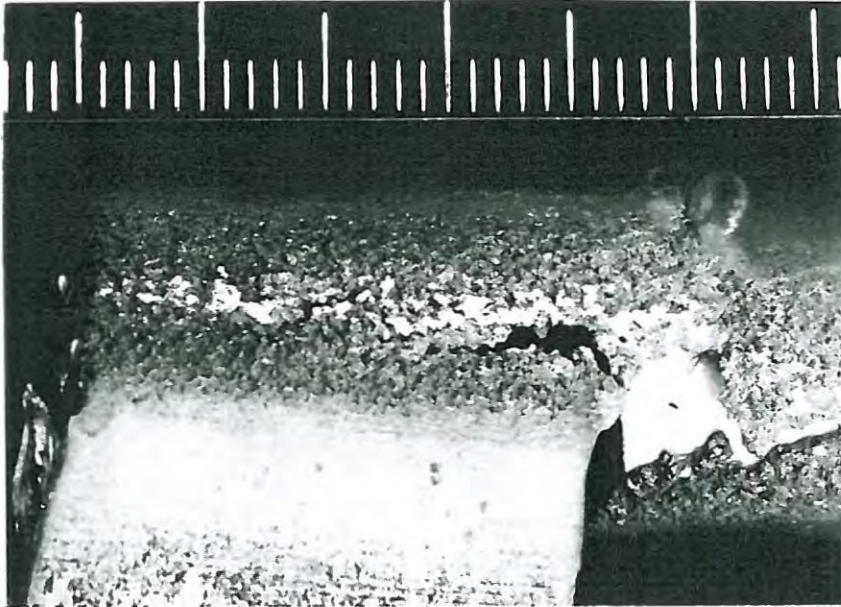
Detail photo showing the fracture profile and the leading edge wear of the seventh cut section from the outer portion of the protective Ti-Strip (inner end of the leading edge fracture).

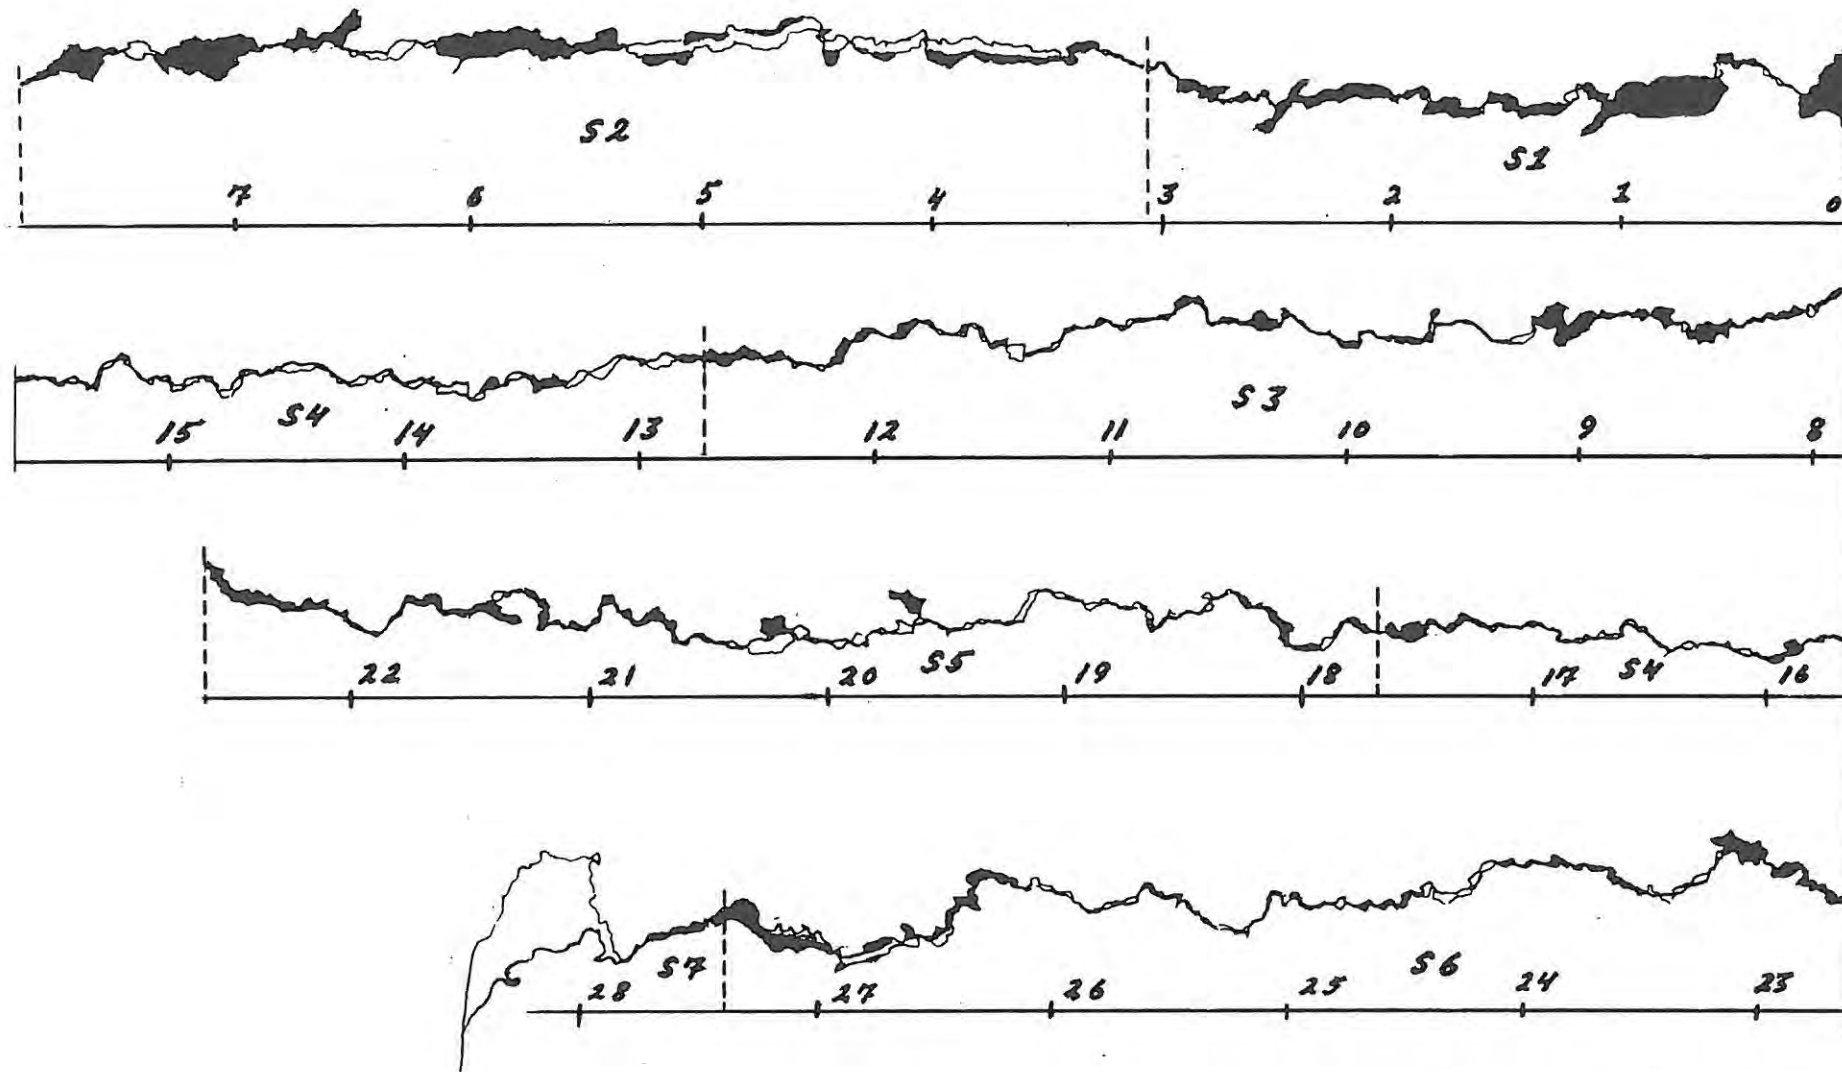
Sketch illustrating the profile of the eroded fracture surfaces at the leading edge, elements S1 - S7, respectively. The scale 0 - 28.5 represents the location in centimetres from the "zero line". The dark areas represent eroded surface material missing after the accident.

1.16.5.1 A piece of the leading edge strip, 285 mm long, containing one half of the main crack (the lower side) was cut away and examined more closely by DNV. To fit the pieces into the SEM, the piece was cut into 7 sections (S1 - S7) where S1 represents a segment which was 0-31 mm from the zero line. Figure 34 represents the erosion of the leading edge strip along the edge of the crack. Figure 35B illustrates part of the crack surface at S1. The picture shows that the leading edge strip was perforated by erosion in places. A framed section of the picture is illustrated at x350 magnification in Figure 36A. This picture shows the microstructure in a transition zone between an even surface and a more uneven surface against the vulcanised surface (at the top of the picture). A further magnification to x1200, in Figure 36B, shows that the lower part contains a microstructure with parallel lines (striations) characteristic of a fatigue fracture. The upper part contains a microstructure equivalent to a overload fracture. This general picture of the character of the crack was also confirmed in sections S2 - S7, but such that erosion has contributed to a gradually smaller portion of the crack's shape at S7 compared with S1. In its report, DNV stated:

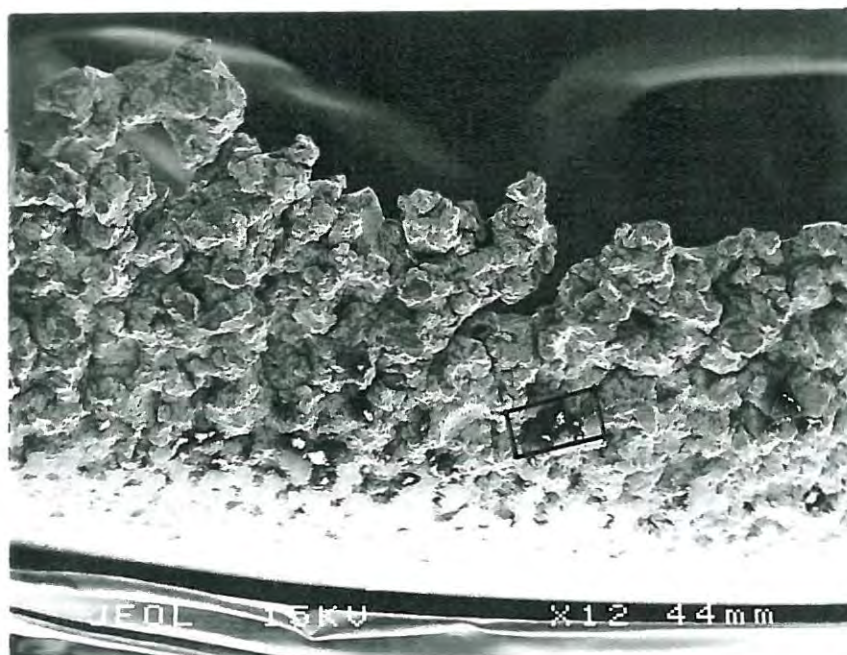
Eroded fracture surface from section S1, close to the section S2.
SEM-photo, magnification x 12.

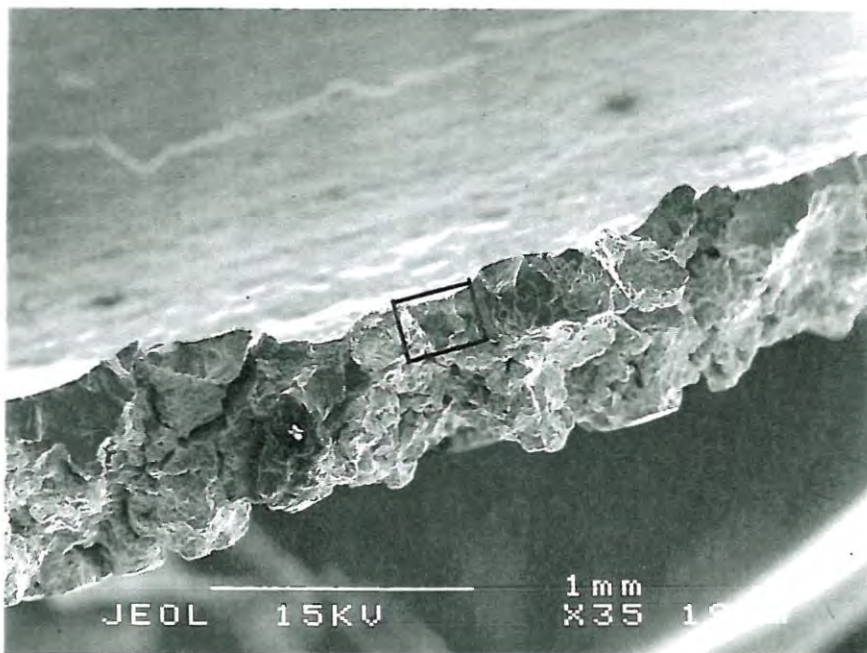
General SEM view of the section S1 fracture surface. The inner surface of the Ti-strip is located to the upper half of the photo. A close-up of the framed area is seen on the next figure.

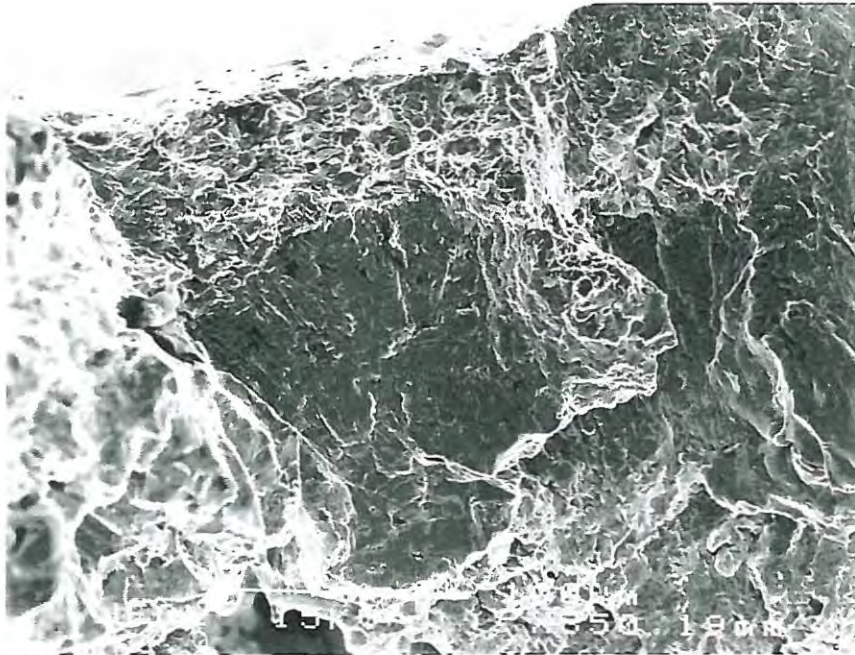
Another smooth fracture surface area in the section S1, detail from the area framed in Fig. 35B.

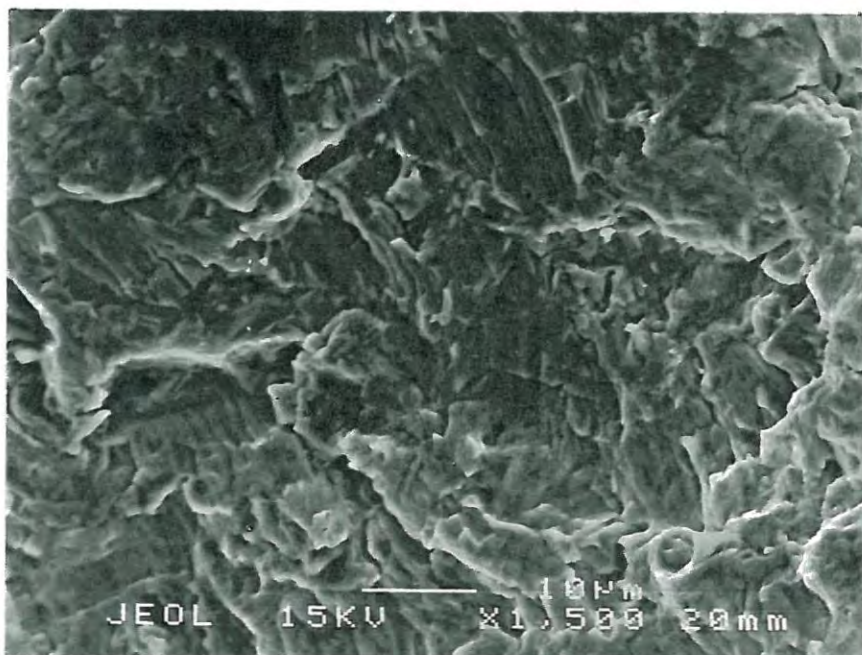
1.16.5.2 As previously discussed in section 1.16.2.3, the main cracks had 8 transverse cracks linked to the main crack. Two of these cracks from section S2 were examined in more detail in the SEM. One of the cracks is illustrated in Figure 37A. This crack proved to have been caused by a fatigue fracture both in its starting area (see Figure 37B) and at the crack toe (extension area) (see Figure 38A). This is further confirmed in detail on the picture in Figures 38B and 39A. The crack's length was measured at 9.8 mm. The total number of load cycles was estimated at approx. 22,790, based on four counts of parallel lines (striations) in the crack (two at the beginning and two in the extension area). Based on the fact that a load cycle comprises one rotation of the helicopter's main rotor, it is equivalent to a flight of

SEM close-up of a local area close to the crack start position seen down to the left in Fig. 37A. Magnification x 1500.

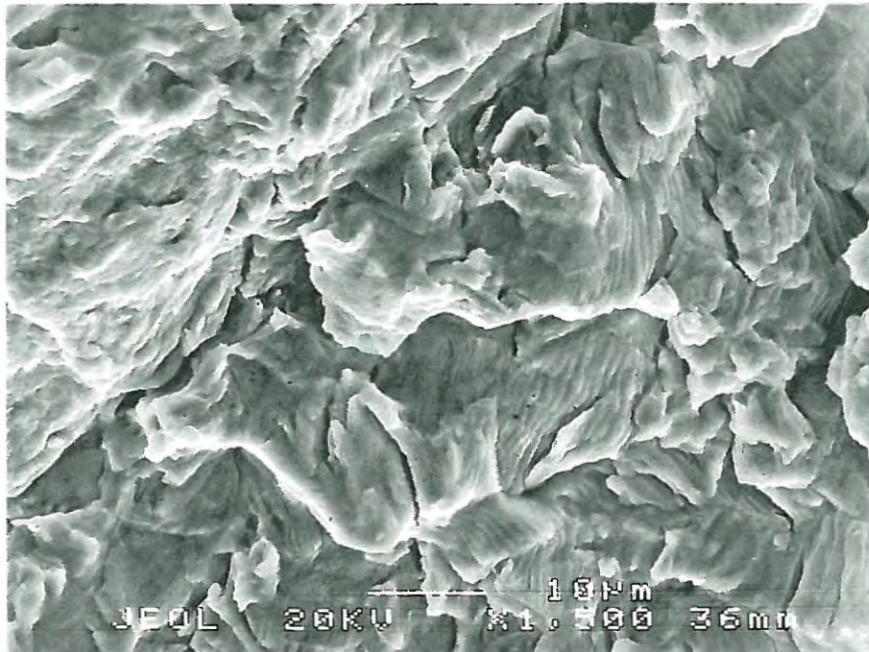
SEM close-up of a local area close to the toe (to the right) of the transverse crack surface seen in Fig. 37A.
Magnification x 1500.

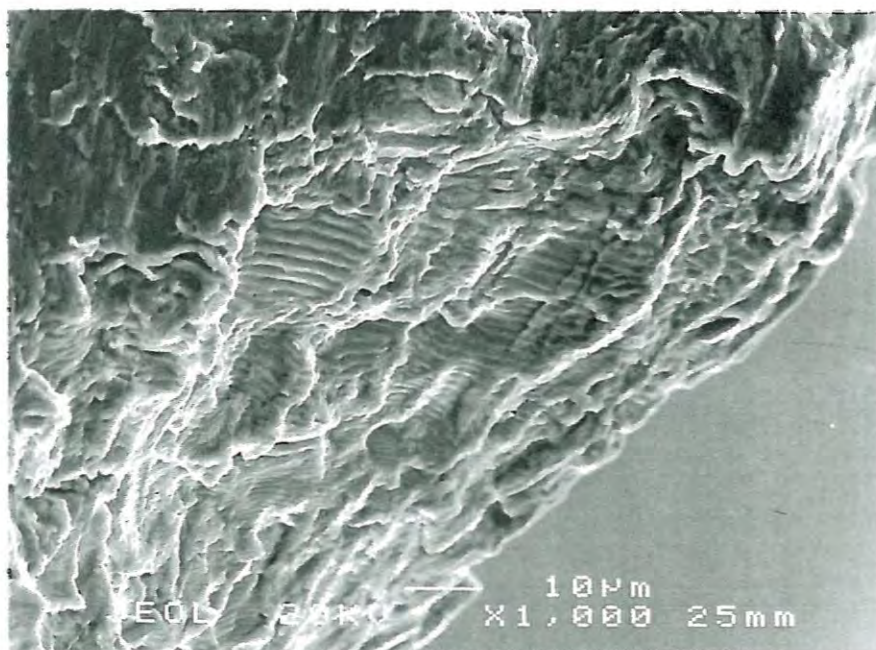
SEM-photo representing a transverse crack surface located to the section S2. The location in question is from the start zone of the crack. Magnification x 1000.

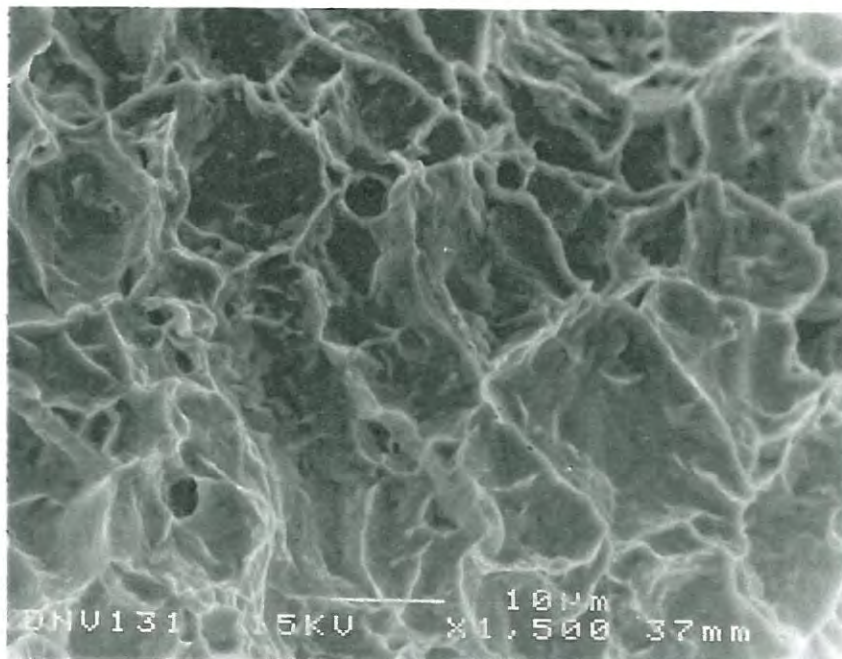
Fracture micropattern for the comparison of fracture mode, ductile material overload made by VERITAS.
SEM-photo, magnification x 1500.

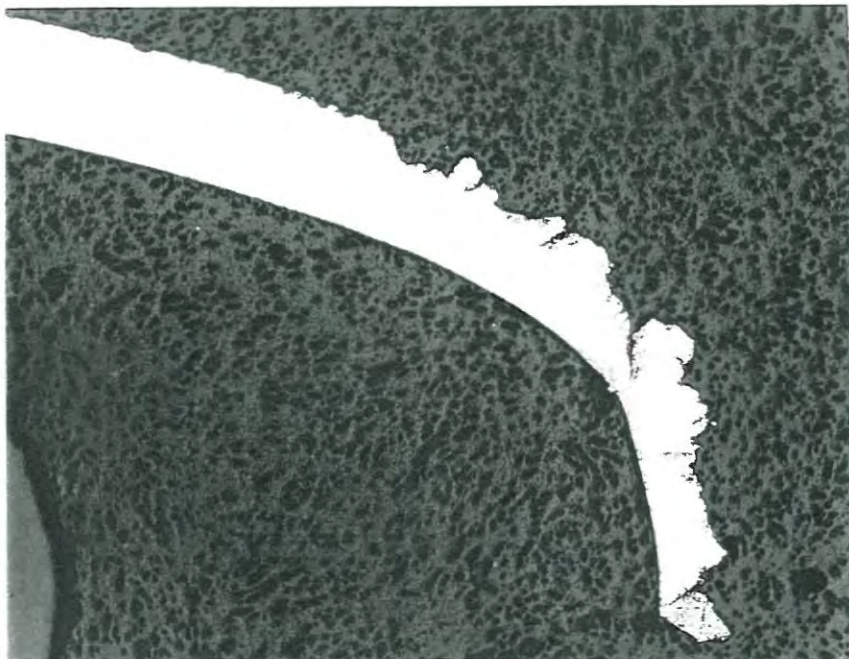
Transverse section through the leading edge zone of the protective Ti-strip.
Magnification x 20.

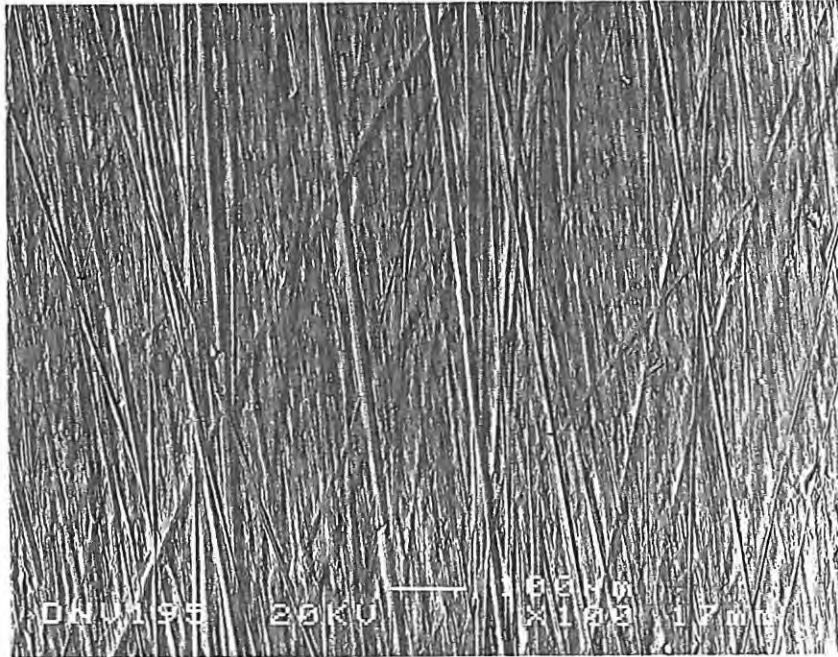
SEM-photo illustrating the rate of original hand grinding undertaken on the bonding surface of the Ti-strip.
Magnification x 100.

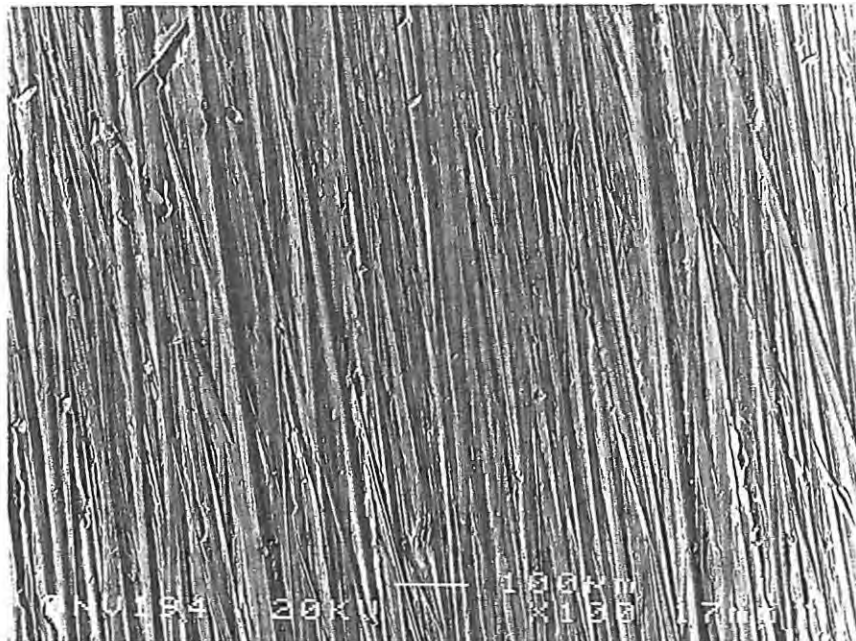
SEM-photo illustrating the rate of hand grinding undertaken on the bonding surface of the Ti-strip by VERITAS. Note that a brand new sheet of the specified (100 μ m) abrasive paper was used by this grinding operation.
Magnification x 100.
