REPORT

SL 2012/05

REPORT ON SERIOUS INCIDENT DURING
DESCENT TO SØRKJOSEN AIRPORT, NORWAY
ON 21 FEBRUARY 2006 WITH BOMBARDIER
DHC-8-103, LN-WIE OPERATED BY WIDEREØES
FLYVESELSKAP AS

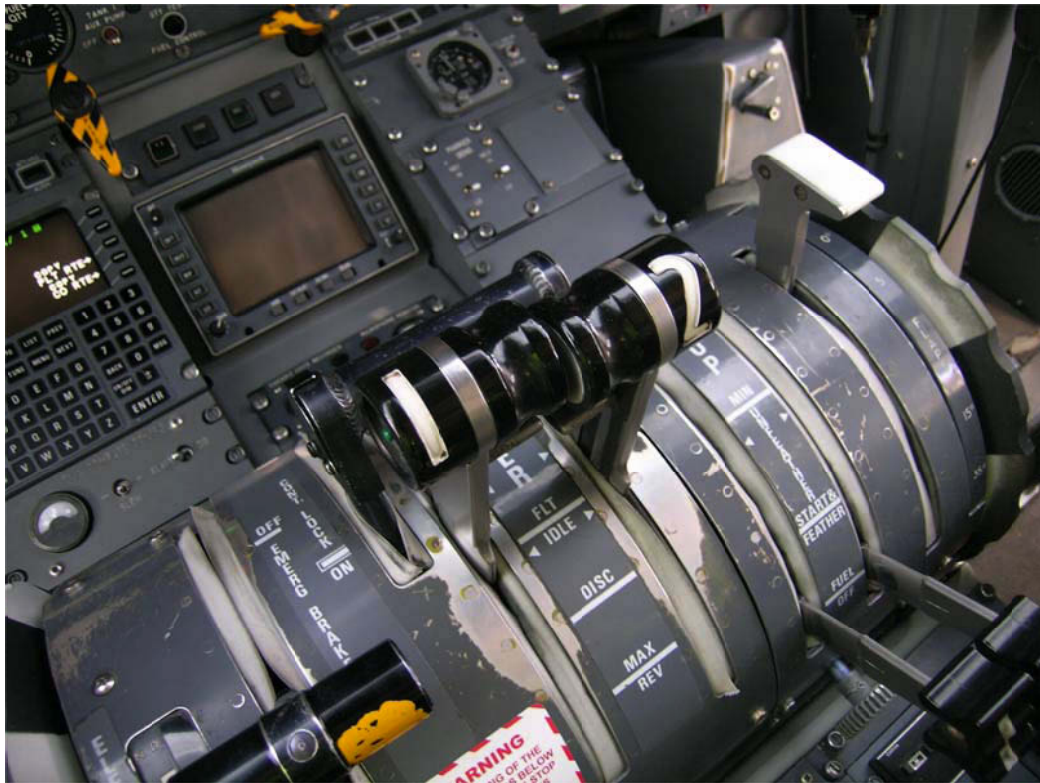
Figure 2: Power Levers marked 1 and 2 in the centre of the photo and condition levers in the bottom right corner (Fuel Off).

Any movement of the Power Levers behind Flight Idle while the aircraft is airborne has an element of risk. The propeller rotational speed can exceed permitted values and at worst cause mechanical damage. Furthermore, the aerodynamic drag increases severely, which might cause loss of control of the aircraft. To prevent unintended moving of the Power Lever into the Beta-range, each Power Lever has protection and warning mechanisms. To enter the Beta-range, a small release trigger must be lifted about 5 mm to disengage a mechanical stop (se Figure 3).

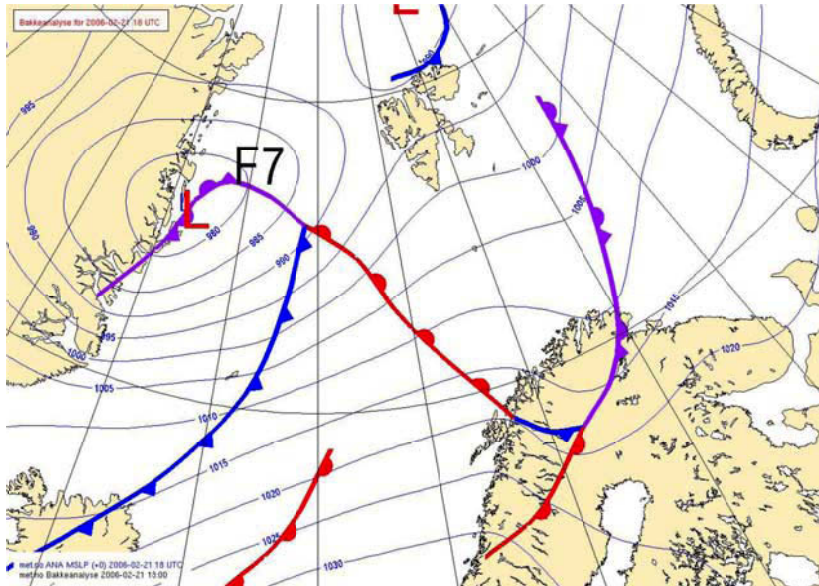
”Based on the available observations and models, it can be assumed that the general weather situation on 21 February 2006 was not uncommon for the area or season. Wind speeds were not abnormally strongly or with abnormal wind shear. In addition, the temperature distribution was not uncommon.

However, the available data cannot preclude that there were minor areas with strong shear and subsequent turbulence in connection with the incoming warm front.”

Figure 4: The general weather situation in the northern region on 21 February 2006 at 1800 hours (UTC).

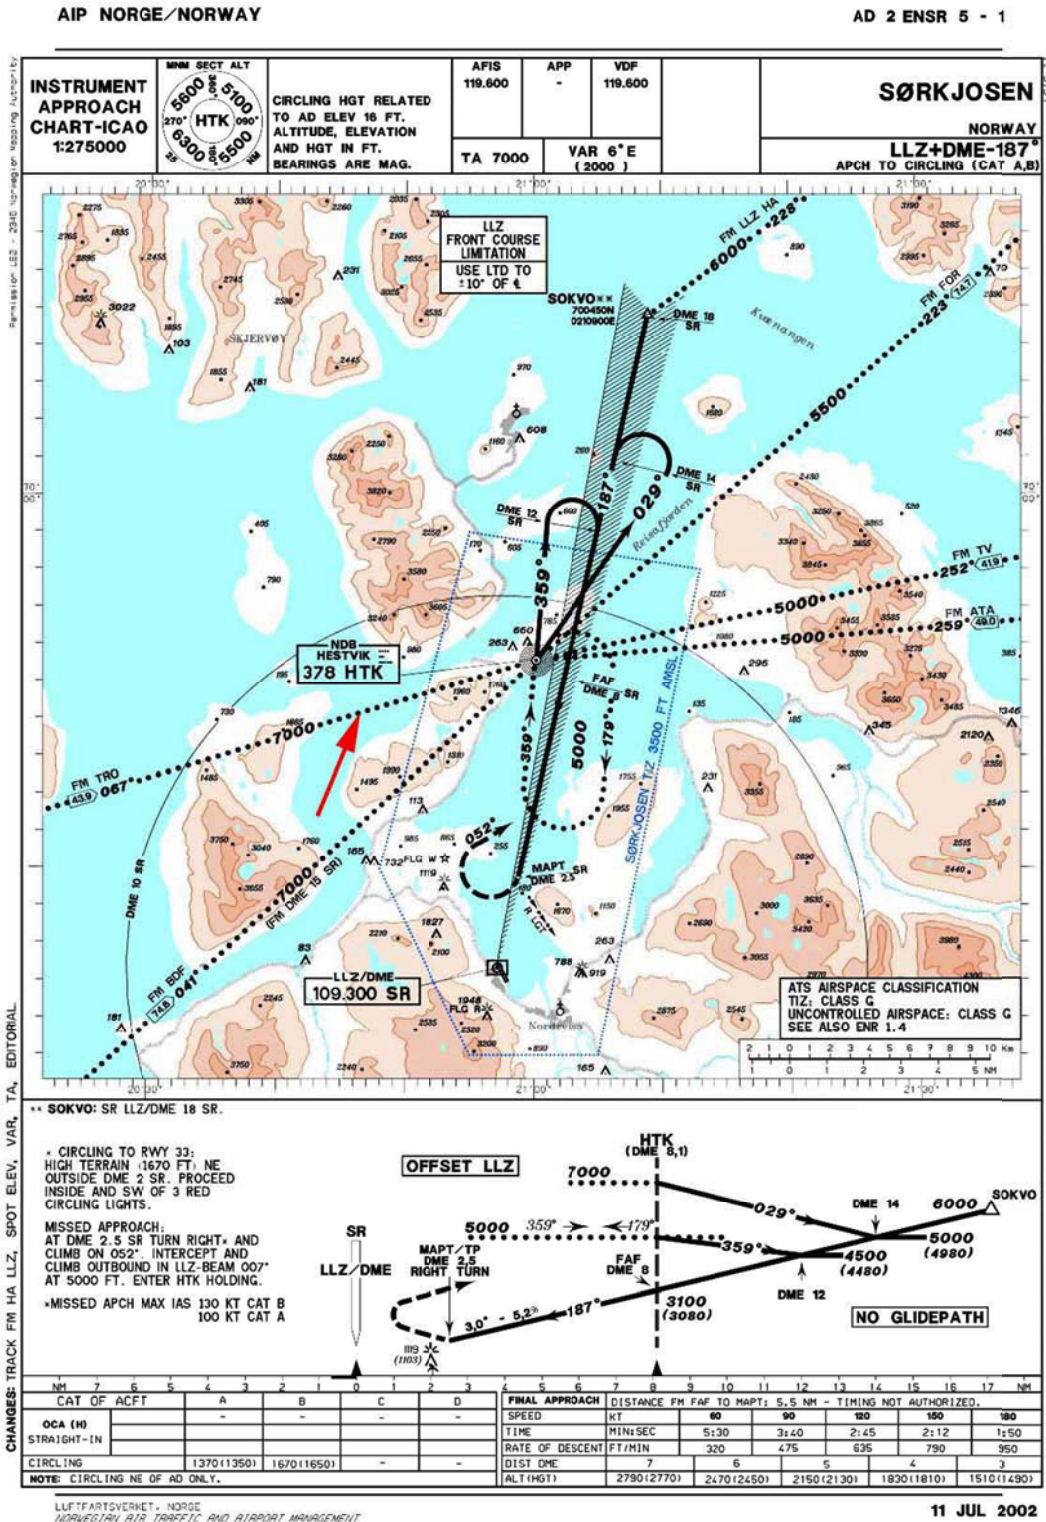
Figure 5: Approach chart with assumed incident site marked with red arrow.

1.10.2 The highest mountain peak in the area where the incident took place was about 3,600 ft.
