# REPORT

SL 2012/13

REPORT ON AIR ACCIDENT AT DALAMOT IN  
ULLENSVANG, HORDALAND COUNTY, NORWAY  
ON 4 JULY 2011 WITH EUROCOPTER AS 350 B3,  
LN-OXC, OPERATED BY AIRLIFT AS

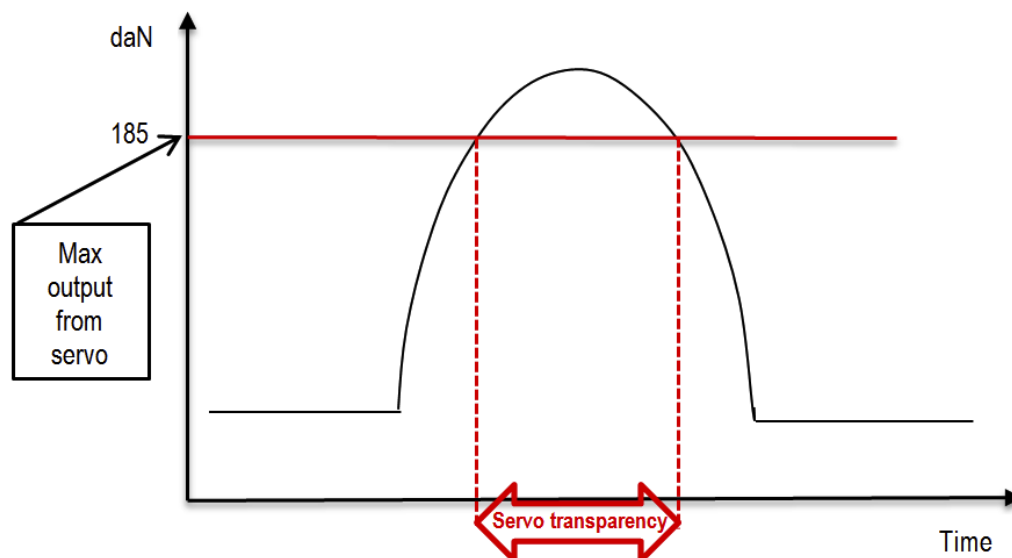
Figure 16: Illustration of servo transparency - the required force exceeds the servo's capacity in the period between the dotted red, vertical lines.

- 1.18.1.4 The figure below shows this schematically. The maximum force that a servo can deliver is 185 daN. In a situation where more force, for example 195 daN, is needed to adjust the blade angle of a main rotor blade, the pilot must add the additional force manually. Although the extra need for force comes gradually, it happens over a relatively short period of time. The cyclic on the AS 350 normally requires very little force. The pilot may, depending on how much friction he or she has added, experience that the stick force goes from almost zero to 10 daN (equivalent to about 10 kg) over a short period of time, and may perceive that the controls are jammed.

- 1.18.1.5 If the pilot is prepared and adds this extra force, the rotor system may become overloaded. If the pilot is surprised by the phenomenon, the helicopter's flight path (altitude and track) may change. As mentioned above, the lift from the rotor blade passing aft on the right side will become insufficient. This creates a rolling movement to the right. Due to the gyroscopic effect on the rotor, this will also cause the helicopter's tail to drop and the nose to pitch up. Under normal circumstances, this pitch up causes the flying speed to drop. A result of the reduction

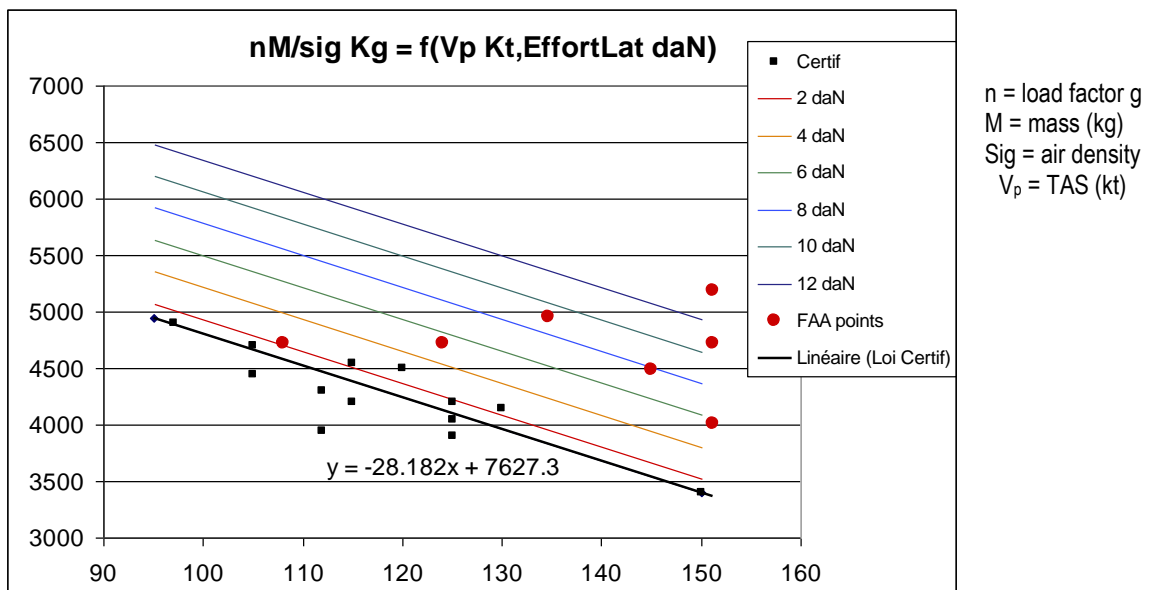
Figure 17: Results from the test flight. The red points are recorded stick forces on the cyclic during induced servo transparency at 3000 ft, 4 °C, mass 2250 kg. The black line shows the limit of the flight envelope. (Source: Eurocopter).

- 1.18.2.3 Some of the results from the test flight have been plotted in a diagram reproduced in Figure 17. The X and Y axes in the diagram in the figure show speed and load, respectively, on the main rotor during manoeuvring. Load values on the y axis depend on both helicopter mass (M) and air density (sigma,  $\sigma$ ), making it impossible to read normal load (n, corresponding to what is usually called g-load) directly from this diagram.

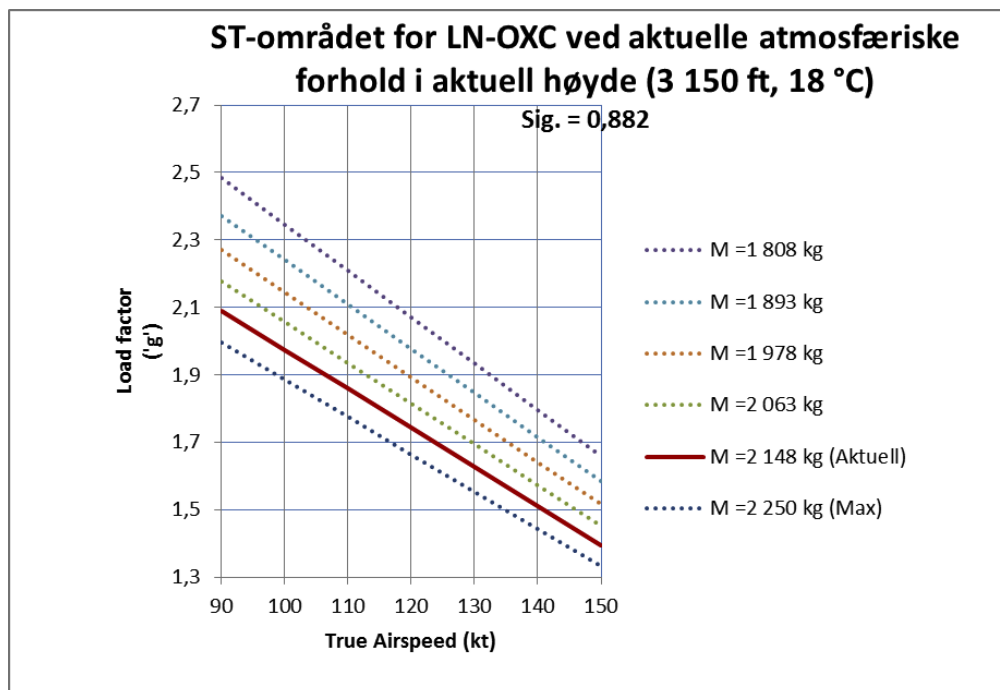
Figure 18 a): The situation for LN-OXC at the ambient atmospheric conditions (temperature at 3 150 ft. approx. 18 °C). The dotted lines show the effect of variation in mass.

- 1.18.4.2 The red continuous line in Figure 18: a) shows the situation at relevant mass, 2 148 kg. The servo transparency area is above the line. The slope of the line shows how servo transparency may be encountered at lower g-loads with increasing speed. For example, the threshold for LN-OXC in the ambient conditions would be approx. 2 G at 100 kt, while the phenomenon would occur at 1.5 G at a speed of 140 kt.

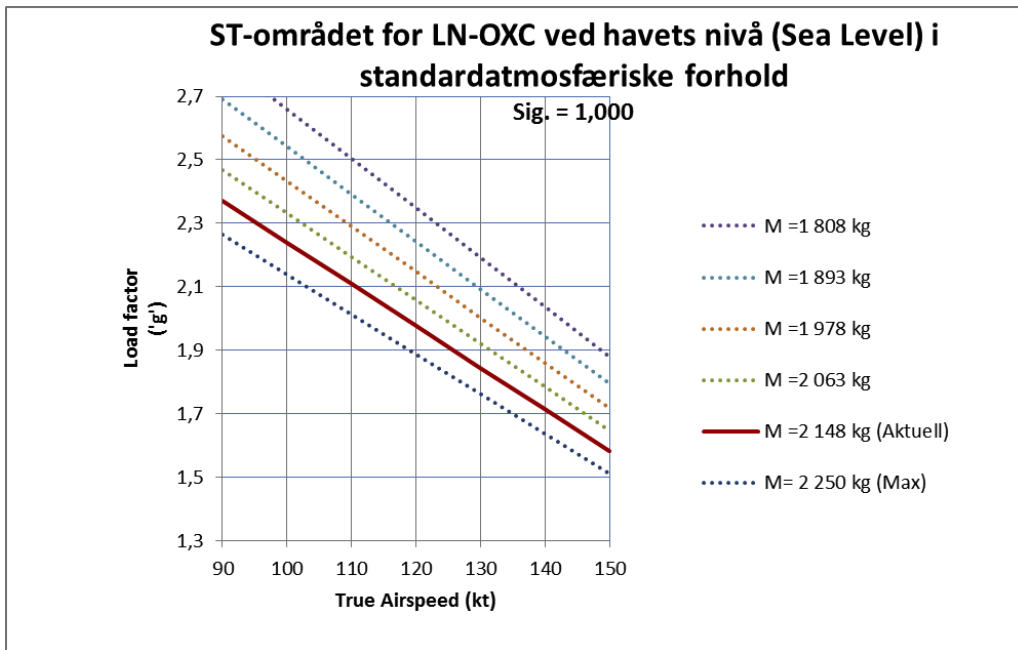
Figure 18 b): Theoretical situation where LN-OXC is operated at standard atmospheric conditions at sea level.

- 1.18.4.4 Figure 18 b) is included to illustrate how the situation would be at sea level in standard atmospheric conditions compared to the situation in the mountains on a warm day. When comparing Figure 18 a) and b), one sees that the lines are higher in the diagram b). During manoeuvring at 130 kt in the ambient conditions at 3 150 ft, the threshold for encountering servo transparency was approx. 1.63 G. At the same speed near sea level on a “standard day” the threshold would be approx. 1.85 G.

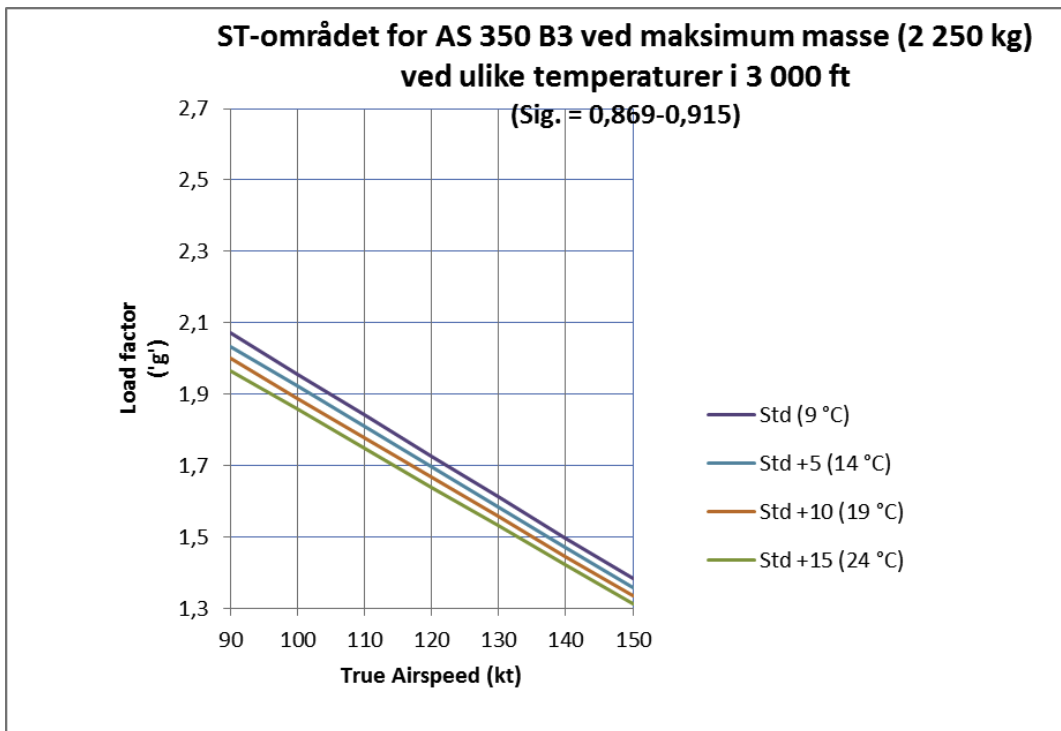
Figure 18 c): Theoretical situation where the mass is equal to 2 250 kg at a flight altitude of 3 000 ft. The lines show the effect of temperature.

- 1.18.4.5 Figure 18 c) is included to illustrate the effect of temperature, assuming max. AUM and an altitude of 3 000 ft. The figure shows that servo transparency will occur at lower g-loads on a warm day. When manoeuvring at 130 kt at this altitude it would be encountered at approx. 1.61 G if the temperature had been 9 °C, while at 24 °C at the same altitude it would be approx. 1.53 G.

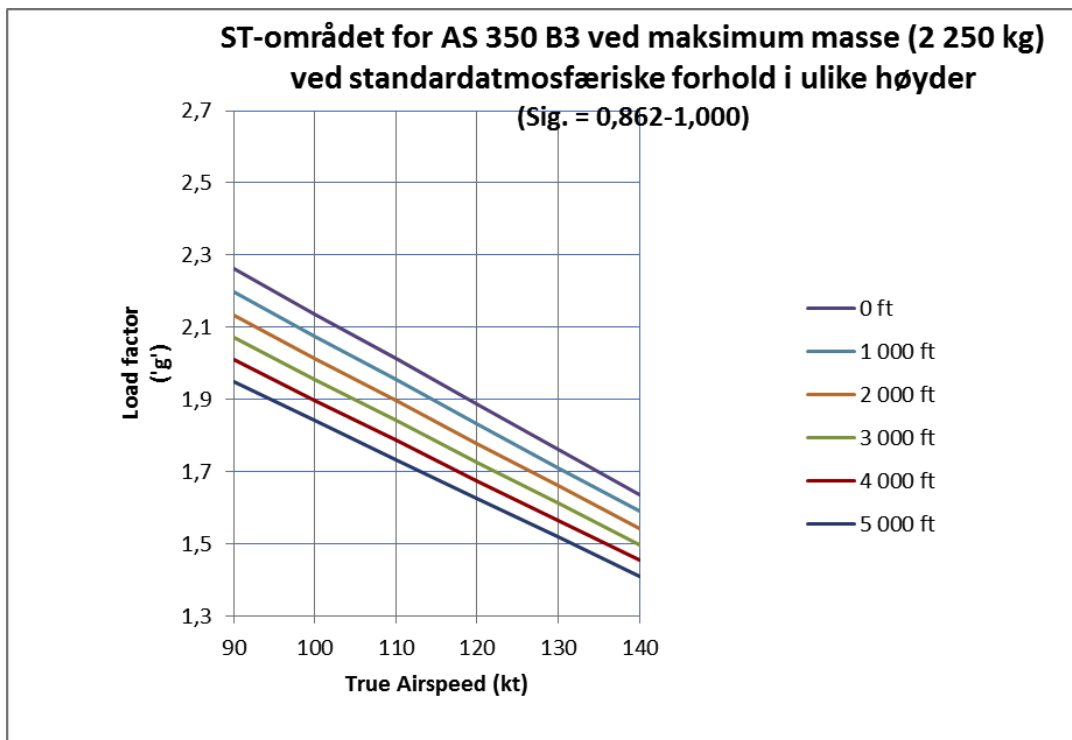
Figure 18 d): Theoretical situation where the mass is equal to 2 250 kg at standard atmospheric conditions. The lines show the effect of altitude.

- 1.18.4.6 Figure 18 d) illustrates the effect of altitude, assuming max. AUM at standard atmospheric conditions. The lines shift downwards as altitude increases. For example, the threshold for encountering servo transparency when manoeuvring at 130 kt at sea level would be approx. 1.8 G, while at 5 000 ft it would be at approx. 1.5 G.

2.8.5.4 AIBN understands the argument that the information in the flight manual must not be too comprehensive and complicated (cf. 1.18.7.2). In response, the AIBN asserts that charts similar to those prepared in connection with this investigation (cf. Figure 18: ), can be useful in raising pilot understanding of the phenomenon and should be included in information material and training programmes. Although the helicopter is not equipped with a g-load indicator and the information cannot be used directly during flight planning or during flight,

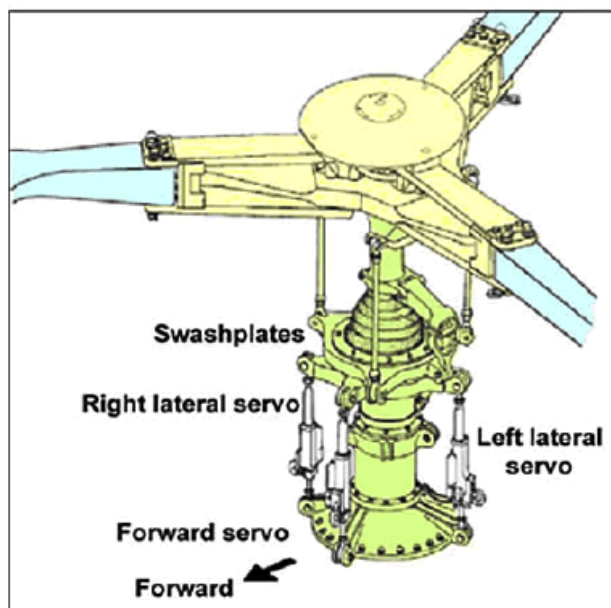
2.3 Hydraulic control boost is accomplished by irreversible hydraulic systems which isolate the pilot from the aerodynamic forces of the main rotor by the use of servos. The loads are transmitted from the blades through the pith rods to the swash plate assembly. The hydraulic power system counter-acts these forces through the servos. Since this results in zero control forces, artificial pilot control forces are then created by frictions, springs or force trims. The maximum force the servo actuators can produce is constant and is a function of hydraulic pressure and of the servo characteristics. The system is designed to exceed the requirements of the approved helicopter flight envelope. However, the maximum available power must be limited by design to protect the airframe against overstress, if the approved flight is exceeded. With excessive manoeuvring and under a combination of the above listed factors, the aerodynamic forces can increase beyond the opposing servos forces and Servo Transparency occurs.

The aerodynamic forces in excess of the hydraulic forces are then transmitted back through the control links to the pilots cyclic and collective controls. On clockwise turning rotors, as on the AS350 and EC120, the right servo is the highest loaded when manoeuvring (retreating blade), so servo transparency results in gradually increasing left cyclic control loads required to avoid un-commanded right cyclic motion accompanied by down collective movement due to the general overload on the swash plate assembly. The cyclic and collective control inputs required to counter these control motions may give a pilot who is unaware of this phenomenon an impression that the controls are jammed. If the severity of the manoeuvre is not reduced, the aircraft will roll right and may pitch up. The amplitude of the induced control feedback loads is proportional to the severity of the manoeuvre, but the phenomenon normally lasts less than 2 seconds since the resultant aircraft reaction helps to reduce the factors that contribute to the severity of the manoeuvre and of the Servo Transparency.

2.5 The pilots reaction to the first indication of control forces feedback should be to IMMEDIATELY reduce the severity of the manoeuvre. Once developed Servo Transparency will reduce the helicopter speed due to some pitch-up and reduce control loads by included down collective movement, so the servo transparency phenomenon is self correcting. The pilot reaction is to follow the control movement and to allow the collective pitch to decrease (of course, monitor main rotor rpm speed at very low pitch) to reduce the overall load on the rotor system and smoothly counteract the right cyclic tendency to prevent an abrupt left cyclic movement as hydraulic assistance is restored.

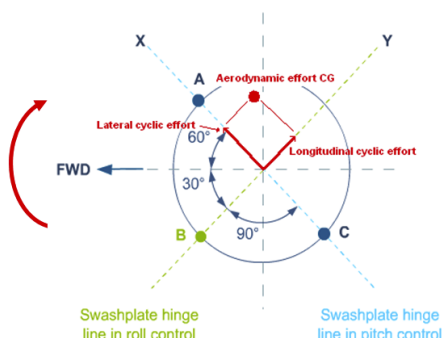
With excessive manoeuvring and under a combination of the previous listed factors,

the aerodynamic forces can increase beyond the opposing hydraulic servo forces and Servo Transparency can occur.

On clockwise turning main rotor systems, the right servo receives the highest load when manoeuvring,

If the pilot takes no action to counter\* the servo transparency then it will result in a roll, a pitch up and a lowering by itself of the collective.
