REPORT

SL 2013/26

REPORT ON AIR ACCIDENT AT SKJELBREIA IN SKI, AKERSHUS ON 2 APRIL 2009 WITH DIAMOND DA40-D, LN-NEX

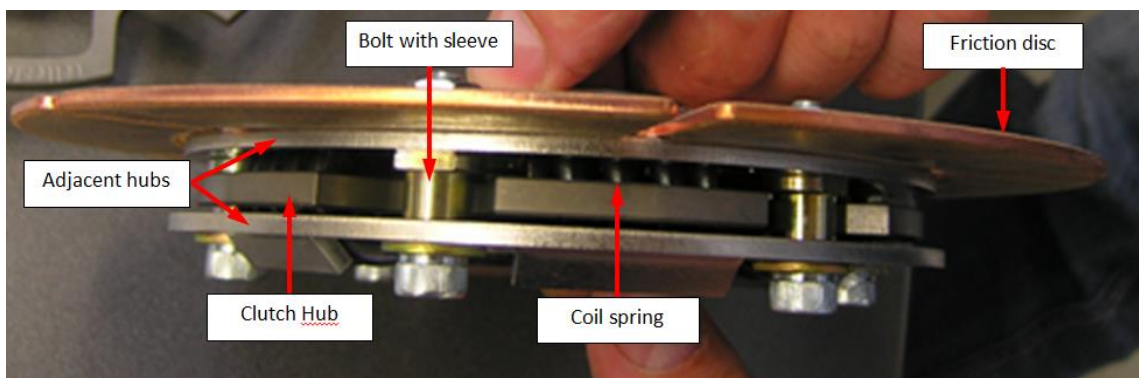
- 1.16.2.1 Clutch Hub (part number 05-72211-K011) is mounted between two adjacent hubs and transmits power from the crankshaft to the engine gearbox (see Figure 6).

Figure 6: ASSY Clutch as delivered from the manufacturer. Photo: AIBN

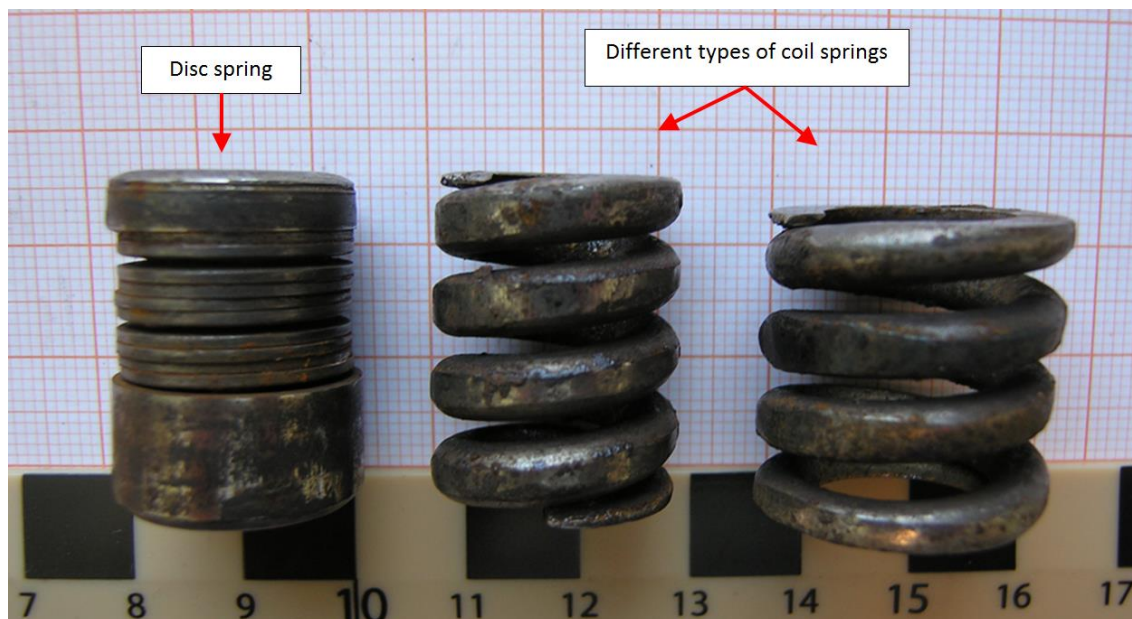
- 1.16.2.2 Six springs of three different types are to ensure that the propeller runs softer (see Figure 7). The clutch functions such that vibrations, pulses and jolts are first intercepted by these springs so that a minor relative movement occurs between the Clutch Hub and the two adjacent hubs. The movement is restricted by the two disc springs which can only be compressed to a modest degree. Impacts that are so strong that the spring system “bottoms” are absorbed in that the friction coating on the friction disc yield.

Figure 7: The three different types of springs mounted on the clutch hubs to damp torsional vibrations, pulses and jolts. The two coil springs types have different diameters and lengths. The unit consists of a total of six springs, two of each type. Photo: AIBN

- 1.16.2.3 Before delivery of new clutch units, the factory tests and adjusts spring tension (see Section 1.6.4.6).
- 1.16.2.4 When the AIBN measured the dimensions of the springs, it proved that both of the two coil springs that had the greatest diameter did not have the correct length. The length of the two springs was measured at 23.8 mm and 24.8 mm respectively. According to information from TAE the correct length is 27.5 mm. The other coil springs were also somewhat shortened (in the order of 1 mm).
- 1.16.2.5 The Clutch Hub was broken in six places so that the rim was separated from the inner part. In addition, three of the twelve radial spokes between the cut-outs were broken (see Figure 8).

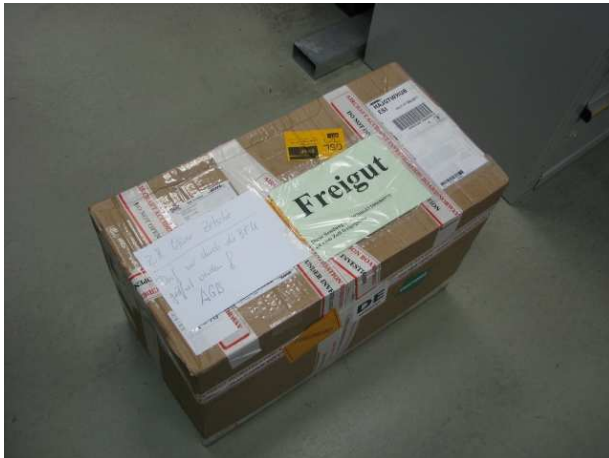
The loom was delivered to Thielert in a sealed box. The seal was undamaged and opened in the presence of a BFU employee.

Picture 1 Undamaged seal

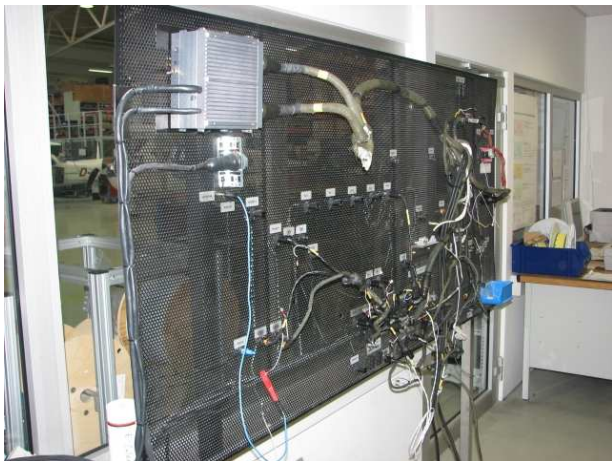
The next step was to connect the loom to a test rig (see picture 6). In order to put the loom on the rig, some of the cable ties had to be removed. The loom tested OK (see picture 7), no short circuit or discontinuity were found. To rule out any intermittent faults, the loom was moved (shaken) in all areas. The loom still tested OK.

Picture 6 Test rig

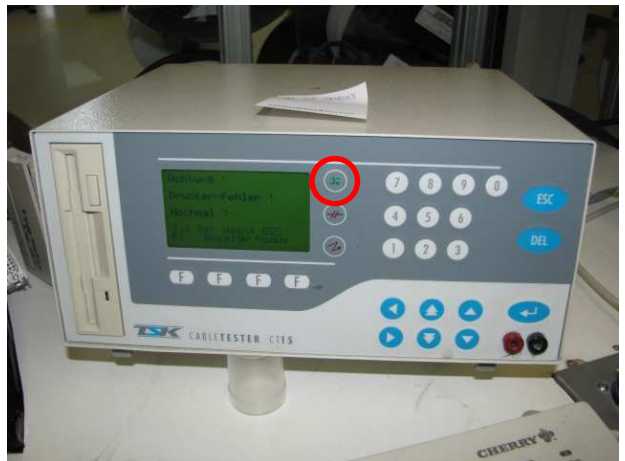
Picture 7 Tester

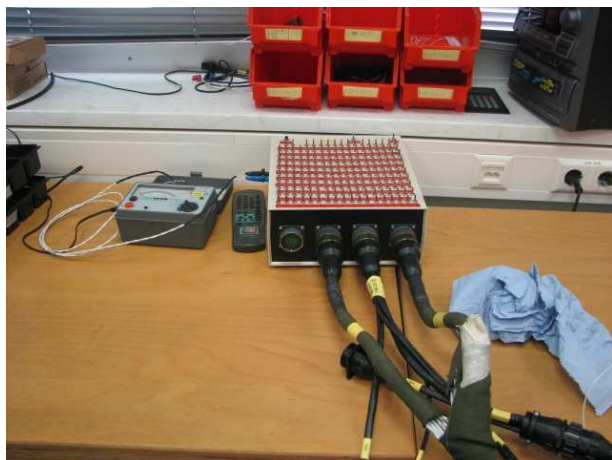
As a final step, an isolation test was conducted. This was done by applying 1000V DC to the shield of the cable and measuring the current on the return path, thus getting the isolation resistance. The isolation resistance was the same as for a new, good cable. The same was done while shaking the loom. Again, no problem was found.

Picture 8 Isolation test set-up
