RAPPORT

SL 2015/01

RAPPORT OM ALVORLIG LUFTFARTSHENDELSE UNDER INNFLYGING TIL KITTILÄ LUFTHAVN FINLAND (EFKT) 26. DESEMBER 2012 MED BOEING 737-800, LN-DYM, OPERERT AV NORWEGIAN AIR SHUTTLE ASA

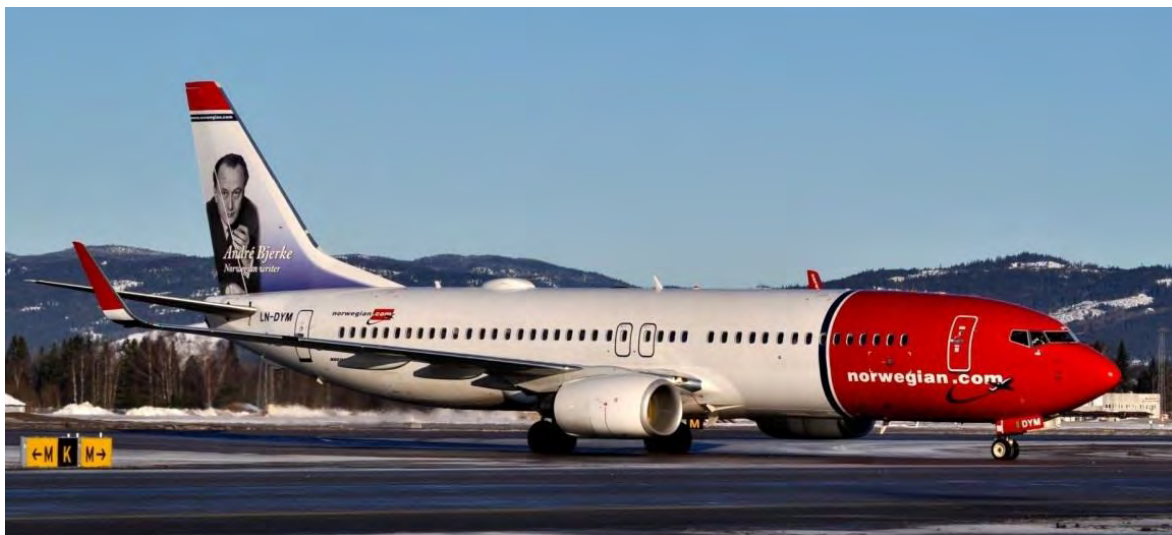
Figur 2: Boeing 737-800 NG, LN-DYM. Foto: Privat

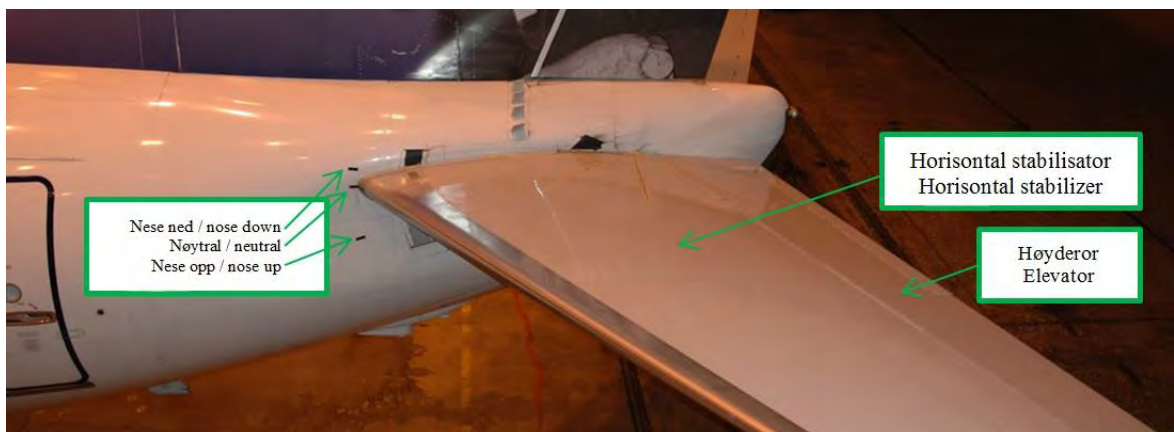
- 1.6.3.5 Høyderoret er plassert på bakkant av den horisontale stabilisatoren. Flyet trimmes ved at monteringsvinkelen endres på den horisontale stabilisatoren. Trimmingen skjer elektrisk og styres automatisk eller via trim-bryterne på stikka (control column) i flight deck. Den horisontale stabilisatoren utgjør en relativt stor flate som i stor grad vil påvirke flyets aerodynamiske krefter om tverraksen (pitch) (se figur 3).

Figur 3: Viser størrelsesforholdet mellom horisontal stabilisator og høyderor, samt bevegelsesområde for horisontal stabilisator. Foto: SHT

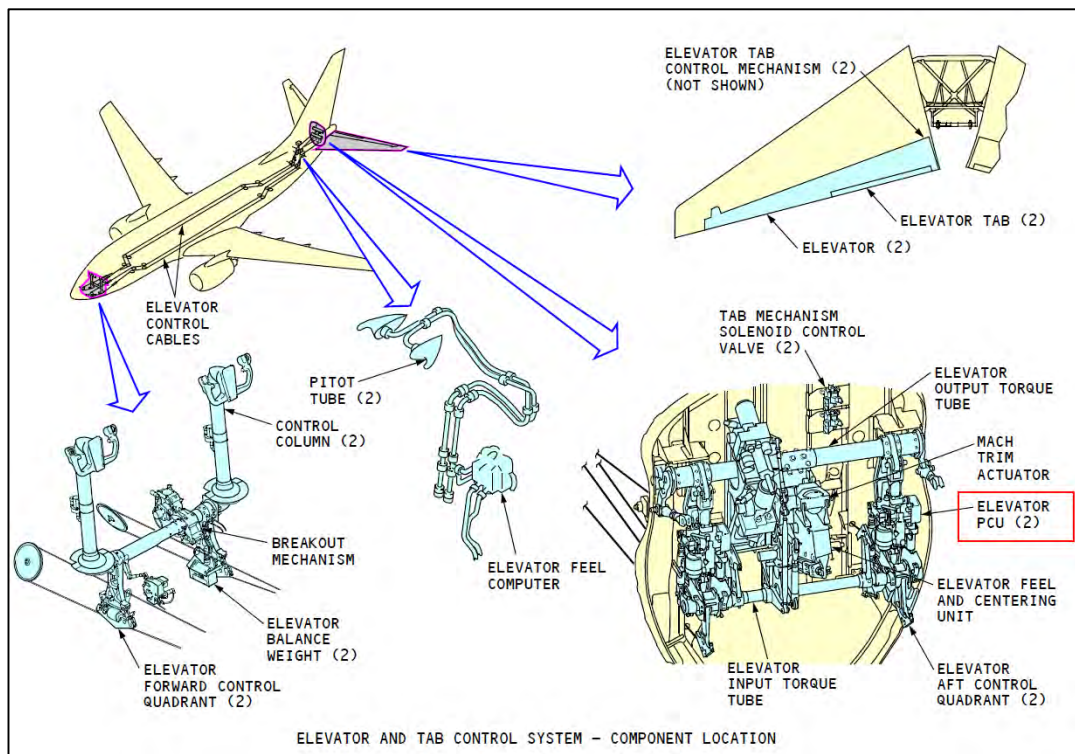
Figur 4: Illustrasjonsskisse over høyderorssystemet og plassering av komponenter.

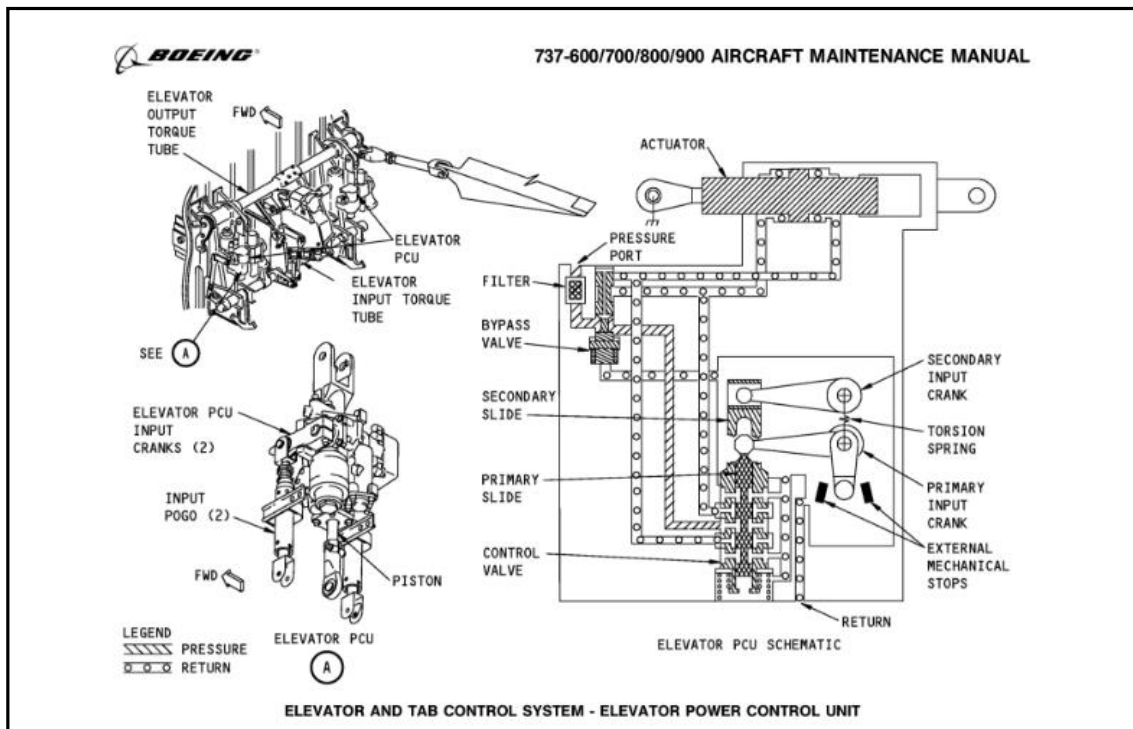
Figur 6: Viser skjematisk oppbygging av en høyderors PCU. Kilde:- Boeing Proprietary Information. Copyright © Boeing. Reprinted with permission of the Boeing Company.

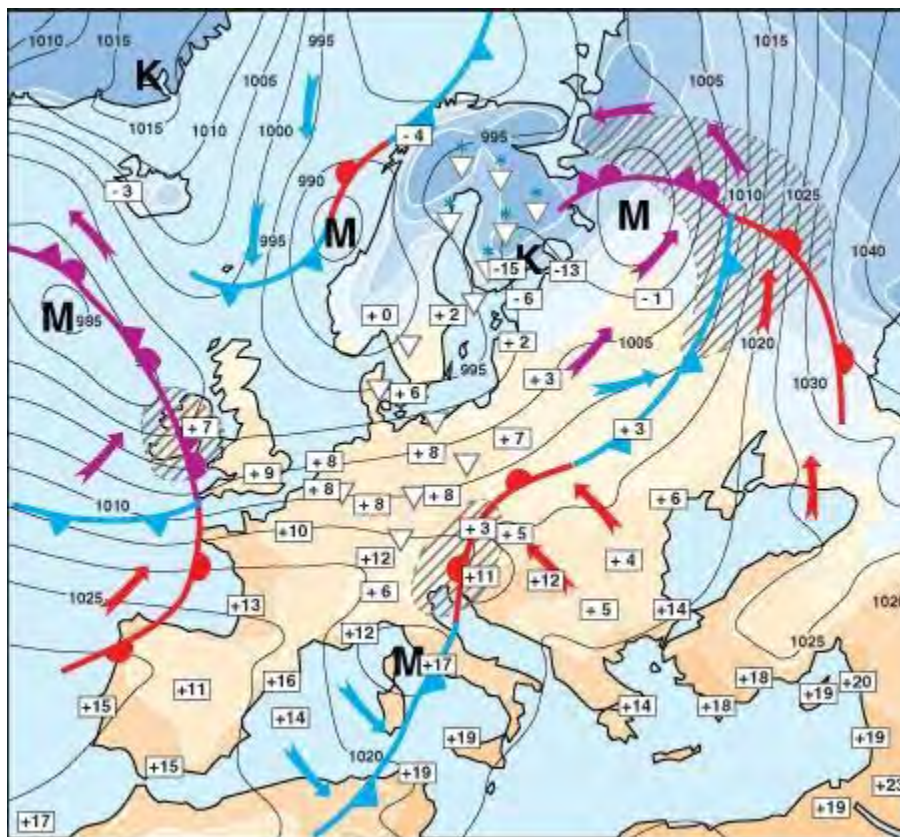
Ridge of high extending from Baltic States to Finland, and cold airmass over Finland and Northern Scandinavia and locally light snowfall. Winds are weak.

Picture 1. Finnish Meteorological Institute’s weather analyze at 12 UTC 26.12.2012.

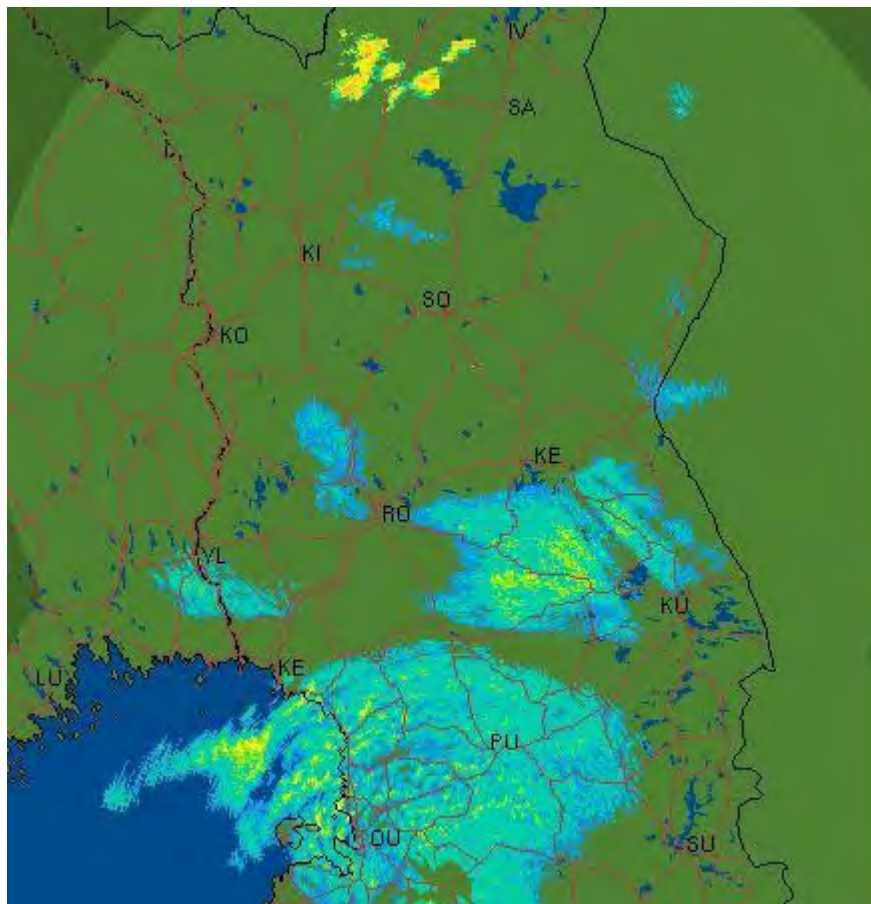
Based on metar's and radar it was dry weather in Kittilä. Picture 2 shows radar picture at time 08.30 UTC. It seems some light snowfall towards northeast from Kittilä (KI) and also towards south near Ro that is city of Rovaniemi.

Picture 2. Radar picture 26.12.2012 at 08.30UTC.

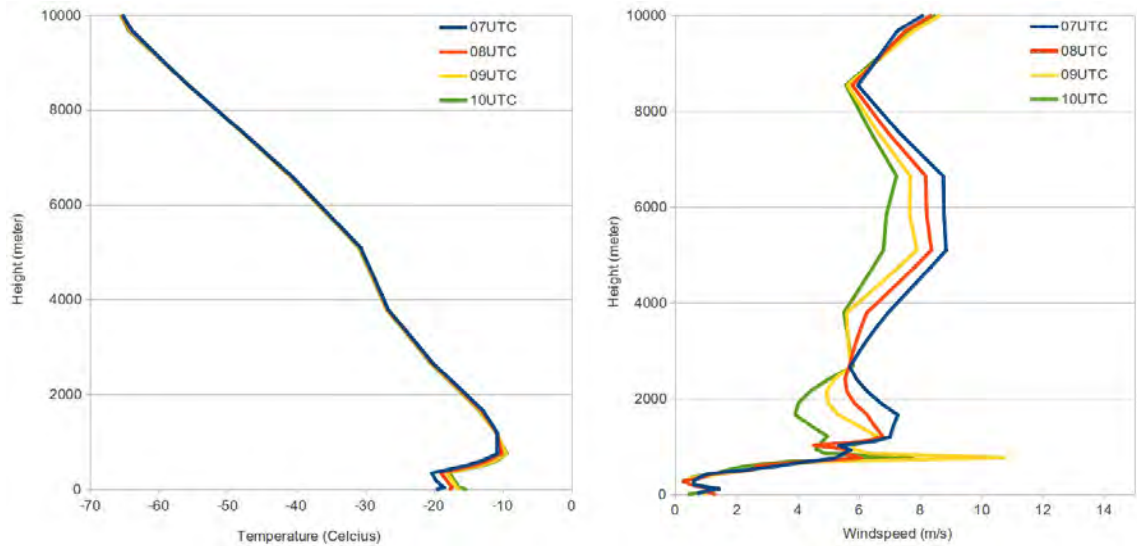
Temperature on the ground was about minus 20 degrees and there were a strong inversion near the ground which can be seen from Laps, picture 4. Also sounding from Lulea 00 UTC picture 3 indicates strong inversion in Northern Scandinavia. In Finland we have Sodankylä sounding at 12 UTC, picture 5. There can still be seen inversion level below one kilometer. An another inversion level is around 5000ft in Sodankylä 12 UTC it's anymore about 5 degrees, but earlier pilot report (Boeing 737) has noticed there 11 degrees inversion at 0911UTC.

Picture 4. Laps analyze about temperature (on the left) and wind speed (on the right) profiles in Kittilä. Blue colour shows how model has seen the situation at 07UTC, red 08UTC, yellow 09UTC and green 10UTC.

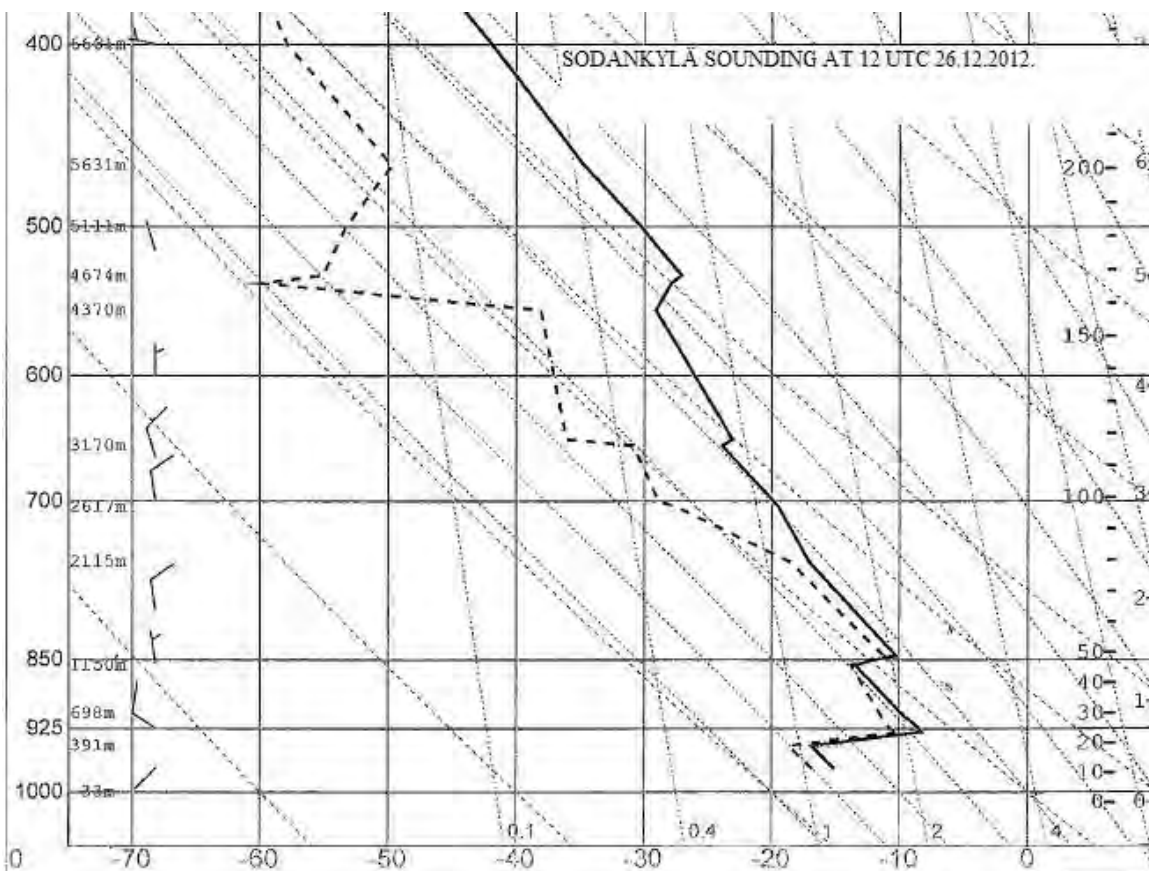
Picture 5. Sodankylä sounding at 12UTC 26.12.2012.

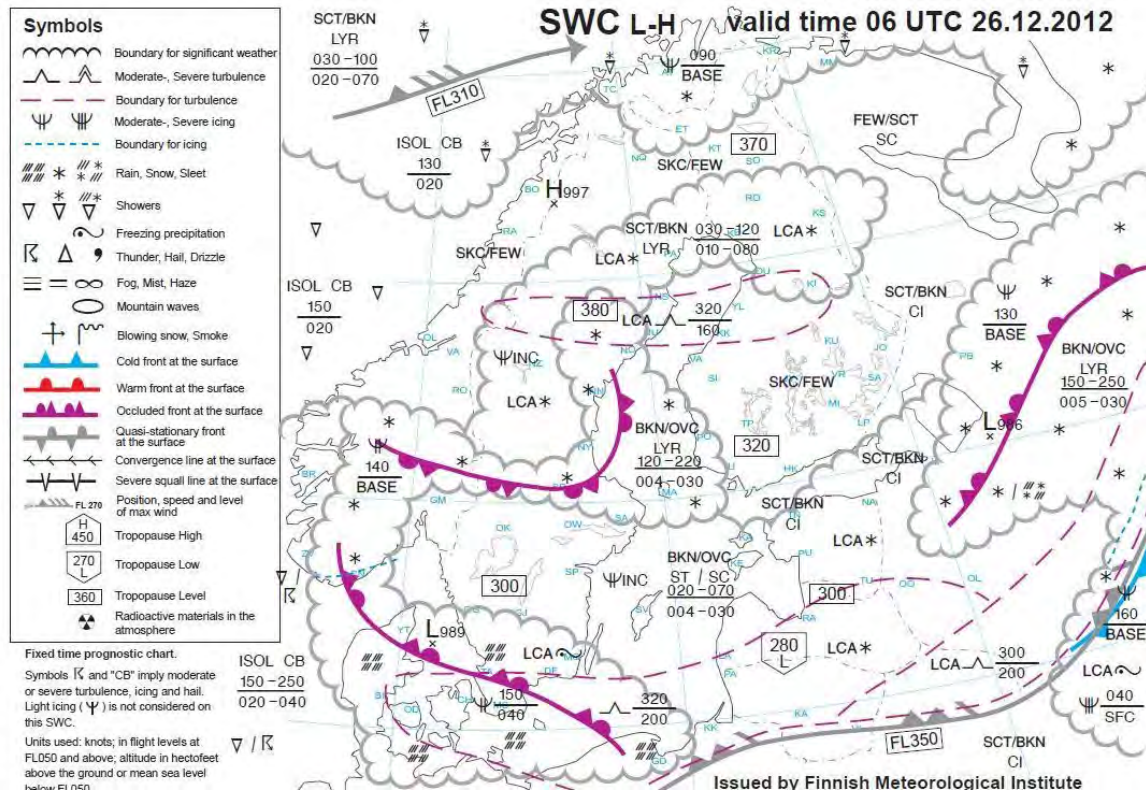
Picture 6. Scandinavian significant weather chart 06UTC 26.12.2012 made by FMI.

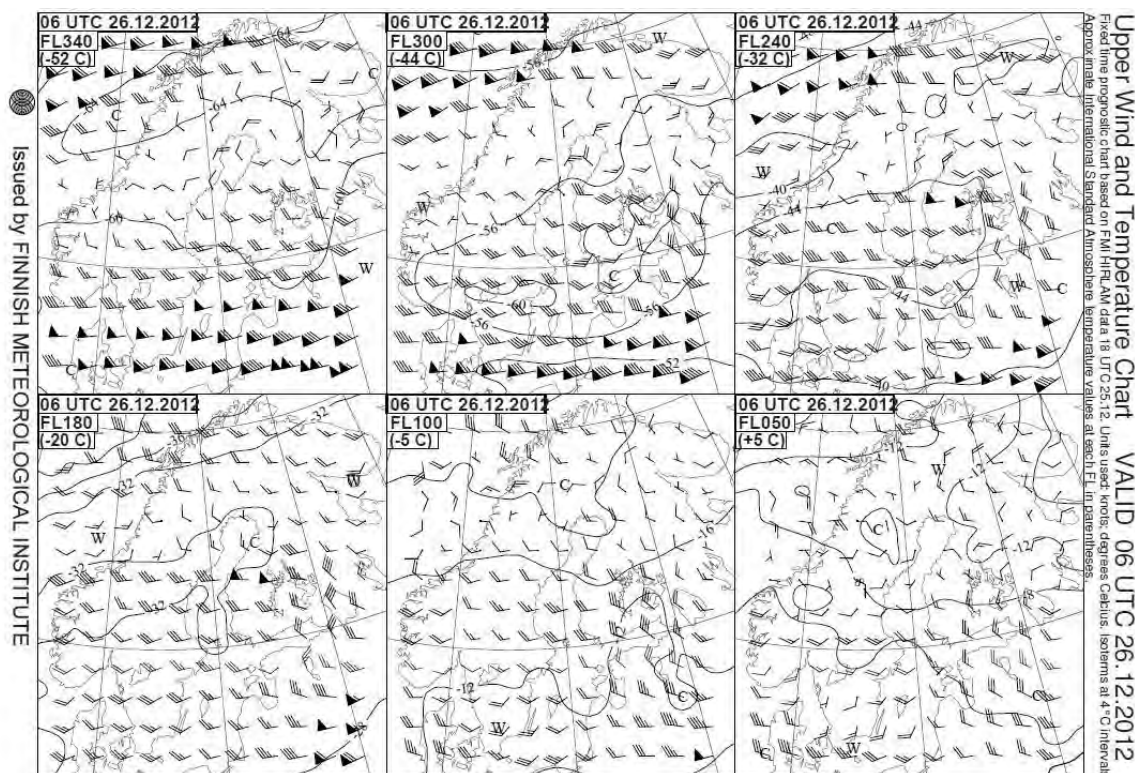
Picture 7. Upper wind and temperature chart over Skandinavia based on FMI Hirlam model date run 18UTC 25.12.2012. Chart is valid 06UTC 26.12.2012.
