REPORT

SL 2015/06

REPORT ON AIR ACCIDENT AT SOLLIHØGDA IN BUSKERUD, NORWAY 14 JANUARY 2014 WITH AIRBUS HELICOPTERS EC 135 P2+, LN-OOI OPERATED BY NORSK LUFTAMBULANSE AS

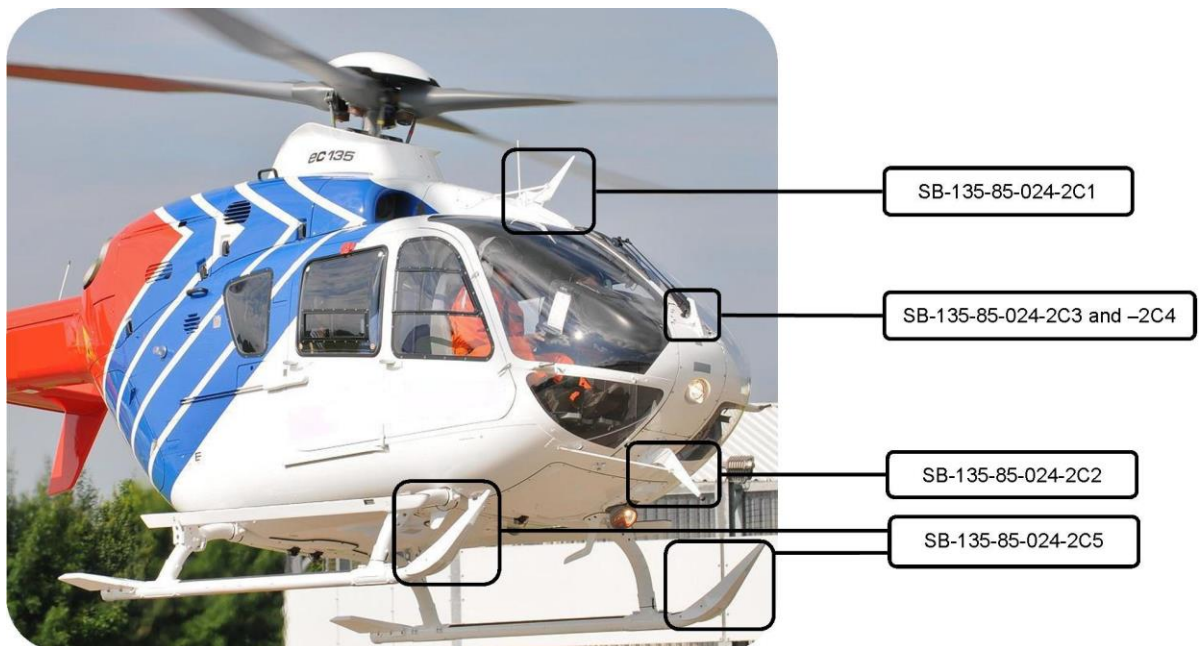
LN-OOI was equipped with wire cutter, devices that will deflect and cut power lines and transport cables if the helicopter collides with these. There is an upper and lower knife that will cut wires. The precondition is that the target is within the area for the upper and lower knives. If a wire passes above the upper knife, it could hit the main rotor. If a wire passes below the lower knife, it will also pass under the skids. According to Airbus Helicopters, the system is designed so that it is efficient at speeds between 13 and 52 kt.

Figure 4: The system for protection against wires is shown on an equivalent helicopter. Photo: Airbus Helicopters

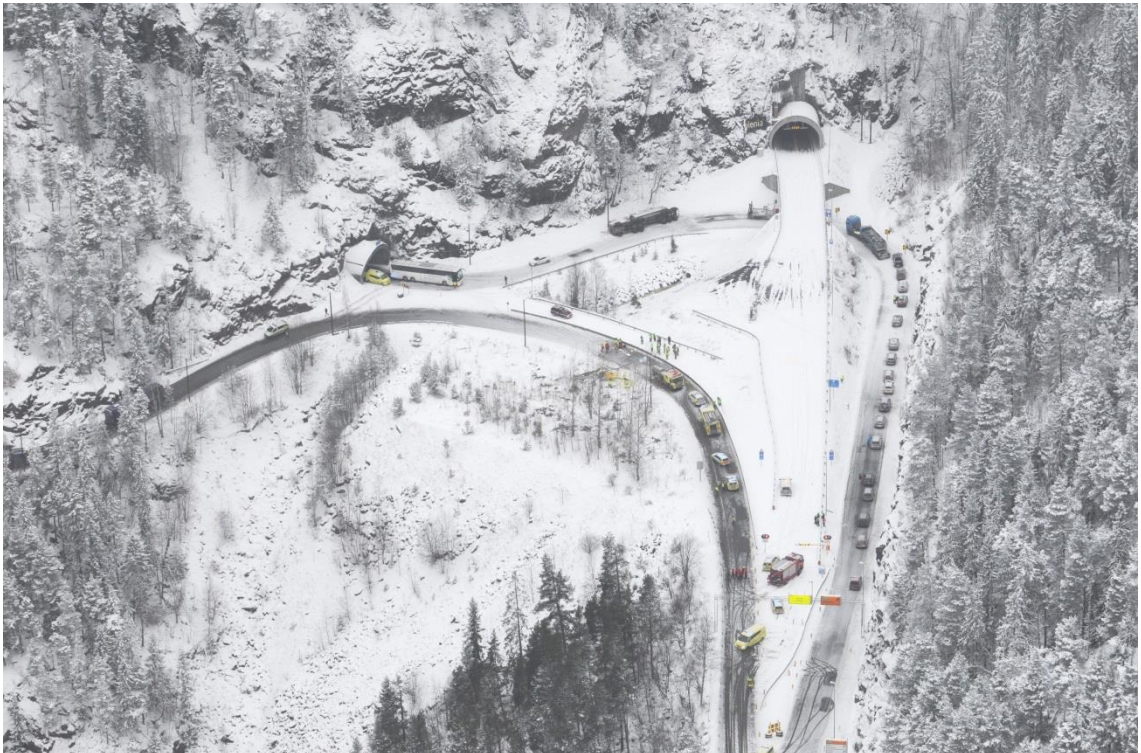
Figure 14: The same photo as in Figure 1, but without text boxes. Photo: The Police

- 2.4.2.2 It was unusually difficult to spot the power line which the helicopter hit, and nearly impossible to detect visually from the angle in which the helicopter was flying. There was no snow on the lines. It was difficult to spot the grey colour against the busy backdrop (see Figure 14). The southwestern poles were the same colour as the trees they were hidden behind, and the northeastern poles were hidden amongst trees. It was also difficult to see signs of power line corridors through the forest. The Accident Investigation Board therefore believes that the circumstances indicate that the accident could have happened to any crew in the company.
