# REPORT

SL 2015/08

## REPORT ON AVIATION ACCIDENT 24 JUNE 2014 AT HJERKINN IN DOVRE MUNICIPALITY, OPPLAND COUNTY INVOLVING AIRBUS HELICOPTERS AS 350 B3E, LN-OSY

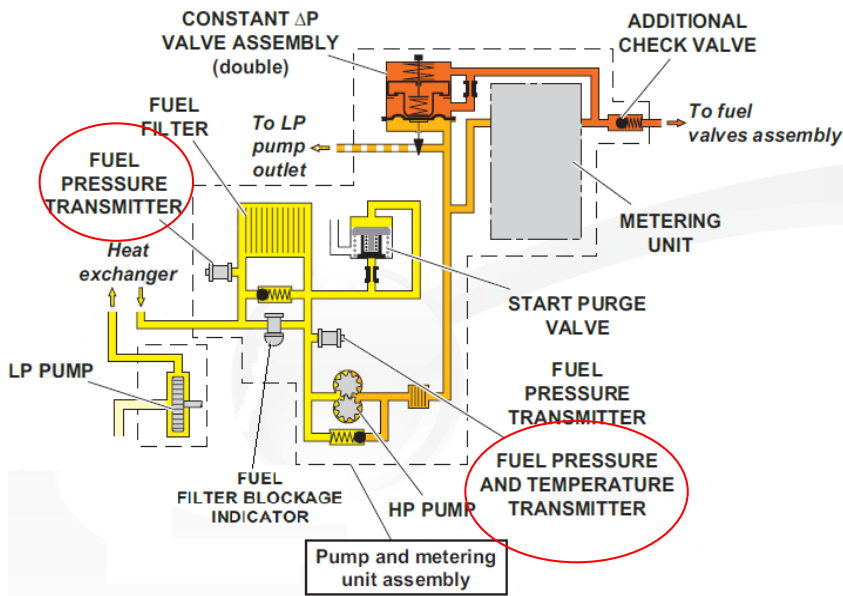
Figure 10: Excerpt from Figure 2 that shows the location of fuel pressure sensors. Source: Turbomeca

1.11.4.3 It was possible through sub-menus to see that the VEMD had registered failures in the fuel pressure at both the inlet and outlet of the fuel filter (see Figure 9). This was registered simultaneously via both channels in FADEC 1 minute and 32 seconds after VEMD had started to register data for the flight (from engine start). The pressure sensors are located as indicated in Figure 10.

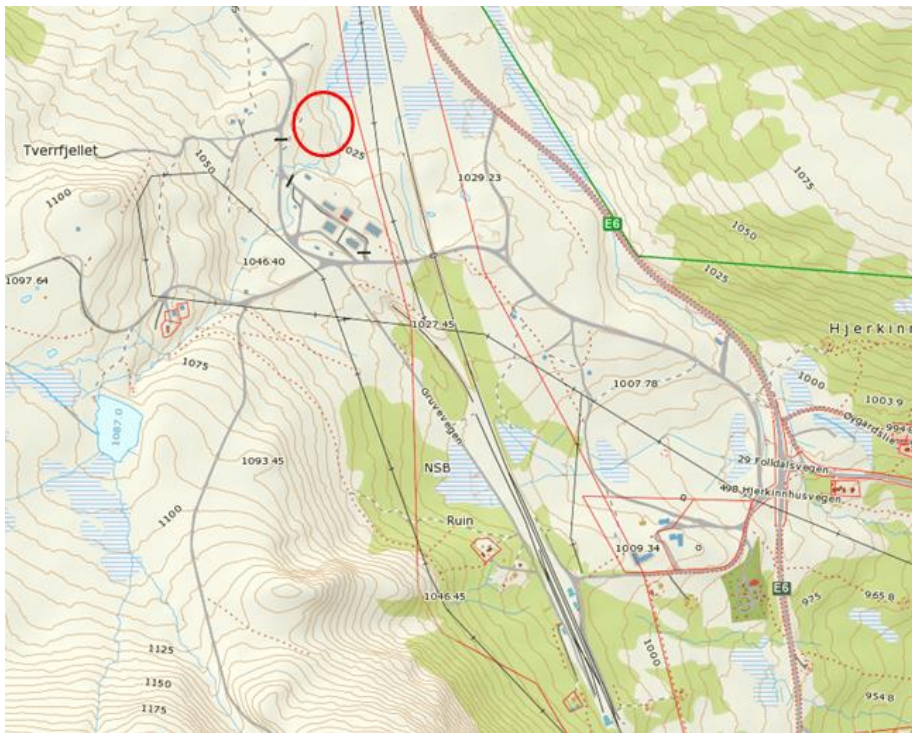
Figure 13: Overview image of crash site. Source: The Norwegian Mapping Authority , Geovekst and municipalities

The accident occurred during take-off from the Norwegian Armed Forces' facility at Hjerking. The distance between the helipad and the crash site was approximately 185 metres. The terrain had a slight incline, and was partially covered in heather and birchwood. The ground was dry.

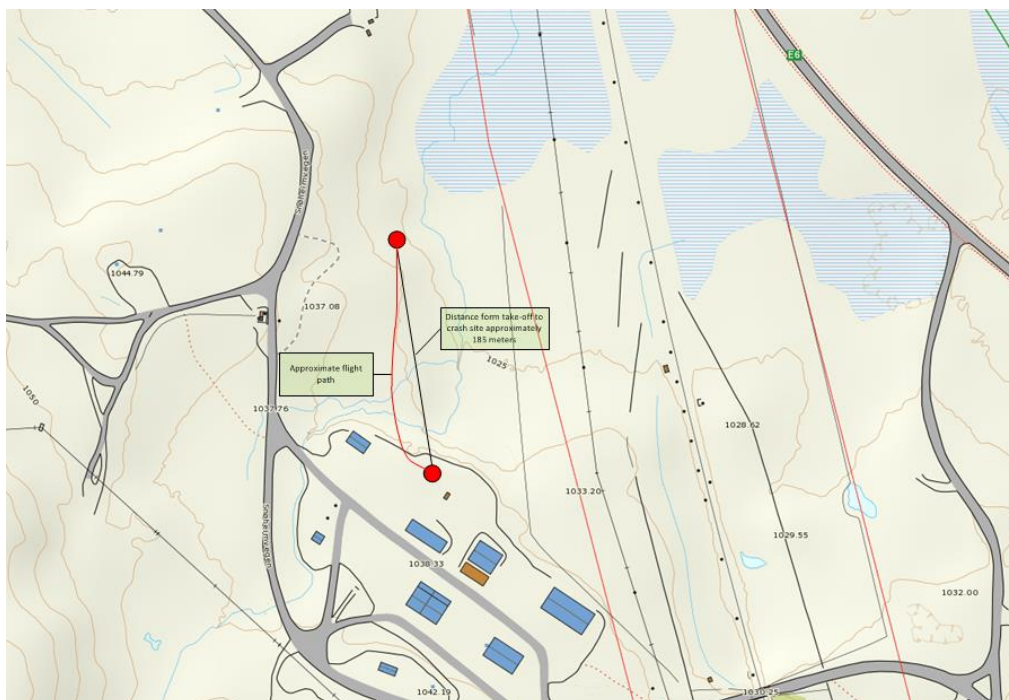
Figure 14: Approximate flight path. Source: The Norwegian Mapping Authority , Geovekst and municipalities

Because the helicopter was at a low altitude when the problem occurred, it was not possible to establish an autorotation. The helicopter landed with forward speed and hit the ground with the underside of the nose of the aircraft. This caused the helicopter to tilt forward and to come to rest on the left side with the nose in the opposite direction of the

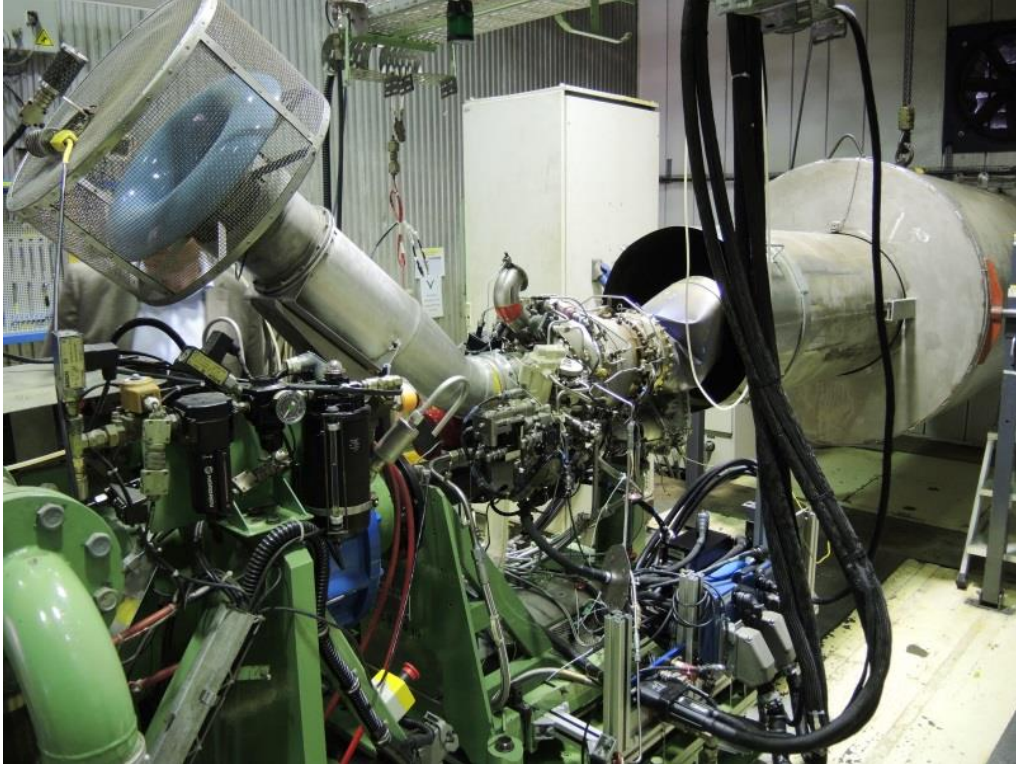
Figure 17: Engine installed on test bench. Photo: AIBN

- 1.16.1.1 The engine was removed from the helicopter and installed on a test bench at Turbomeca, Tarnos (see Figure 17) for testing. LN-OSY's FADEC was used to regulate the engine in order to achieve conditions as similar as possible to the flight where the engine stopped.
- 1.16.1.2 Based on stored FADEC data available from the flight, a similar profile for power settings was defined for running on the test bench.

The engine ran for 19 minutes with variations in power from ground idle to 92.7 % NG, and it functioned normally throughout the test.

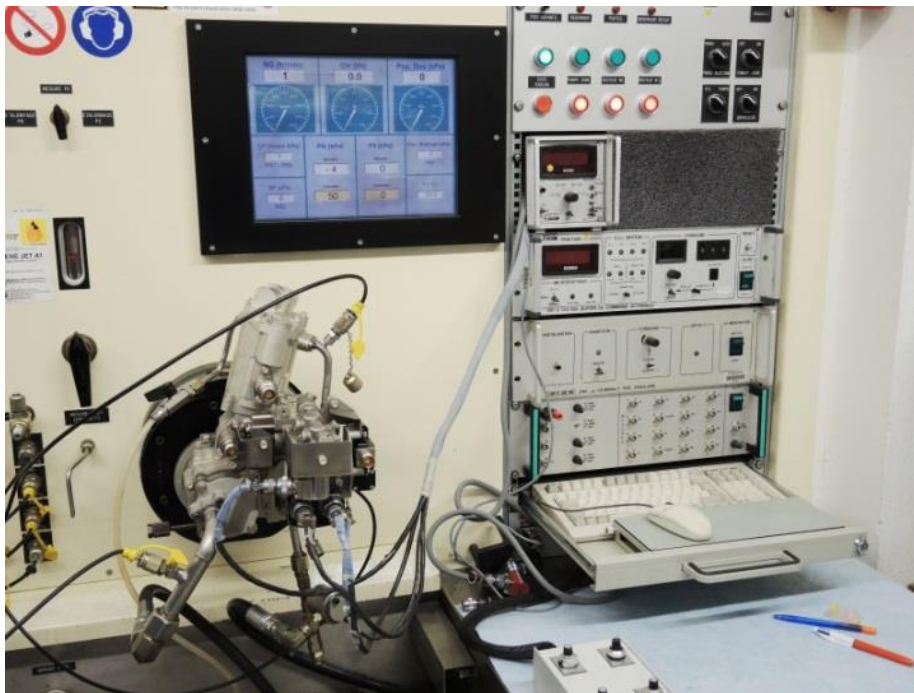
Figure 18: Test configuration HMU. Photo: AIBN

- 1.16.2.1 The purpose of this test was to check if the HMU functioned in accordance with the specified criteria (see Figure 18). This was done by controlling the pressure, the HMU valve position and regulated fuel volume.

All tests showed that HMU worked as it should.

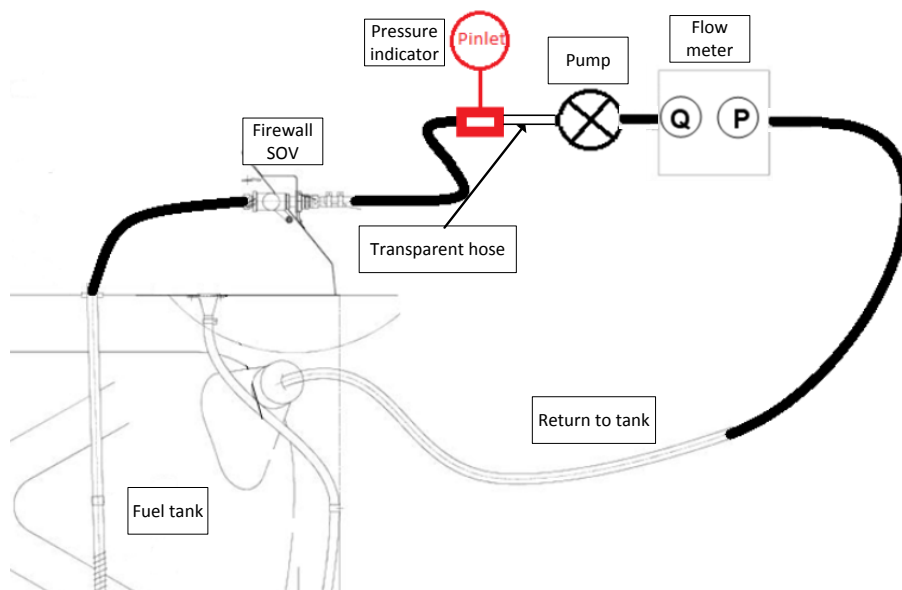
Figure 24: Chart for test of the helicopter's fuel system. Source: Airbus Helicopters/Processed by AIBN

Under normal operations, the fuel pump in the helicopter's fuel tank does not run, it is the low-pressure pump in the engine's HMU that draws the fuel from the tank. In order to simulate this, a test set-up was prepared with a pump simulating the HMU low-pressure pump, an adjustable flow meter and a pressure indicator (Figure 24). The pump was placed at the same height as the HMU inlet in relation to the helicopter's fuel tank, and the tank was filled with the same amount of fuel as the helicopter had prior to take-off. The purpose of this was to achieve the correct under pressure conditions. A transparent hose was used between the pressure indicator and pump to visually check if the fuel system sucked in air due to under pressure in the liquid column between the level in the fuel tank and the pump. A hose returned fuel to the helicopter's tank. The flowmeter was adjusted to the engine's consumption at take-off.

No air was observed in the transparent hose during the test.

The performed test showed no leaks or other conditions that could explain loss of engine power. Moreover, the complete examination of the airframe fuel system components and plumbing after dismantling did not exhibit any damages, or evidence of foreign objects ingestion causing blockage.
