REPORT

SL 2015/09

REPORT ON SERIOUS INCIDENT EN-ROUTE OSLO – TRONDHEIM, NORWAY, ON 25 SEPTEMBER 2014 TO BRITISH AEROSPACE ATP, SE-MAF OPERATED BY WEST AIR SWEDEN AB

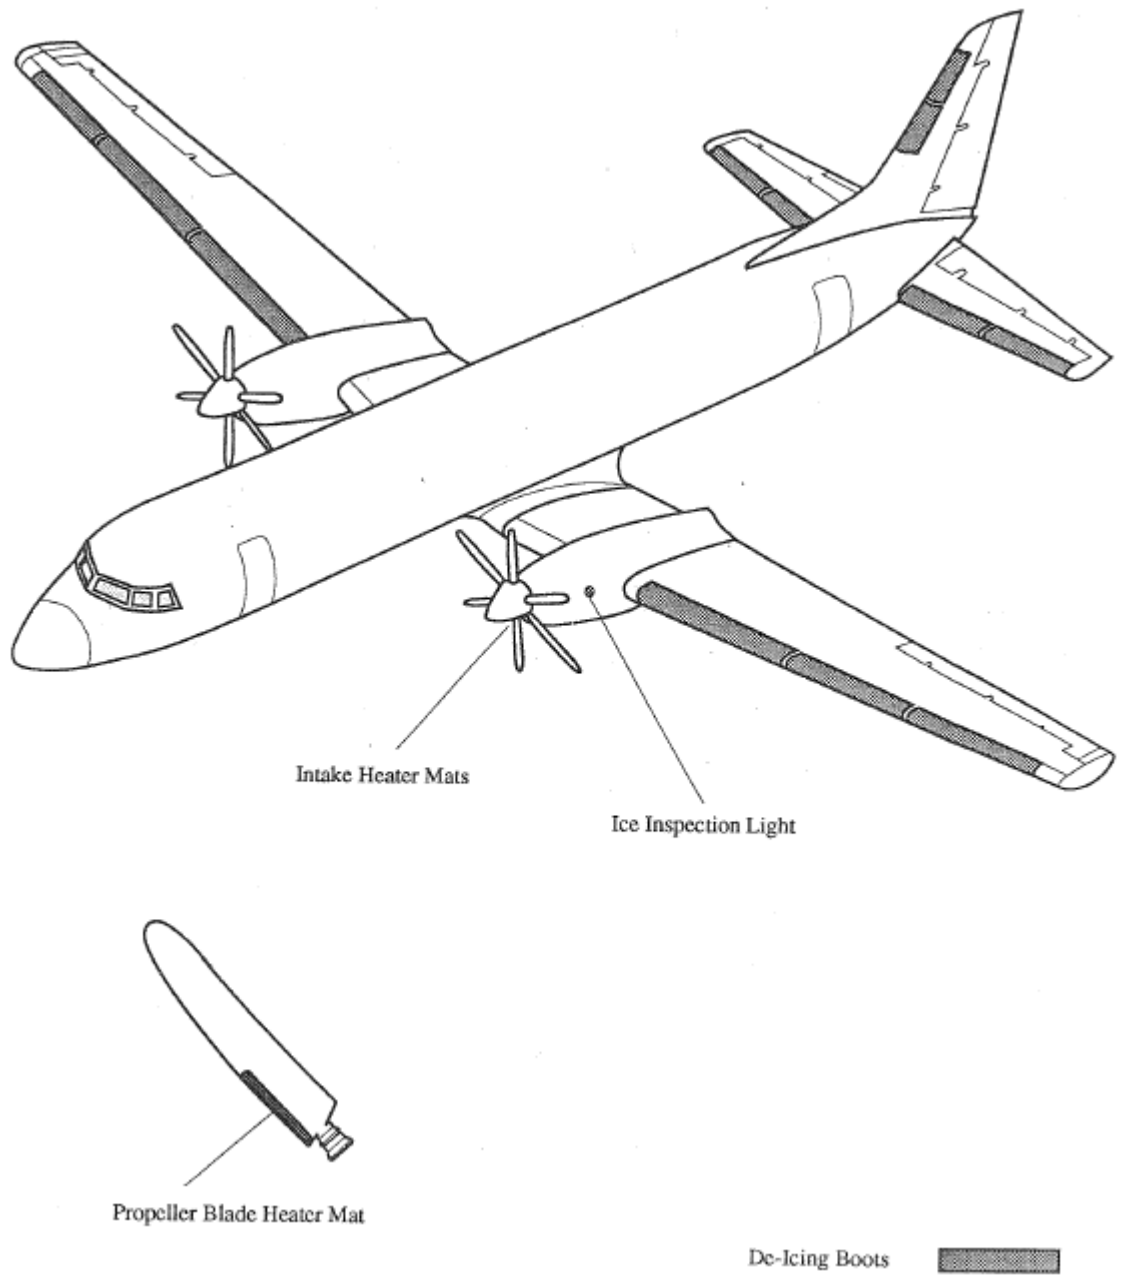
Figure 2: ATP systems for protection against icing, de-icing boots and inspection lights. Source: BAE Systems

1.6.4.2 The airframe de-icing system is shown in Figure 2 and Figure 3. The leading edges on the wing outboard of the engine nacelles, and the horizontal and vertical stabilizers are equipped with pneumatic boots (inflatable rubber tubes) that are used to remove ice. The system is divided into three groups:

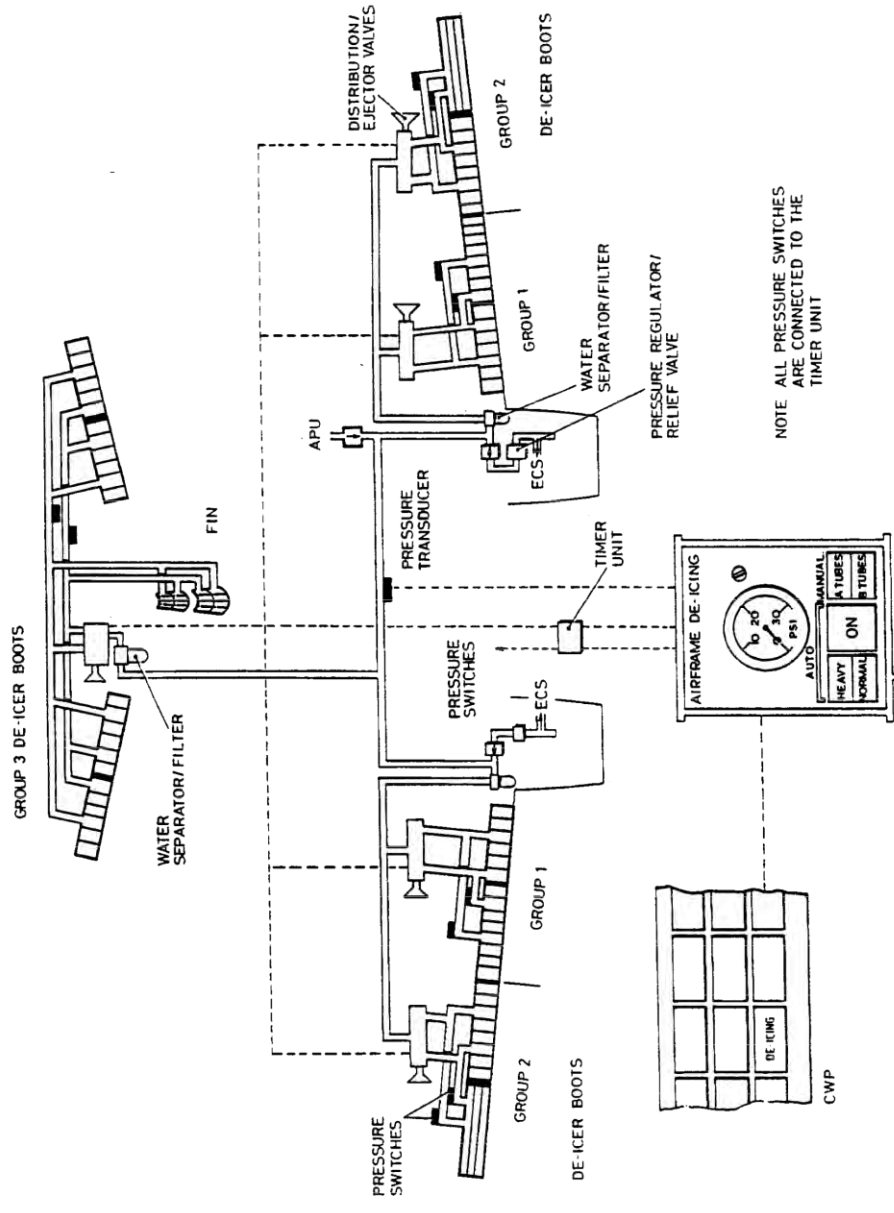
Figure 3: Schematics of the de-icing system. Source: BAE Systems ATP Operations Manual, Systems description and procedures, Ice and rain protection 14.20.13

1.6.4.3 The three groups are controlled by five valves (see Figure 3). Each valve is connected to two sets of tubes (A TUBES and B TUBES). The system is operated by pressure-regulated bleed air from the engines.

1.6.4.4 When the system is in operation, the valves inflate the A TUBES and deflate the B TUBES. Then, the B TUBES are inflated and the A TUBES are deflated. This causes a group by group sequential inflation (corrugation) of the surfaces of the rubber-covered leading edges on wings and stabilizers. This deformation of the leading wing edges normally breaks off the ice. Between inflations and when the system is not activated, all tubes are deflated using suction.

- If the pressure gauge is showing the correct steady pressure but less than six kicks per cycle, a distributor valve is suspect and the affected airfoil section may no longer be fully de-iced.*

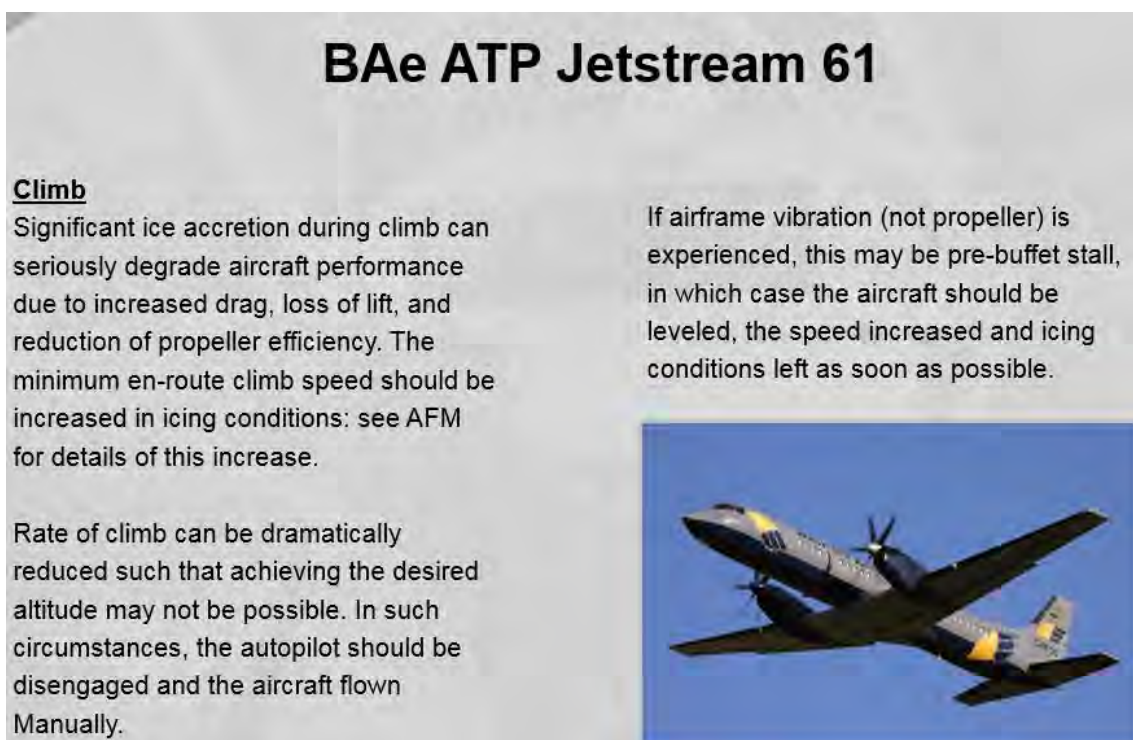
Figure 5: Summary from the operator's training material on winter operations for ATP crews. Source: West Air Sweden AB

- 1.6.10.3 For icing during climb, the description was more comprehensive, and it was mentioned that the minimum speed must be increased. The method for finding the minimum speeds was not specified, however, and reference was again made to the AFM:

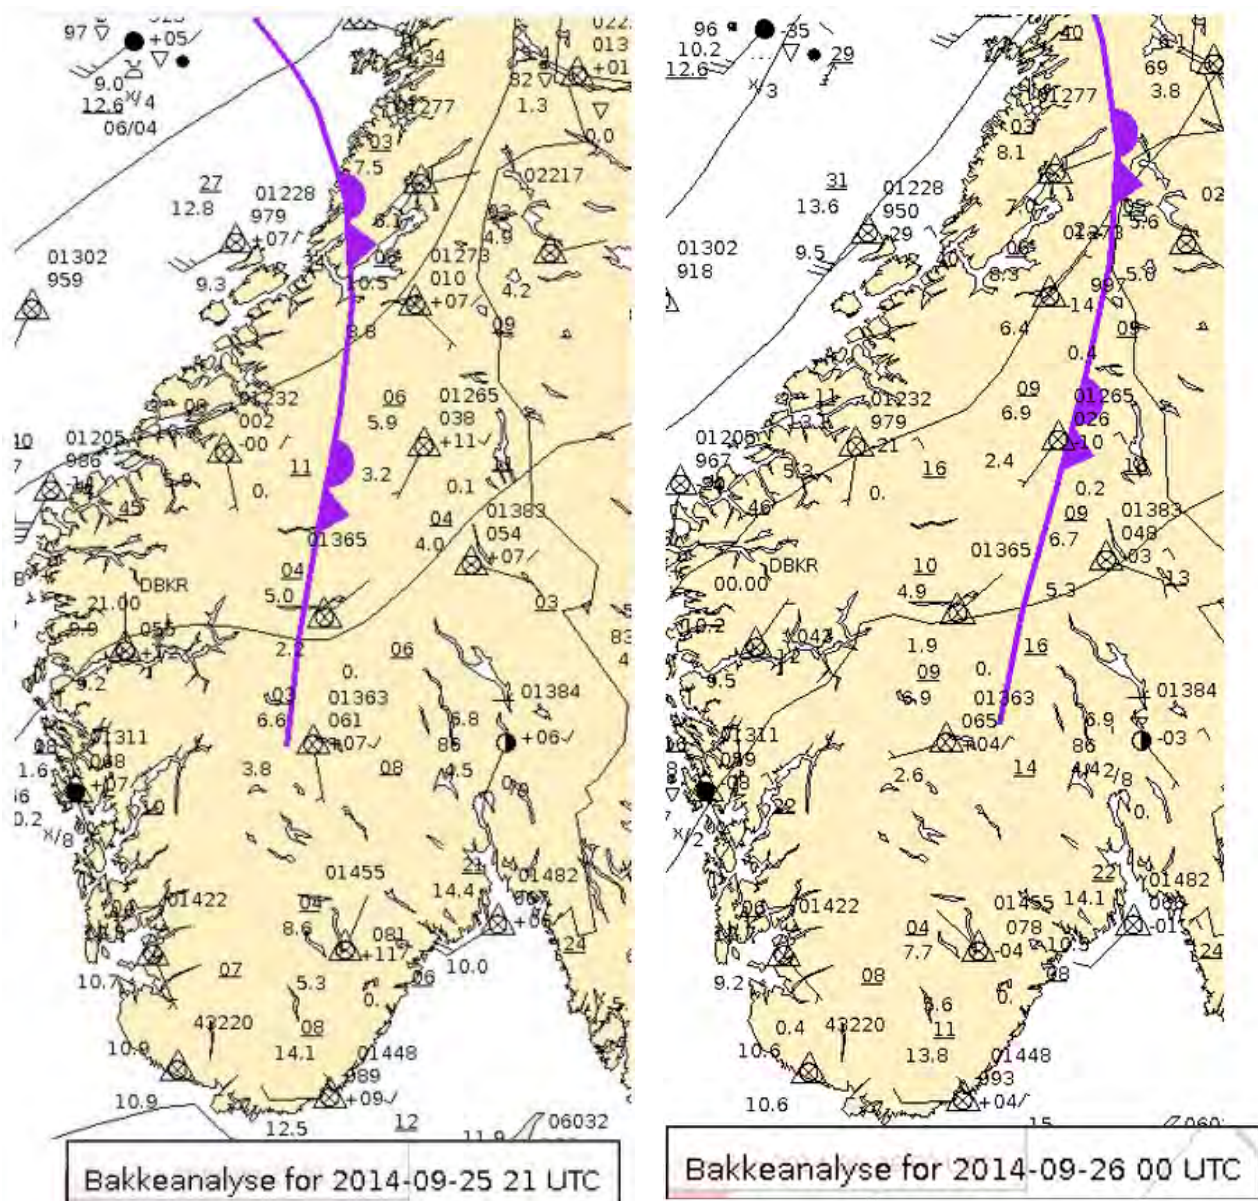
Figure 6: Surface analyses at 21 and 00 UTC. Source: The Norwegian Meteorological Institute

1.7.3.2 The fronts and their movements are visible on surface analyses and significant weather charts. It emerges that moderate icing was forecast from FL060 and up to more than FL150 over Trøndelag, and that the area with icing spread southward towards the lake Mjøsa over the course of the evening.
