REPORT

SL 2015/11

REPORT ON INCIDENT APPROX. 120 NM SOUTHWEST OF SOLA, NORWAY 4 OCTOBER 2013, WITH SIKORSKY S-92A, LN-ONW, OPERATED BY BRISTOW NORWAY AS

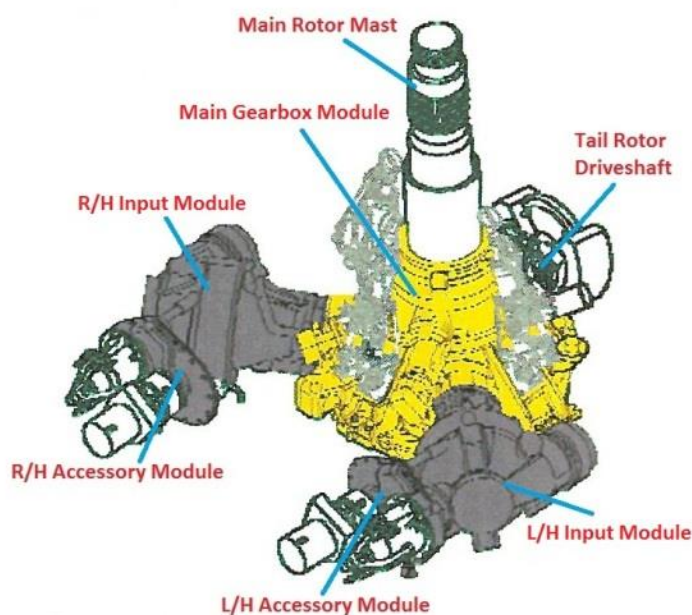
The main gear box (MGB) consists of five modules. These are: right and left Input Module, right and left Accessory Module, as well as the Main Gearbox Module (see Figure 3). The main task for the main gearbox is to reduce the engine speed of 21,945 rpm to the main rotor speed of 257.8 rpm. In addition, the main gearbox drives the tail rotor, two oil pumps for internal lubrication, two generators, and two hydraulic pumps. The main gearbox also constitute the attachment for the main rotor, consequently all loads from the main rotor are transferred through the gear box to the fuselage.

Figure 3: Overview of the main components on MGB. Source: FlightSafety
