REPORT

SL 2016/01

REPORT ON THE SERIOUS AIRCRAFT INCIDENT 12 AUGUST 2014 AT RØRVIK AIRPORT, NORWAY, WITH AIRBUS HELICOPTERS EC 130 B4, LN-ORR, OPERATED BY HELICOPTER UMLEIE AS

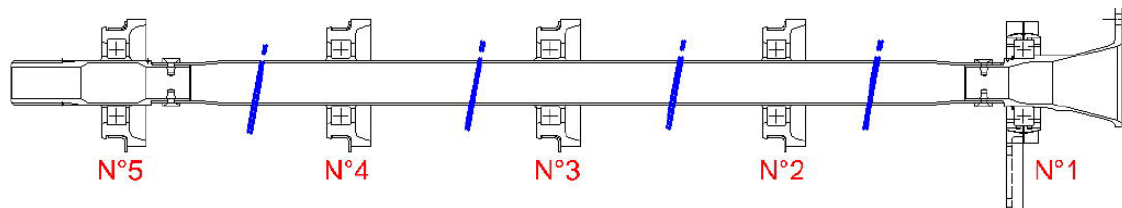
Figure 2: Illustration of the intermediate section of the tail rotor shaft. Source: Airbus Helicopters

A shaft consisting of three sections drives the fenestron (tail rotor). The shaft fracture occurred in the intermediate section. This section is supported by five bearings (see Figure 2). The aft part of the intermediate shaft section consists of a steel adapter attached with six rivets. This adapter is the part of the shaft on which bearing no. 1 is installed. From bearing no. 1, a short shaft (not illustrated) runs back to the tail rotor's gearbox. This short shaft is connected to the intermediate shaft section's adapter with a flexible coupling that absorbs movements between the tail boom and tail structure with the tail rotor. The tail boom is made of aluminium, whereas the tail structure is made of composite material.

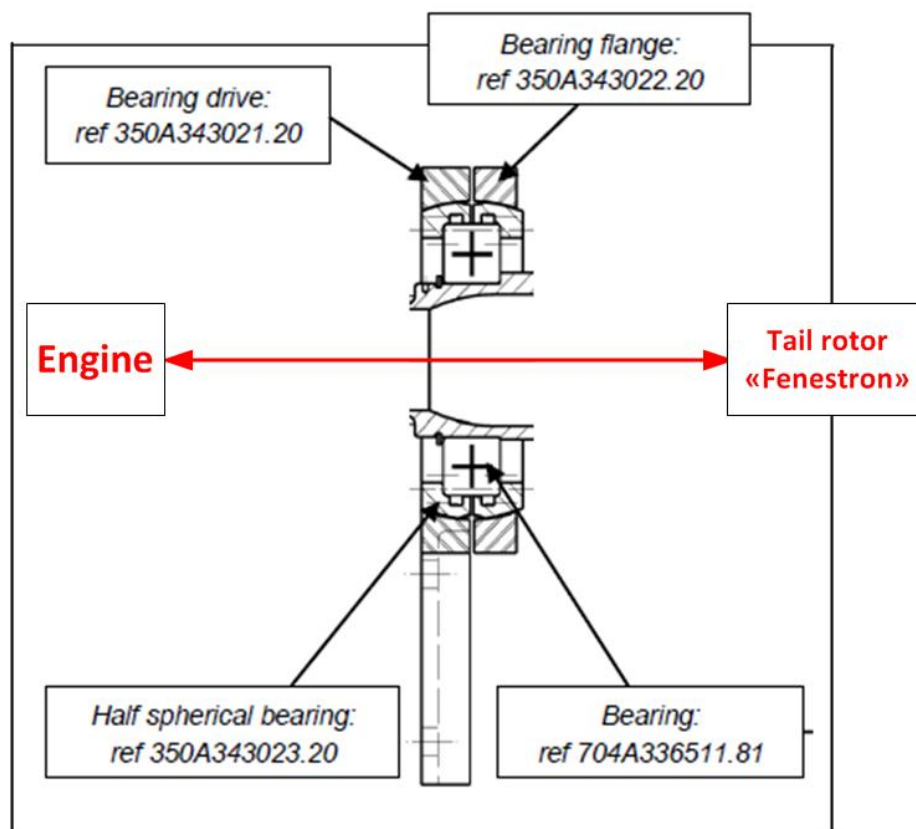
Bearing no. 1 is the aft bearing on the tail rotor shaft. The bearing is held in place by clamping the outer bearing race, which consists of two "Half Spherical Bearings", between "Bearing drive" and "Bearing flange" (see Figure 3). The purpose of this installation is to allow for adjustments of the bearing's position to prevent bending of the tail rotor shaft.

Figure 3: Bearing no. 1 layout. Source: Airbus Helicopters/processed by AIBN

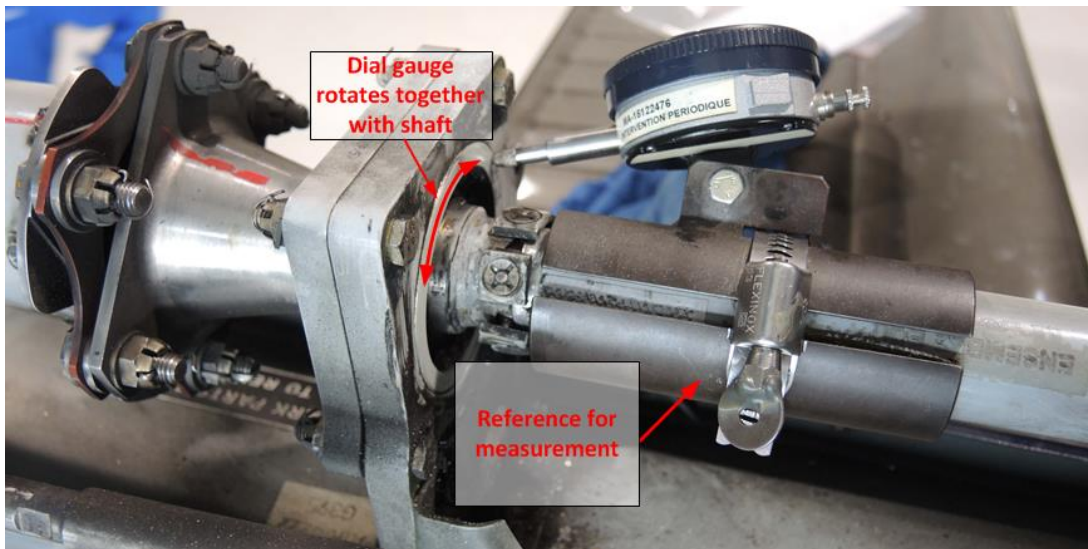
AIBN asked the technician who installed the bearing to demonstrate the measurement method for verifying the bearing's position in "Bearing drive/Bearing flange". The measurement demonstrated to AIBN did not comply with the method described in the helicopter's AMM. The tail boom was used as a reference for the measurement in the demonstration (see Figure 11).

In order to achieve a result that expresses the bearing's position in relation to the tail rotor shaft, the tail rotor shaft must form the basis for the measurement, as shown in Figure 12. This is also illustrated in the AMM (see Figure 13).

Figure 12: Correct use of measuring equipment. The tail rotor shaft is the reference for the measurement. Photo: AIBN

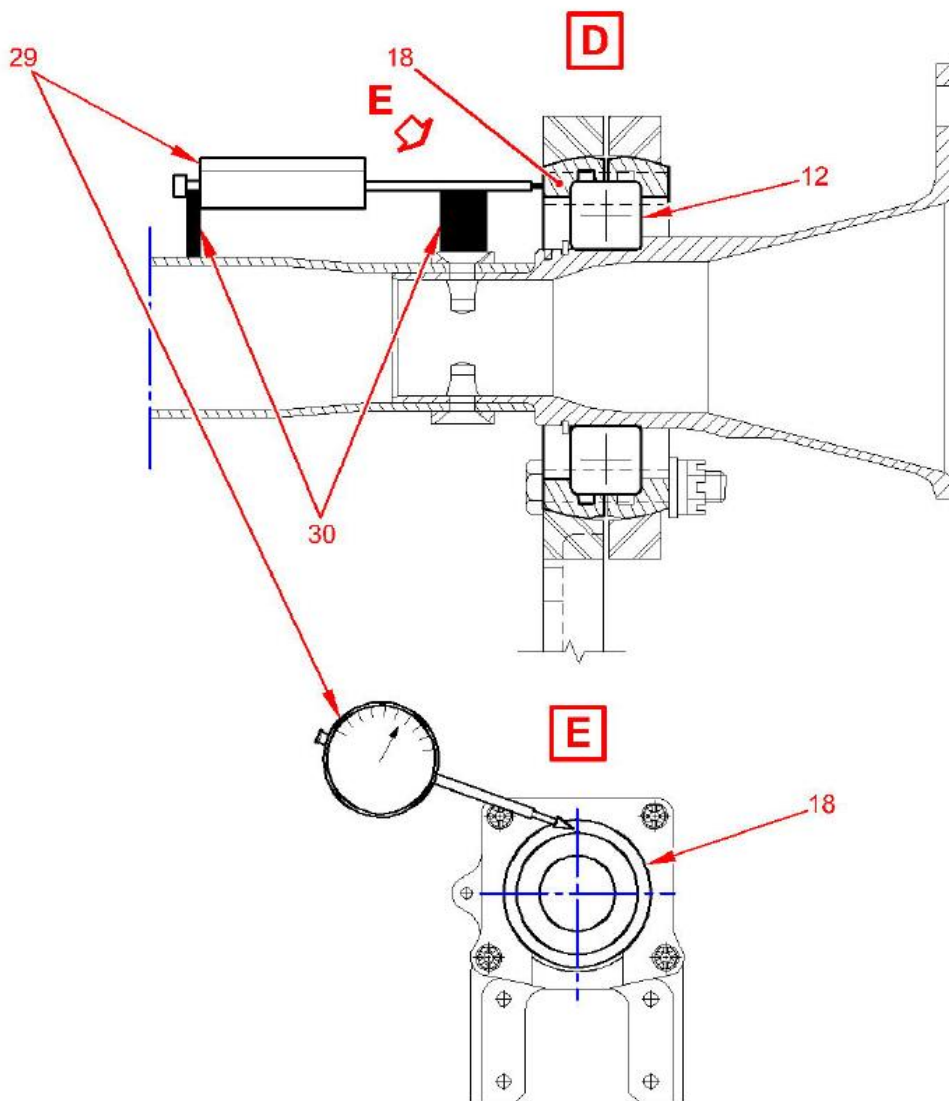
Figure 13: Measurement method i.a.w. AMM. Source: Airbus Helicopters

An adapter is attached to the tail rotor shaft, and the dial gauge is installed on this adapter. This causes the dial gauge to rotate together with the shaft, and a potentially skewed installation of the bearing can be measured.
