REPORT

SL 2018/03

REPORT ON AVIATION ACCIDENT AT HATTEN IN LESJA MUNICIPALITY, OPPLAND COUNTY, 24 SEPTEMBER 2015 WITH ALEXANDER SCHLEICHER GMBH & CO SEGELFLUGZEUGBAU ASW 24, LN-GNA

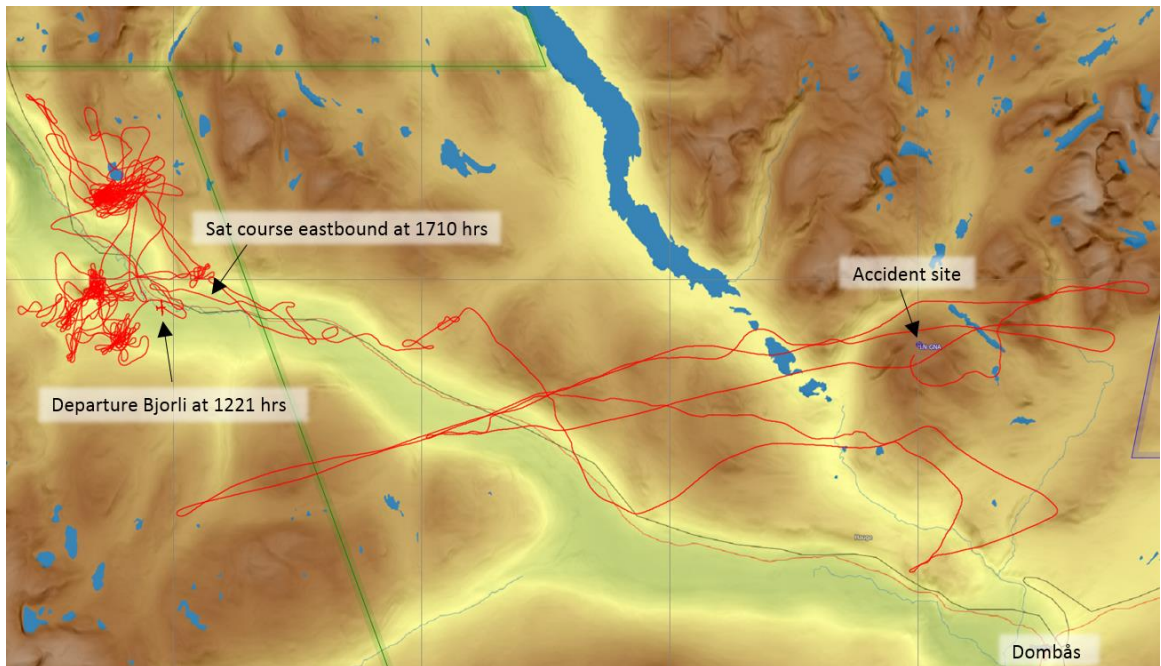
- 1.1.1.3 The first five hours of the flight took place in the area around Bjorli (see Figure 1). The flight had then mainly stayed at altitudes below 1 800 metres. The exception was a brief period after a few hours of flying where the sailplane reached an altitude of approx. 2 100 metres. The pilot then entered an area east of Bjorli with good lift. The character of the flight then changed from containing a number of course changes to a flight with long straight legs and relatively little manoeuvring.

Figure 1: Tracker from FLARM. Source: FLARM/LN-GNA

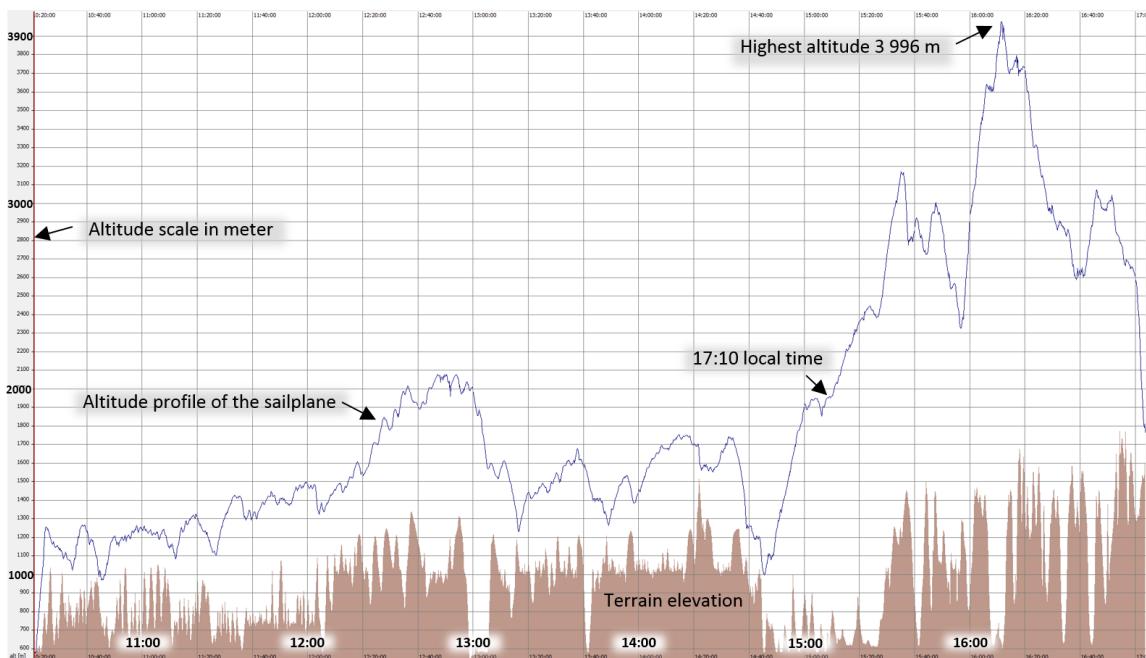
1.1.1.4 The altitude profile shows that the sailplane was flown at considerably higher altitudes over the last hour and a half than during the first part of the flight. The highest altitude of 3 996 m (13 110 ft) occurred at 18:11:47 hours (see Figure 2).

Figure 2: Altitude profile LN-GNA. Time in UTC. For local time, add 2 hours. Source: FLARM/LN-GNA

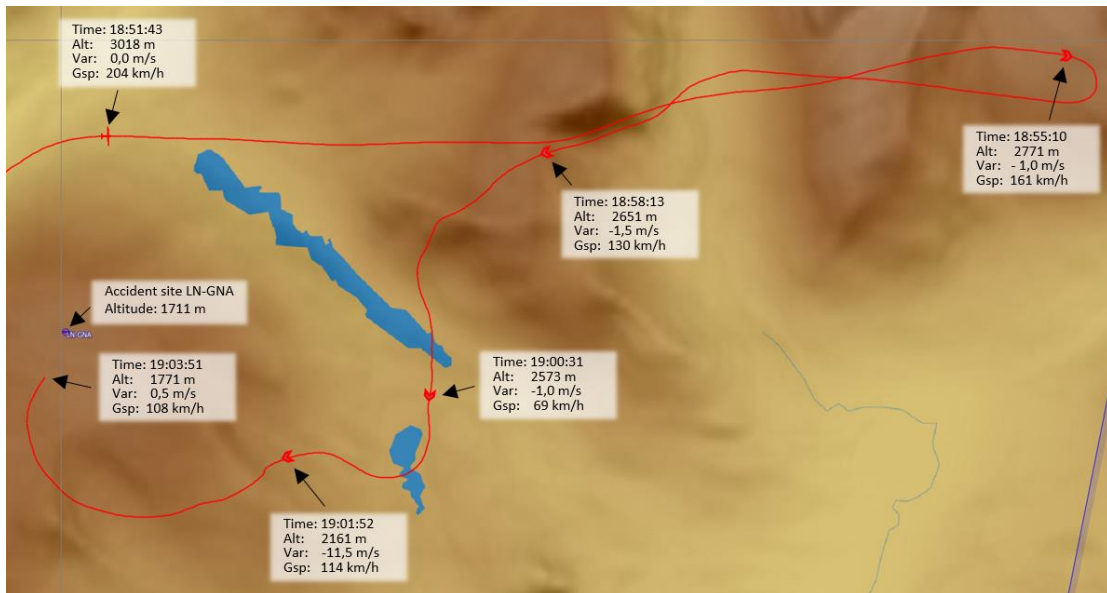
1.1.1.5 At 1855 hours, approx. nine minutes before the accident occurred, the pilot turned the sailplane westward (see Figure 3). Three minutes after the course change toward the west, the pilot began a gradual course change to the south toward Dombås.

Figure 3: The last part of the flight with depiction of the crash site. Source: FLARM/LN-GNA

- 1.15.3.5 The last FLARM (GPS) plot was registered at 19:03:51 hours (see Figure 3). AIBN presumes that the power supply came loose when the pilot released the canopy before the bail out and that the last plot could therefore be the precise point where the pilot started the sequence of bailing out from the sailplane. The pilot was found 650 m from the last registered plot. The speed at this plot was 108 km/h (30 m/s). Based on this, as well as NLF's projected bail out altitude (see Chapter 1.15.5), AIBN has estimated that up to 18–19 seconds elapsed from the bail out was initiated by triggering the canopy until the pilot was out of the aircraft.

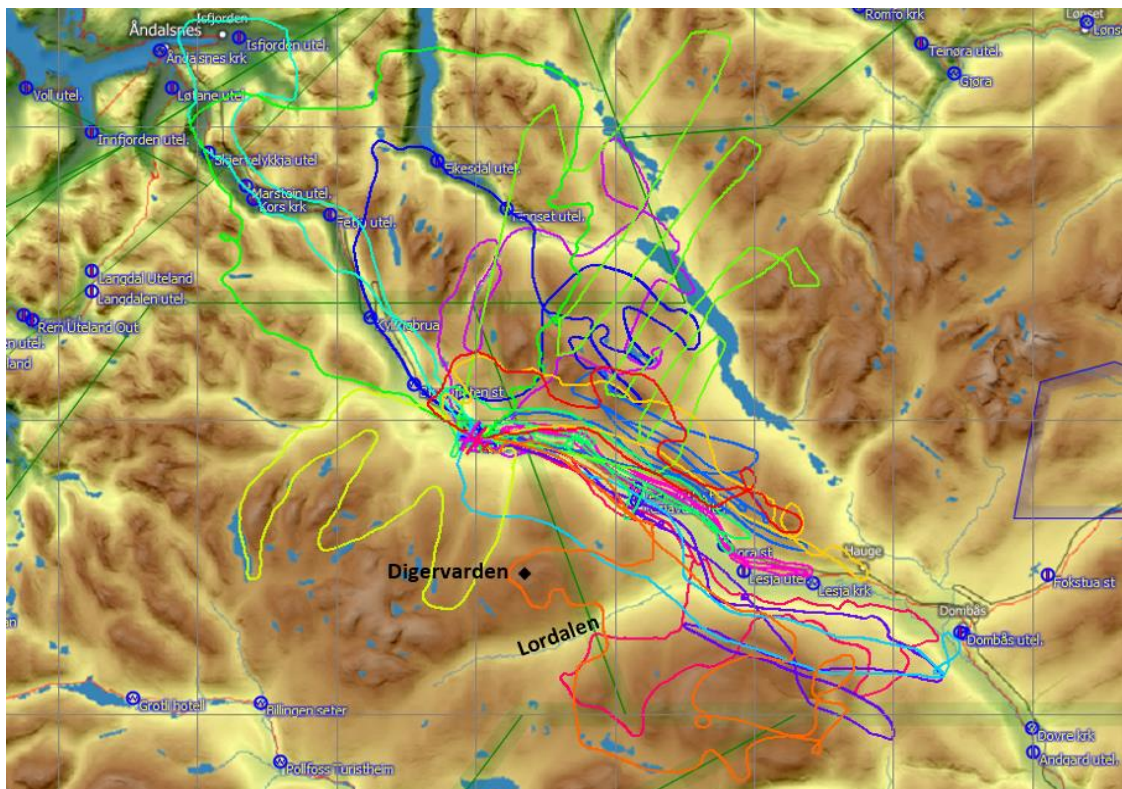
1.15.1.3 The missing sailplane's last known position was stated to have been approx. 15 km southeast of Bjorli, in the area around Digervarden and Lordalen (see Figure 13). This information was based on an observation made by another glider pilot at approx. 1835 hours, who was then in the same area as LN-GNA. Based on the last known position, the early part of the search phase therefore focused on this area.

1.15.2.4 The sailplane operations leader from NTNUF coordinated the civilian air search along with the police on-scene commander and JRCC S-N. The majority of air searches were registered electronically. One example of map plots from the "light aircraft search" can be found in Figure 13, which shows the search carried out the day after the sailplane was reported missing. The different aircraft movements are shown in different colours. Equivalent plots were also created for flights carried out by the Air Force helicopters and Police helicopter.

Figure 13: Search with light aircraft on Friday, 25 September. Source: NTNU Flying Club

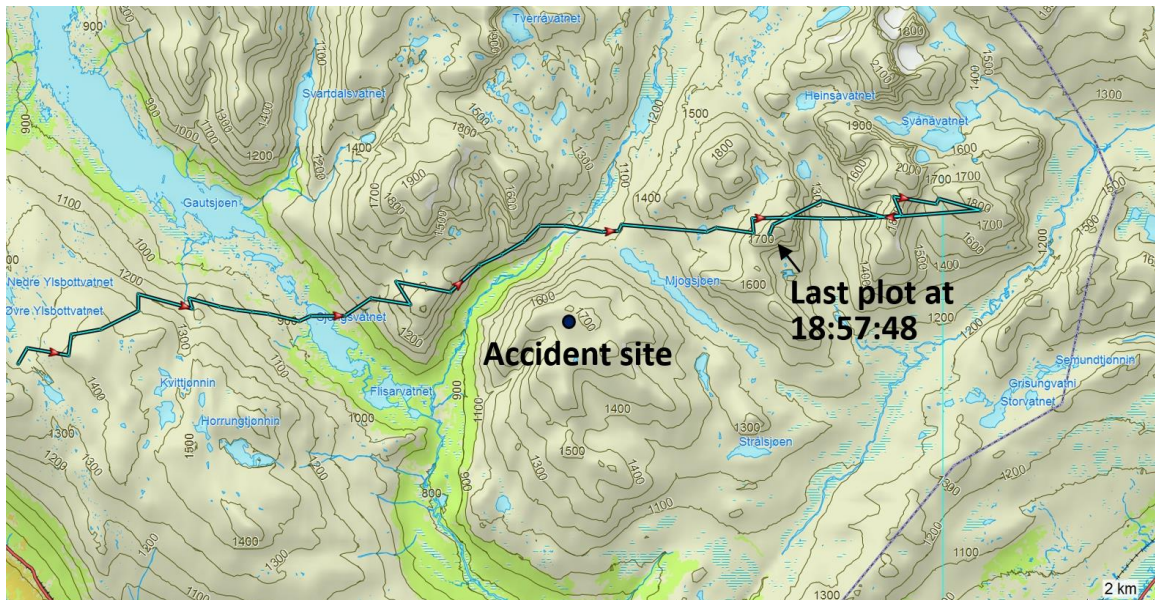
- 1.15.2.6 The radar plot showed an object moving toward the east, and later turns to the west (see Figure 14). The object disappeared from the radar approx. five minutes before the distress call was sent on the radio frequency. AIBN presumes that the sailplane disappeared under the radar's coverage area as it was losing altitude.

- 1.15.2.7 On the morning of Friday, 25 September, this information was forwarded to RSC. For some unknown reason, RSC perceived that these plots should not be used to prioritise search areas. AIBN has attempted to find out why this occurred, but has been unsuccessful in finding an explanation. What we can see in hindsight is that all light aircraft activity was mainly organised from Bjorli, and the aircraft were kept away from the areas where the helicopters would be searching (ref. Figure 13). In the following days, JRCC S-N prioritised using the police helicopter, air ambulance, Sea King and Bell 412 from the Royal Norwegian Air Force in areas around the radar plot.

Figure 14: Radar plot from Friday, 25 September, from the Royal Norwegian Air Force. The plot is reproduced with permission from the Royal Norwegian Air Force. Text in black added by AIBN. Source: Royal Norwegian Air Force's Control and Reporting Centre Mågerø

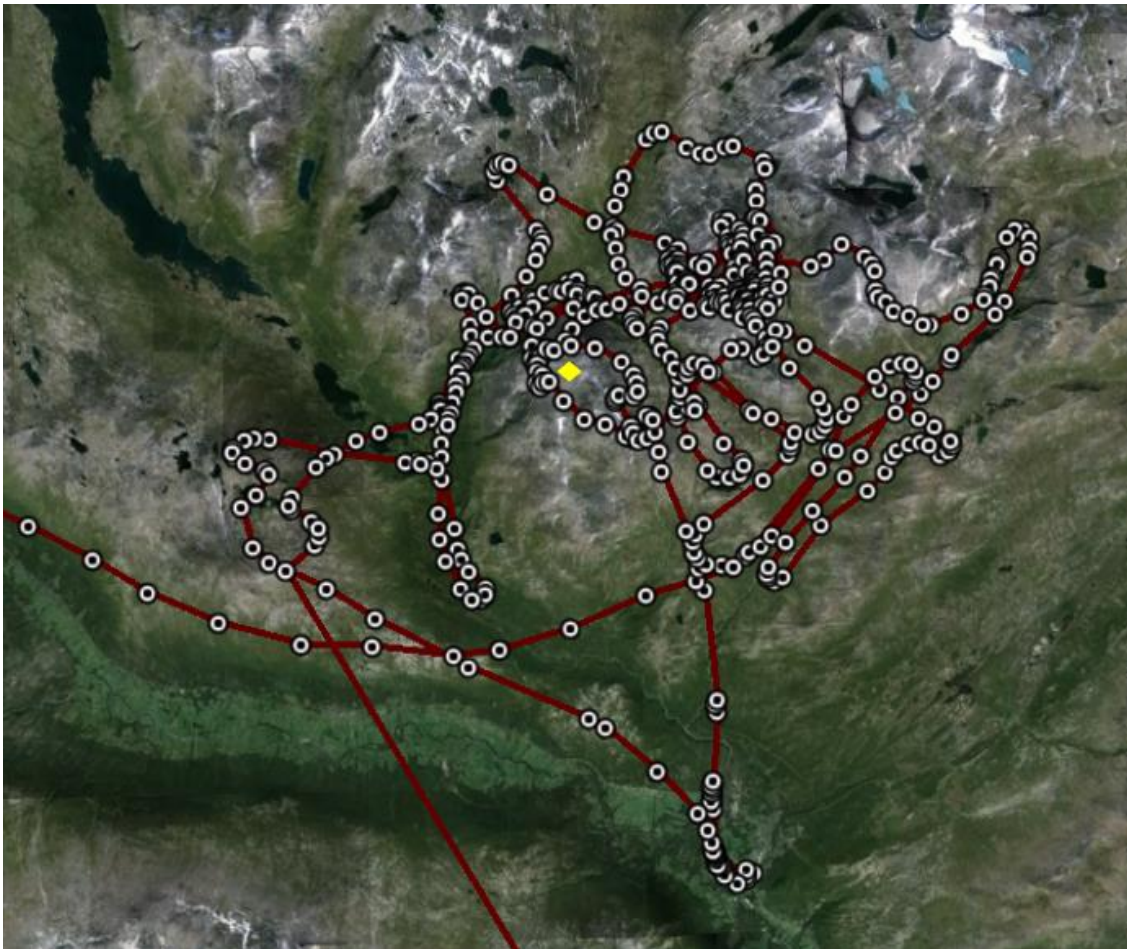
- 1.15.2.8 Multiple daily flights were flown in the area. Over the first four days, the cloud layer covered the highest peaks, including the mountain area where the sailplane was later discovered. The plot in Figure 15 shows the police helicopter's search, which was carried out on Friday, 25 September, the day after the sailplane was reported missing. It shows that it could not fly over the highest mountain peaks. In hindsight, one can see from the map plot that it passed the crash site on a few occasions by only a few hundred metres without spotting the sailplane.

Figure 15: Map plot from the police helicopter's search. The yellow mark shows the crash site.
Source: the Police
