APPENDIX D: METALLURGICAL EXAMINATION

LN-OJF EC225 Super Puma Accident Summary of the Metallurgical Examination of the Epicyclic Gearbox Components at QinetiQ

QINETIQ/18/00263/1.0

26 January 2018

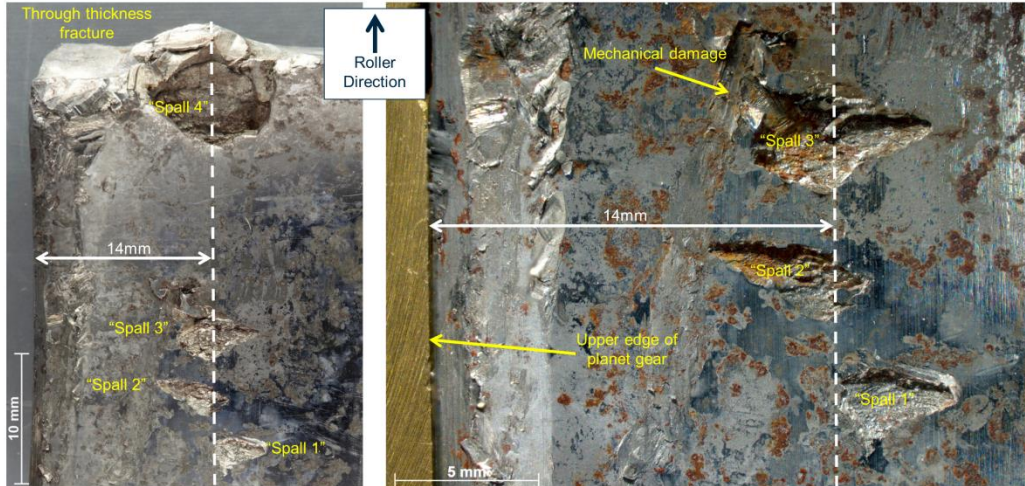
Fractured Second Stage Planet Gear Sample FE13961 Race Surface – After Cleaning

Note: The line placed at 14mm from the upper edge of the planet gear refers to the approximate location of maximum Hertzian stress for a FAG planet gear, as informed by Airbus Helicopters and previously noted in the AAIB report on the G-REDL accident.

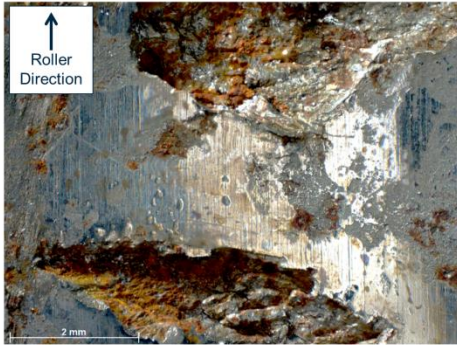
Fractured Second Stage Planet Gear Sample FE13961 Race Surface – Between Spall 2 and Spall 3

small indentations consistent with particle/debris imprints observed between spall 2 and spall 3.

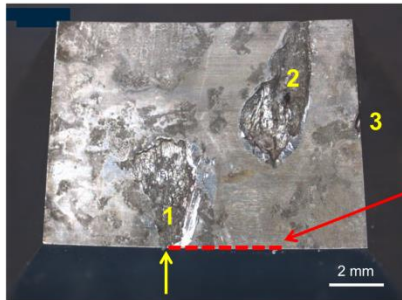
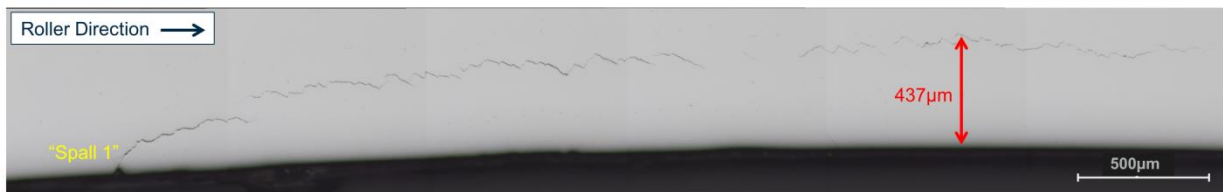
Fractured 2nd Stage Planet Gear Sample FE14226 - Longitudinal Microsection Spall 1

Extent of crack from spall 1 on this microsection

Main crack path length = 5.18mm
Main crack length along race surface = 4.19mm

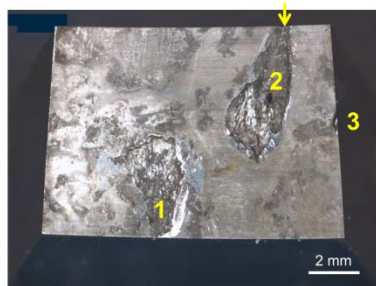
Fractured 2nd Stage Planet Gear Sample FE14226 - Longitudinal Microsection Spall 2

Main crack path length = 2.19mm
Main crack length along race surface = 1.80mm

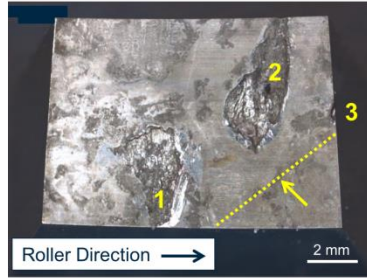
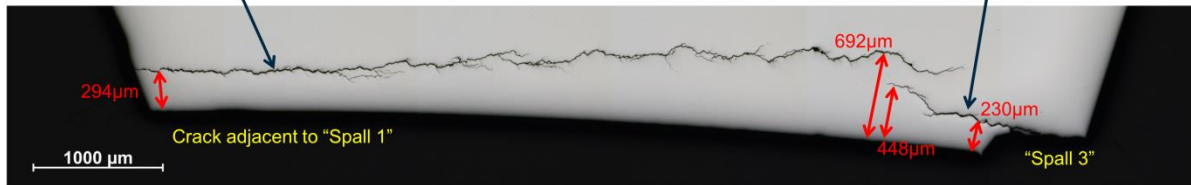
Fractured 2nd Stage Planet Gear Sample FE14226 - Angled Microsection Between Spall 1 and Spall 3

Crack propagation from Spall 1
Main crack path length = 7.15mm
Main crack length along race surface = 6.22mm

Crack propagation from Spall 2 to Spall 3 or a branched crack from Spall 1?
Main crack path length = 1.18mm
Main crack length along race surface = 0.96mm

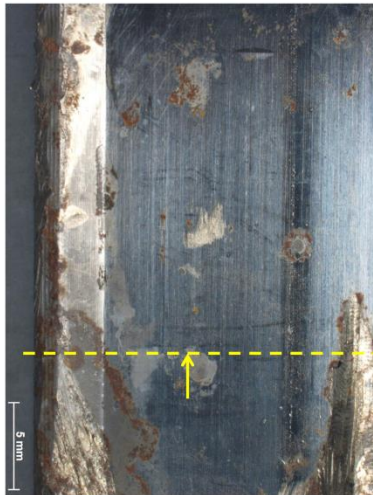
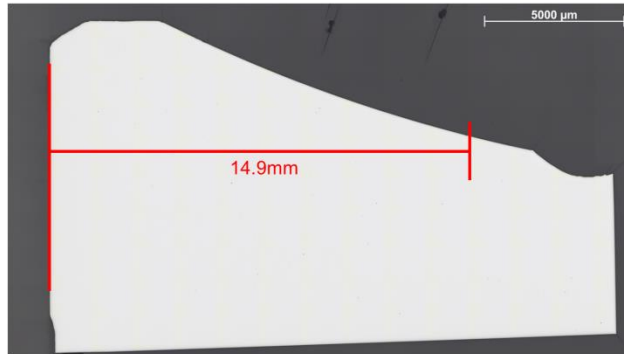
Fractured 2nd Stage Planet Gear Sample FE13962 – Race Surface Micro-Pitting; Transverse Microsection

Sequential grinding & polishing of transverse microsection to reveal micro-pitting and cracking

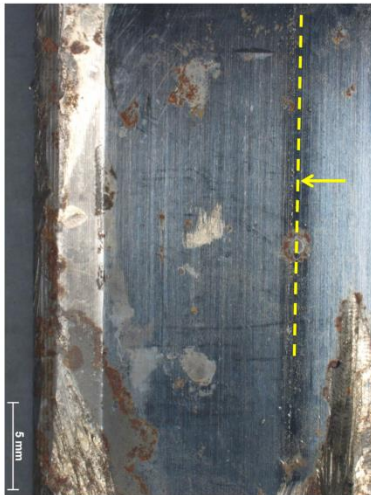
Fractured 2nd Stage Planet Gear Sample FE13962 – Race Surface Micro-Pitting; Circumferential Microsection

Sequential grinding & polishing of circumferential microsection to reveal micro-pitting and cracking

Microsections examined at 15.8mm, 15.1mm and 14.9mm from upper surface of gear

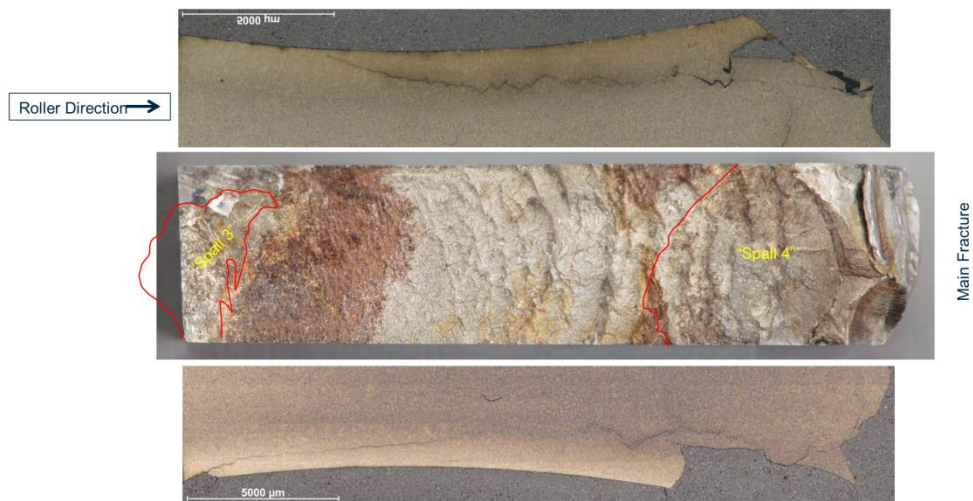
Fractured 2nd Stage Planet Gear Sample FE13961 – Fractography Spall 3 to Main Fracture

Micrographs A to C show a decreasing amount of intergranular fracture as the subsurface crack propagates deeper into the material.

Insufficient evidence to determine the crack growth rate from striation spacing measurements.

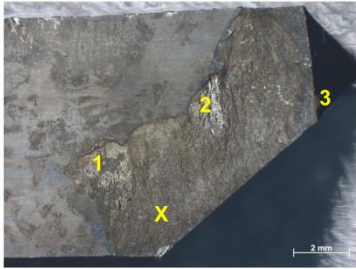
Fractured 2nd Stage Planet Gear Sample FE14226 – SEM Fractography

Subsurface crack has a predominantly intergranular fracture surface.

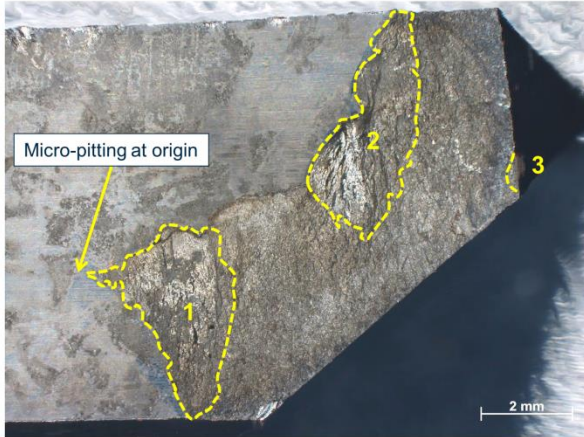
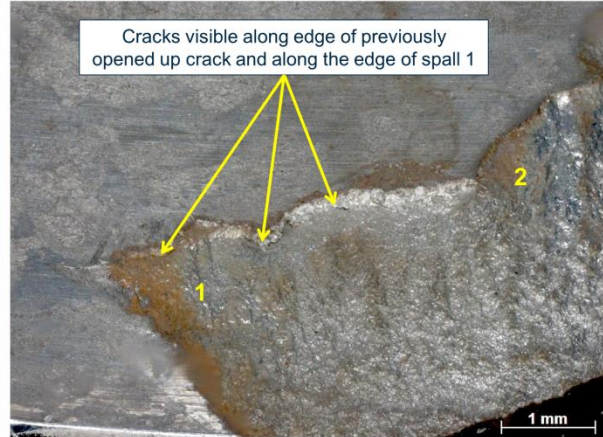
Fractured 2nd Stage Planet Gear – Sample FE14226

Objective: To determine the extent (length and depth) of subsurface cracking between spall 1 and spall 2, plus examine the micro-pitting at the origin of spall 1.

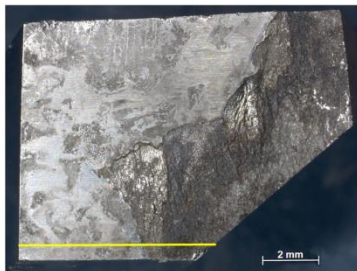
Fractured 2nd Stage Planet Gear – Sample FE14226 Sequential Polishing

Sequential polishing to determine the extent of subsurface cracking and location of micro-pitting near the origin of spall 1.

Yellow line indicates the location of the slice shown below. A total of 19 slices were examined.

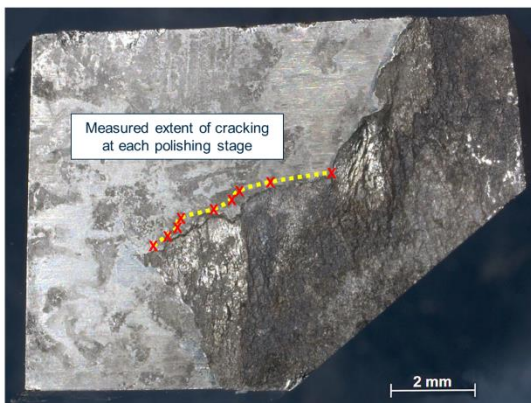
Fractured 2nd Stage Planet Gear – Sample FE14226

Approximate location of subsurface crack

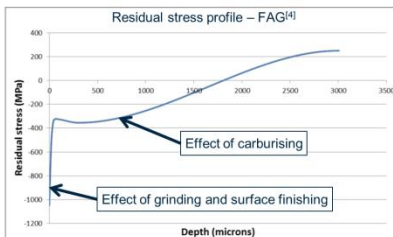
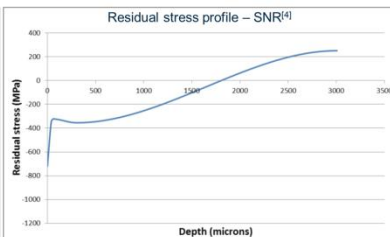
Residual stress profiles measured on new FAG and SNR outer race surfaces shows a greater compressive residual stress at the surface (<50µm) of the FAG gear compared to the SNR.

These results are consistent with the differences in final finishing operations employed by the two suppliers.

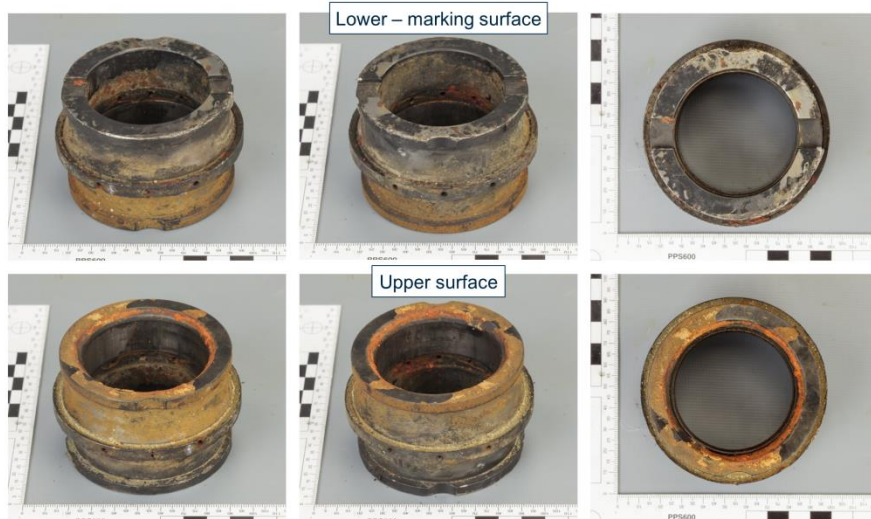
Second Stage Planet Gear Inner Race 10-1292 As-Received

Circumferential "wear" bands observed on the inner-race surfaces

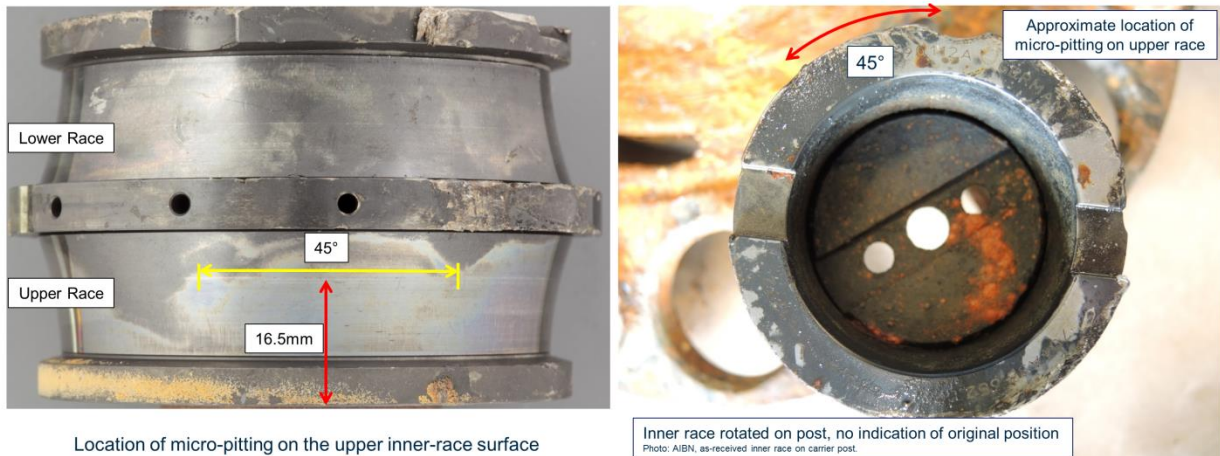
Second Stage Planet Gear Inner Race 10-1292 After Cleaning

SEM examination of the micro-pitting on the upper inner-race surface shows features similar to the micro-pitting observed on the outer race.

Location of micro-pitting on the upper inner-race surface

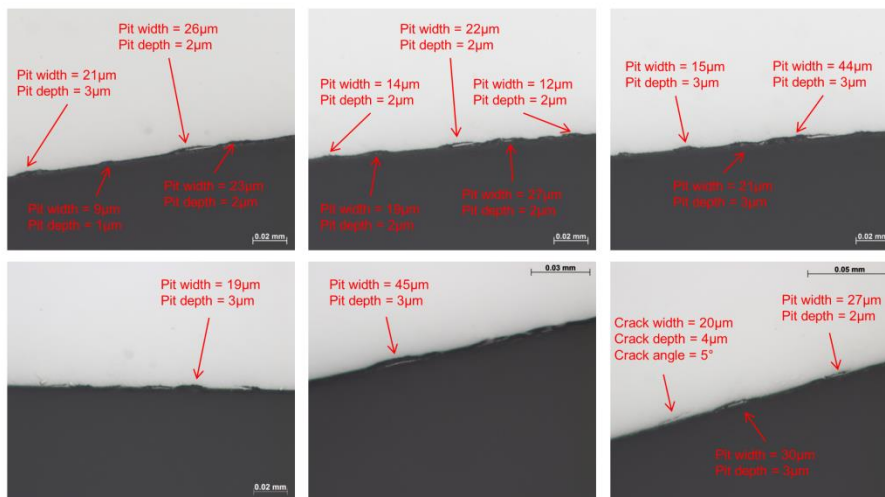
Second Stage Planet Gear Inner Race 10-1292 Upper Race Circumferential Microsection

Micro-pitting observed on the upper race surface, approximately 16.5mm from upper edge of gear. No indication of micro-pitting on the lower race surface after several iterations of polishing.

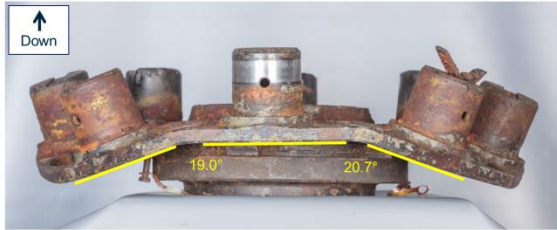
Second Stage Planet Gear Carrier As-Received – Deformation and Post Damage

Symmetrical deformation of carrier around post of fractured gear

Mechanical damage consistent with gear teeth impressions on three posts

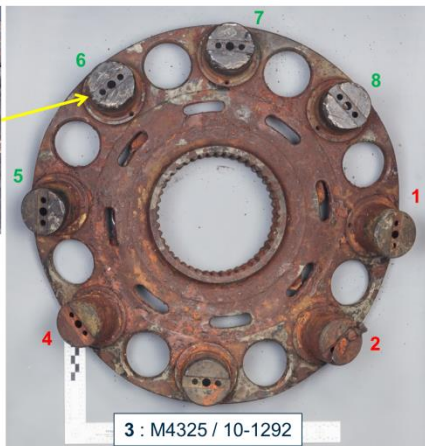
Hand engraved post numbers identifiable on some posts
