**PRELIMINARY REPORT ON THE AIR ACCIDENT NEAR TURØY, ØYGARDEN  
MUNICIPALITY, HORDALAND COUNTY, NORWAY 29 APRIL 2016 WITH AIRBUS  
HELICOPTERS EC 225 LP, LN-OJF, OPERATED BY CHC HELIKOPTER SERVICE AS**

28 April 2017

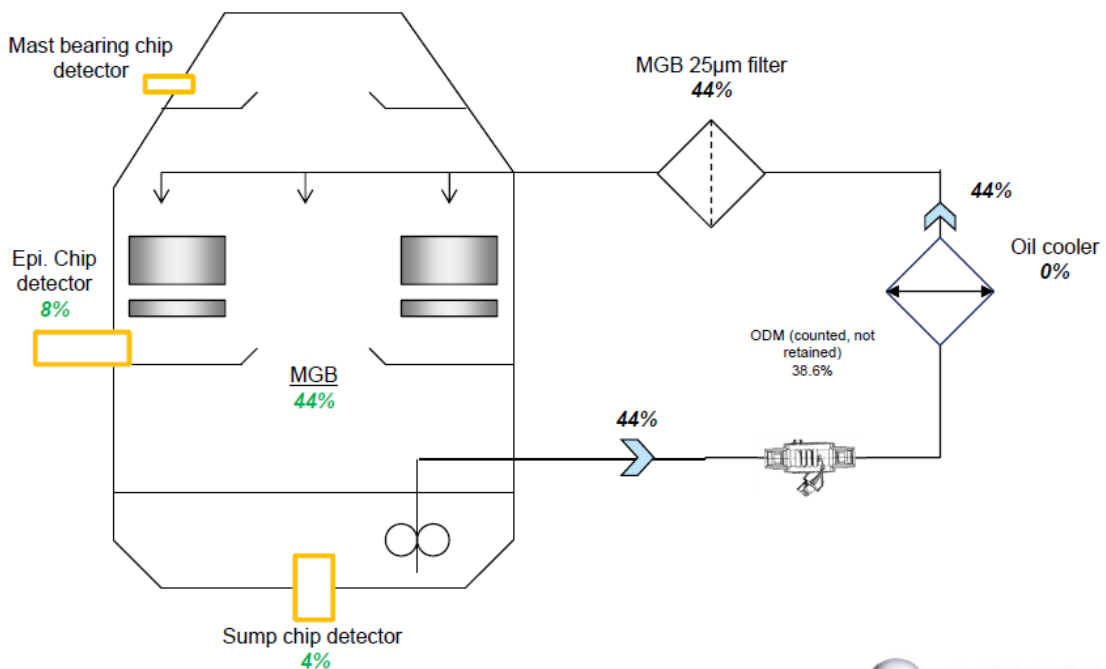
Airbus Helicopters launched a MGB spalling test program following the G-REDL accident (see chapter 1.18.3). The single test, presented to the AIBN, has shown that the total detection rate (% of all free magnetic particles expected to be collected on the plugs) is 12 %, while 44 % of the particles were said to end up in the oil filter. However, due to the recent finding of several particles recovered from inside the oil cooler of LN-OJF (see chapter 1.16.8.3), Figure 12 is no longer representative. 44 % of the particles do not reach the MGB oil filter like the figure shows, but particles are actually also collected by the oil cooler.

Figure 12: The test set-up and the detection rate of chip detectors (%: Particle quantity) presented following the G-REDL MGB spalling test program. Source: Airbus Helicopters

- 2.4.5 At the time of the LN-OJF accident, the criteria for MGB removal was 50 mm<sup>2</sup> of metal particles or a 0.4 mm particle thickness or a 2 mm length particle or a 2 mm<sup>2</sup> surface particle of dedicated material. The MGB spalling test, which Airbus Helicopter launched after the G-REDL accident, has shown that the total detection rate for the magnetic plugs is 12 % (see Figure 12). In other words; in relation to the total area of maximum 28 mm<sup>2</sup> released from spall 1-3, approximately 3.3 mm<sup>2</sup> would be the potential detectable amount, which is far below the limit of 50 mm<sup>2</sup> for MGB removal at the time. This is on the condition that particles were smaller than a 0.4 mm thickness or a 2 mm length or a 2 mm<sup>2</sup> surface. The process of identifying particles also relies on human performance and interpretation, which turned out to be challenging in connection with the G-REDL accident (see section 1.18.3.7).

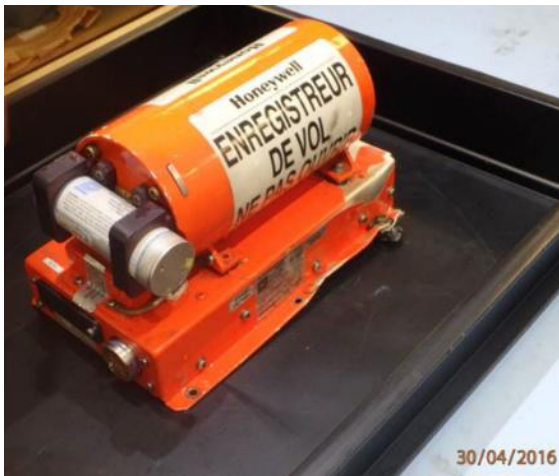
The CVFDR was removed from the tail boom that had been picked up from the seabed in the late evening of the 29 April and transported in fresh water by the AIBN to the Air Accidents Investigation Branch (AAIB) at Farnborough UK. Initially, it was not possible to download data because the wiring between the base unit and the CSMU was damaged. Following repair a successful download of all the data was performed.

Figure 14: CVFDR from LN-OJF as received at the AAIB. Photo: AIBN

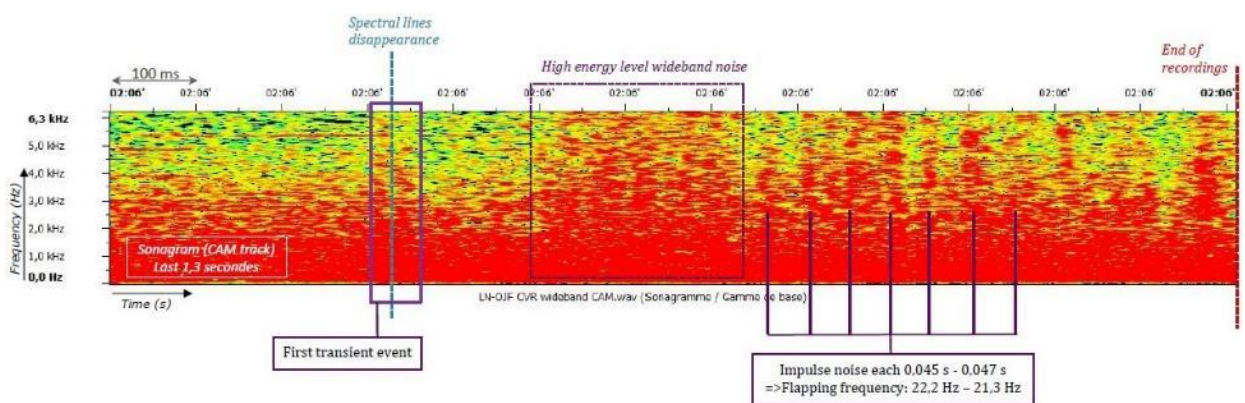
Following the readout at the AAIB, four audio files was transferred to the BEA in France for further analysis. Spectrum analysis from the CAM recording is shown in Figure 16. The CAM spectrogram shows that the CVR recording ended 1 second after the first transient event.

Figure 16: Spectrum analysis from the CAM audio file showing 1.3 seconds believed to be the beginning of the MGB break-up. Source: BEA

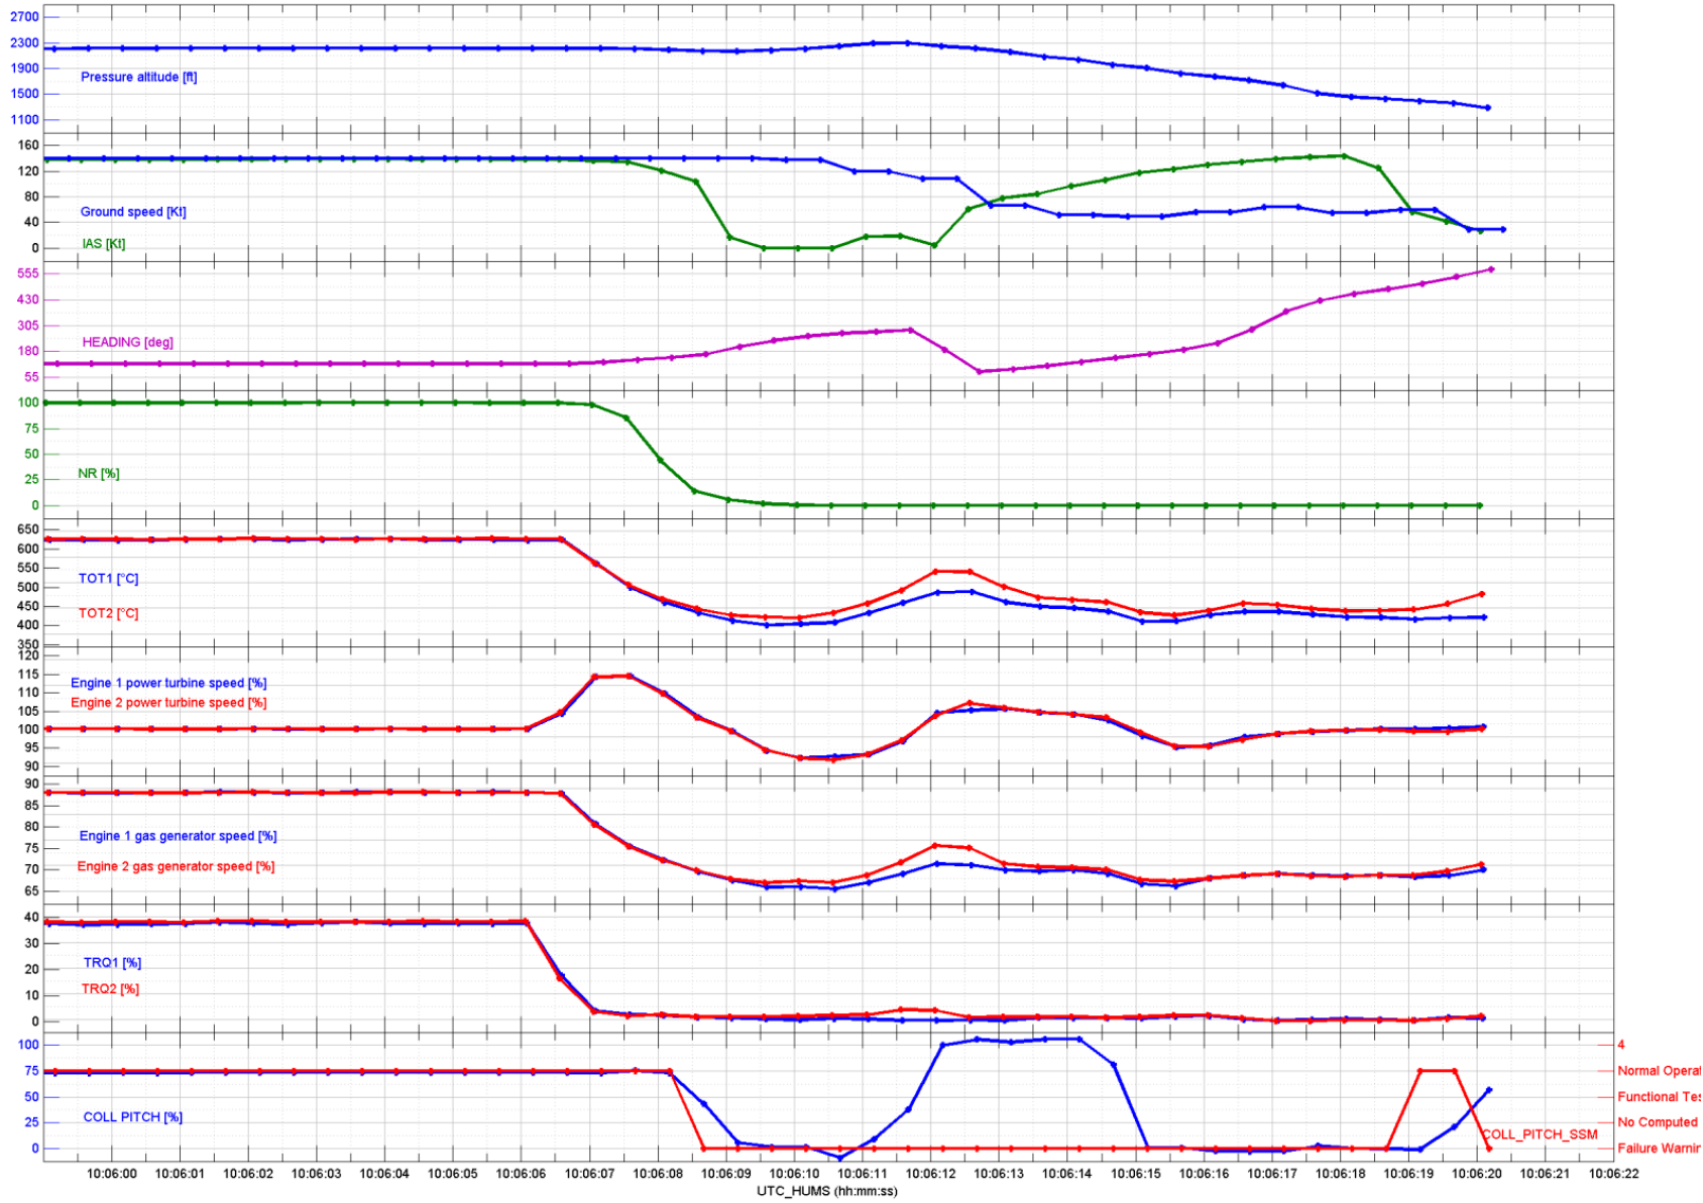
Time (second)	Event
T0	Torque value deviates from cruise value
T0	Eng 1 and 2 NF starts to increase
T0+0,25	MGB starts to loose oil pressure (0 at T0+2s)
T0+0,25	MGB oil press warning (duration 1.5 s)
T0+0,25	Discrete word «Aircond» change state
T0+1	NR starts to drop. (0 at T0+3s)
T0+1	Signal variations begin on lat/long/vertical accelerometers
T0+1	NF speeds top out at 115%
T0+1,5	Discrete word «FDRS fail» change state
T0+1,5	Discrete word «Door or CWL» change state
T0+1,5	Helicopter starts to roll
T0+2	First movement collective pitch lever
T0+2,25	MGB oil sump chip warning
T0+4	NR at 0%
T0+4	Helicopters starts to pitch down

Figure 18: Recorded parameters from the PCMCIA card. T0 is defined as 10:06:06. Note: Time is UTC minus approximately 11 min. Source: BEA

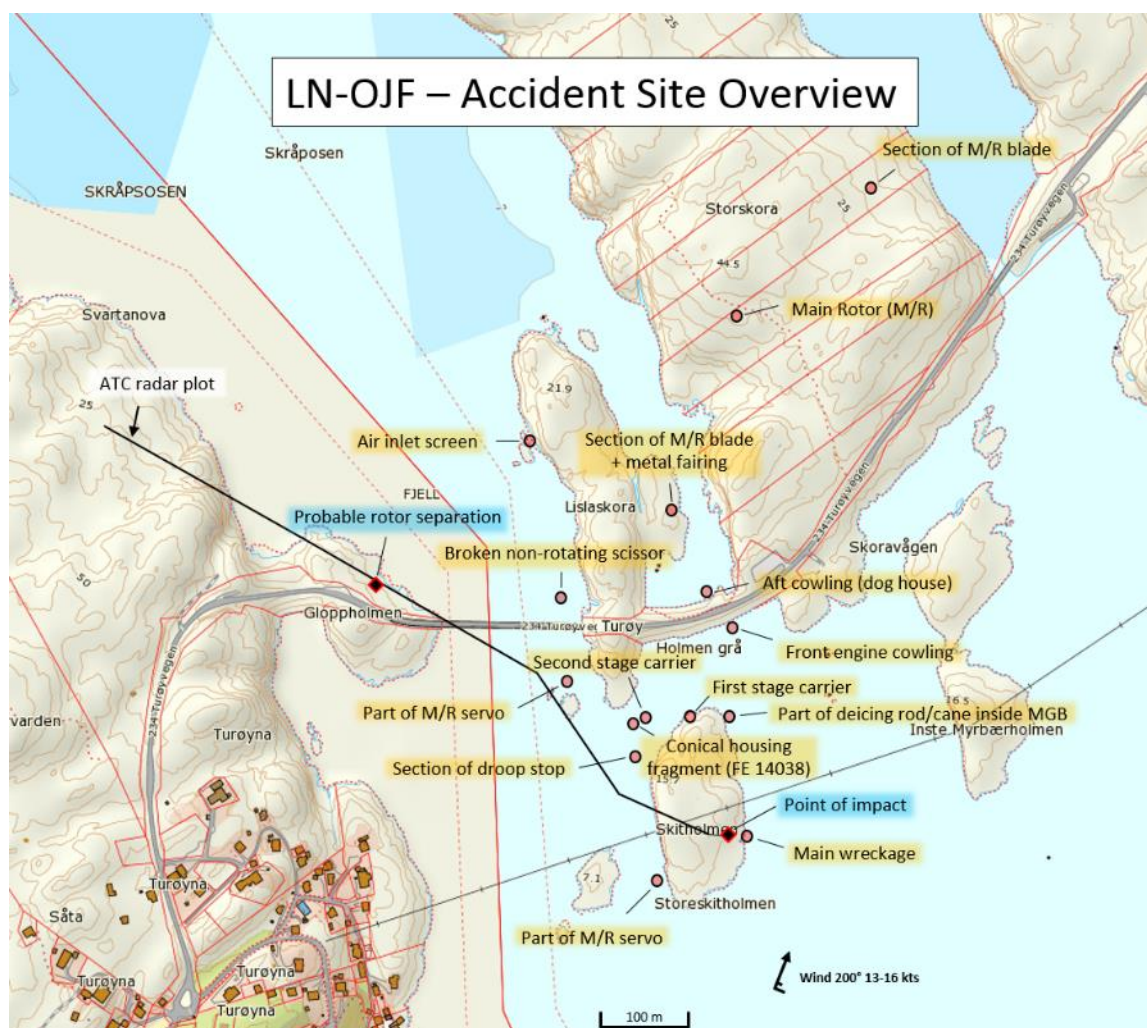
Figure 21: This map does not include all findings. However, it illustrates the location of larger parts or parts where the location can give useful information. The AIBN finds reasons to believe that the aft MGB cowling did fall down on the shown position, but was rather moved there by people at an early stage. Source: The Norwegian Mapping Authority and AIBN

As mentioned in chapter 1.12.1.1, a number of parts from the helicopter were found dispersed over an area of about 180,000 m<sup>2</sup>. However, most of the helicopter wreckage came to rest on the seabed just outside Storeskitholmen. The largest part found separate from the accident site itself, was the main rotor, which was at Storskora Island. The map in Figure 21 shows where a number of parts were discovered.

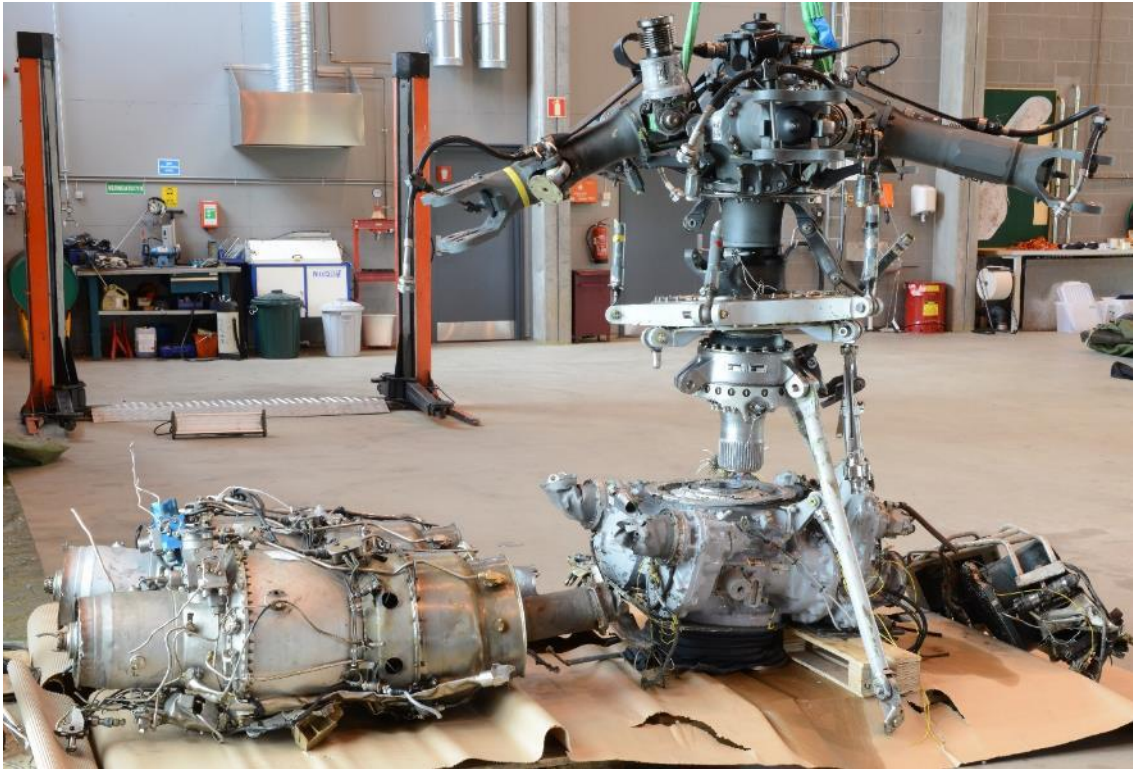
Figure 25: Engines, substantial parts of the MGB, two suspension bars and main rotor head assembled at the AIBN premises. Photo: AIBN

The main module was relatively complete and with little damage. Both ingoing high speed shafts from the engines had been twisted off near the main gearbox in a manner which indicates high torque, possibly combined with bending. The linking tubes (liaison tubes) were heavily bent upwards (see Figure 25). The oil sump in the main module contained large quantities of metal bits and shavings. All results from the examinations of the main module indicate that the helicopter hit the ground with great force and then ended up in the sea. Seawater had caused heavy corrosion, particularly to magnesium parts. Furthermore, the findings are consistent with fracture in the epicyclic reduction gear module and indicate that the main module continued to rotate after this.

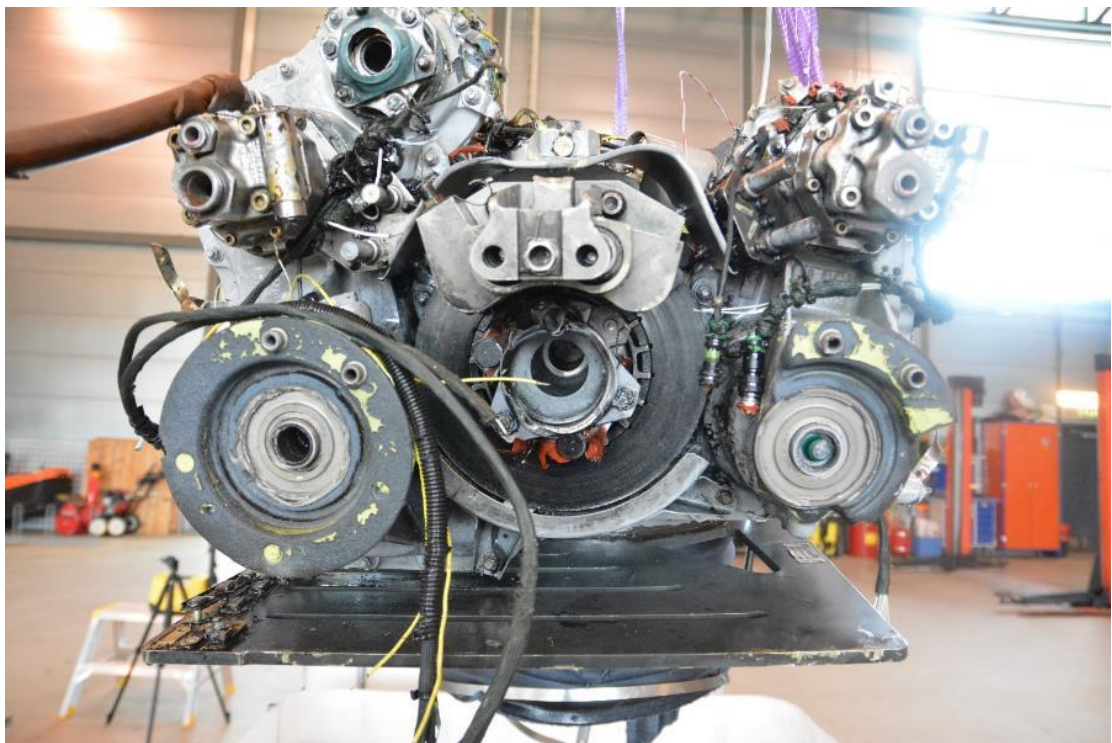
The right and left accessory modules were relatively complete and with only minor damage (see Figure 26). Both generators had come loose from the gear box. Both hydraulic pumps were still attached. The axles for the cooling fan and tail rotor had broken off very close to the connections. Moreover, seawater had caused heavy corrosion, particularly to magnesium parts.

Figure 26: L/H and R/H accessory modules seen from behind. The flexible mounting plate is seen attached to the MGB oil sump. Photo: AIBN

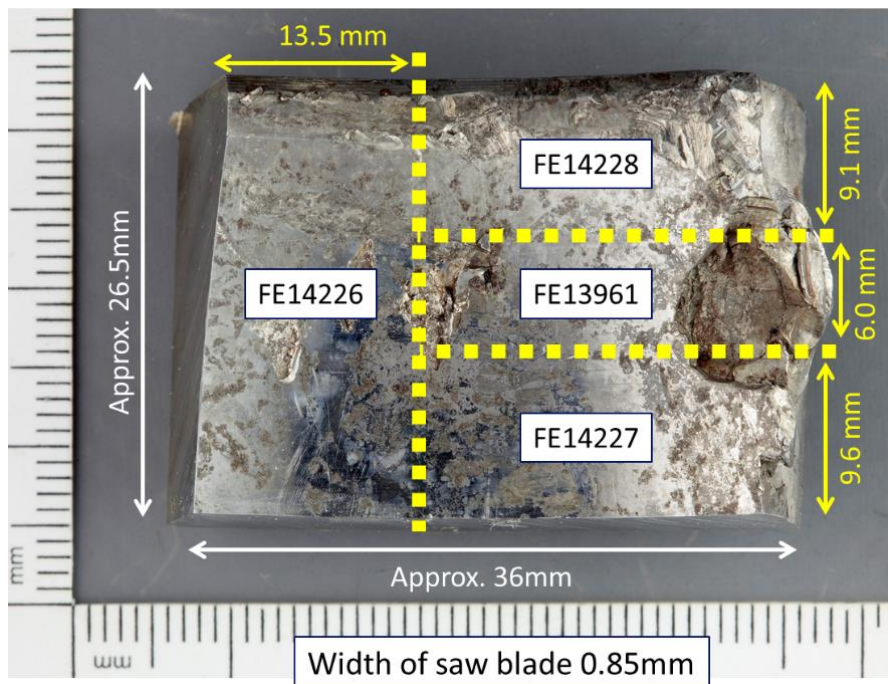
Figure 40: Cutting lay out based on CT-scan results (see Figure 37). FE13961 contains spall three and four, FE14226 contains spall one and two. Photo: AIBN/QinetiQ

- 1.16.3.15 Based on the CT-scan results, examples shown in Figure 38 and Figure 39, further cuts were agreed, see Figure 40. The teeth had been cut off prior to this. The cutting described in Figure 40 together with the cuts shown in Figure 45, made it possible to examine the crack path between spall three and four and also to open up the crack to examine the crack fracture surface (remove the race surface). The opened up crack fracture surface was examined in attempt to understand the propagation direction and speed.

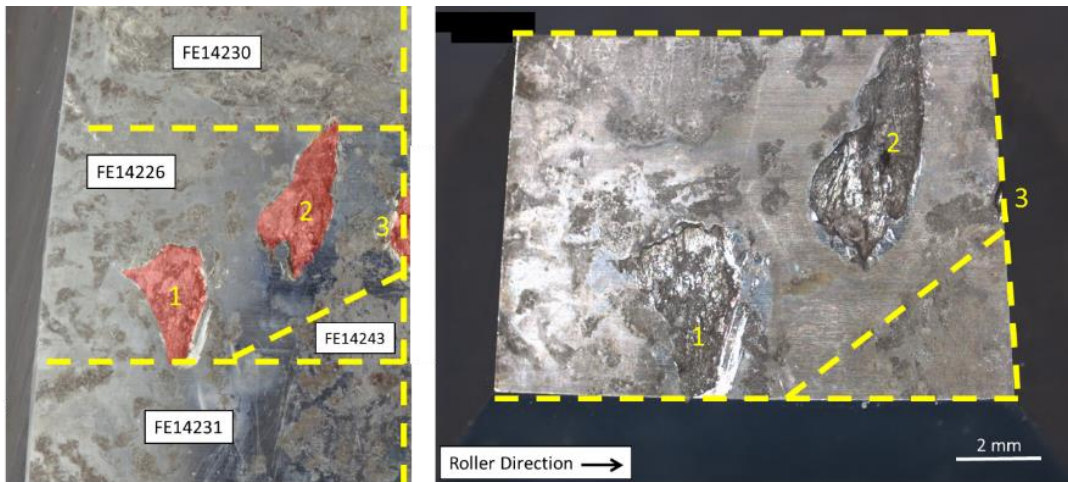
1.16.3.20 In order to examine spall one and two and the area between spall one, two and three, further cutting was made (see Figure 45).

Figure 45: Figure showing cutting for examining spall one and two and the area around and between the spall one, two and three. Photo: AIBN/QinetiQ

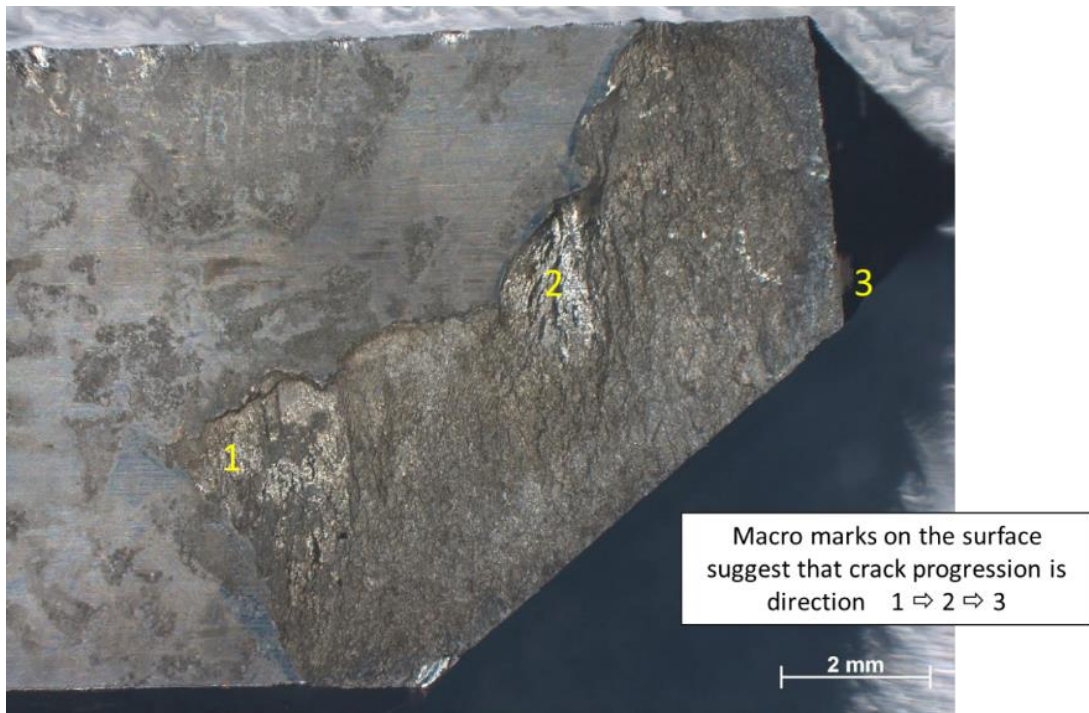
Figure 46: Figure showing the area between spall one, two and three after removal of the race surface. Photo: AIBN/QinetiQ

1.16.3.21 Spall one, two and three have a V-shaped profile with shallow entry angle indicative of initiation at or near the surface. Evidence of flaking on the edges of the spalls suggest growth by releasing debris. Indents observed on the race surface between the spalls might support this. Spall four is significantly larger than the other spalls, with steeper side walls which were found to be overload fracture. This indicates that the spall four might have been released as one piece and possibly at the time of break-up.

- 1.16.3.22 The microsection between spall one and three shows that cracks originating from spall one is below those originating from spalls two and three. When opening up of the crack fracture surface between spall one, two and three, the macro marks suggest that crack progression is in the direction from one towards four. The cracks from spalls two and three merged with the crack from spall one. The crack from spall one would have progressed towards spall four regardless of spall two and three (see Figure 46). The AIBN is aware that Airbus Helicopters does not fully agree with this.

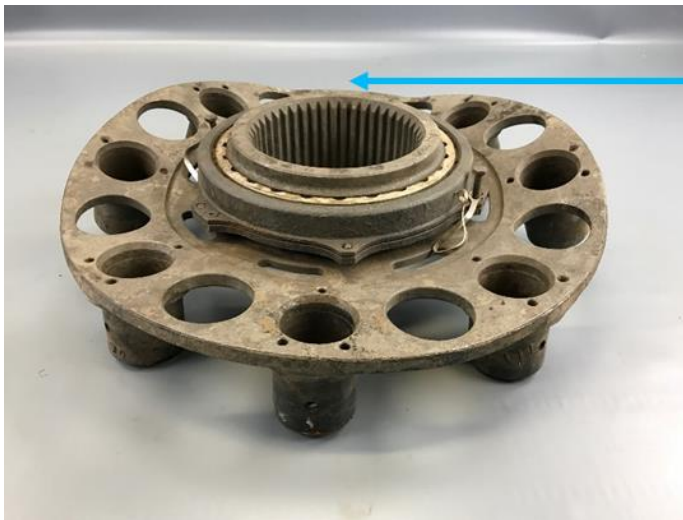
During a diving exercise in February 2017 the second stage planet carrier was found (see Figure 49). On the planet carrier the inner race of the fractured planet gear was still on the carrier but pulled off 20.4 mm. The lower rotor mast bearing was installed on the carrier. After cleaning, the inner race surface (see Figure 50) appears to be in good condition for further examination at QinetiQ together with the carrier and the bearing. The rotor mast splines have been visually inspected and no geometrical deviations were observed. Further investigation of the carrier is in progress.

Figure 49: The second stage planet carrier found in February 2017 shown after cleaning. The lower mast bearing is shown on top of the carrier. Photo: AIBN/QinetiQ

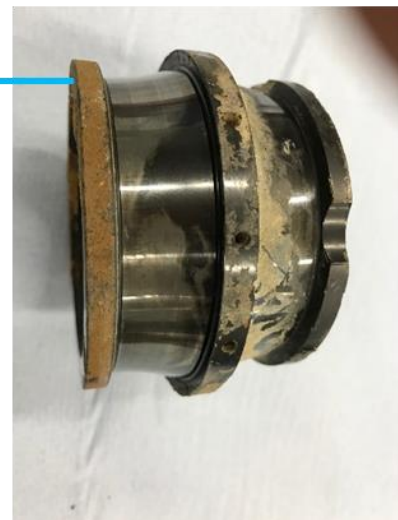
Figure 50: The inner race of the fractured planet gear after cleaning of the upper race (left in photo). Position on the carrier is given by the arrow. Photo: AIBN/QinetiQ

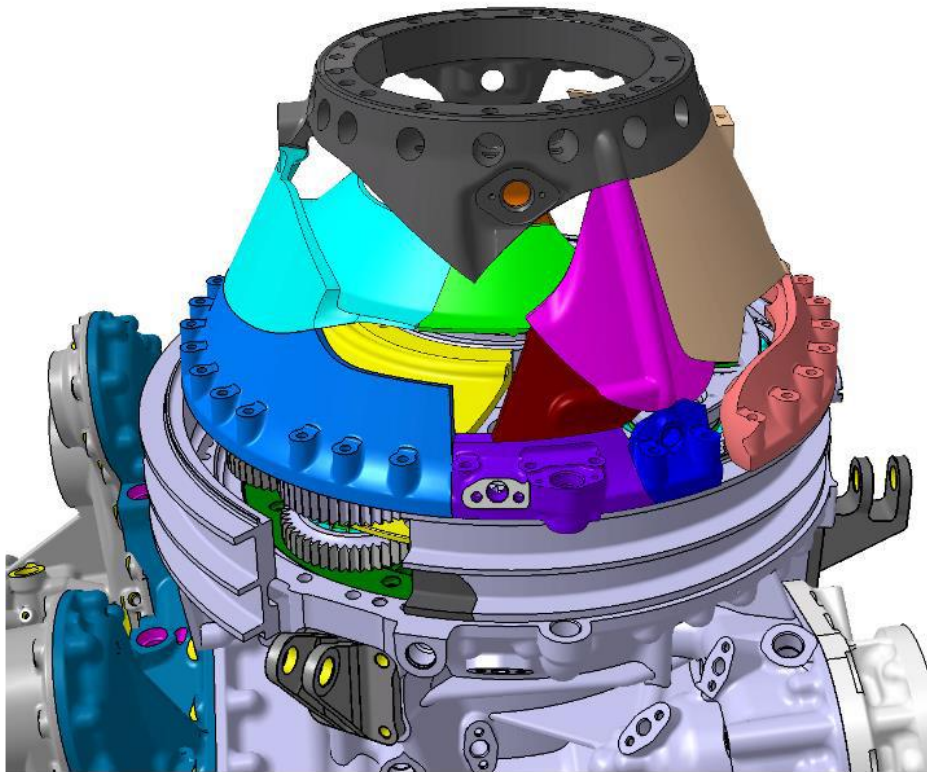
*Figure 51: Illustration of how the retrieved fragments of the conical housing are pieced together in order to look for break-up sequence/mechanism. Illustration: Airbus Helicopters*

- 1.16.5.1 The conical housing is made from an aluminum alloy casting and was found in many smaller segments. As these segments were gradually salvaged piece by piece, they were examined, scanned and documented. A complete conical housing was used as template at QinetiQ. Airbus Helicopters used their design and manufacturing data model in order to fit the different parts in the correct position (see Figure 51).

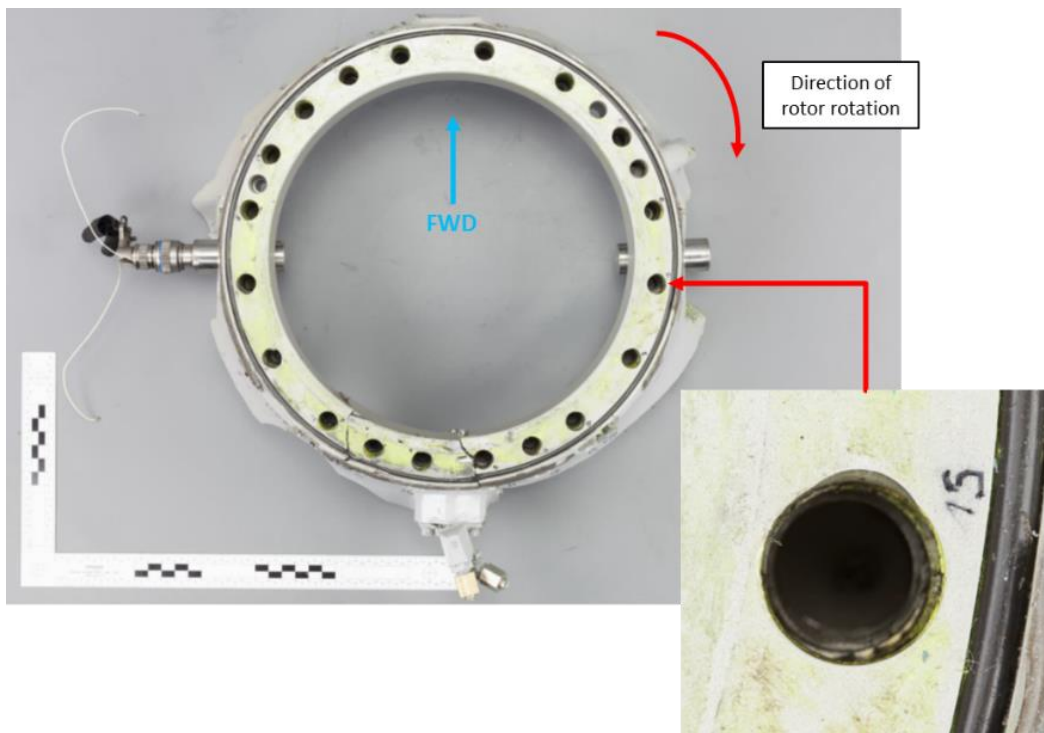
Figure 53: Top of conical housing. This segment of the conical housing was still attached to the rotor mast following the accident. Photo: AIBN/QinetiQ

1.16.5.4 To conclude; fracture examinations show indications of overload on all conical housing segments.

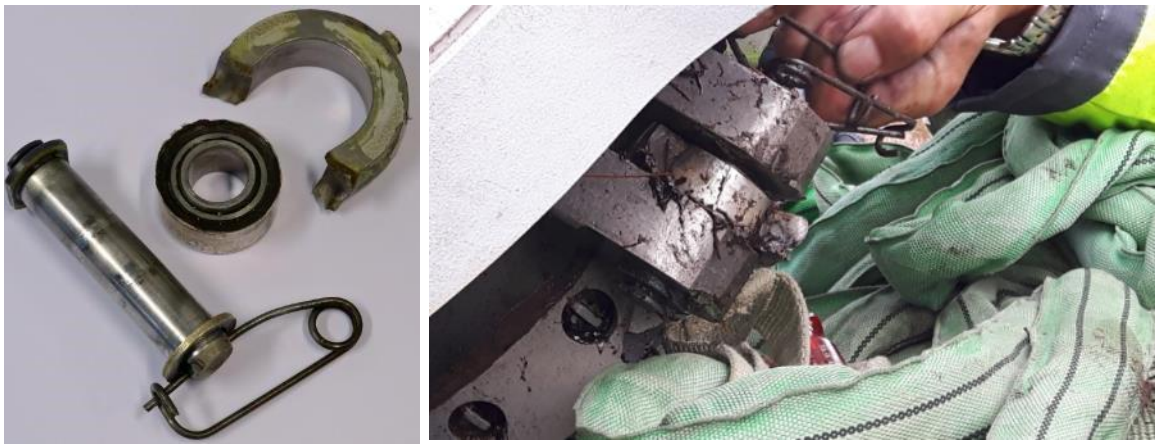
The only parts from the forward suspension bar that were recovered were the upper fractured mounting lug with its clevis, and two safety pins that were attached to the lift housing. These parts were brought to the QinetiQ laboratories for metallurgical examination, see Figure 56 (two safety pins shown on right photo).

Both top and bottom fractures were examined in a scanning electron microscope (SEM) and found to be overload. There was no evidence of progressive crack growth such as fatigue. Both top and bottom fractures exhibited necking and deformation consistent with tensile overload failure. The deformation was consistent with the lift strut bending in a port direction. More deformation (twisting) was observed on the bottom fracture, which suggests that the top of the lug failed first, allowing the strut to twist about the remaining bottom part of the lug before final failure. Bottom fracture face appears to be twisted approximately 10° anticlockwise, see Figure 57.

Figure 56: Upper forward suspension bar, part of the mounting lug, the bearing, the clevis pin (with only one of the two safety pins) and the safety pins. Here shown both as found at the rotor mast (right photo) and dismantled (left photo). Photo: AIBN
