REPORT

SL 2018/04

REPORT ON THE AIR ACCIDENT NEAR TURØY, ØYGARDEN MUNICIPALITY, HORDALAND COUNTY, NORWAY 29 APRIL 2016 WITH AIRBUS HELICOPTERS EC 225 LP, LN-OJF, OPERATED BY CHC HELIKOPTER SERVICE AS

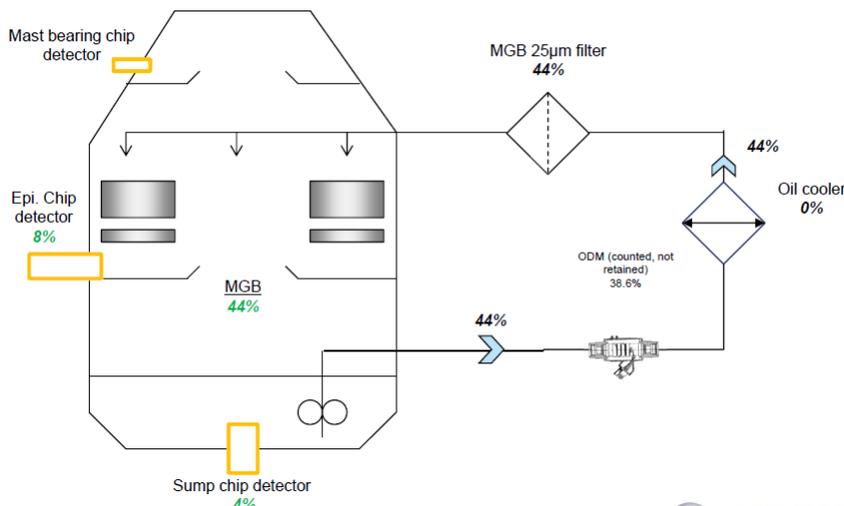
Following the LN-OJF accident, Airbus Helicopters provided an updated justification of the status of available MGB monitoring means. Based on the G-REDL test (see section 1.18.3.3) it was initially found that 12 % of the debris had been detected by the chip detectors while 44 % of the debris had been captured by the MGB oil filter (see Figure 12).

The configuration of the G-REDL test bench was different from the helicopter as it was not fitted with a standard oil cooler. Later, during the investigation of the LN-OJF accident, it was discovered that the standard oil cooler acted as a particle trap thus preventing the largest debris from reaching the filter. 44 % of the debris would not have reached the MGB oil filter as shown in Figure 12, but would have been partly retained in the oil cooler. This led to a thorough inspection of the LN-OJF oil cooler, in which several particles were recovered (see section 1.16.10.3).

Figure 12: The configuration of the G-REDL test and the detection rate of chip detectors (%: Particle quantity). Source: Airbus Helicopters

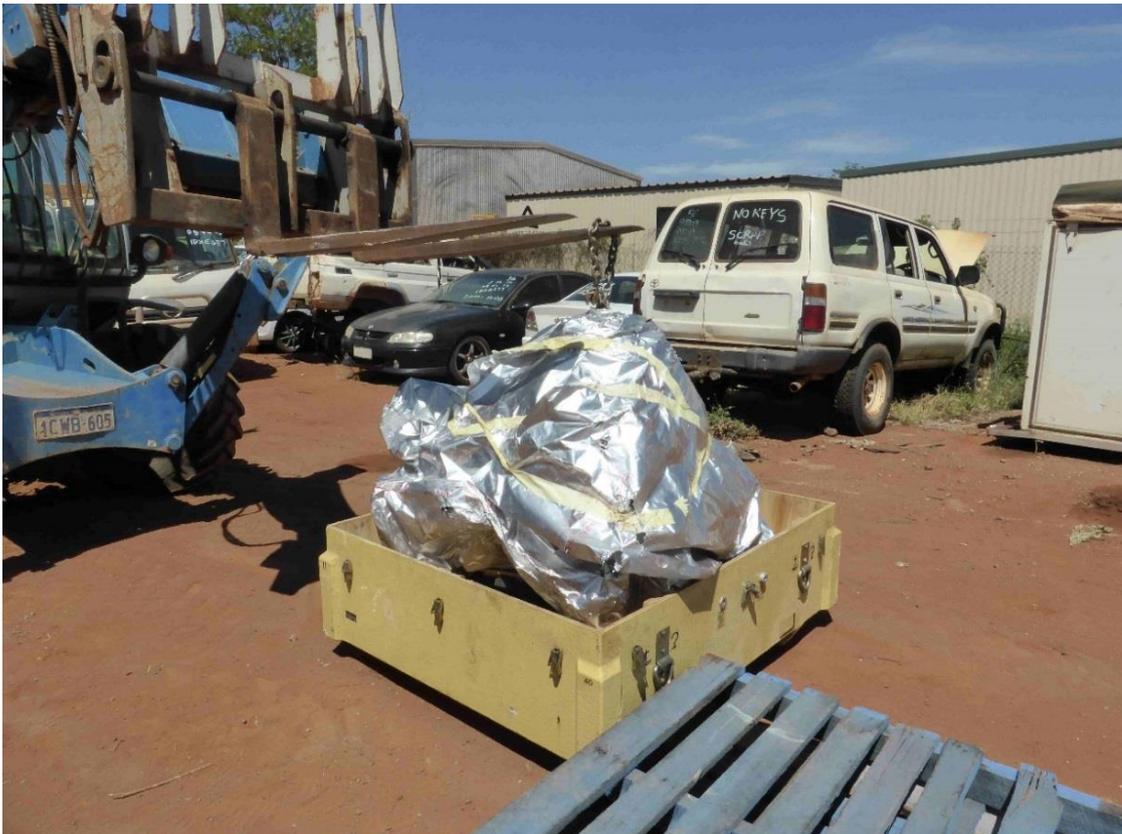
Figure 14: The MGB in the transport container without the damaged top after the ground transport accident 13 March 2015. Photo: Airbus Helicopters

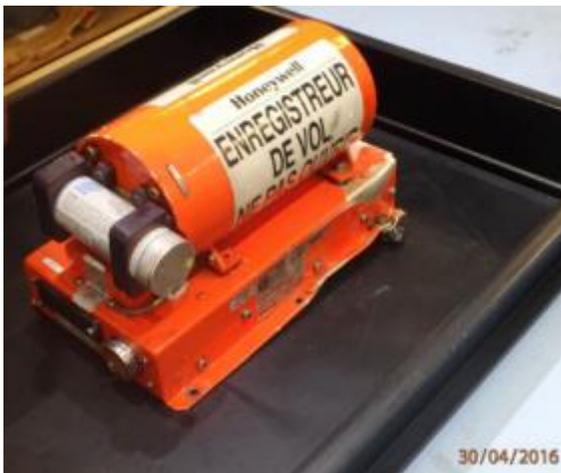
The CVFDR was removed from the tail boom that had been picked up from the seabed in the late evening of the 29 April 2016 and transported in fresh water by the AIBN to the AAIB at Farnborough, UK. Initially, it was not possible to download data because the wiring between the base unit and the CSMU was damaged. Following repair and use of a dummy fixture a successful download of all the data was performed.

Figure 15: CVFDR from LN-OJF as received at the AAIB. Photo: AIBN

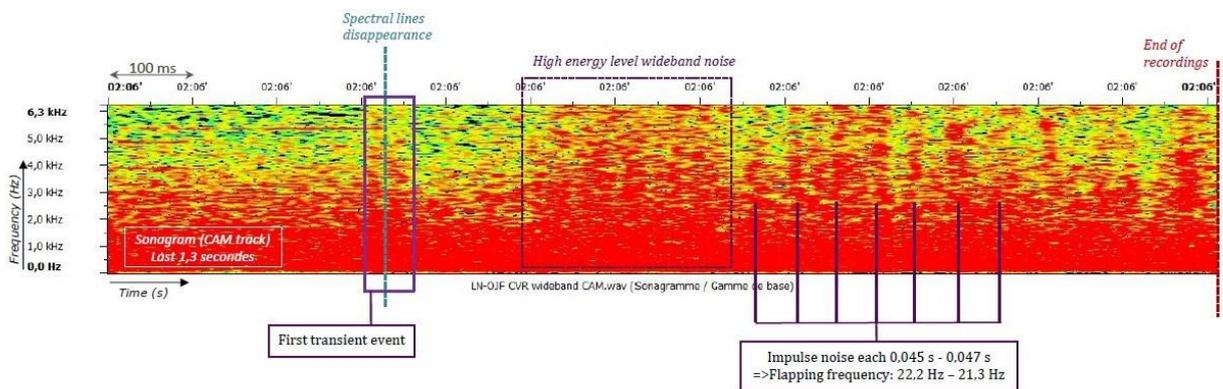
Following the readout at the AAIB, all four audio files were transferred to the BEA in France for further analysis. Spectrum analysis from the CAM recording is shown in Figure 17. The CAM spectrogram shows that the CVR recording ended 1 second after the first transient event.

Figure 17: Spectrum analysis from the CAM audio file showing 1.3 seconds believed to be the beginning of the MGB break-up. Source: BEA

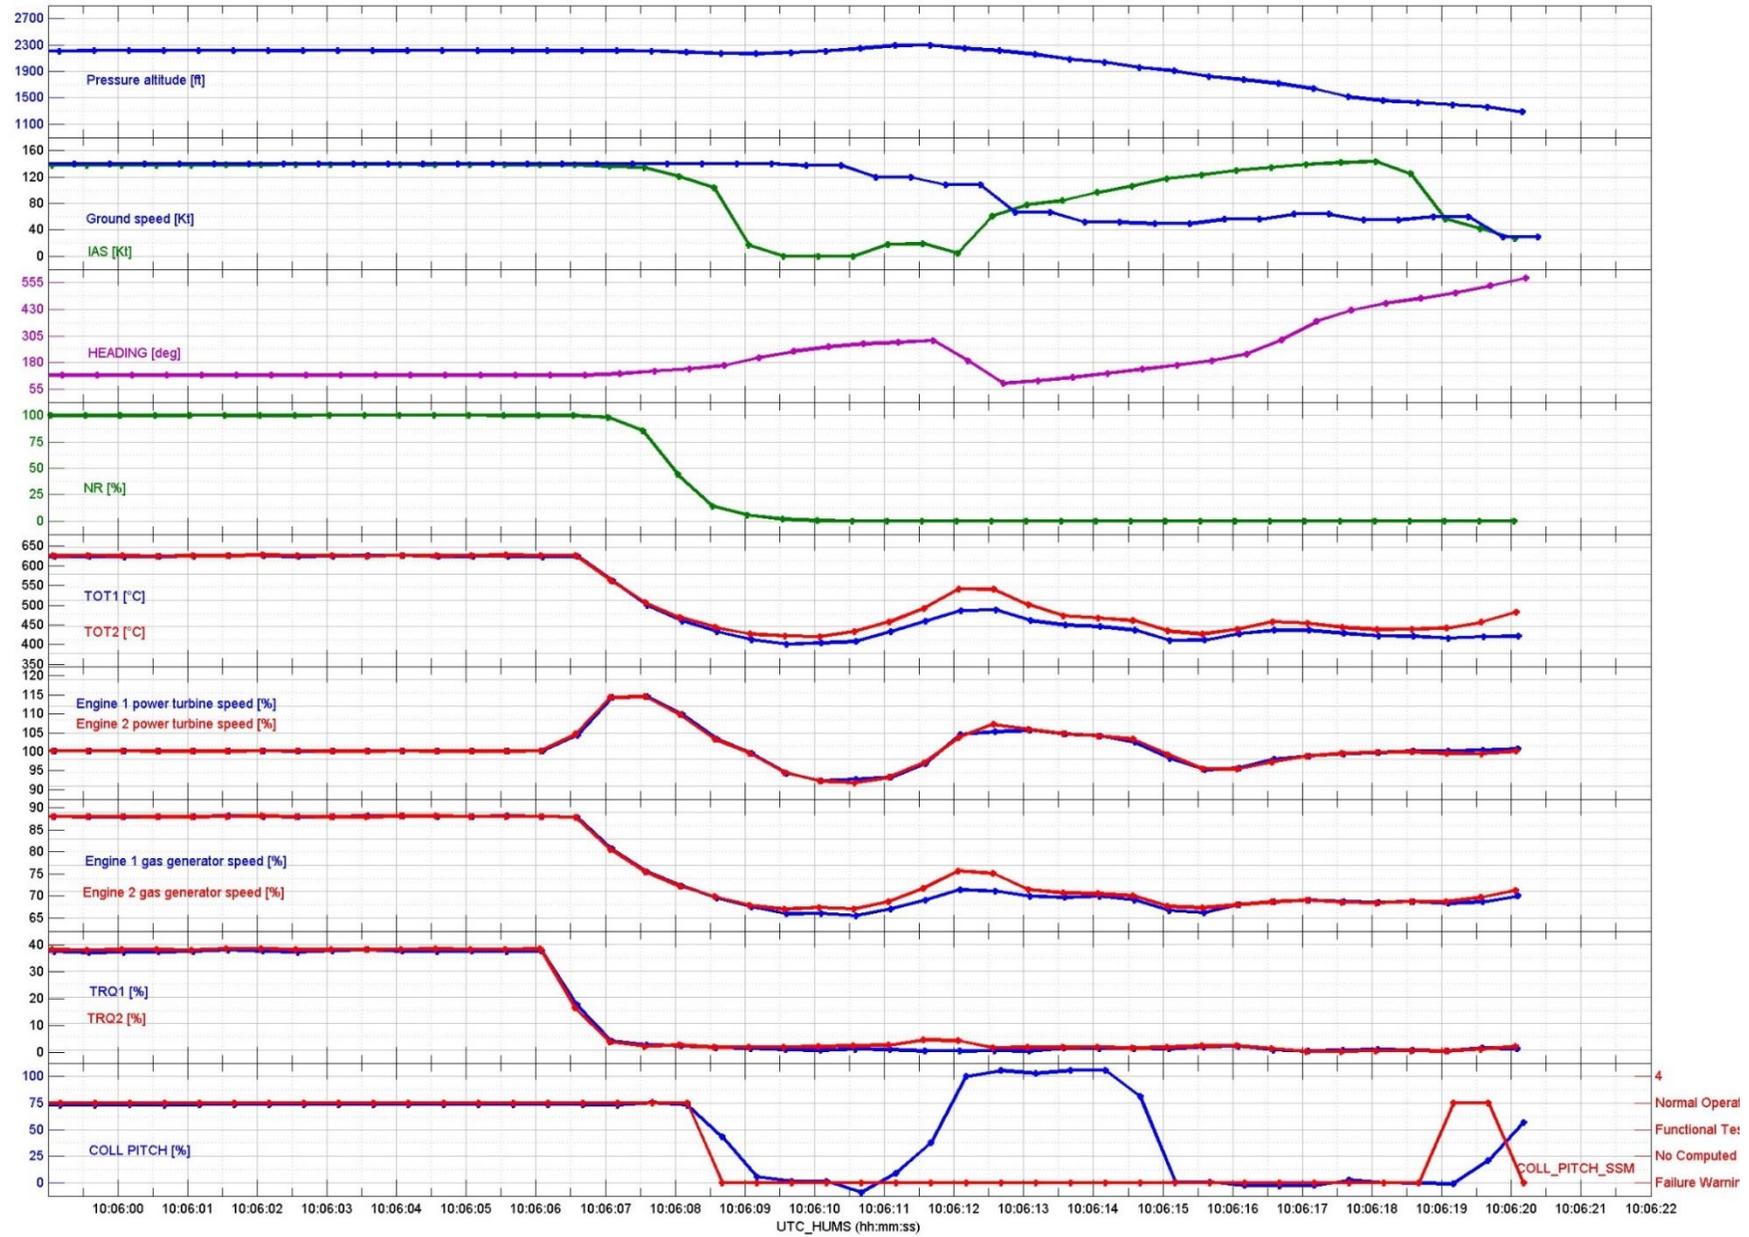
Figure 19: Recorded parameters from the PCMCIA card. T0 is defined as 10:06:06. Note: Time is UTC minus approximately 11 min. Source: BEA

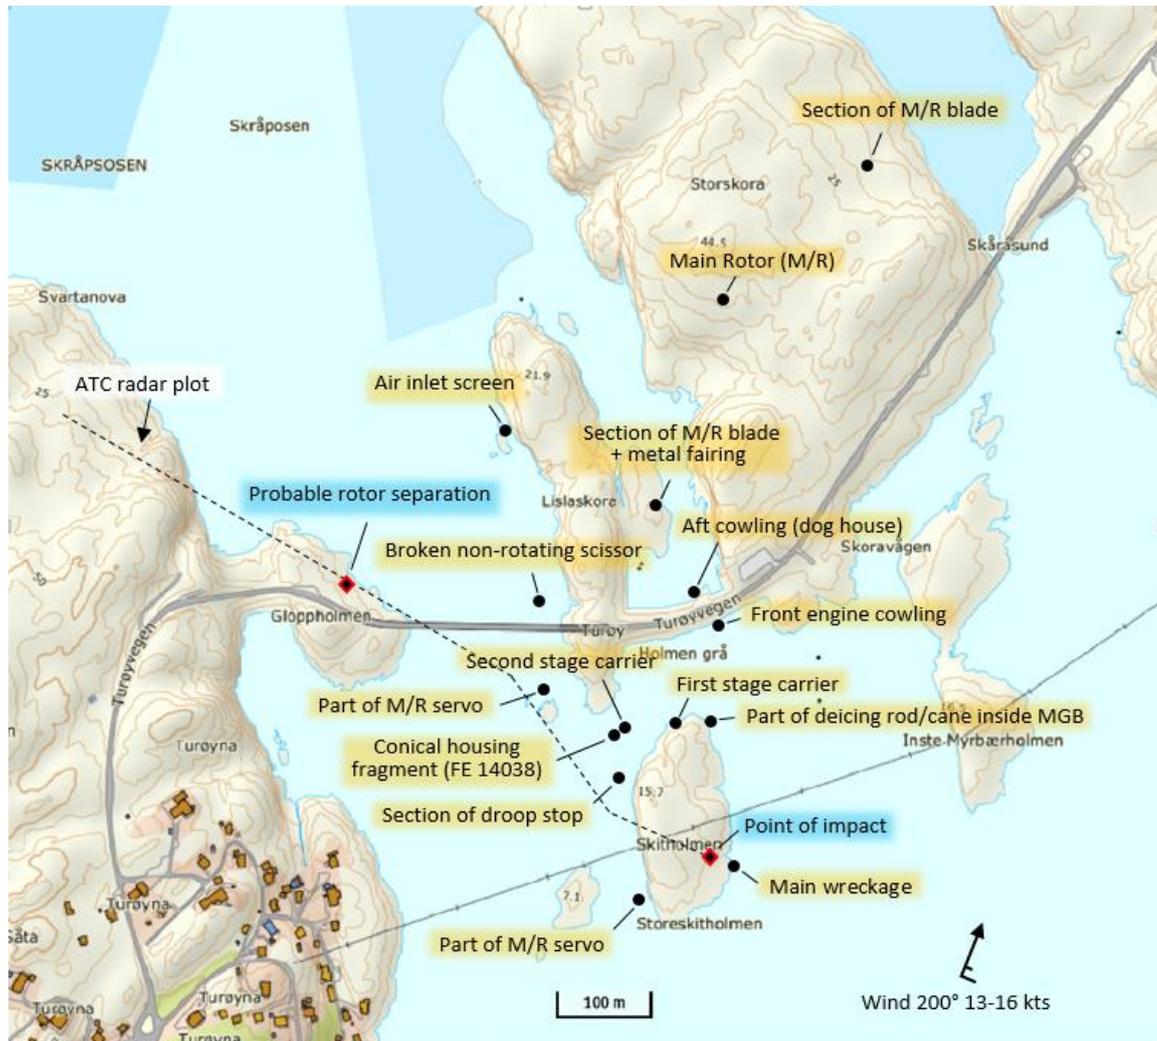
As mentioned in section 1.12.1.1, a number of parts from the helicopter were found dispersed over an area of about 180,000 m². However, most of the helicopter wreckage came to rest on the seabed just outside Storeskitholmen island. The largest part found separate from the accident site itself, was the main rotor, which was at the Storskora island. The map in Figure 21 shows where a number of parts were discovered.

Figure 21: Accident site overview with wreckage parts of interest. Source: The Norwegian Mapping Authority adapted by the AIBN

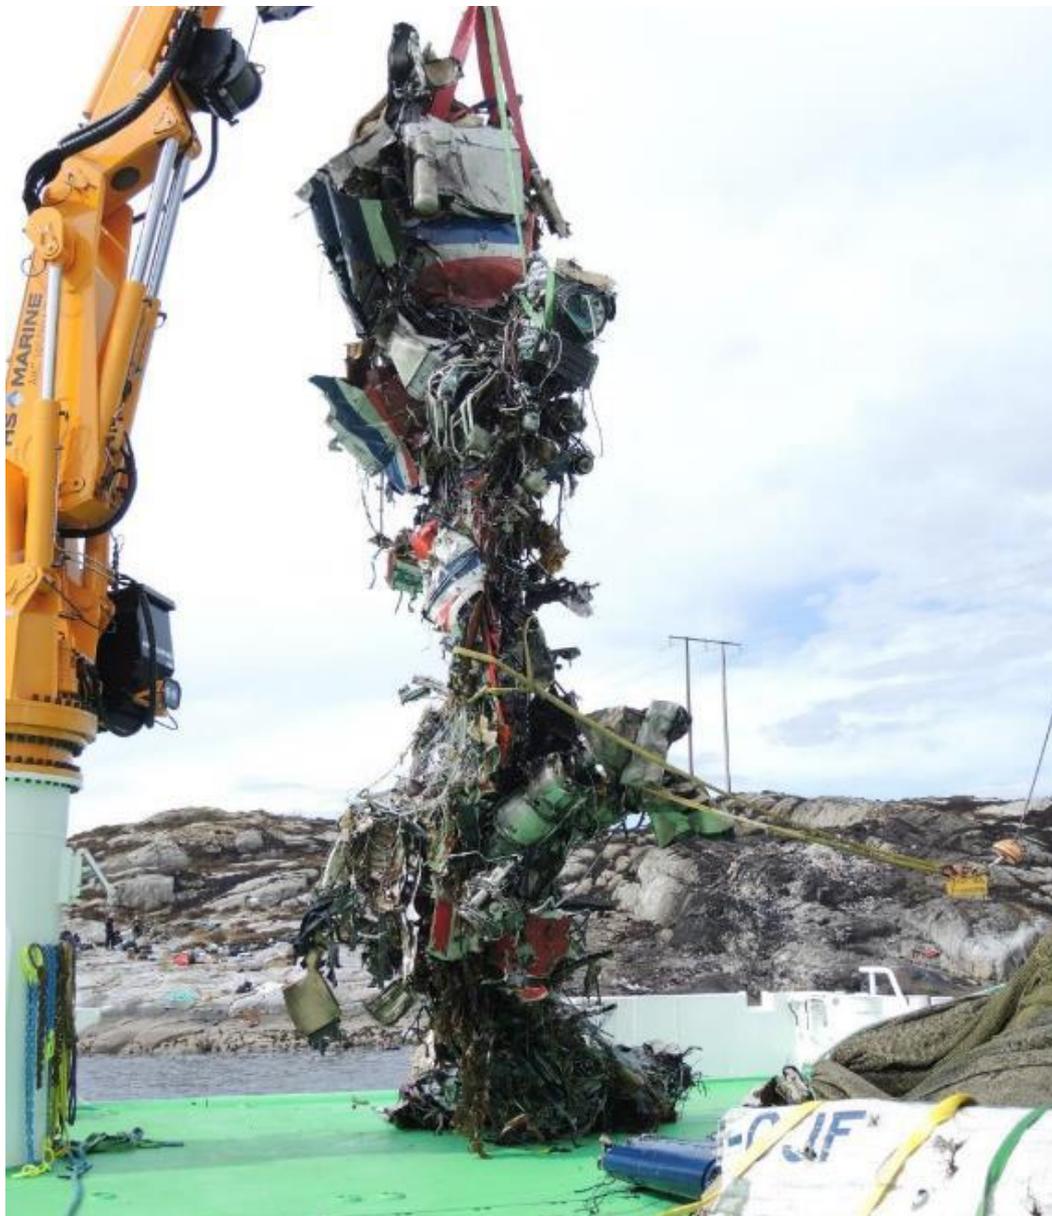
The main parts of the helicopter cabin, including the cockpit, were recovered as one piece, held together by bars, wires, tubes and pipes, but otherwise structurally destroyed. They were damaged to such extent that it was almost impossible to conduct any meaningful investigations of the wreckage components (see Figure 22).

Figure 22: The main wreckage during recovery. The tail boom seen at the lower right had already been recovered. Photo: AIBN

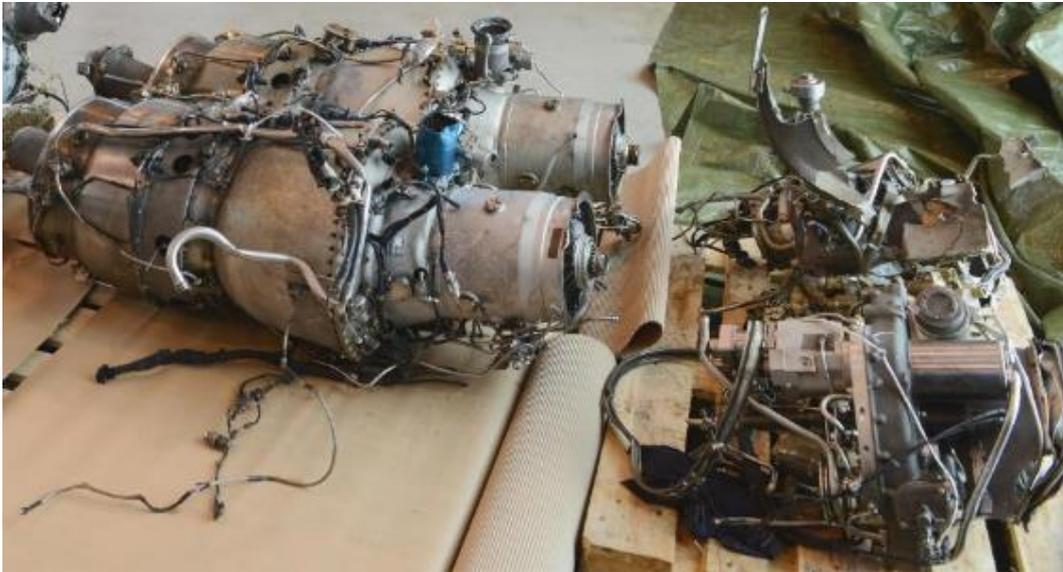
the report reference [RA2016 098]. On both engines there was a symmetry concerning all damages found and all these damages were the consequence of collision with the ground and external loads applied on both engines.

Figure 23: The engines at the AIBN hangar. They had similar damage to a large extent. Both intake sections (Module M01) which had separated from the front part of the engines can be seen to the right of the photo. Photo: AIBN

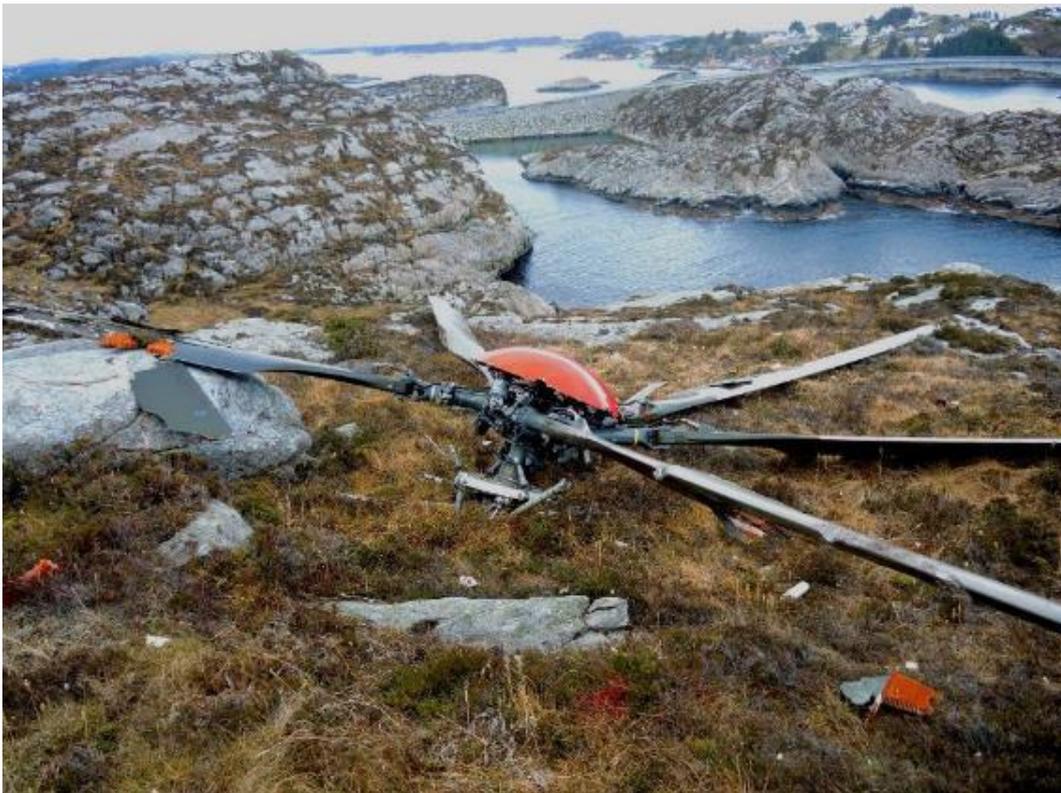
The main rotor blades were dismantled from the rotor head and examined by the AIBN. In general, the innermost sections of the main rotor blades were structurally intact, but the outer parts of the black, white, red and blue blades were significantly damaged. Several blades had lost large sections of the honeycomb structure behind the main spar. There was a clear imprint on the yellow blade, after contact with one of the engine's air inlet screens, 1.9 metres from the blade bolts.

The rotor head and the mast were sent to Airbus Helicopters and further examined under the supervision of the AIBN and the BEA. Detailed examinations of the Main Rotor Mast coupling splines and the Main Rotor Mast bearing did not reveal any pre-impact anomalies and they were found to be in normal and standard operational conditions.

Figure 24: The main rotor and rear suspension bars as found on the island Storskora.
Photo: AIBN

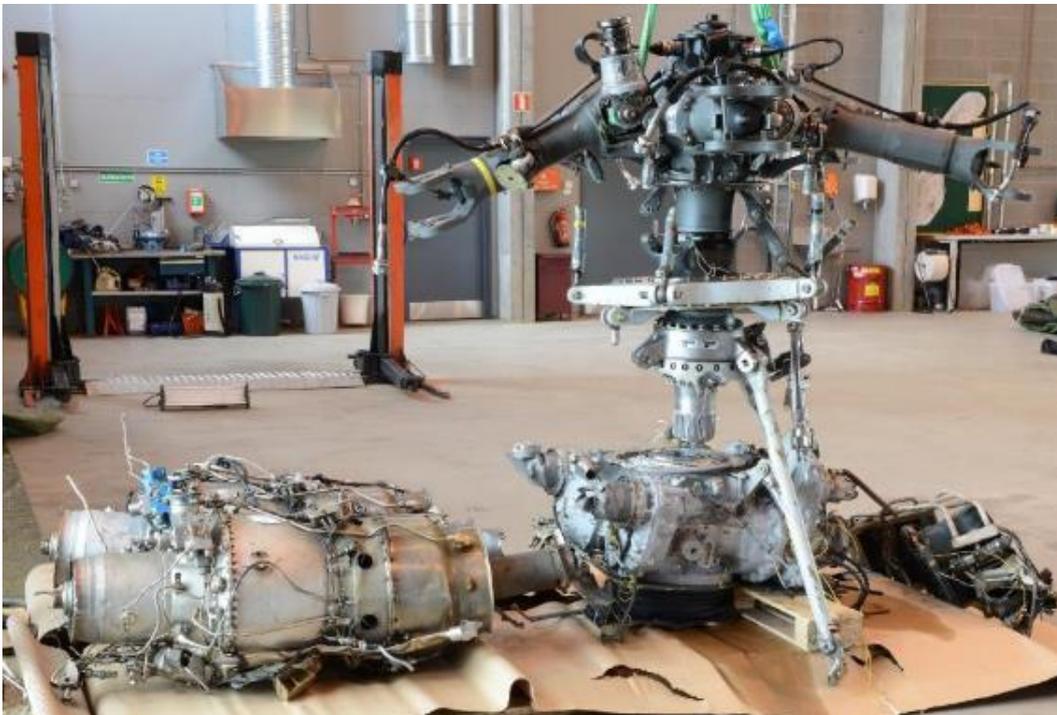
The main module was relatively complete and with limited damage. Both engine high speed input shafts had been twisted off near the main gearbox in a manner which indicates high torque, possibly combined with bending. The linking tubes (liaison tubes) were bent upwards (see Figure 25). The oil sump in the main module contained large quantities of metal fragments and shavings. All findings during examinations of the main module are consistent with the helicopter hitting the ground with great force and then ending up in the sea. Seawater had caused heavy corrosion, particularly to magnesium alloy parts.

Figure 25: Engines, substantial parts of the MGB, two suspension bars and main rotor head assembled at the AIBN premises. Photo: AIBN

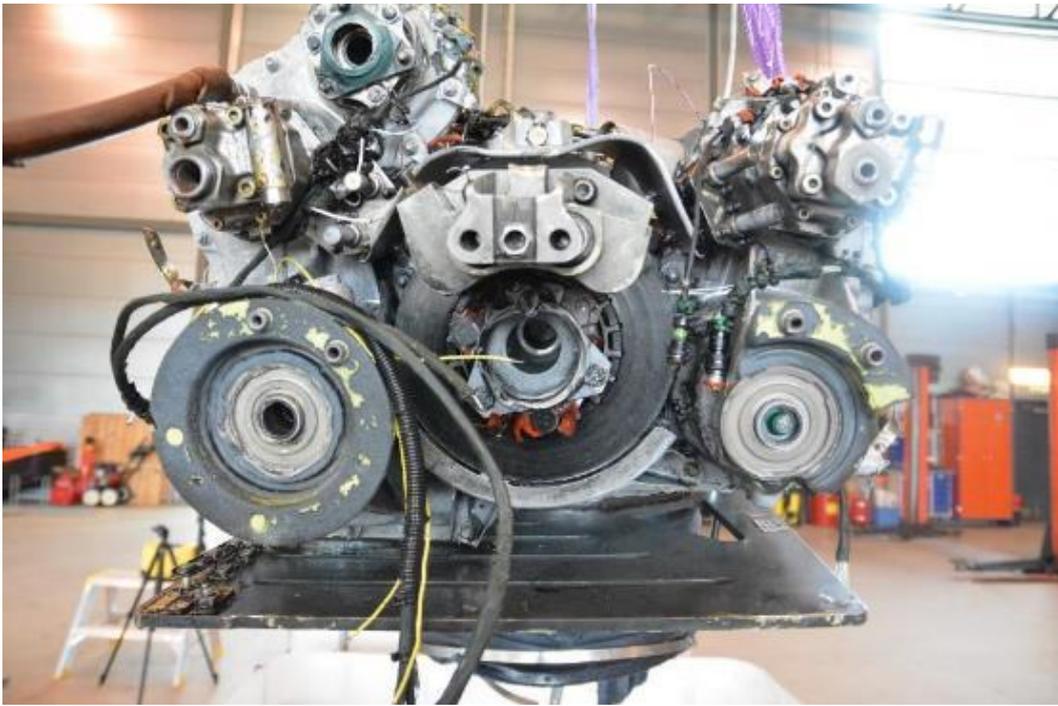
The right and left accessory modules were relatively complete and with only minor damage (see Figure 26). Both generators had come loose from the gear box. Both hydraulic pumps were still attached. The axles for the cooling fan and tail rotor had broken off very close to the connections.

Figure 26: L/H and R/H accessory modules seen from behind. The flexible mounting plate is seen attached to the MGB oil sump. Photo: AIBN

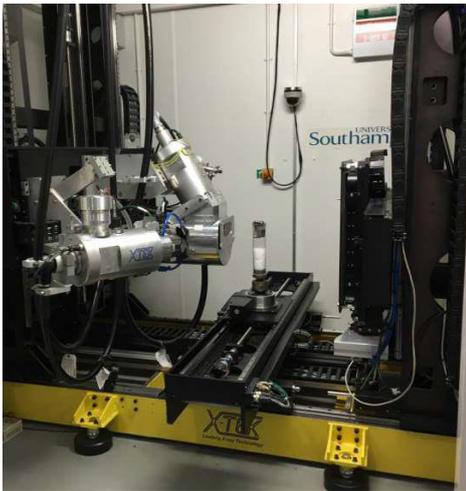
Based on the assumption that there might be cracks or voids in the area between spall one and four it was important to get an understanding of the area before cutting the part for further examination. The piece was inspected using x-ray computed tomography (CT) (see Figure 37).

The first CT-scan was of the complete segment to the left in Figure 27. Due to the size of the segment the resolution was not sufficient to distinguish the presence of subsurface cracks. Based on the first scan, the segment was reduced in size to that shown in Figure 34 and re-scanned. Results are shown in Figure 38 and Figure 39. In order to further improve resolution the gear teeth were removed and further scanning performed. This gave a good indication of the crack location and extent prior to cutting. Even so, the technique was unable to resolve very tight cracks observed in micro-section after cutting.

Figure 37: The x-ray tomography set up. The part to be scanned is in the tube in the centre of the figure.
Photo: AIBN

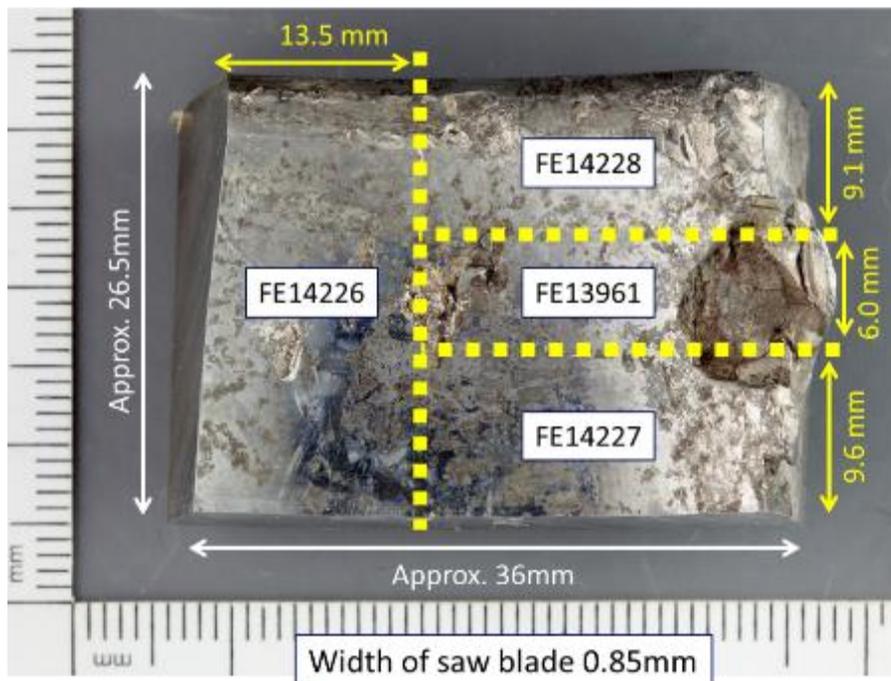
Based on the CT-scan, examples shown in Figure 38 and Figure 39, further cuts were agreed, see Figure 40. The cutting described in Figure 40 together with the cuts shown in Figure 46, made it possible to examine the crack path between spalls 1, 2, 3 and 4 and also to open up the crack to examine the crack fracture surface in attempt to understand the propagation direction and speed.

Following detailed examination, the outer race of section FE 13961 (see Figure 40) was separated from the gear bulk material at QinetiQ. The outer race (cap/calotte) was later sent to Airbus Helicopters for additional examinations.

Figure 40: Cutting lay out based on CT-scan results (see Figure 38). FE13961 contains spall three and four, FE14226 contains spall one and two. Photo: AIBN/QinetiQ

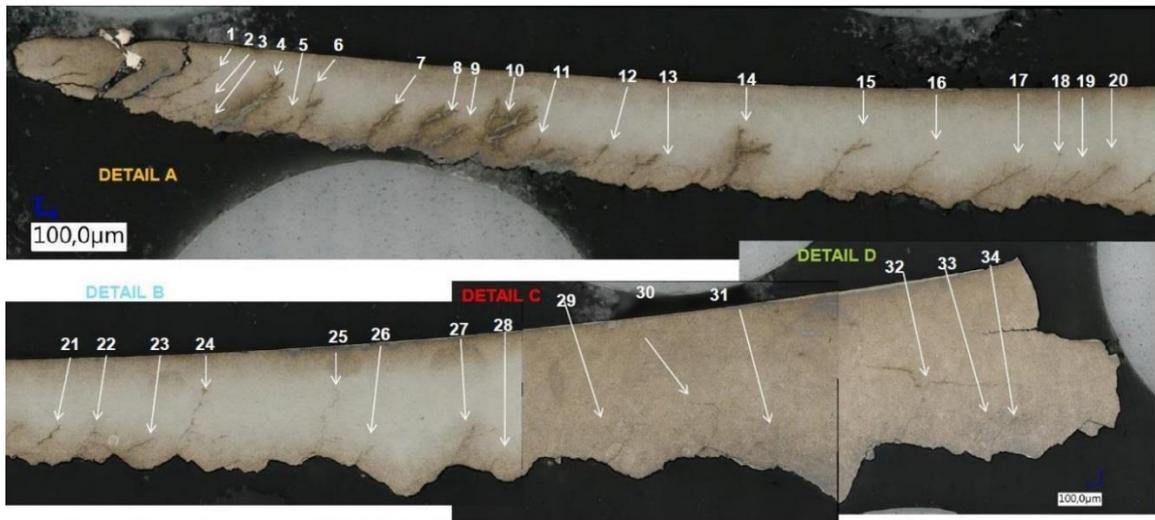
The outer race of sample FE13961 (cap/calotte) was examined by Airbus Helicopters in an attempt both to understand why the cracks stop before breaking the surface and creating spalls, and to look for striations. The section was polished towards the 14 mm line (see Figure 45). This exposed 34 secondary cracks which progressed towards the surface between spall 3 and 4.

Figure 45: Polished section at the 14 mm line of the removed area (cap/calotte) between spall 3 and 4. Photo: Airbus Helicopters

These results are in broad agreement with the similar examination performed at QinetiQ before the cap/calotte was removed from the bulk material. The cap/calotte had to be forced off, and may have elongated some existing cracks (see Figure 42, Figure 43 and Figure 44).

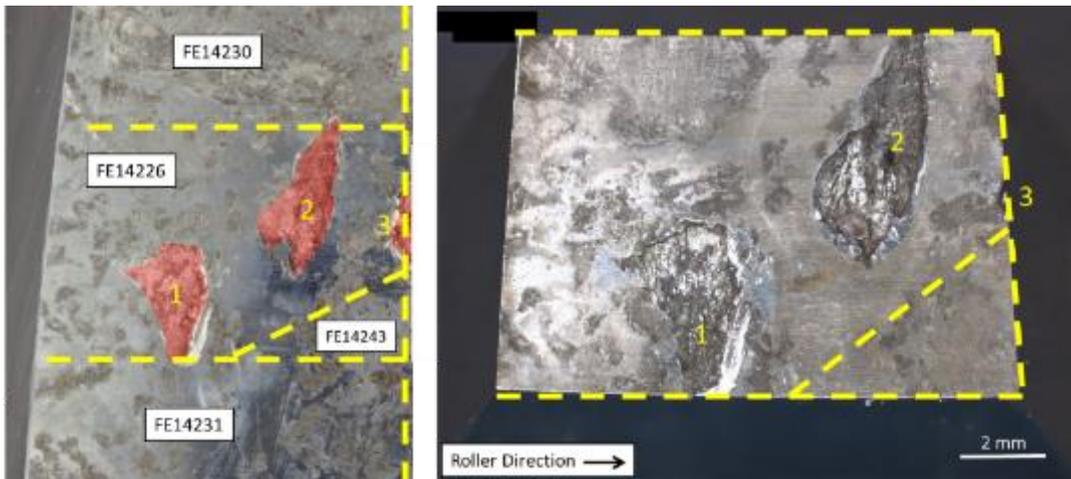
The sample (section FE 14226) was cut again in order to examine spalls 1 and 2 and the cracks between spalls 1, 2 and 3 (see Figure 40 and Figure 46).

Figure 46: Figure showing cutting for examining spalls 1 and 2 and the cracks between spalls 1, 2 and 3. Photo: AIBN/QinetiQ

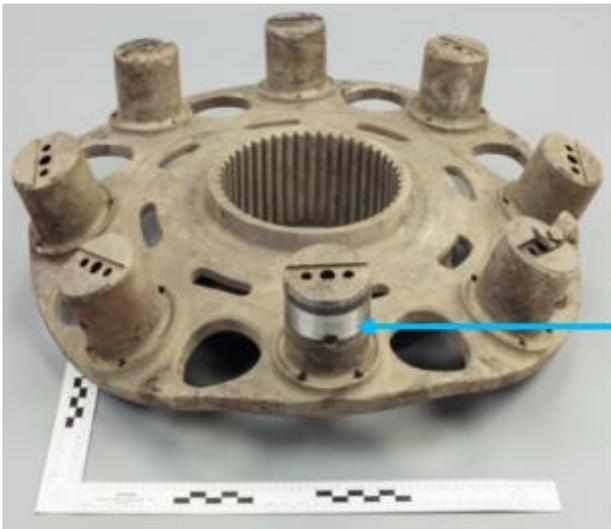
- 1.16.4.1 During a diving exercise in February 2017, about 10 months after the accident, the second stage planet carrier was found (see Figure 52). On the planet carrier the inner race of the fractured planet gear was still on the carrier, but rotated 35° and pulled off 20.4 mm. The lower rotor mast bearing was still attached to the carrier.

Figure 52: The second stage planet carrier found in February 2017 shown after cleaning. The inner race of the fractured second stage planet gear has been removed from stub shaft number 3 in front. Photo: AIBN/QinetiQ

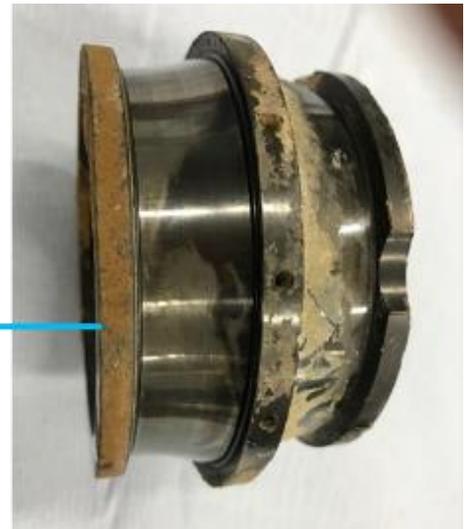
- 1.16.4.2 After cleaning, the inner race surface (see Figure 53) was in good condition for further examination at QinetiQ together with the carrier and the mast bearing. The rotor mast splines have been visually inspected and no geometrical deviations or mechanical damage, other than corrosion, were observed. Examination of the lower rotor mast bearing showed no mechanical damage, see Figure 54, as might arise from misalignment or jamming. The carrier had symmetrical deformations around the stub shaft where the fractured planet gear had been mounted (see Figure 55).

Figure 53: The inner race of the fractured planet gear after cleaning of the upper race (left in photo). Position on the carrier is given by the arrow. Photo: AIBN/QinetiQ

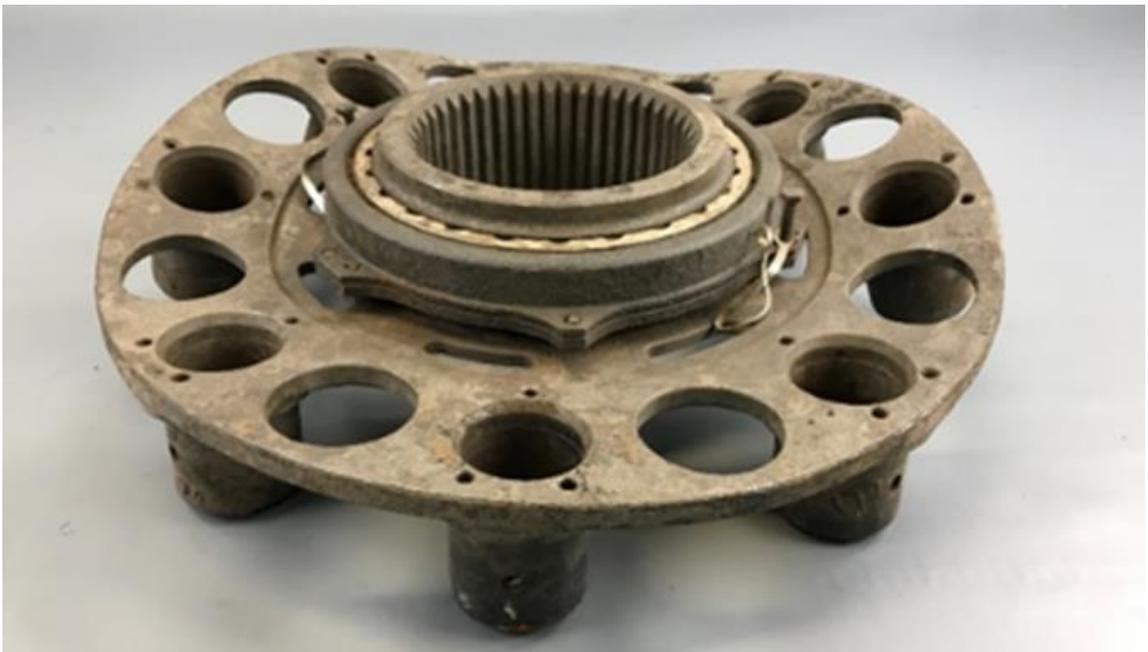
Figure 54: The second stage planet carrier found in February 2017 shown after cleaning. The lower mast bearing is shown on top of the carrier. Photo: AIBN/QinetiQ

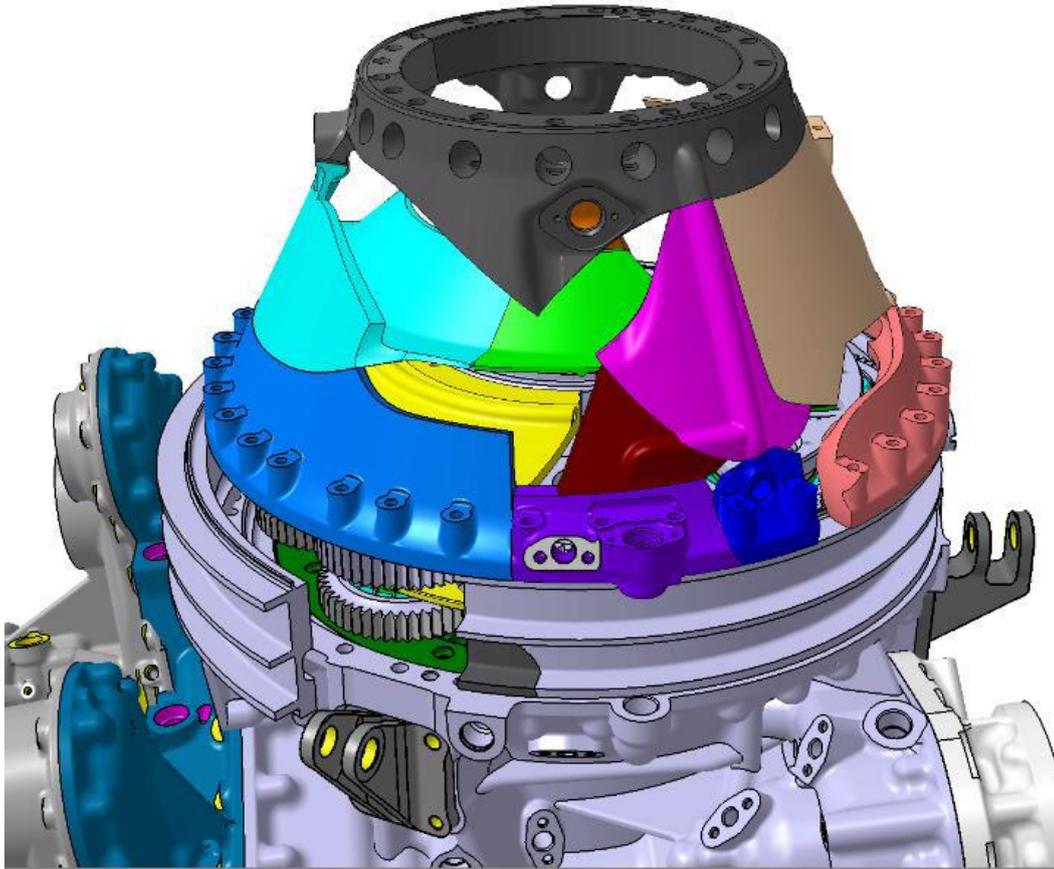
Figure 58: Illustration of how the retrieved fragments of the conical housing are pieced together in order to look for break-up sequence/mechanism. Illustration: Airbus Helicopters

- 1.16.7.1 The conical housing is made from an aluminium alloy. The conical housing was shattered and found in many smaller segments. As these segments were gradually salvaged piece by piece, they were examined, scanned and documented. A complete conical housing was used as template at QinetiQ. Airbus Helicopters used their design and manufacturing data model in order to fit the different parts in the correct position (see Figure 58).

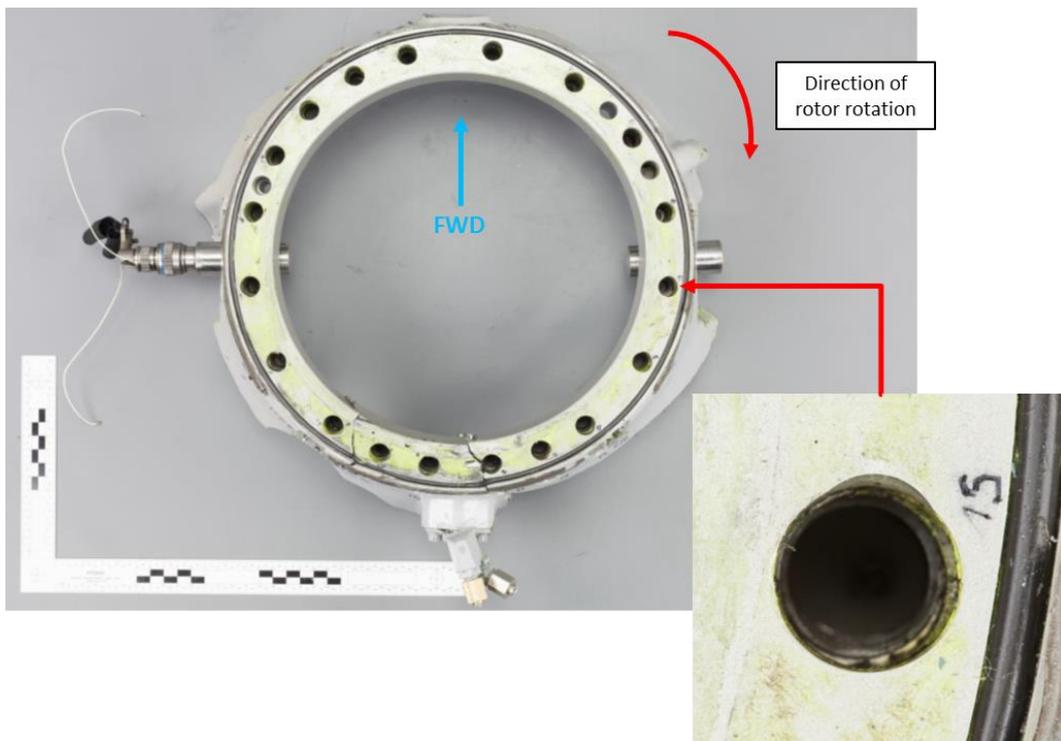
Figure 60: Top of conical housing. This segment of the conical housing was still attached to the rotor mast following the accident. Photo: AIBN/QinetiQ

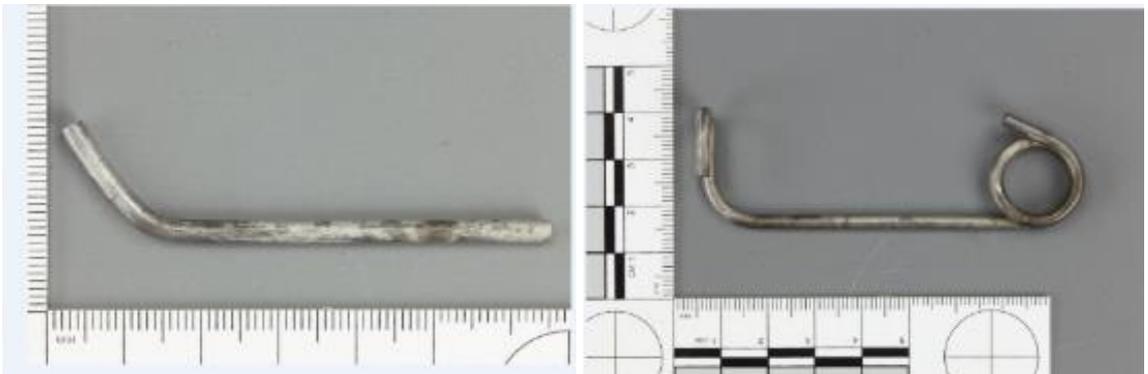
Figure 62: Two segments of safety pins found near the rotor mast. Metallurgical examination proved these to be from two different pins. Photo: AIBN/QinetiQ

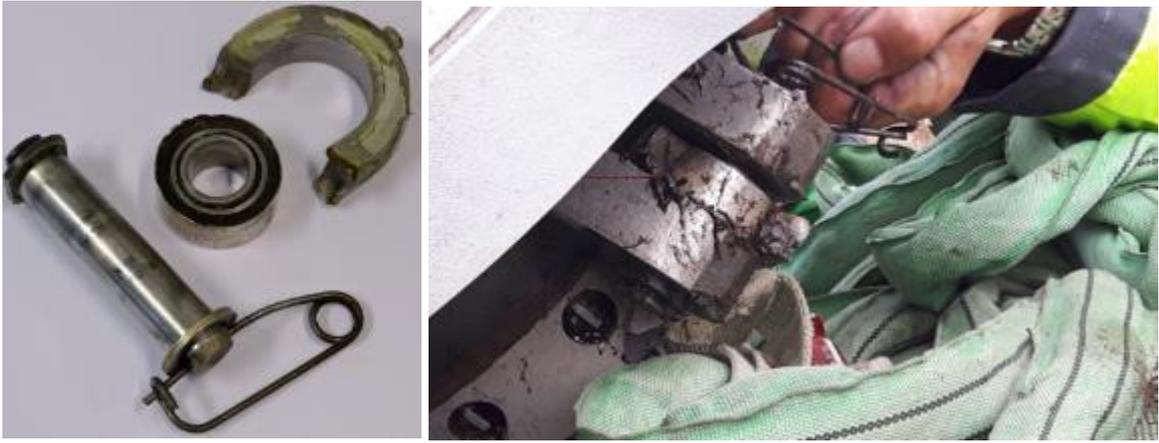
The only parts from the forward suspension bar that were recovered were the upper fractured mounting lug with its clevis, and two safety pins that were attached to the lift housing. These parts were brought to the QinetiQ laboratories for metallurgical examination, see Figure 63 (two safety pins shown on right photo).

Both top and bottom fractures were examined in a scanning electron microscope (SEM) and found to be overload. There was no evidence of progressive crack growth such as fatigue. Both top and bottom fractures exhibited necking and deformation consistent with tensile overload failure. The deformation was consistent with the lift strut bending in a port direction. More deformation (twisting) was observed on the bottom fracture, which suggests that the top of the lug failed first, allowing the strut to twist about the remaining bottom part of the lug before final failure. Bottom fracture face appeared to be twisted approximately 10° anticlockwise, see Figure 64.

Figure 63: Upper forward suspension bar, part of the mounting lug, the bearing, the clevis pin (with only one of the two safety pins) and the safety pins. Here shown both as found at the rotor mast (right photo) and dismantled (left photo). Photo: AIBN

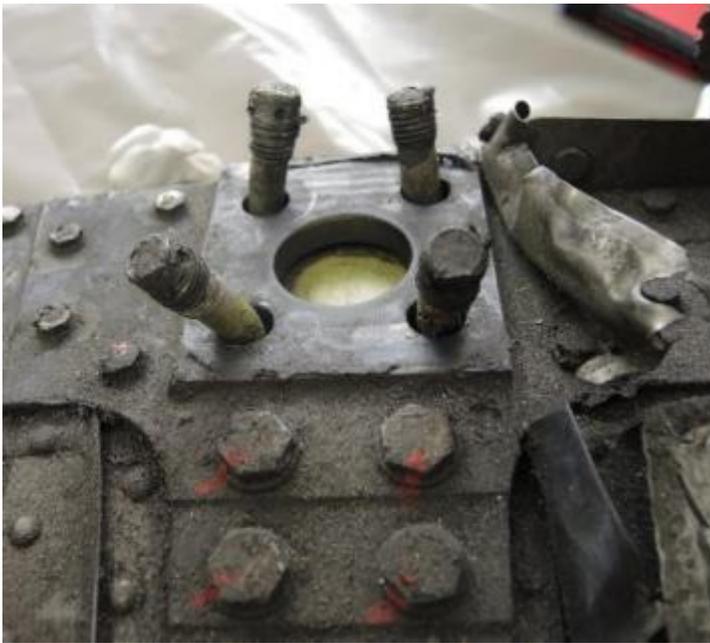
Inspection of available suspension bar airframe fittings, the mating airframe shim and plate, showed no major fretting, see Figure 65.

No evidence of fatigue failure was observed on the parts.

Figure 65: The four bolts from the lower forward fuselage fitting protruding from the support plate. Photo: AIBN

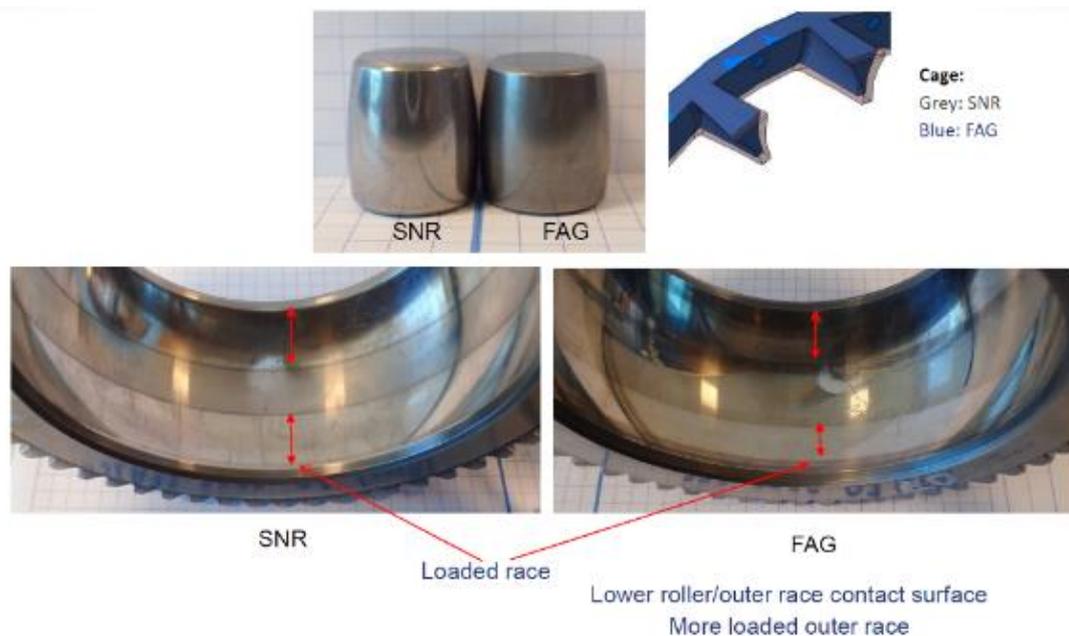
Figure 68 shows the geometry differences between a FAG and a NTN-SNR bearing and their contact pattern on outer race. The roller geometry and the cage dimensions differ.

Figure 68: Geometry differences between NTN-SNR and FAG bearings and contact pattern on outer race. The two cages, one grey and one blue, superimposed to show the difference in design. Source: Airbus Helicopters

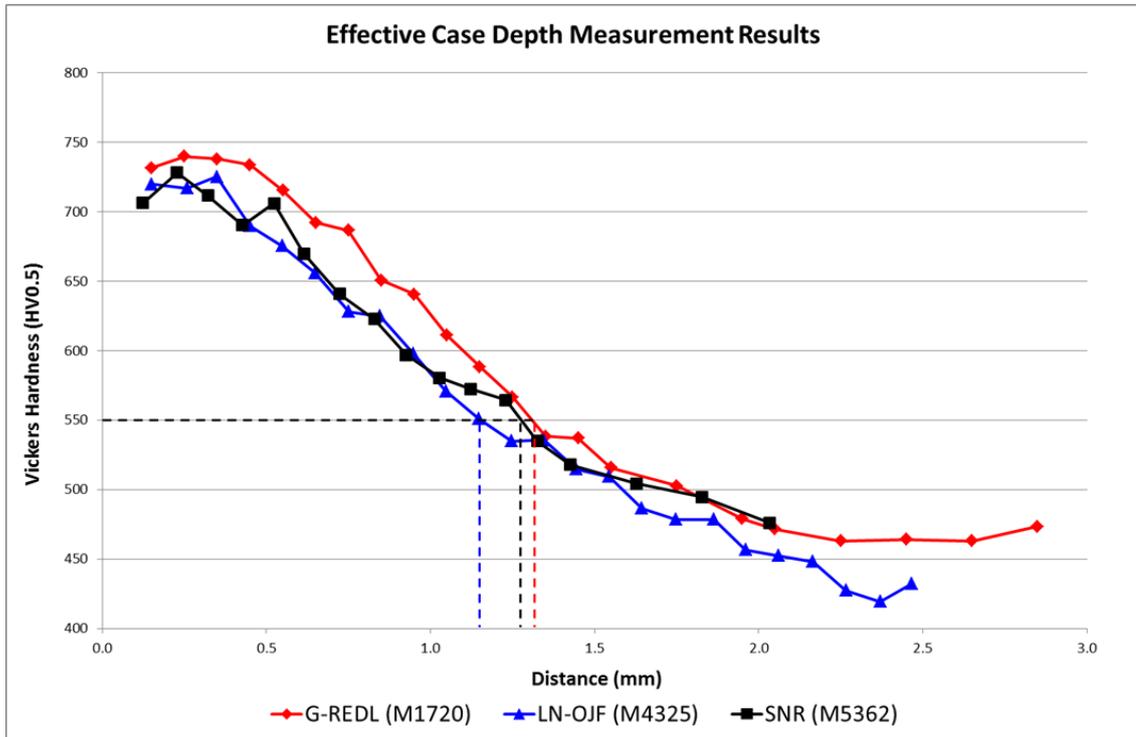
All of the planet gears are case hardened (carburised) by Airbus Helicopters before final grinding of the bearing surfaces. No significant differences in effective case depth have been noted between any of the gears examined, see Figure 69. Surface hardness measurements by both AIBN/QinetiQ and Airbus Helicopters at a range of different loads showed that the FAG gears tend to have a higher surface hardness, see Figure 70. This is consistent with the typically higher surface compressive residual stress in FAG gears, and is believed to be related to the final stage of the manufacturing process.

Figure 69: Outer race hardness values, comparison between a NTN-SNR gear, LN-OJF and G-REDL Figure: AIBN/QinetiQ

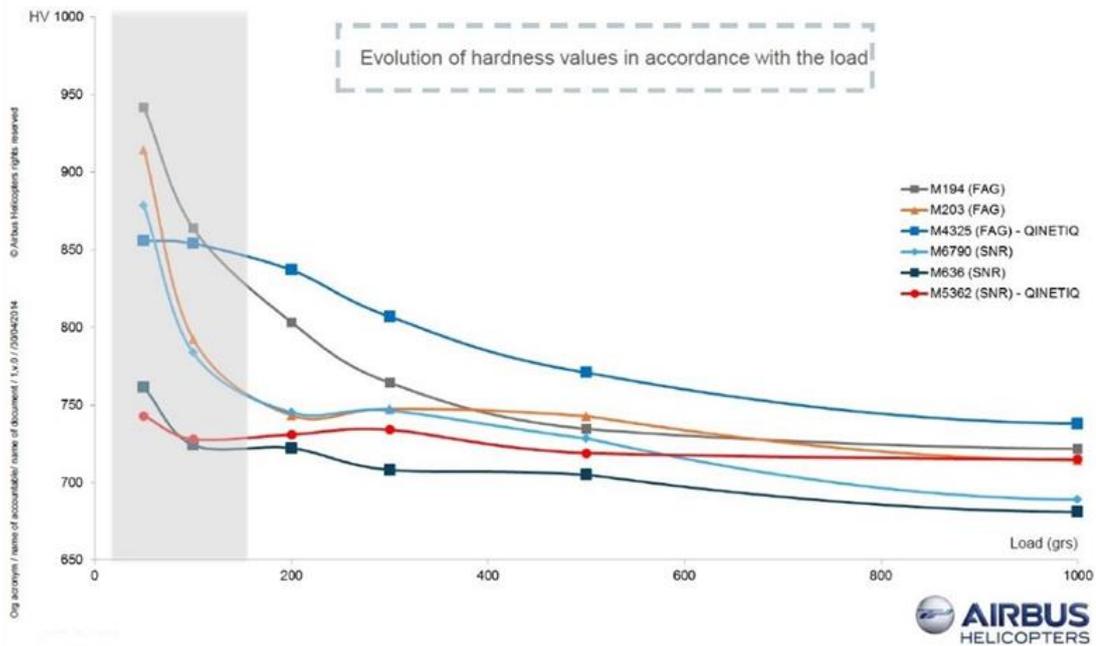
Figure 70: Hardness values vs. indentation load. From upper at the left hand side in the figure: FAG, FAG, FAG (QinetiQ), NTN-SNR, NTN-SNR, NTN-SNR (QinetiQ). Figure: Airbus Helicopters
