REPORT

SL 2018/04

REPORT ON THE AIR ACCIDENT NEAR TURØY, ØYGARDEN MUNICIPALITY, HORDALAND COUNTY, NORWAY 29 APRIL 2016 WITH AIRBUS HELICOPTERS EC 225 LP, LN-OJF, OPERATED BY CHC HELIKOPTER SERVICE AS

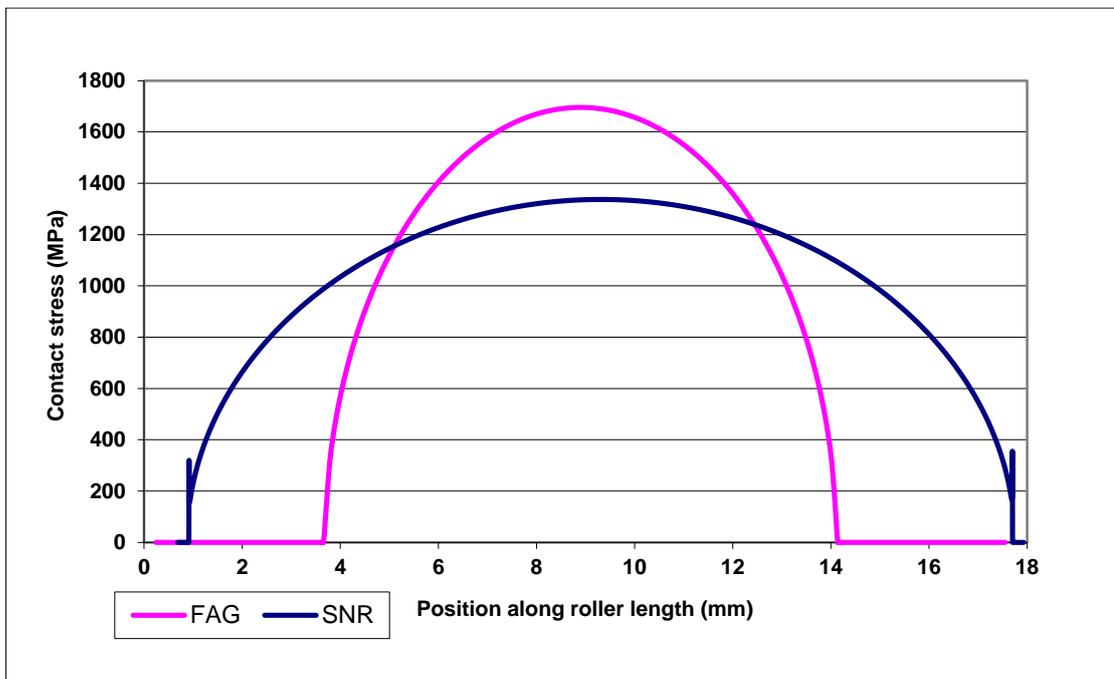
Both inner and outer raceways of the FAG bearing experience higher central contact stress than the SNR bearing. The stresses for the outer raceway are the most relevant to the failure mode in this investigation, and the graph below compares the two types (see Figure 71). As can be seen, the contact pattern for the FAG bearing is more concentrated towards the centre of the roller length. These results are consistent with Airbus Helicopters calculations performed after the accident.

ISO 281 (2007 and earlier) calculation methods for bearing L10 life do not take into account the curvature of the raceway and roller profiles, and therefore show almost identical L10 lives (within 10 %) for both bearing types. This method would have been used for design and assessment purposes, and so there was nothing at the time to alert the helicopter manufacturer to possible differences between the bearings.

Figure 71: Comparison of outer race contact stresses for peak roller load. EC 225 LP mean cubic power condition. Source: Romax/AIBN

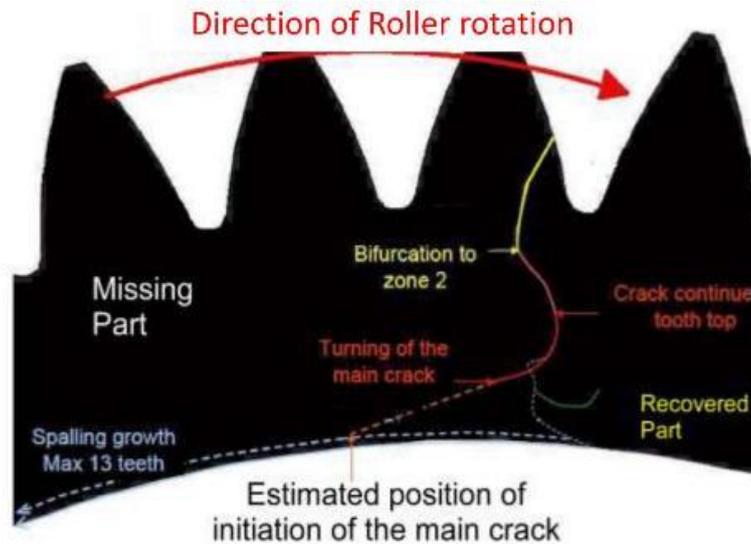
Figure 74: Stress model estimation of crack growth. Source: Airbus Helicopters

- 1.18.2.4 The origin of the crack was found to be in a section of the failed gear which was not recovered. Figure 74 shows a stress model prediction of crack growth as displayed in the G-REDL report. The Findings section in the report contained amongst the following:

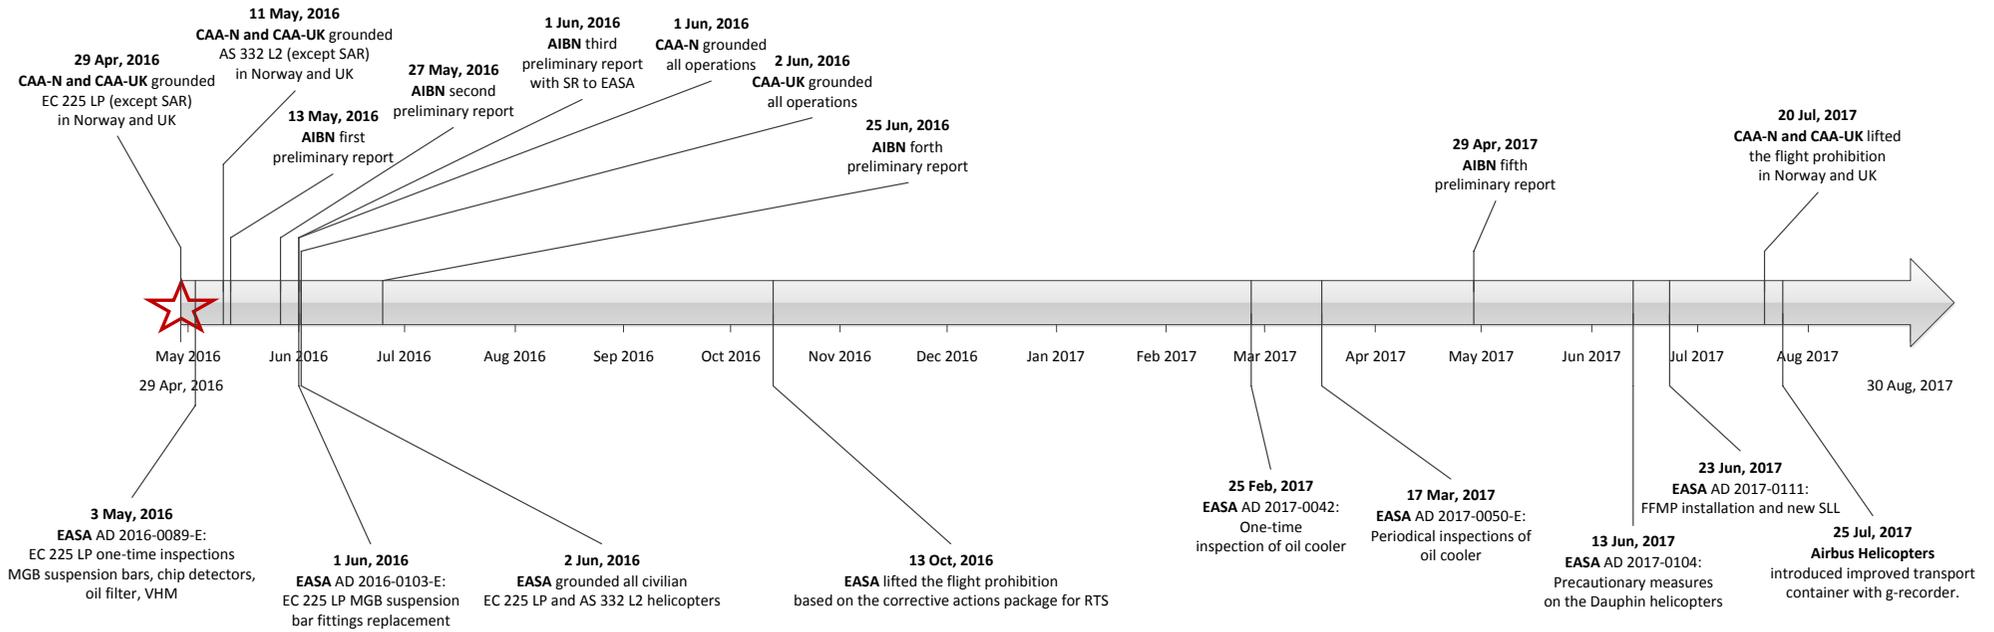
Figure 75: Overview LN-OJF safety actions. Illustration: AIBN

- 1.18.6.8 The detailed changes in maintenance requirements for the EC 225 LP are described in Appendix C.

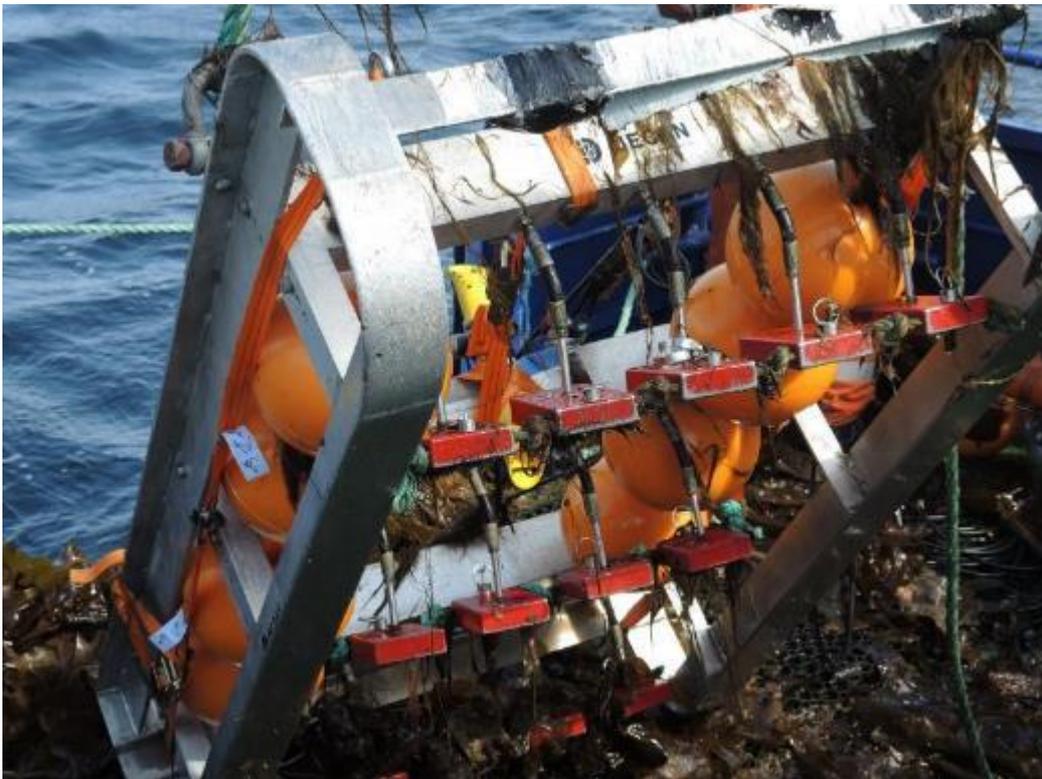
- 1.19.1.1 During the early search phase, Miko Marine AS was contacted by the AIBN and asked if they could provide a device for picking up magnetic parts from the sea bed. The company produced a sledge with magnets intended to be towed along the seabed (see Figure 76). The sledge was 200 cm long, 100 cm wide and 50 cm high. It was designed from aluminium and weighed 150 kg. The sledge had three rows of strong magnets (14 in total) installed on flexible supports and each with a capacity of lifting 500 kg. The sledge was equipped with buoyancy measures for operating sub-sea and two video cameras for operations monitoring.

- 1.19.1.4 The main challenge was to follow a defined search line on anything but even, flat seabed. The width of the sledge limited the progress if 100 % coverage was to be achieved. Heavy sea weed growth did also cause trouble as it accumulated on the sledge and caused the magnets to bend.
- 1.19.1.5 The magnetic sledge found parts such as fragments from epicyclic gear inner races and rollers from epicyclic gear bearings.

Figure 76: The magnetic sledge being retracted from the sea. Photo: AIBN

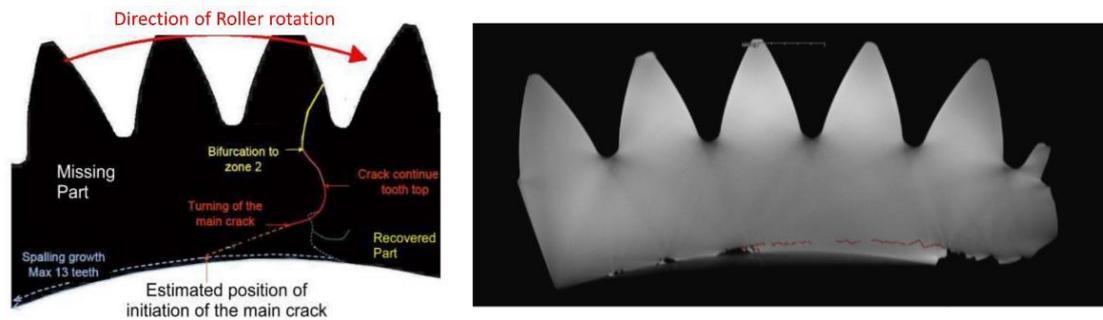
- 2.8.2.5 As the parts of the planet gear in which the fracture initiated were recovered from LN-OJF, the AIBN/QinetiQ was able to document the full extent of the crack, i.e. the initial micro-pit and crack formation subsurface. In the G-REDL, AAIB/QinetiQ did not have the initial part of the crack so they could only make assumptions on crack initiation and propagation.

- 2.8.2.6 The G-REDL report displayed a stress model prediction of crack growth in the section of the planet gear which was not recovered (see section 1.18.2). The crack propagation underneath the depth of the carburized layer in the retrieved second stage planet gear from the LN-OJF accident appears to be very similar to the G-REDL stress model prediction of crack growth (see Figure 77). The LN-OJF gear segment closely resembles the estimated missing gear part from G-REDL.

Figure 77: Stress model estimation of crack growth from the G-REDL accident to the left (Source: Airbus Helicopters) compared with the CT scan from the LN-OJF gear with the crack in red (Photo: CT-scan from AIBN/Southampton University).
