REPORT

SL 2019/01

REPORT ON AIR ACCIDENT IN PORT OF BERGEN, HORDALAND COUNTY, NORWAY, 10 MAY 2017 INVOLVING AIRBUS HELICOPTERS AS 350 B3, G-HKCN

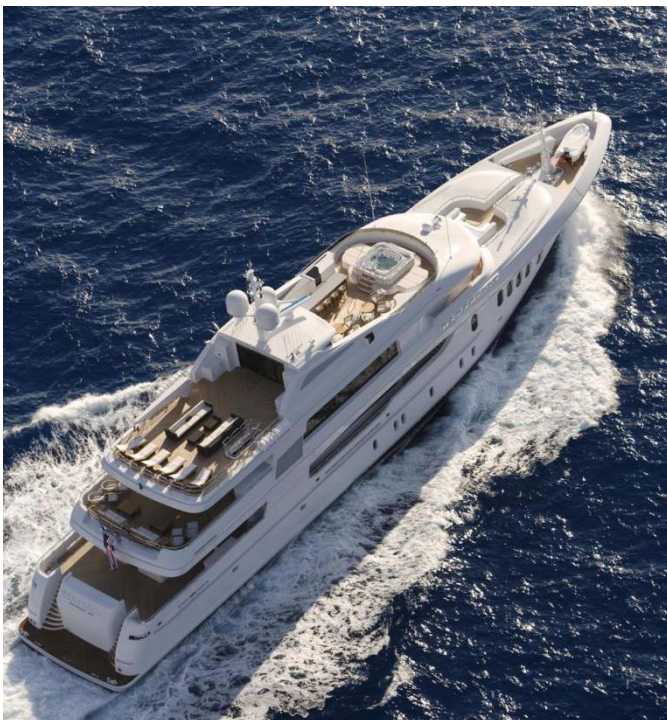
Figure 9: M/Y Bacarella; the upper aft deck was used as a helideck. Source: YachtCharterfleet.com

1.17.2.5 In spite of the fact that it was not required from any authority, M/Y Bacarella nevertheless had a Helicopter Operations Manual on board. The procedures laid down in this manual to prepare for helicopter landings were not adhered to on the day of the accident. The newly employed first mate was not properly trained or briefed on the tasks and responsibilities in the role as HLO. The manual's check list for preparing for helicopter operations says the following about loose items on the helideck:
