RAPPORT LUFTFART 2025/04

Luftfartsulykke ved Seterfjellet i Alta kommune, Finnmark fylke 20. mai 2024 med Robinson R44 Raven II, LN-OBN

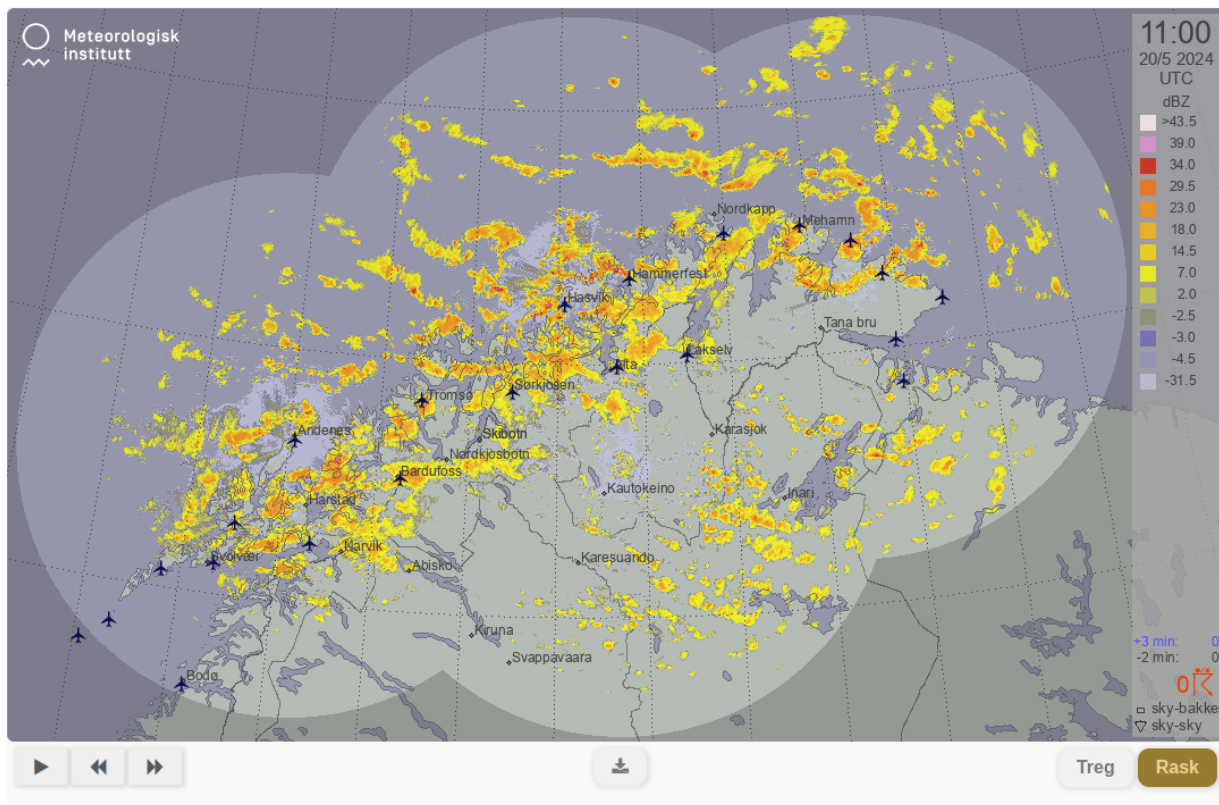
Figur 4: Radarbilde fra 11:00 UTC viser byer langs kysten av Troms og Finnmark. Illustrasjon: Meteorologisk institutt / SHK

Den generelle, observerte, og varslede, værsituasjonen var preget av vest-nordvestlig vind over Troms og Finnmark med moderate snøbyger og vindkast, se figur 4. Værrapporten beskriver i hovedsak en uendret værsituasjon gjennom dagen.

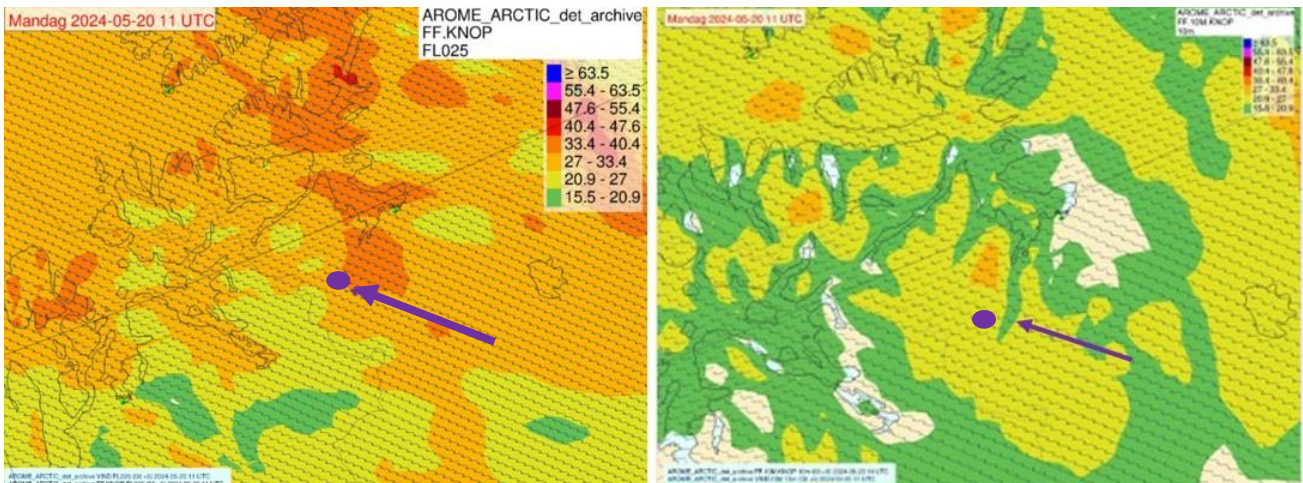
Figur 5: Vindmodell for området rundt Alta i 2 500 ft / 760 m (venstre bilde) og ved bakken (høyre bilde). Ulykkesstedet er markert med lilla punkt og pil. Kilde: Meteorologisk institutt / SHK

Vinden var, ifølge modellen, stabil vest-nordvestlig. Den var rolig i lav høyde, men økte raskt opp mot stiv til sterk kuling (30–40 kt / 14–20 m/s) i høyder over 2 500 ft (760 m), se figur 5.

Havaristedet ligger ca. 560 meter over havet, og modellen viser at vinden på havaristedet var fra vest til nordvest med liten kuling, lokalt opptil stiv kuling. Temperaturen på Alta lufthavn var en plussgrad og aktuell nullisoterm var null grader på 250 ft. Havarikommisjonen har beregnet temperaturen på havaristedet til mellom -1 °C og -2,5 °C. Tabellen under viser hvordan vindkjølingseffekten varierer med den aktuelle temperaturen (i to meters høyde) og den observerte vindstyrken (i ti meters høyde)³, se figur 6.
