REPORT

Sjø 2010/01

REPORT ON MARINE ACCIDENT
FEDERAL KIVALINA - IMO NO. 9205885
GROUNDING AT ÅRSUNDØYA, NORWAY
6 OCTOBER 2008

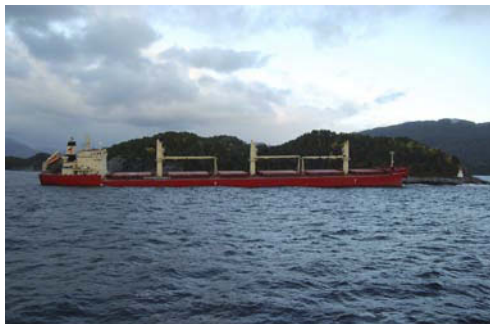
Figure 2: Federal Kivalina. Photo: KV Njord.

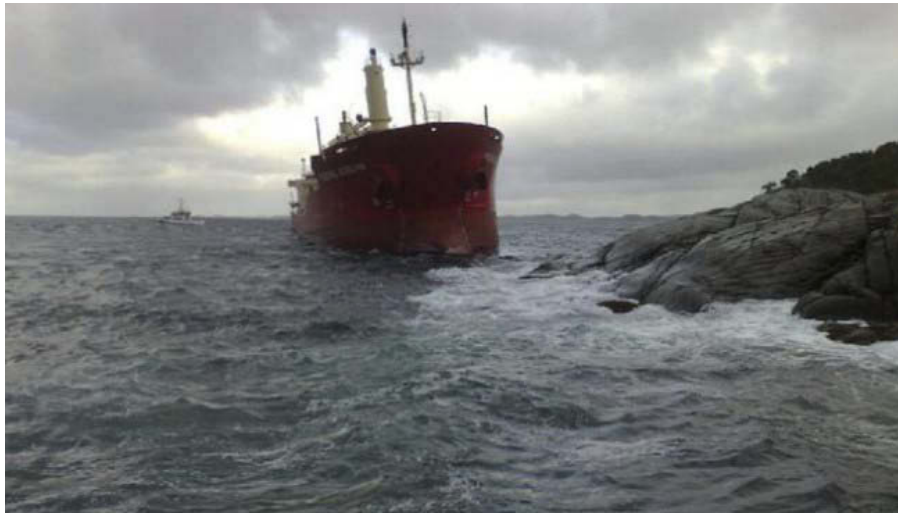
Figure 3: Federal Kivalina. Photo: NRK

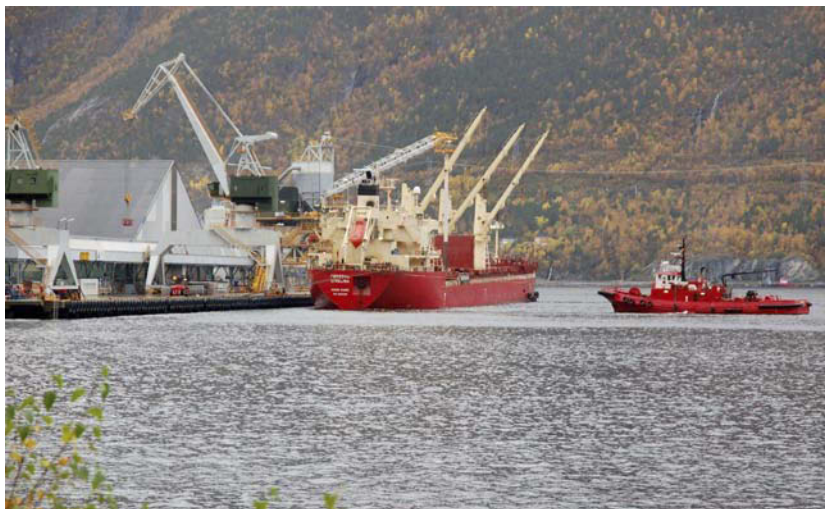
Figure 4: Federal Kivalina by Sunndalsøra, Norway. Photo: Aure Avis

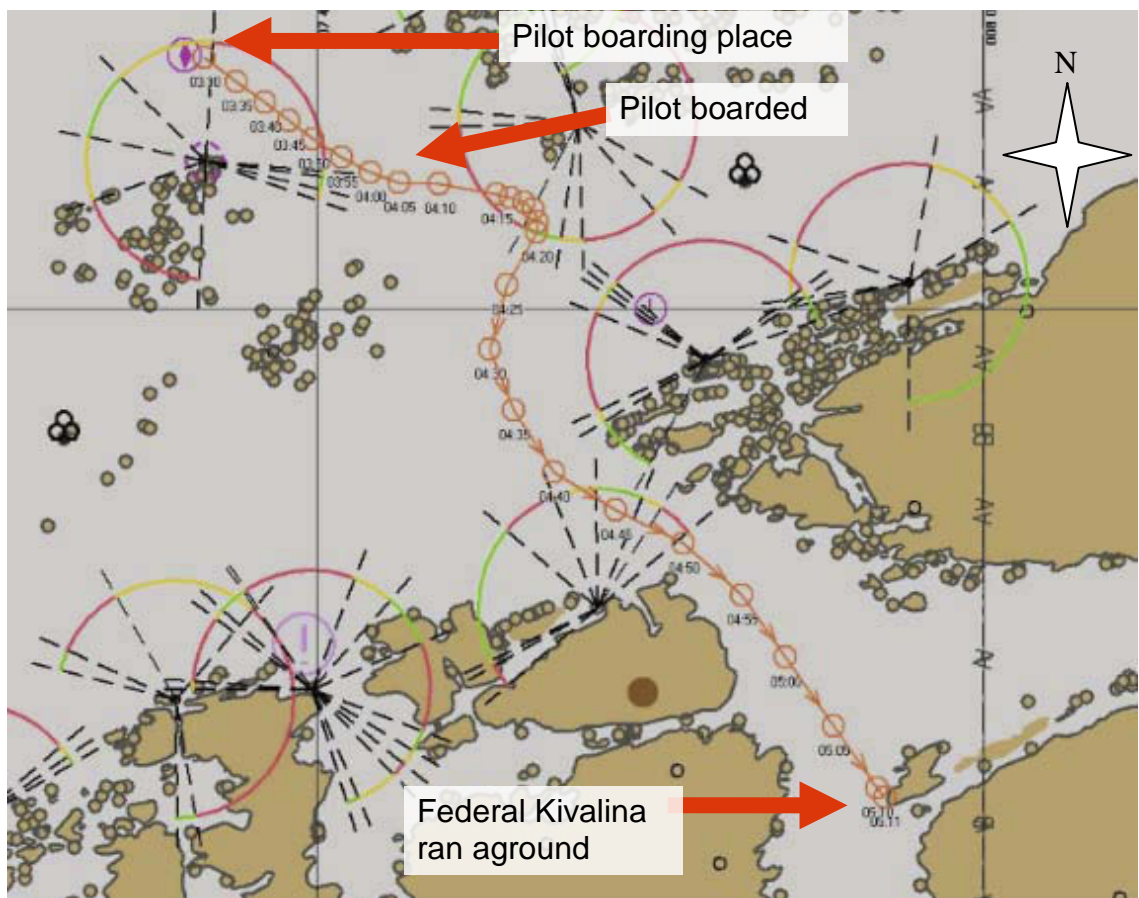
Figure 5: Overview of the ship's movements from Griphølen and south-easterly to the site of the accident at Skarvberneset, Årsundøya.

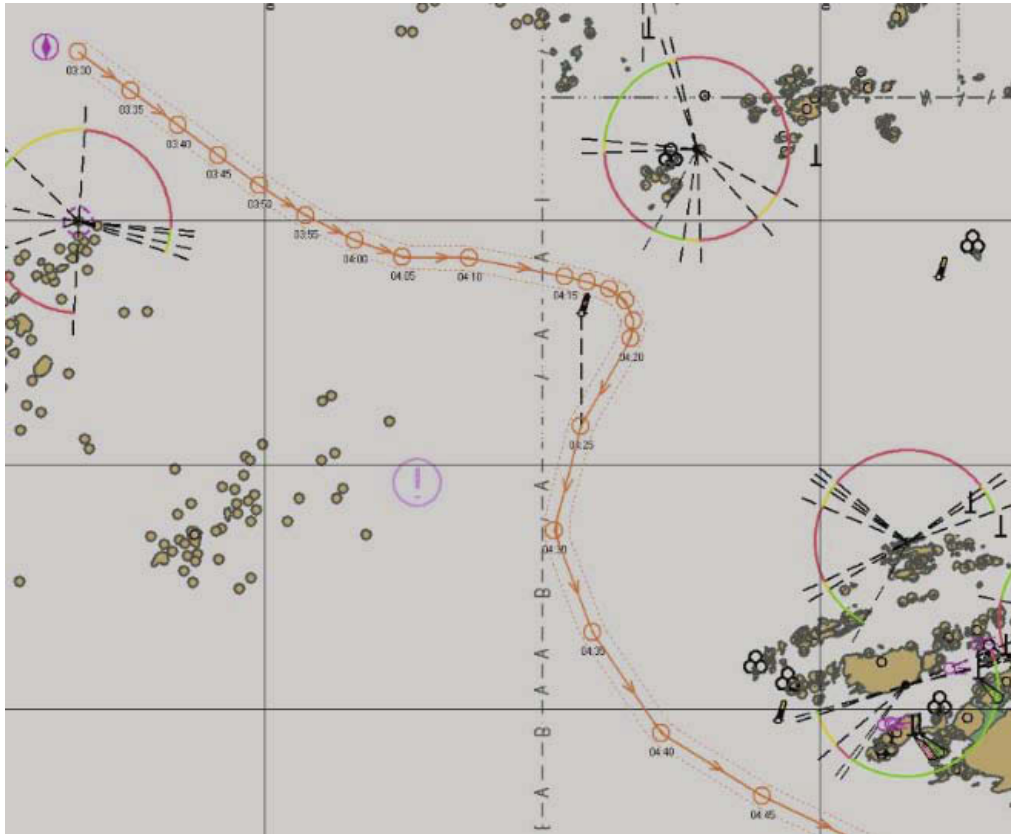
Figure 6: The ship's movements from Griphølen (0330 hrs) and towards the southeast to Talgsjøen (0445 hrs).

At 0452 hours, the ship was in the middle of the fjord in Talgsjøen between Ausfallet at Golma and Kolvikbukta at Nordlandet. The pilot ordered the ship to head for the beacon at Skarvbergneseet, Årsundøya by keeping a steady course of 149 degrees. The ship maintained this course until reaching the accident site. There were no other ships nearby.

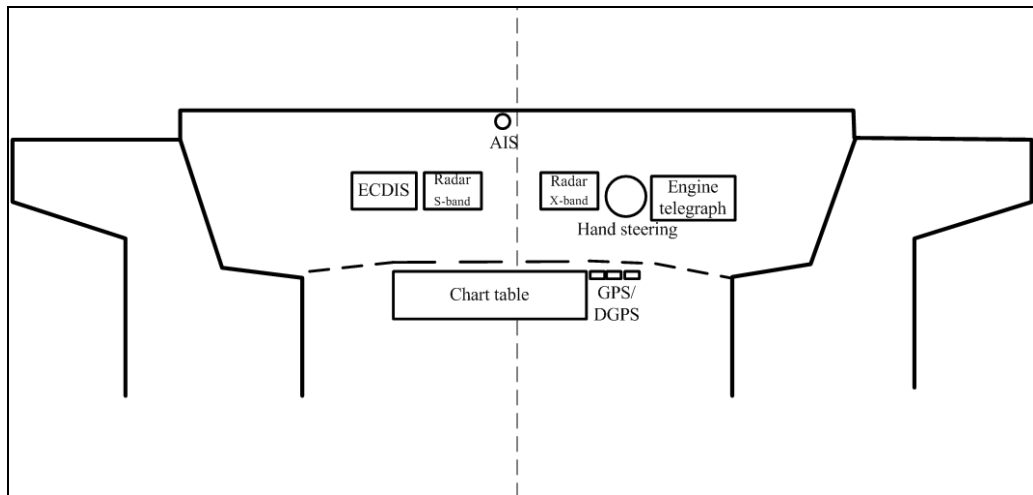
The vessel is equipped with traditional bridge arrangements where instrument desks, an electronic chart machine, two radar consoles (port side: 10 cm (S-band), starboard side: 3 cm (X-band)) and the position for hand steering have been located in a row in the middle of the wheel house, see Figure 9. Manoeuvring of the main

The AIS receiver and the pilot plug have been placed in front of the wheel house, along the centreline. The line of sight straight forwards from the AIS is blocked by the large cranes, which block the sightlines about 3 degrees to either side.

Figure 9: Simplified sketch of some of the ship's bridge equipment. Due to the location of the ship's cranes, the hand steering position has been shifted a bit to starboard to give the helmsman a free line of sight forward.

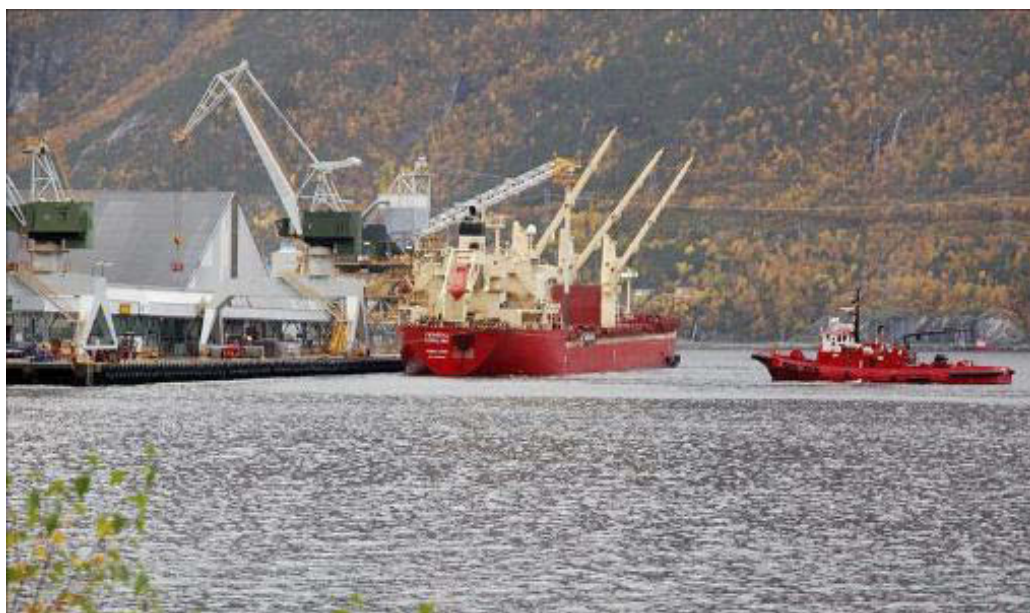
Figure 12: A tugboat assists in keeping the ship clear of the quay since the draught is too great. For ships with an equivalent load capacity to the Federal Kivalina, 6000-9000 tonnes of aluminium oxide are usually unloaded, and it may take up to 24 hours before the ship can lay alongside the quay. Photo: Aura Avis

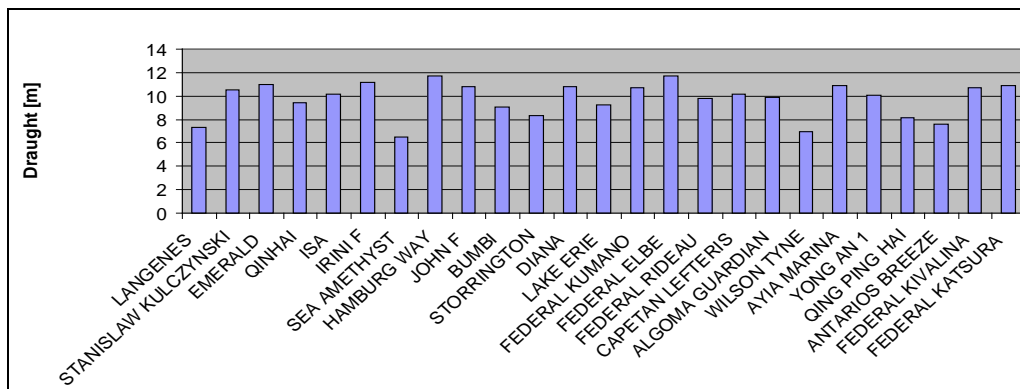
Figure 13 Draught of the ships (meters) calling at the Hydro quay in Sunndal for offloading of aluminium oxide. Only the first 10 months of 2008. Information on the draughts of the ships is from the AIS. The greatest permitted draught for the quay facility is 9.3 metres.

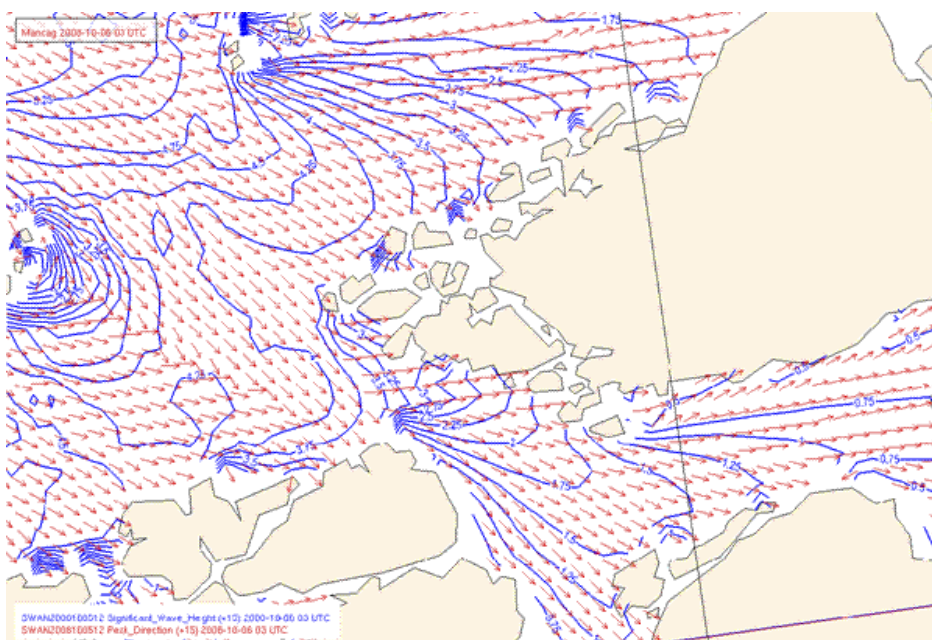
The special forecast from the Norwegian Meteorological Institute for the area, valid for 0500 hours (local time) indicated significant wave heights of 3.5 metres at the inlet to Talgsjøen and 1.25 metres at Årsundøya.

Figure 14: Simulation of the wave conditions carried out by the Norwegian Meteorological Institute. The diagrams indicate significant wave heights (H_s) and the direction of the wave field. The prognosis was valid for 0500 hours local time on 6 October.

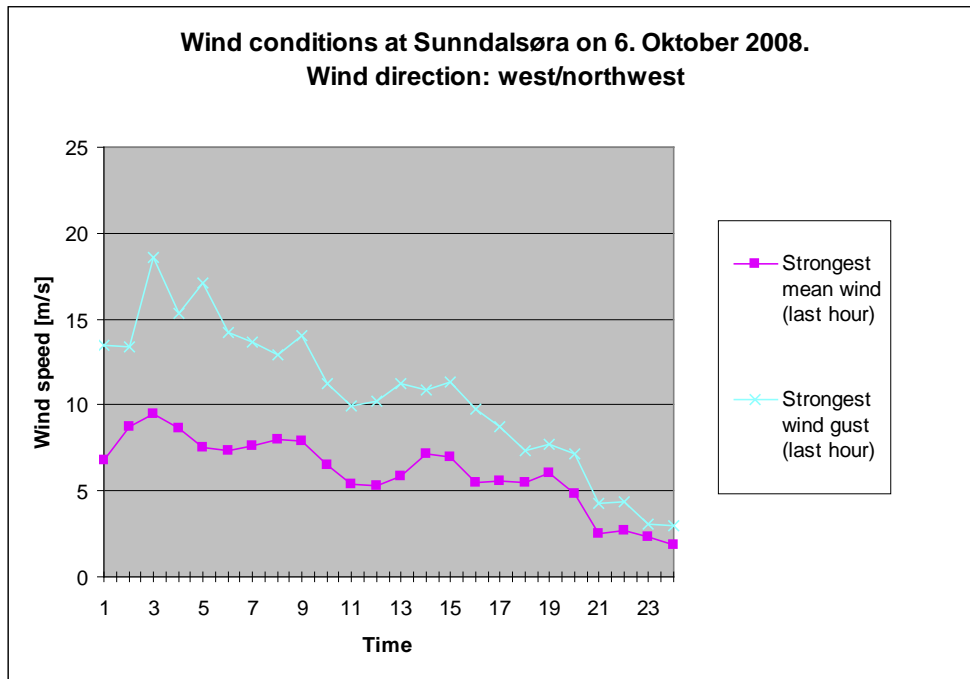
According to the Norwegian Meteorological Institute, the weather conditions at the facility were a moderate breeze (7.5 m/s) with squalls of 17.1 m/s. The wind direction came from a westerly/north-westerly direction.

Figure 15: Wind conditions at Sunndalsøra. The Norwegian Meteorological Institute has an automatic measuring station at Sunndalsøra with observations every hour. The measuring station is located behind the Hydro quay at the river inlet. The AIBN has not evaluated whether these figures are representative of the actual weather conditions at the Hydro quay with the wind direction at the time. Source: The Norwegian Meteorological Institute.

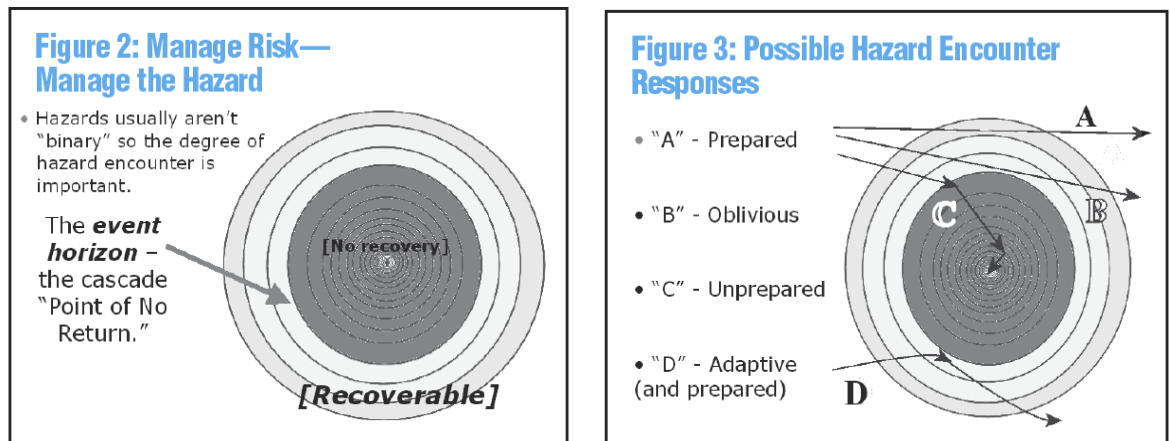
Figure 16: Source: April–June 2007 ISASI Forum – "Accidents & Astrophysics" by Rick Clarke

At left: Hazards illustrated as astrophysical black hole. When approaching a hazard the loss of control may increase gradually until a point of no return.
