REPORT

Mar 2010/10

REPORT ON INVESTIGATION OF MARINE ACCIDENT SUNDSTRAUM IMO NO 8920567 AND KAPITAN LUS IMO NO 9077551 COLLISION IN ØRESUND 3 JULY 2009

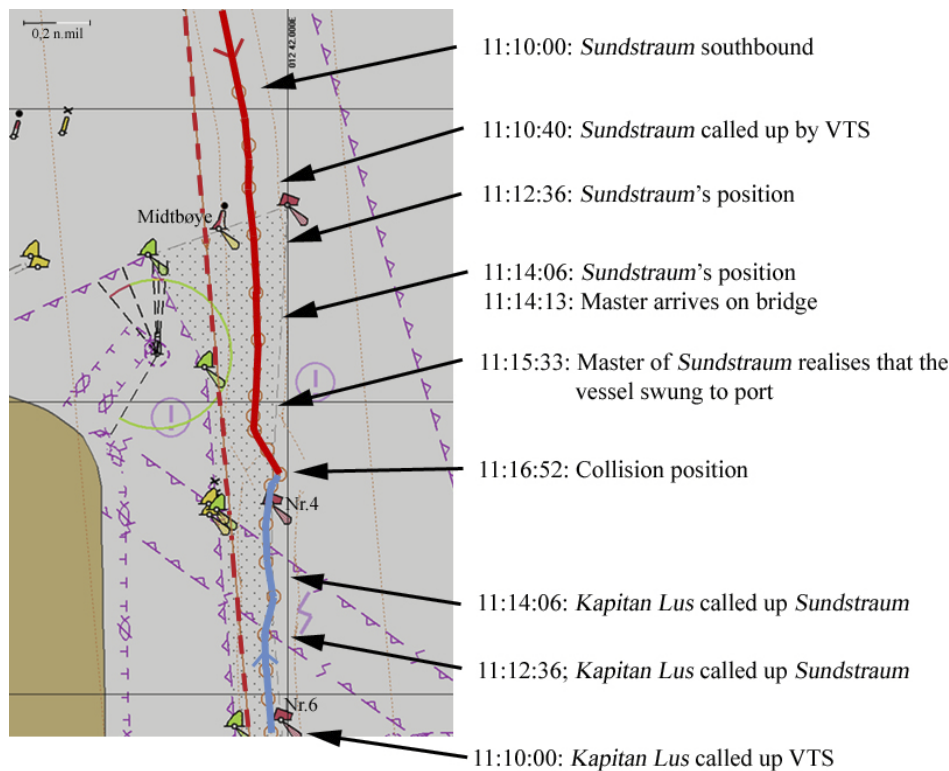
Figure 4: Map section showing a sketch of *Sundstraum*'s passage (red solid line) and *Kapitan Lus*' passage (blue solid line), and *Sundstraum*'s planned passage (red broken line).

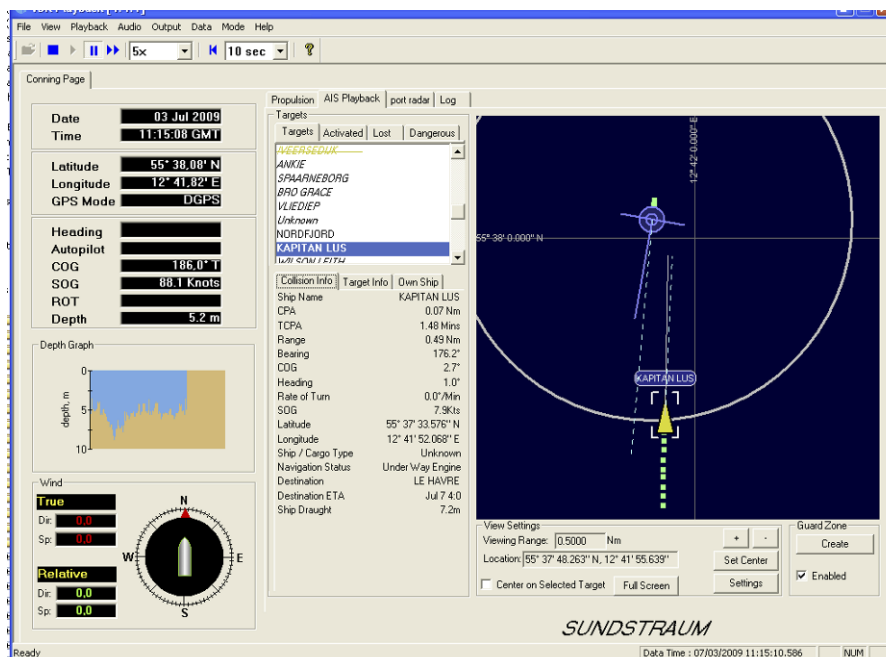
At 11.15.10 the situation, as viewed from *Kapitan Lus*' side, was again clarified, and the intention was for a port to port passing with a closest point of approach of 0.07 nautical mile (130 m) (see Figure 6). Nevertheless, the pilot and Master on board *Kapitan Lus* were uncertain of *Sundstraum*'s movements, and the pilot ordered the engine reduced to slow ahead and placed the vessel as far to starboard in the fairway as he could.

Figure 6: Picture from *Sundstraum*'s S-VDR showing the situation at 11.15.10. The distance between the vessels at this time was 0.49 nautical miles (907 metres).

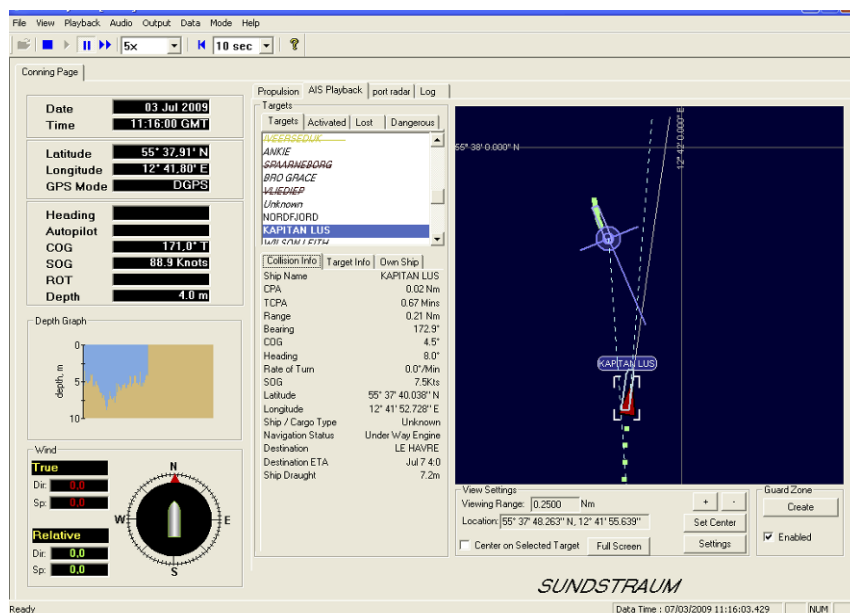
At 11.16.03 *Sundstraum's* Master went to the VHF radio at the rear of the bridge and announced that the vessel was not under command. He then returned to the manoeuvre console and put the engine into reverse. The distance to *Kapitan Lus* was now 0.21 nautical miles (see Figure 7). At this time the pilot on *Kapitan Lus* realised that his turn to starboard could not prevent collision with *Sundstraum*. He then ordered the engine put hard astern in the hope that the *Sundstraum* would pass in front. The pilot soon observed that *Sundstraum* would not pass in front of *Kapitan Lus*. He then ordered full ahead and the rudder hard to port to make the vessels stern turning away from *Sundstraum* to reduce the impactforce of the collision.

Figure 7: The situation at 11.16.03.

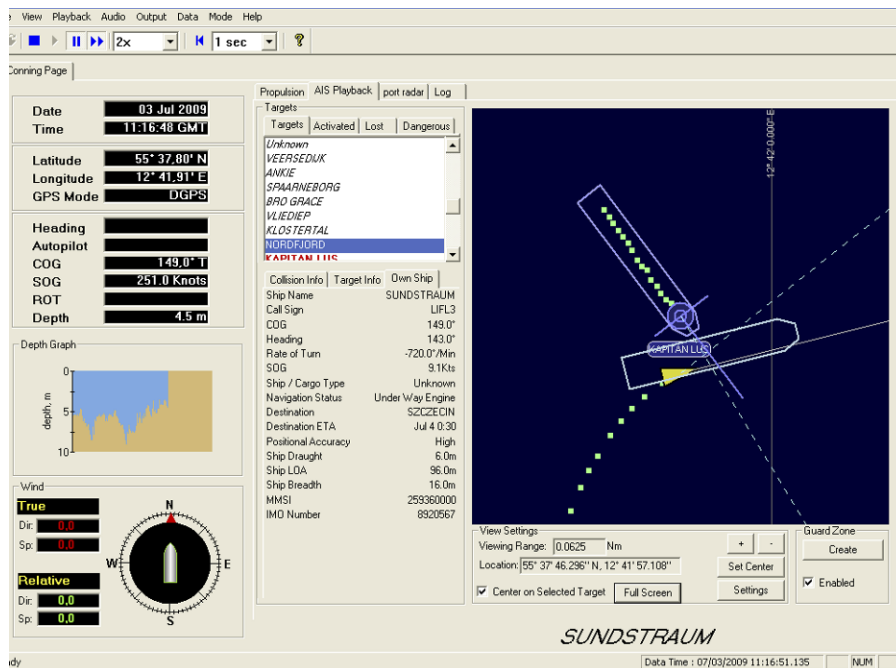
The Master of *Sundstraum* considered that a collision was unavoidable, and decided at this point that he would try to turn the vessel further to port in order to reduce the angle of collision. He tried to turn to port with the aid of the joystick, but the vessel did not react. *Sundstraum* and *Kapitan Lus* collided at 11.16.52. (See figure 8).

Figure 8: The situation just before the collision, 11.16.51. *Sundstraum's* speed had now been reduced to 9.1 knots.

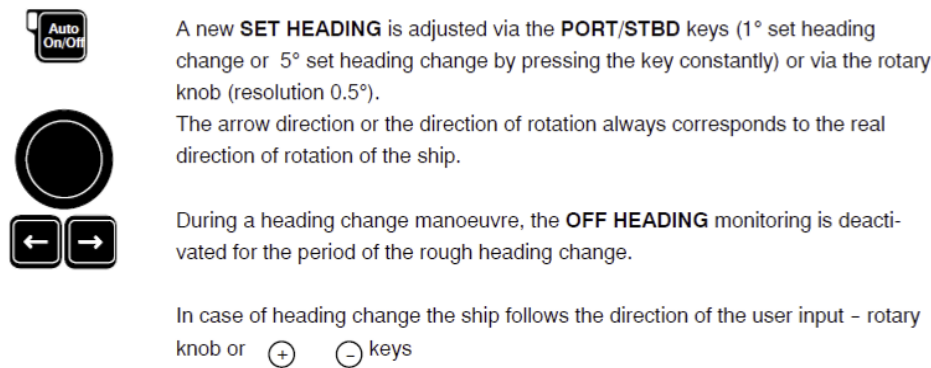
The normal manual steering is linked to the autopilot and located on the right side of the panel (see Figure 11). To change from autopilot steering to manual steering, the button on the right on the panel on the right must be pressed. The switch from autopilot to manual steering is marked by three short, distinct peeps. As long as the ship is set on autopilot steering, movement of the manual joystick will not result in a change of turn. There are two ways of changing the autopilot set heading: either by turning the round knob on the autopilot panel, or by using the two arrows located next to this round knob. The arrows have two functions: pressing once will change the set heading by 1°, while holding the arrow down will change the heading by 5° (see Figure 12).

Figure 12: Excerpt from the autopilot user instructions which describe how to change the autopilot set heading.

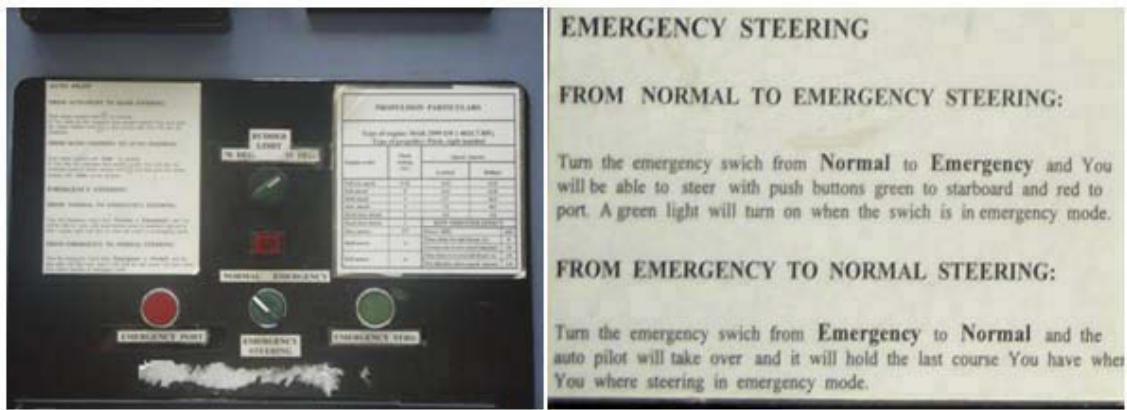
Figure 13: Emergency steering panel and procedure for emergency steering to the left. To the right, enlarged picture of emergency steering procedure.

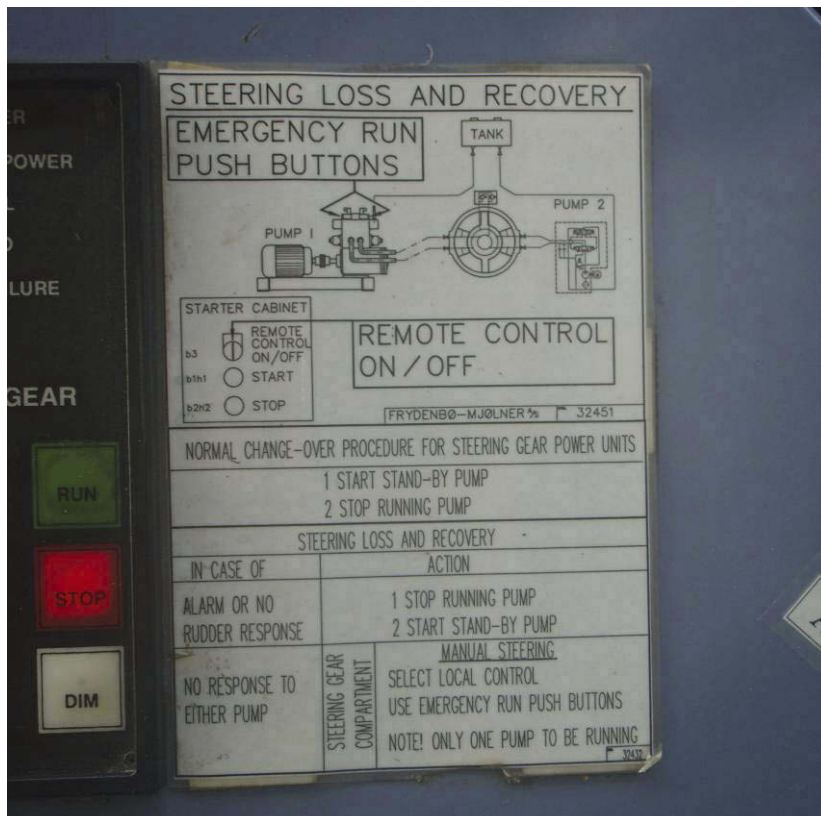
The vessel is also equipped with the option of performing emergency steering from the steering gear room. Instructions for steering recovery are posted up in connection with the panel for manning the steering gear pumps on the central manoeuvring console on the bridge (see Figure 14).

Figure 14: Instructions for handling loss of steering.
