# REPORT

Sjø 2012/09

## REPORT ON INVESTIGATION INTO MARINE ACCIDENT M/V GODAFOSS V2PM7 GROUNDING IN LØPEREN, HVALER ON 17 FEBRUARY 2011

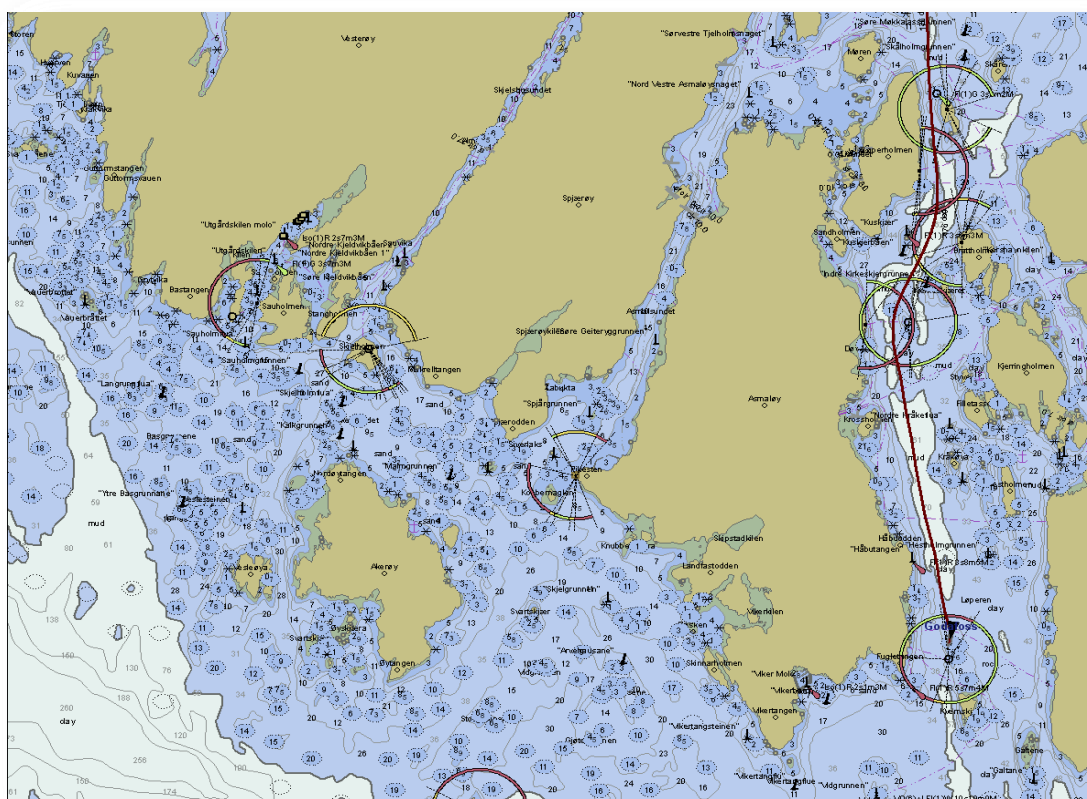
Figure 3: The last part of *Godafoss*' voyage in Løperen on 17 February 2011 (shown by the red line).

At 19:43 the pilot took his leave and left the bridge together with the chief mate. *Godafoss* was then abeam off Skipstadsand on a steady course of 173° doing 8 knots. The vessel was heading just east of Kvernskjærgrunnen beacon, sailing near the boundary between the white and red sectors. The distance to Kvernskjærgrunnen was 1.4 nmi; see Figures 3 and 4.

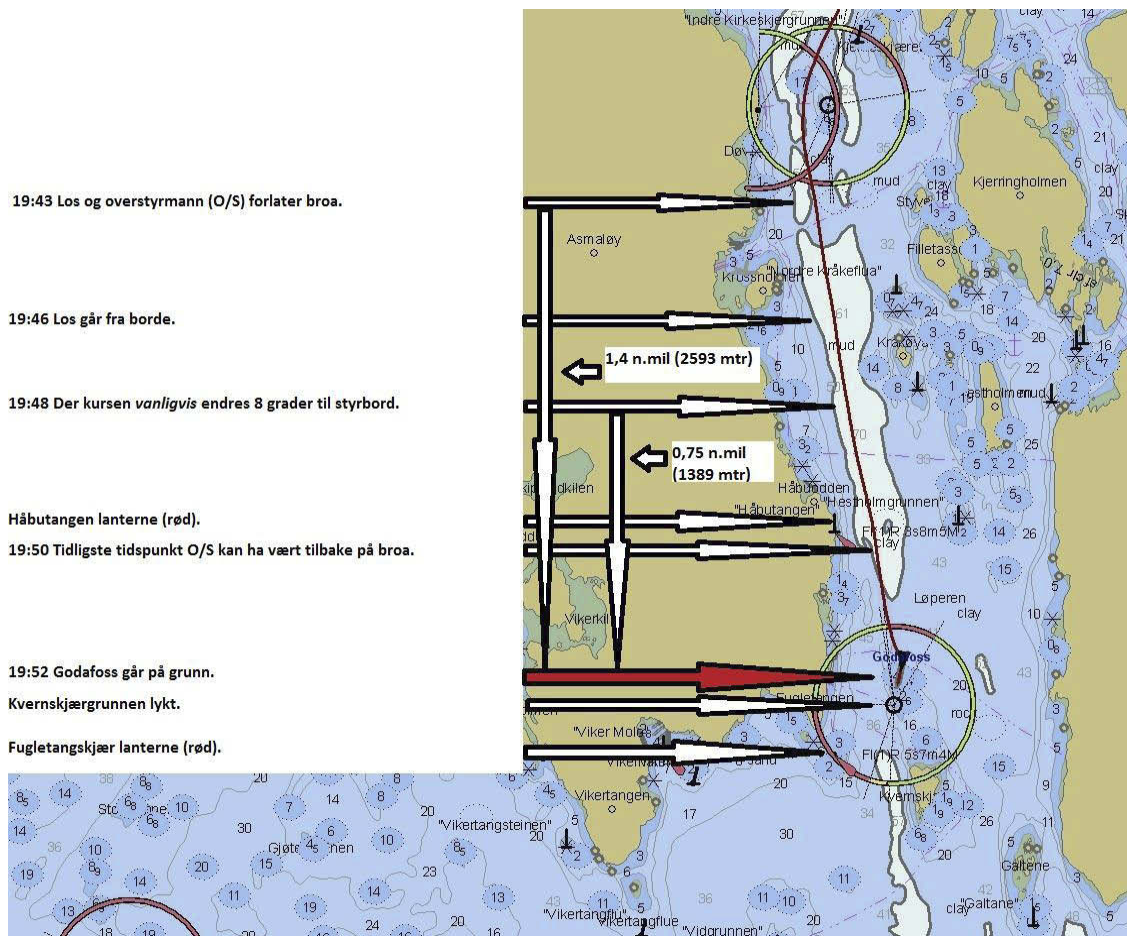
Figure 6: Bearing and comments.

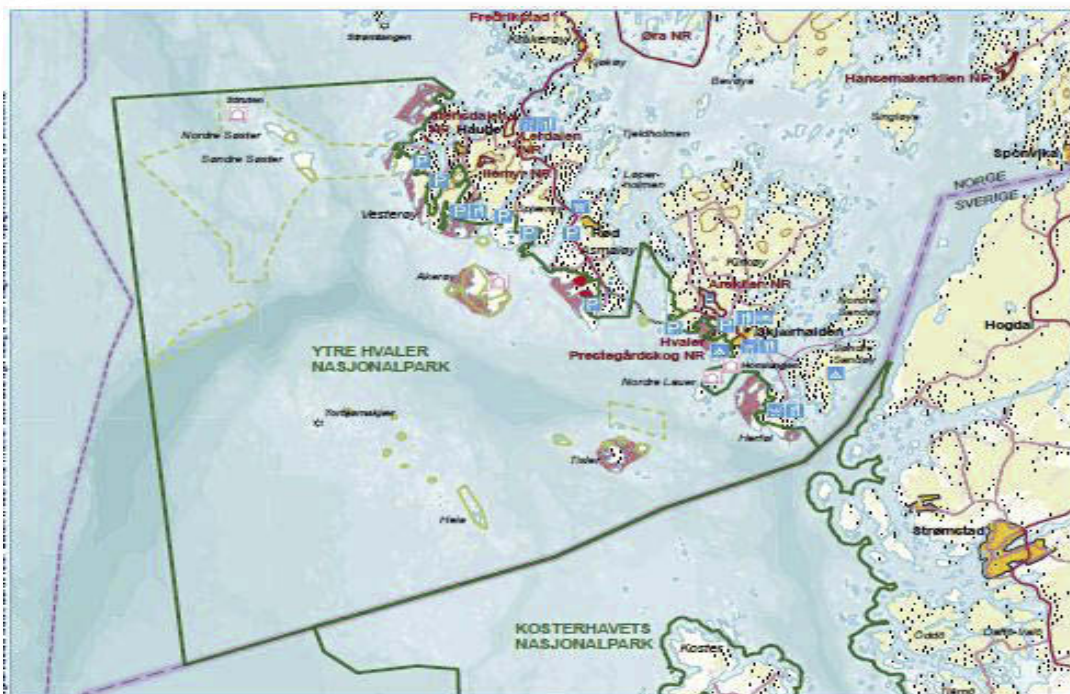
The northern boundary of Outer Hvaler National Park runs through Løperen (Figure 4). Kvernskjærgrunn, on which *Godafoss* ran aground, is just inside the boundary of the national park, and as early as 2006 was made into one of several protected lobster reserves along the Skagerrak coast.

Figure 14: Map section showing the boundaries of Outer Hvaler National Park and Kosterhavet Marine National Park. Source: Norwegian Directorate for Nature Management

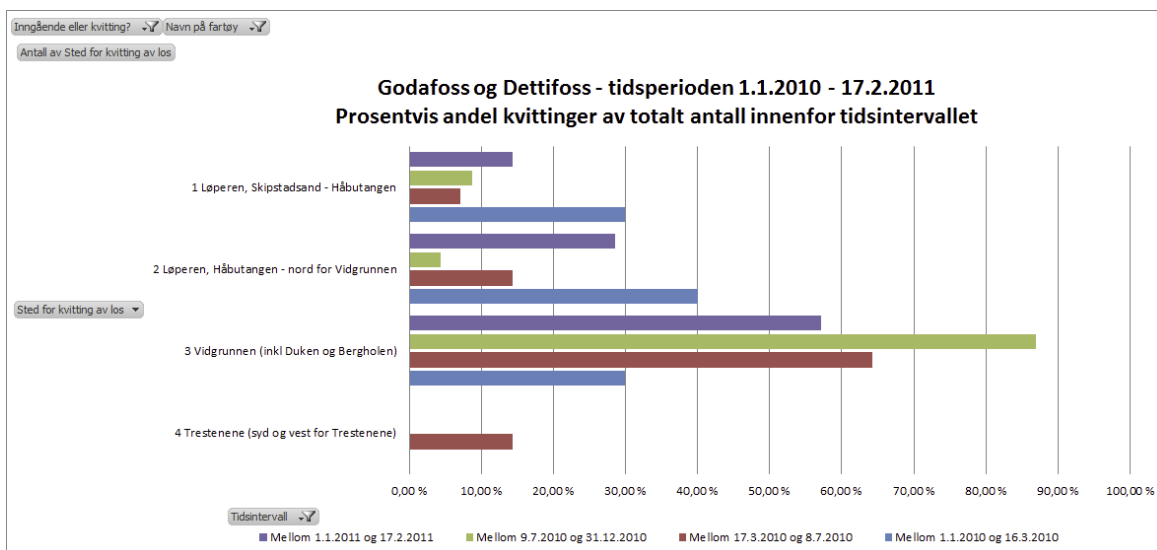
Before the introduction of immediate measures by the head of pilot services, disembarkation took place in Løperen in the case of 70% of all pilot assignments on *Godafoss* and *Dettifoss*; see Figure 15. That is a significantly higher proportion than for the total number of vessels that sailed out Løperen under pilotage.

From the beginning of 2011 until the time of the accident, every third disembarkation during outbound voyages with *Godafoss* and *Dettifoss* took place in Løperen. Disembarkation at Vidgrunnen took place during both calm and very rough seas.

Figure 15: Breakdown in per cent on place of disembarkation for Godafoss and Dettifoss from 1.1.2010 to 17.2.2011. Percentage share is in relation to the total within the same time period.

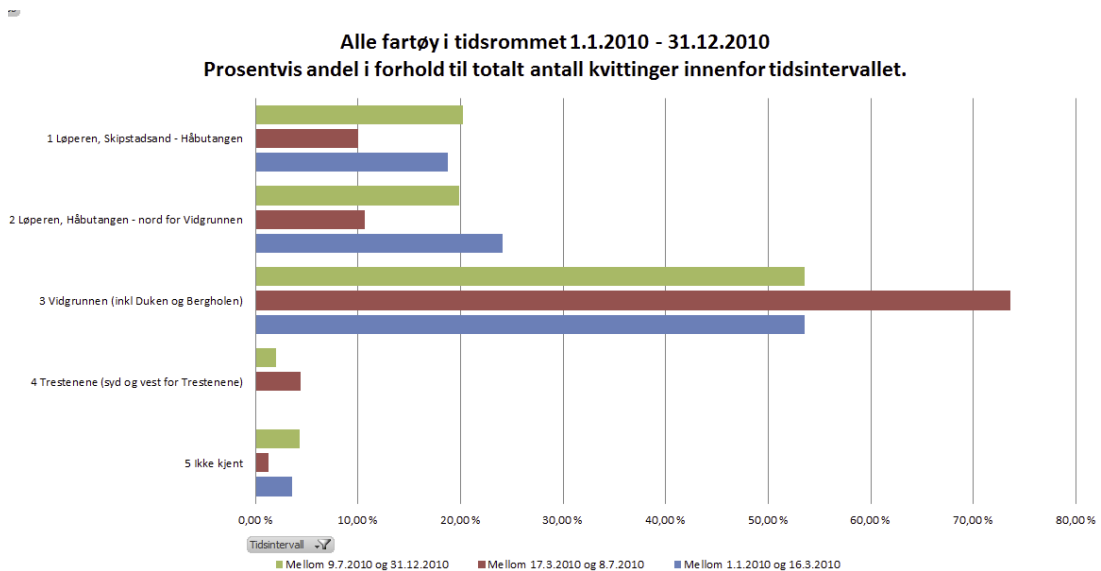
A considerable reduction in the practice of disembarkation in Løperen can be observed following the immediate measure introduced by the head of pilot services in March 2010, see Figure 16. When the new instructions were perceived to be applicable in July 2010, it once again became more common for pilots to disembark in Løperen. After that, pilot disembarkation in Løperen took place in the case of approximately 40% of all vessels under pilotage.

Figure 16: Break-down in per cent on pilot disembarkation points for all vessels in 2010. Percentage share is in relation to the total within the same time period.

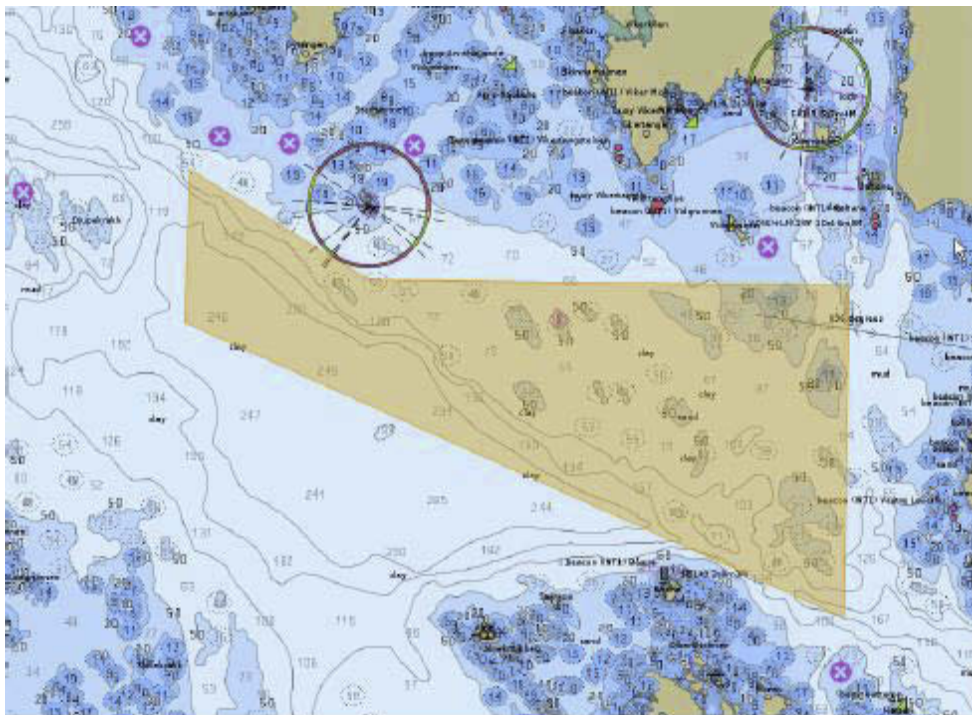
The boarding ground/precautionary area is shown in Figure 18.

Figure 18: Map of parts of Outer Hvaler. The shaded field shows the pilot boarding ground/precautionary area in accordance with the instructions LOS 9.8.1.OSA - Pilot boarding at Vidgrunnen. The instructions were adopted just after Godafoss ran aground.

For its part, the NCA is understood to have updated its procedures to prevent the recurrence of similar incidents, at the same time as specific plans are being drawn up for widening the fairway and installing new sea marks for sailing to the Port of Borg.
