# REPORT

## Sjø 2013/02

## REPORT ON THE INVESTIGATION OF A MARINE ACCIDENT NORDLYS LHCW - FIRE ON BOARD DURING APPROACH TO ÅLESUND 15 SEPTEMBER 2011

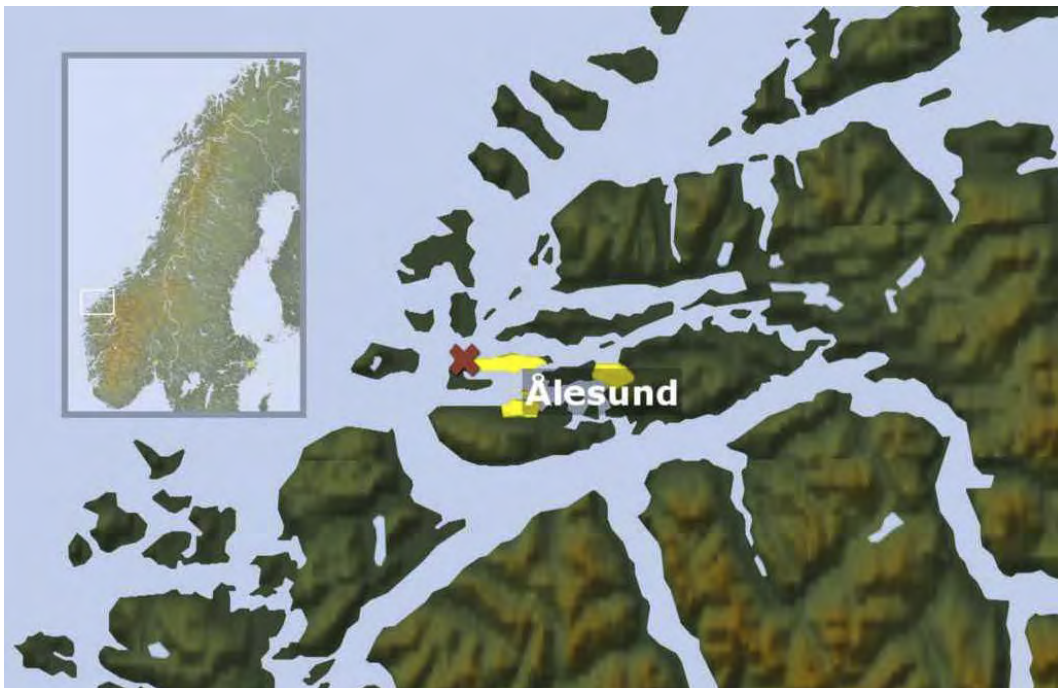
Figure 1: The fire started on 15 September 2011, as the northbound coastal express steamer *Nordlys* was approaching Ålesund.

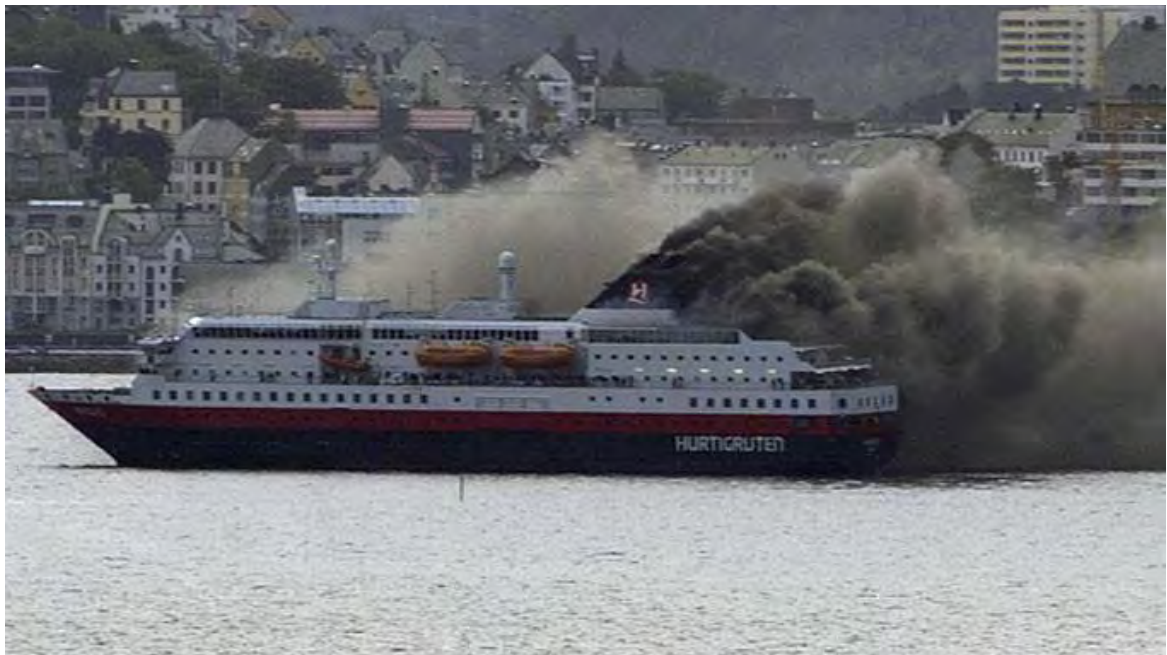
Figure 2: The coastal express steamer Nordlys during the fire 15 September 2011. Photo: Thomas Molnes

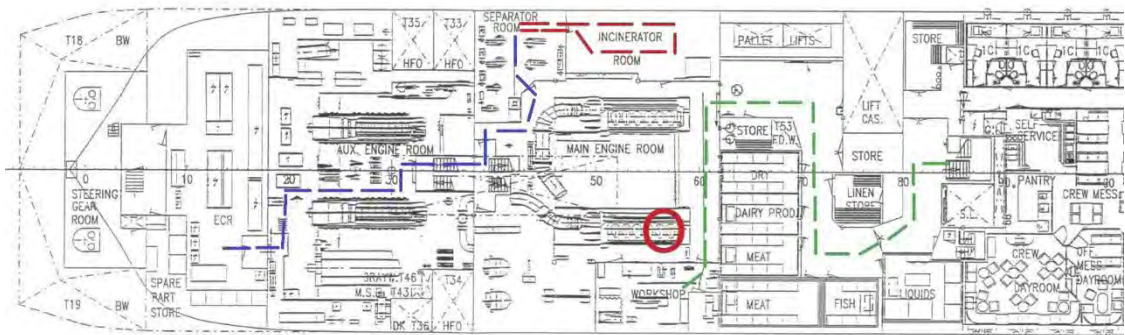
The motorman was present in the separator room during the period immediately preceding the fire. The chief engineer entered the separator room from the incinerator room and started up a conversation with the motorman. After approximately one minute, the chief engineer turned around, called out and wondered what was happening. Through the door they observed that the incinerator room was filled with dense, black smoke. The chief engineer ran out of the separator room and into the incinerator room. The motorman ran in the opposite direction and looked into the engine room through the aft door of the separator room. There was less smoke in that area. He ran back to the incinerator room to look for the chief engineer, but was unable to see anything because of the dense smoke. He ran back to the aft door of the separator room and into the engine room. Immediately outside the door, he went down on his knees and looked underneath the exhaust pipe. He observed dense smoke above the starboard main engine. He observed flames immediately above the engine, between the engine and the smoke. He entered the stairwell aft of the engine room and climbed down onto the tank top. There were no flames there, but plenty of smoke, particularly in front of the engines. He then escaped into the auxiliary engine room through the watertight door on the port side at the aft end of the engine room. From there, he was able to reach the control room and call the bridge.

Figure 3: Sketch of the aft part of deck 1, showing the movements of the chief engineer, first engineer, motorman and repairman.

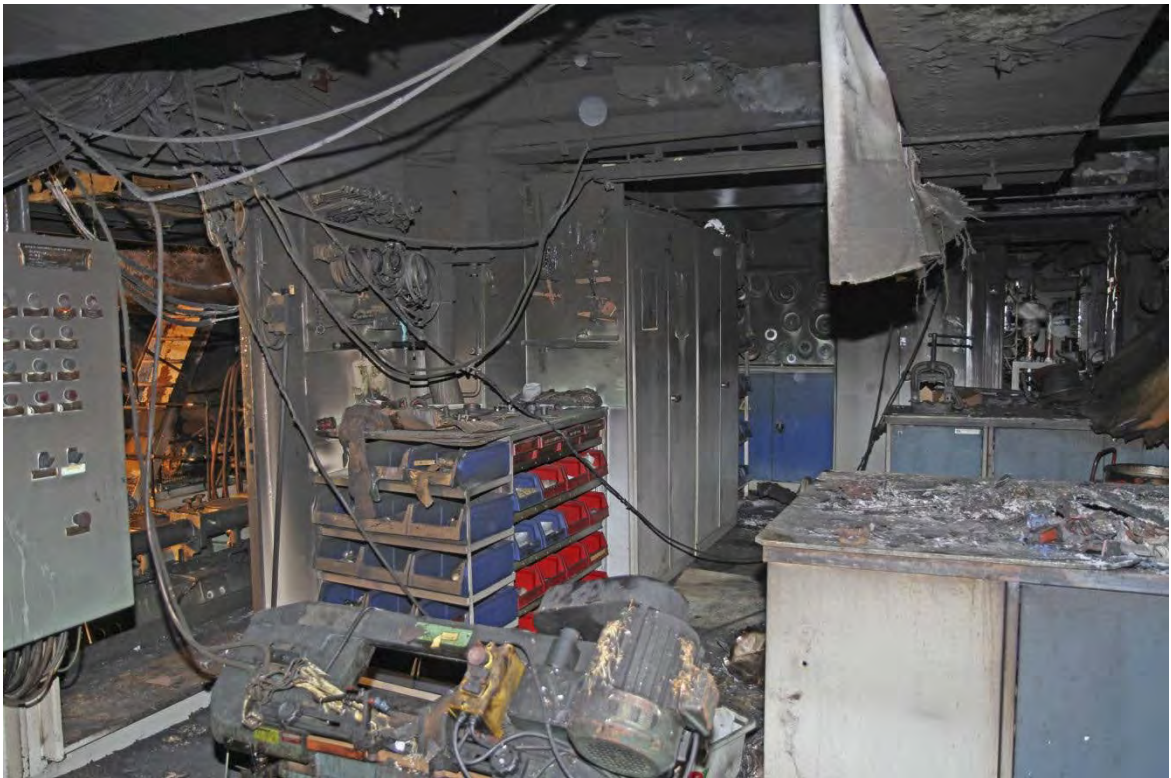
*Figure 7: The interior of the incinerator room where the chief engineer came from when he met the motorman in the separator room. Photo: The police.*

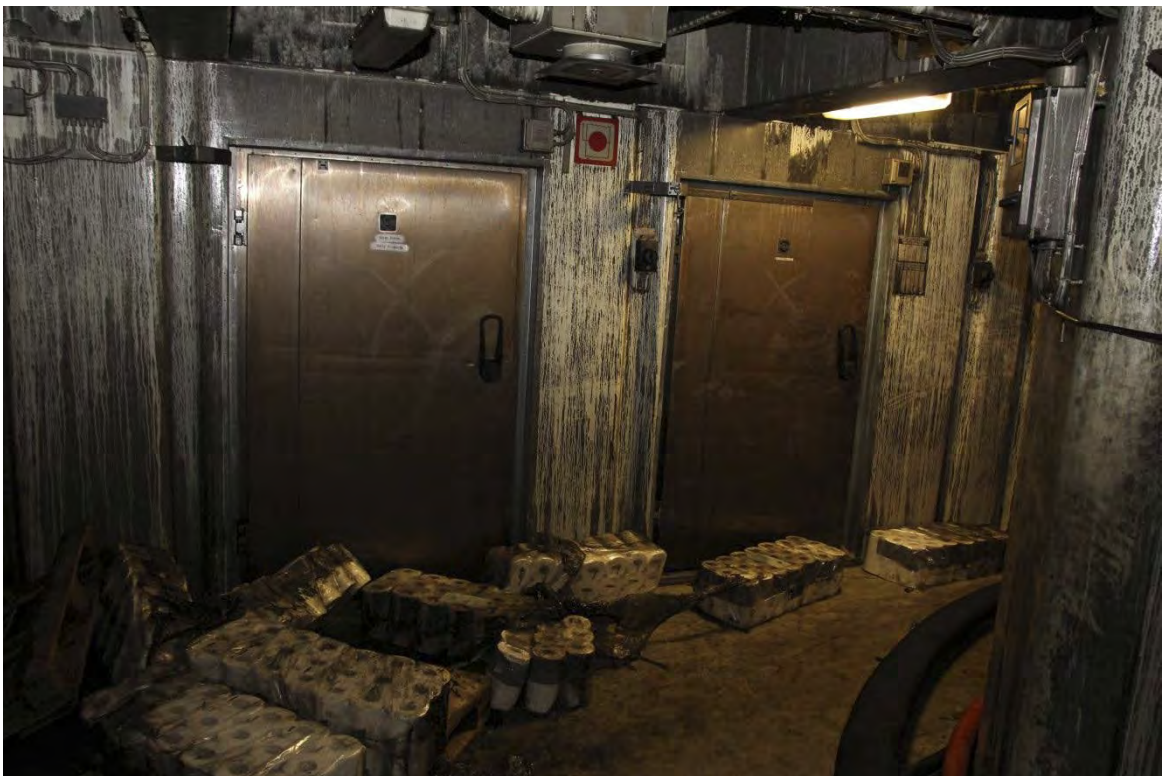
*Figure 8: Outside the cold provision stores between the midship stairwell and the main engine room on deck 1. The temperature was so high that it melted the plastic wrapping around the toilet paper rolls. Photo: SINTEF NBL.*

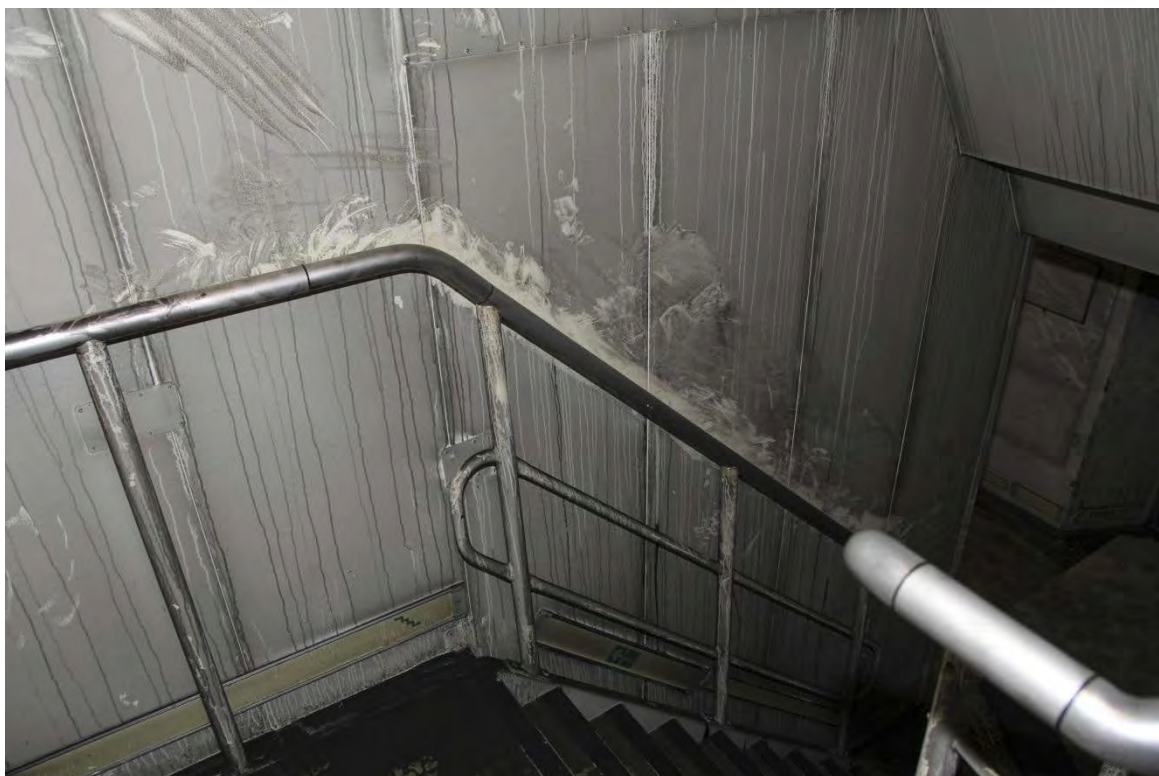
Figure 9: On the landing between decks 2 and 3 in the midship stairwell. Photo: SINTEF NBL.

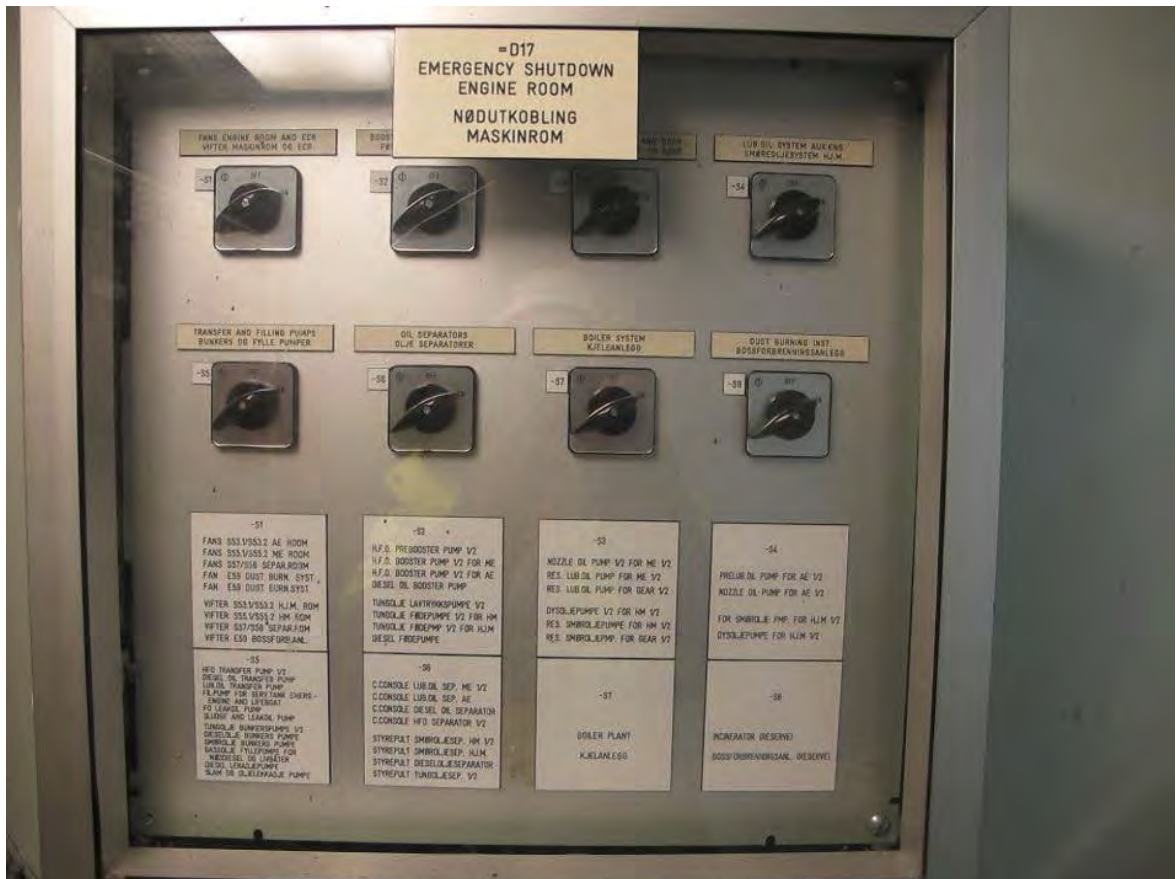
Figure 11: Panel for emergency shutdown of pumps, fans and engine room equipment. Photo: AIBN.

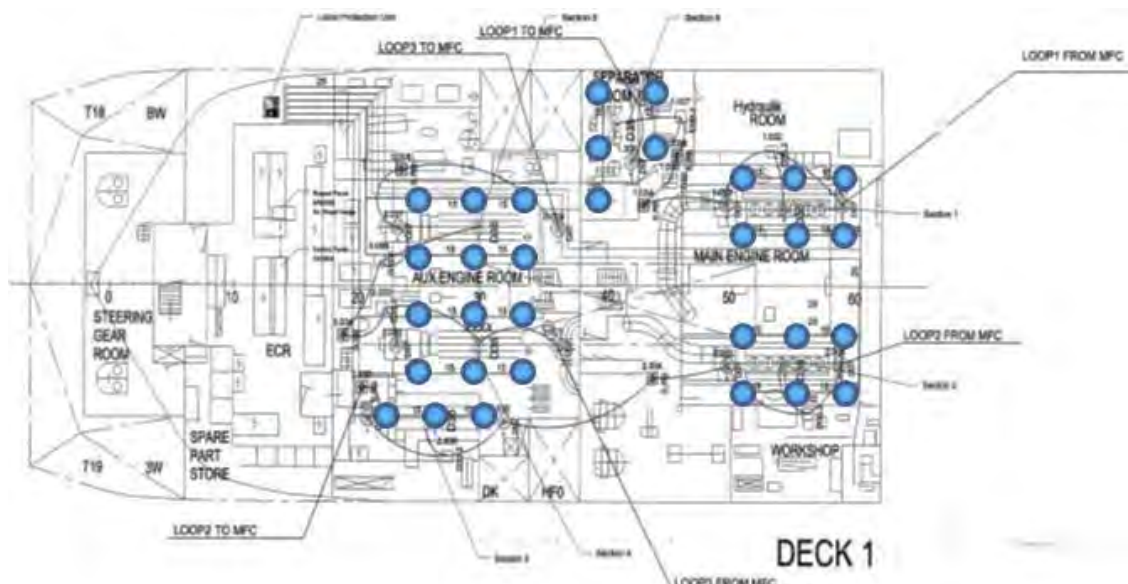
Figure 12: Sketch showing the position of the nozzles in the local application fire-extinguishing system. The nozzles (marked as blue bullet points) are placed above each main engine (six per engine), in the separator room (five), above each auxiliary engine (six per engine) and above the boiler (three). This adds up to a total of 32 nozzles on deck 1 (under deck 2). There are no nozzles at the tank-top level.

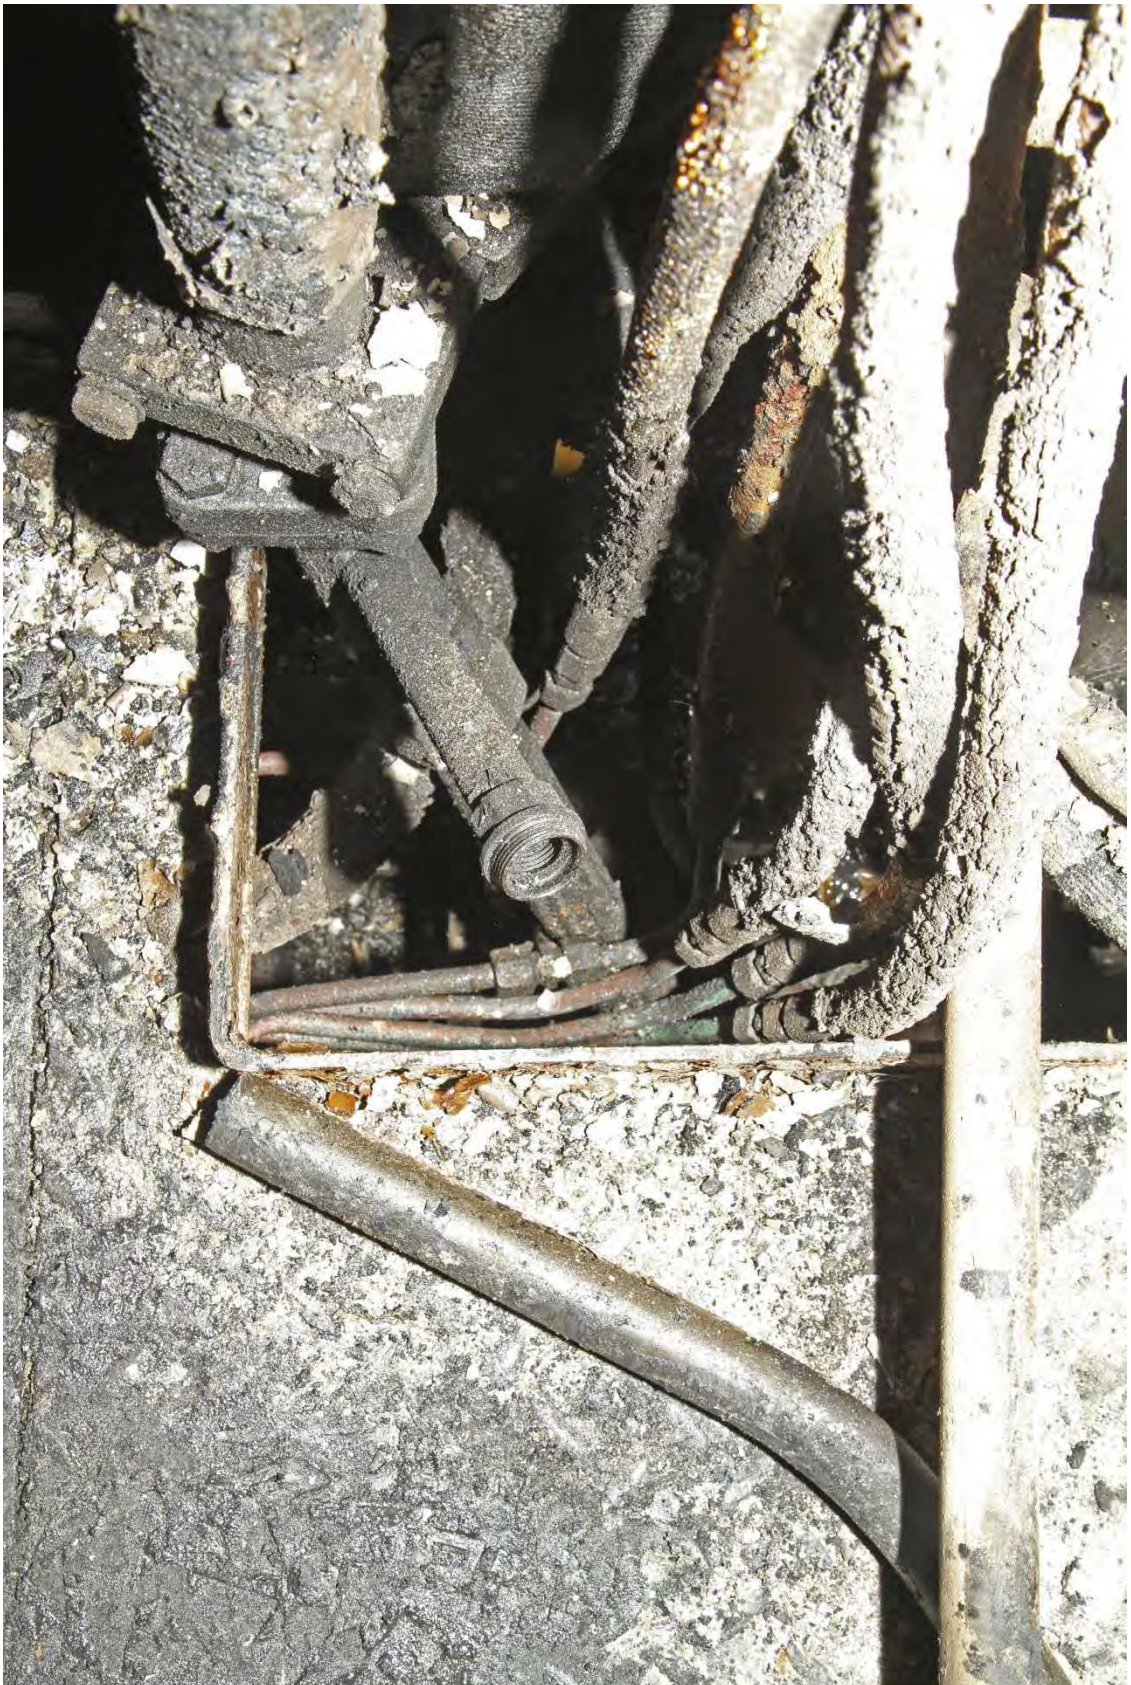
Another observation in connection with the preliminary on board investigations concerned the fuel line for return of fuel from the cylinders. The aforementioned fuel return pipes from each individual cylinder are connected to a single pipe that carries the fuel back to a tank. This pipe follows the main engine on the starboard side and runs down the front of the engine, where a drainage pipe is connected via a T-coupling. The drainage pipe has been closed with a ball valve and plugged with a threaded plug (see Figure 20). The AIBN has been informed that this pipe was probably designed to have a drainage function, but nobody was able to remember whether it had ever been in use. There was no corresponding solution on board the sister ships *Kong Harald* and *Richard With*. When the AIBN conducted its investigations on board *Nordlys* after the fire, only the threaded nipple was left on the pipe. The rest of the valve, ball and end plug were found close by. The lowest point of the fire appears to have been in this area.

*Figure 19: Drainage pipe on starboard main engine, without valve. Photo: The police.*

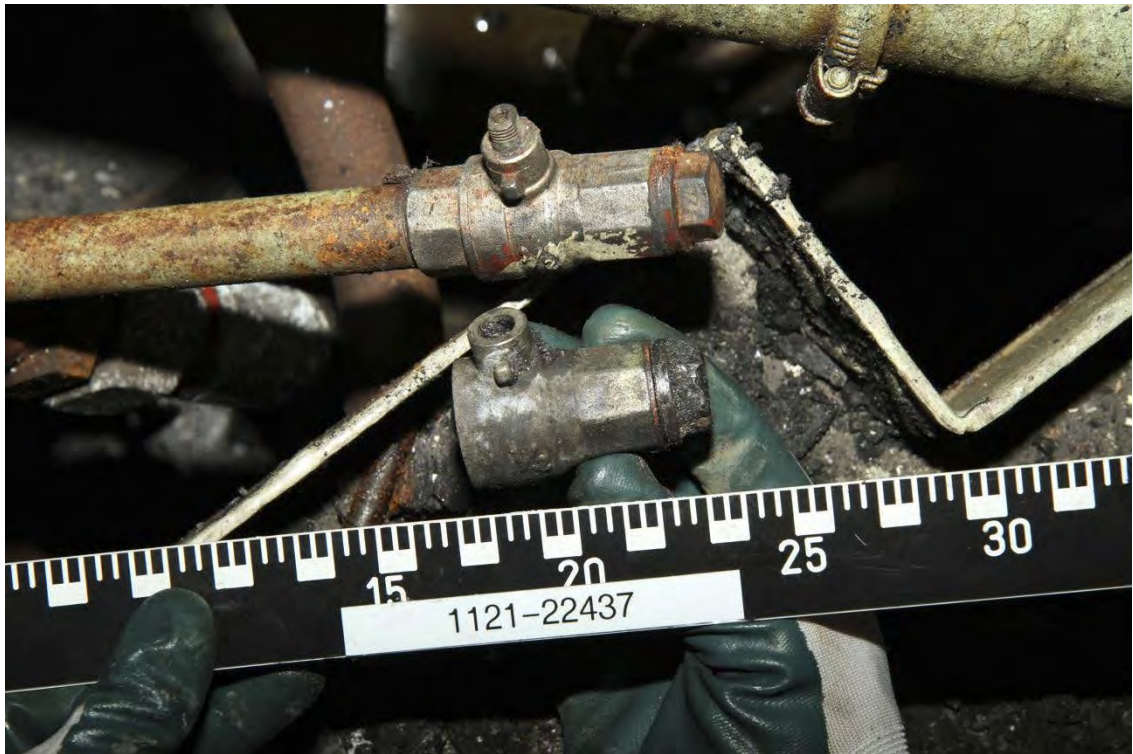
Figure 20: The drainage valve from the starboard main engine held next to the drainage pipe with valve on the port main engine. Photo: The police.

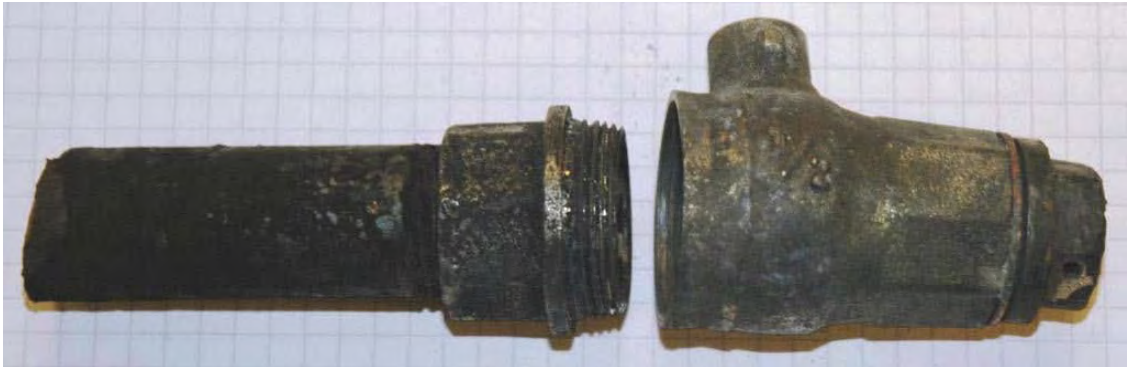
The laboratory examination showed local, apparently penetrating, corrosion in the valve. This may have caused a minor leakage, an assumption supported by discolouring on the outside of the valve housing. It was not possible to determine whether that valve had been functional, as the valve ball and stop cock were missing. The examination also showed that the drainage valve for the starboard main engine had very poor thread alignment and that the valve housing was oval with worn threads; see Figure 21 and Appendix B.

*Figure 21: Drainage valve disconnected from the starboard engines. Photo: The Norwegian Armed Forces' laboratory service.*

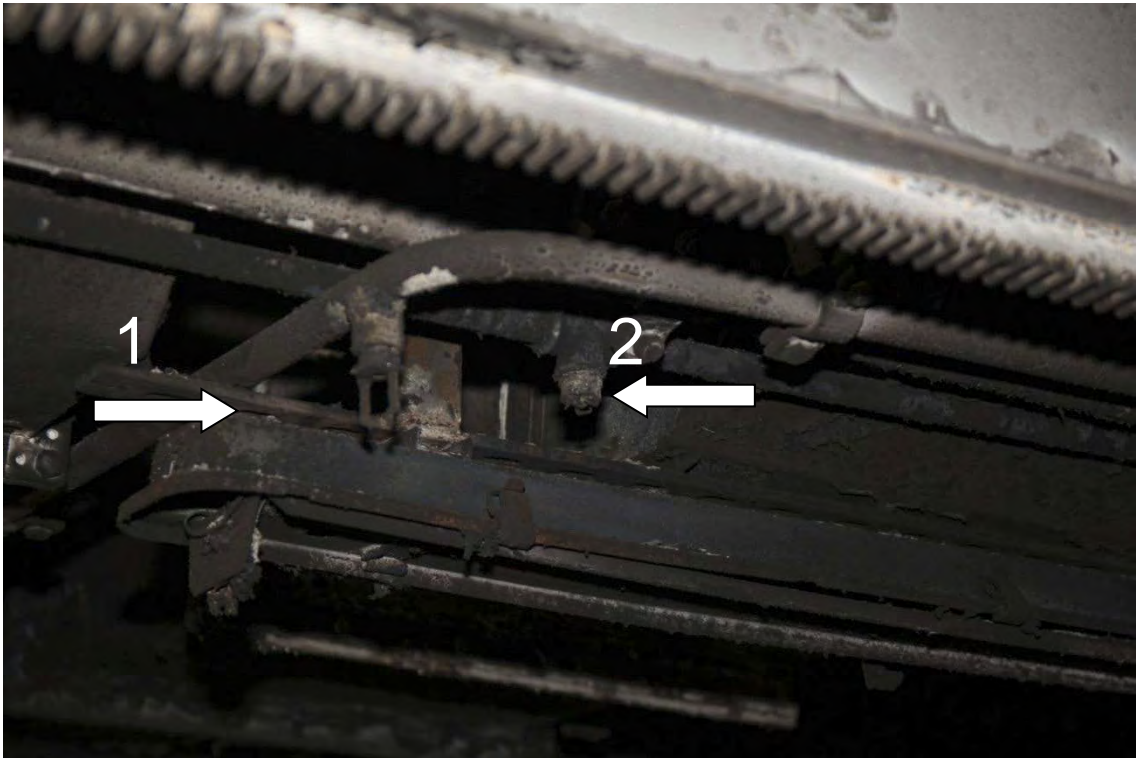
The nozzles for supplying CO<sub>2</sub>, which look similar to the nozzles in a deluge or sprinkler system, are made of cast brass or bronze alloy. Figure 27 shows that parts of the CO<sub>2</sub> nozzle immediately above the centre of the fire had disappeared, probably due to the

impact of heat. Right next to that nozzle, we can see a local application nozzle. This nozzle, which was also made of a brass alloy, was found to be intact.

*Figure 27: Arrow no 1 points to the CO<sub>2</sub> nozzle, while arrow no 2 points to a water mist nozzle. Photo: SINTEF NBL.*

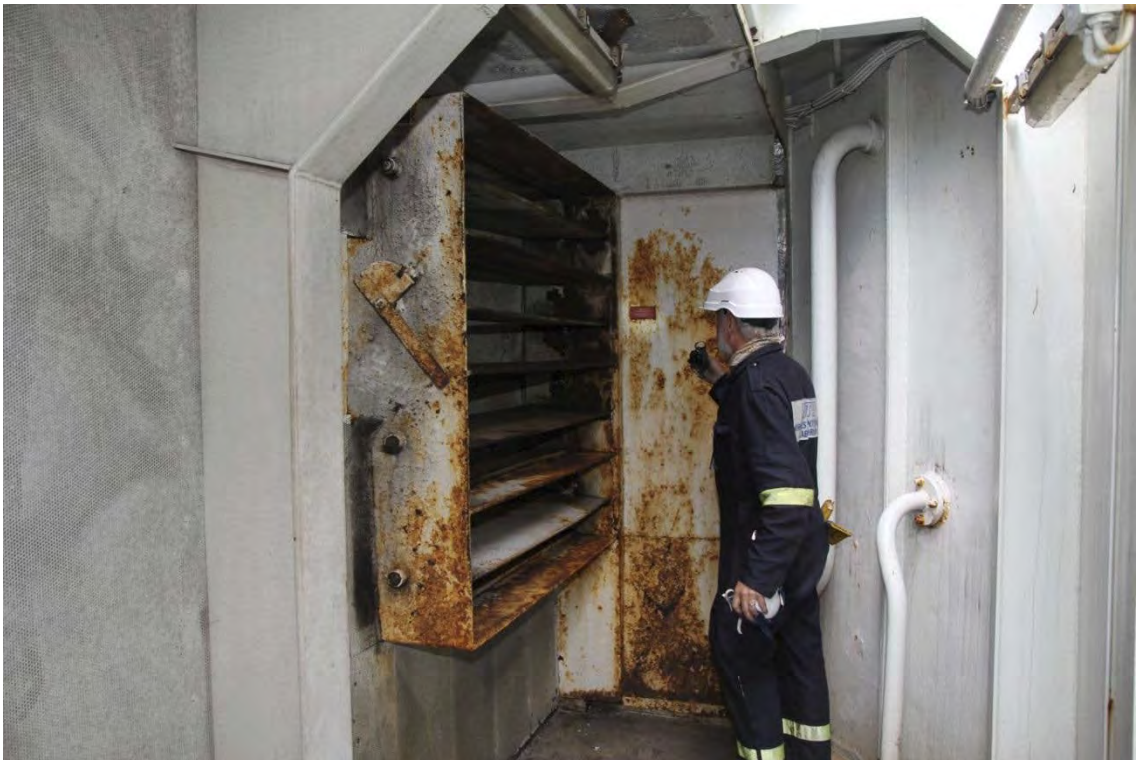
One of the items in the user instructions for release of the CO<sub>2</sub> system is to 'close all openings'. Among the most important openings are the air intake dampers, installed in the smokestack on deck 7. The investigation has shown that the dampers in the smokestack were not closed during the fire, and that fresh air was supplied to the engine room, including via these dampers.

Figure 28: One of the dampers on the air inlet in the smokestack building on deck 7. Photo: SINTEF NBL.

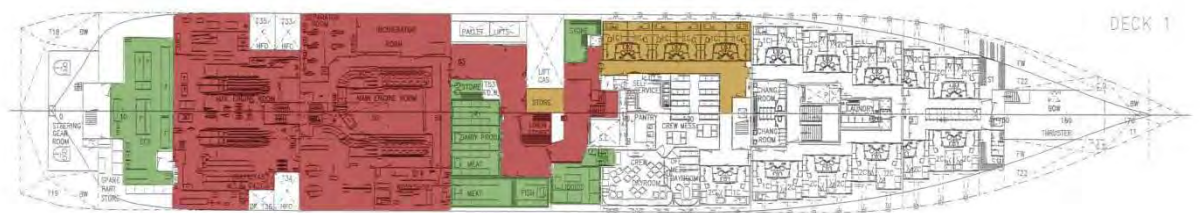
The corridor is also connected to a stairwell through which the smoke escaped, leaving clear traces on both vertical and horizontal surfaces.

In the crew cabins, a thin layer of soot was found on some of the horizontal surfaces, even though the smoke had left no traces around the doors.

Figure 30: Registered soot deposits on deck 1 (green: no spread of smoke; orange: some spread of smoke; red: spread of moderate to heavy smoke; white: uninspected area).

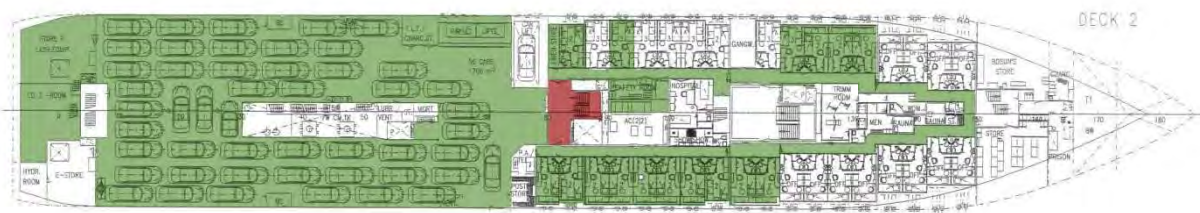
There was a fire door between the stair landing and the car deck. There were no clear traces of smoke on the car deck, apart from a thin layer of soot on the cars.

The ventilation room on deck 2 contained no traces of smoke, with the exception of a small area of soot deposits in a joint between two ventilation ducts, indicating that there may have been smoke in the ventilation system.

Figure 31: Registered soot deposits on deck 2 (green: no spread of smoke; red: moderate to heavy spread of smoke; white: uninspected area).

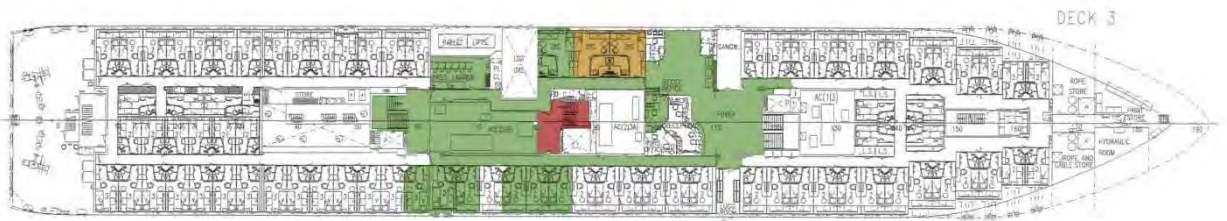
Heavy soot deposits were also found above the ceiling in passenger cabin 332 (no checks

were carried out above the ceilings in other cabins). There was also a thin layer of soot in the rest of the cabin.

Figure 32: Registered soot deposits on deck 3 (green: no spread of smoke; orange: some spread of smoke; red: moderate to heavy spread of smoke; white: uninspected area).

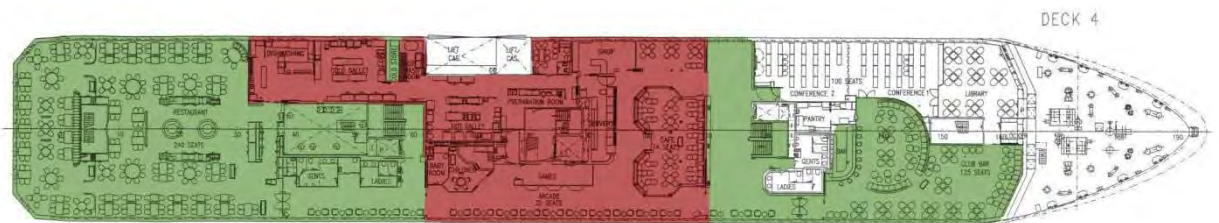
Deck 4 contains the ship's dining areas, galley and passenger mingling area. This is a large, open space, divided into three zones. There were generally clear signs that large volumes of smoke had been present in Zone 2 (the middle section) while the two other zones had been free of smoke, indicating that the fire doors had remained closed and kept Zones 1 and 3 free of smoke during the fire.

The soot deposits indicate that most of the smoke has risen up through the stairwell and welled out through two doors, namely the door to the galley and the door to the passenger mingling area. Soot deposits were also found inside a goods lift in the galley, which indicates that it may also have been filled with smoke. At the centre of the ship, in a cupboard-like room next to the space marked 'preparation room', the soot deposits on deck and other horizontal surfaces were relatively much heavier than outside the door to the room. In this room, too, heavy soot deposits were observed in the hollow space above the ceiling.

Figure 33: Registered soot deposits on deck 4 (green: no spread of smoke; red: moderate to heavy spread of smoke; white: uninspected area).

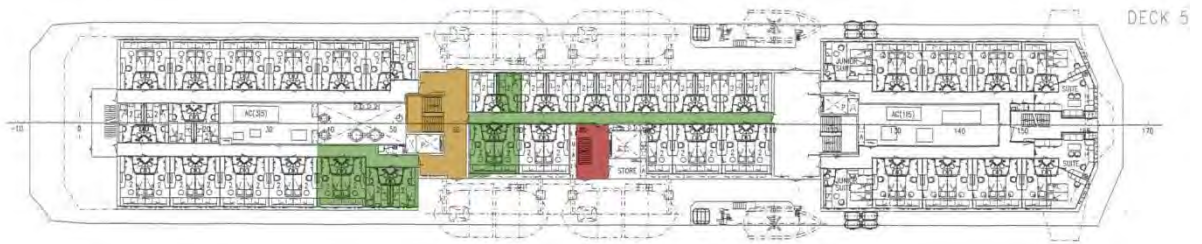
1.18.8.5 Deck 5

In addition to the soot in the stairwell, a thin layer of soot was found to cover the landing aft of the main stairs. Sample observations were made in some of cabins, but no traces of smoke or soot were found.

Figure 34: Registered soot deposits on deck 5 (green: no spread of smoke; orange: some spread of smoke; red: moderate to heavy spread of smoke; white: uninspected area).

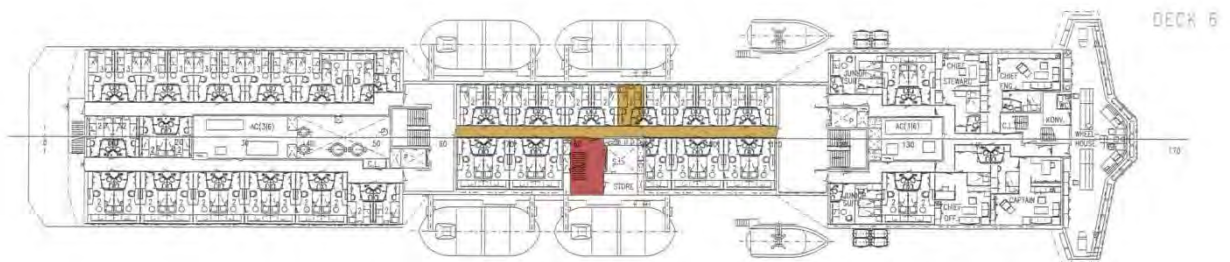
1.18.8.6 Deck 6

In addition to the soot in the stairwell, a thin layer of soot was found in the corridor just outside the stairwell, and in a cabin adjacent to the corridor.

Figure 35: Registered soot deposits on deck 6 (orange: some spread of smoke; red: moderate to heavy spread of smoke; white: uninspected area).

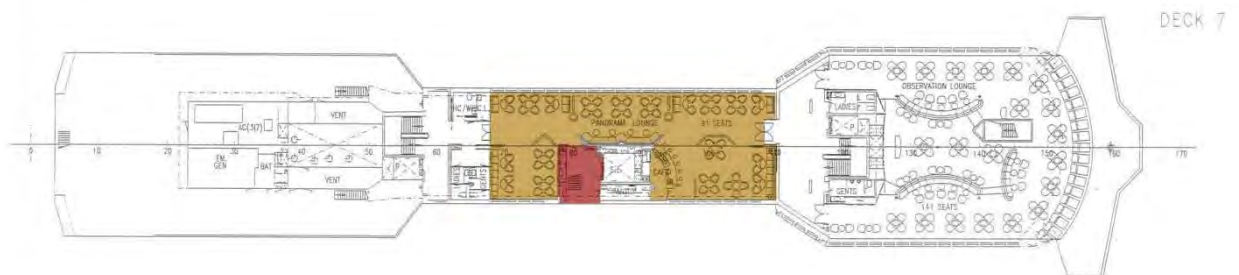
1.18.8.7 Deck 7

There were clear traces of large volumes of smoke having been present in the stairwell. Deck 7 contains an open space with several bars. A thin layer of soot was found in this area.

Figure 36: Registered soot deposits on deck 7 (orange: some spread of smoke; red: moderate to heavy spread of smoke; white: uninspected area).

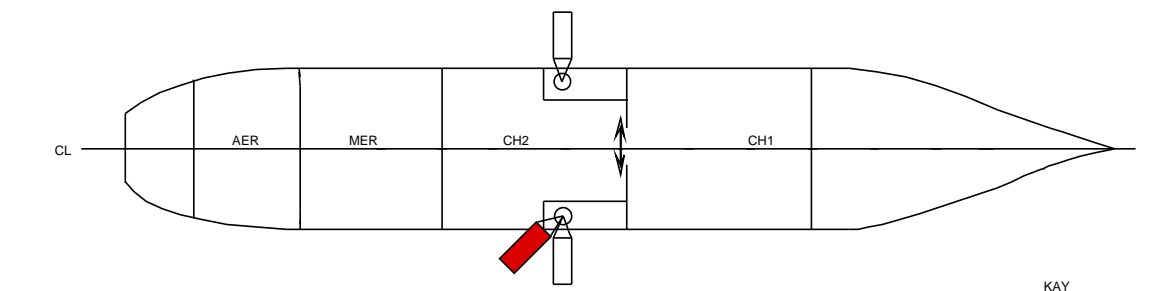
Not until the morning of 16 September 2011, more than 24 hours after the fire had broken out, was the leakage found in the area aft of the starboard stabiliser fin. *Nordlys* had both stabiliser fins extended when the ship was towed to quay.

Not only were the stabiliser fins included in the checklist to be used on approaching port; they were also set to be retracted automatically on start-up of the bow thrusters to ensure that the ship would not go alongside quay with extended fins. The fins are operated hydraulically and controlled electrically in that they are connected to the emergency switchboard and operated from a panel on the bridge. The fins could also be operated using an emergency pump supplied with electricity via the emergency switchboard, or using a manual pump, but none of this was done.

When colliding with the quay, the starboard fin was pressed towards the ship's aft end and penetrated the skin in the area of cargo hold no 2. The damage led to flooding of cargo hold no 2; see Figure 37.

*Figure 37: Schematic drawing showing how the starboard stabiliser fin (highlighted in red) was pressed towards the aft of the ship when *Nordlys* was towed to quay during the fire. This caused the stabiliser fin to penetrate the hull and led to flooding of cargo hold no 2.*

- On ships that have the same design as *Nordlys* as regards the consequences of the stabilisers penetrating the ship's side, a dry tank will be built around the damage-prone area. This has been done on *Nordlys* and *Richard With*, and will be done on the other ships in connection with their docking in shipyards.

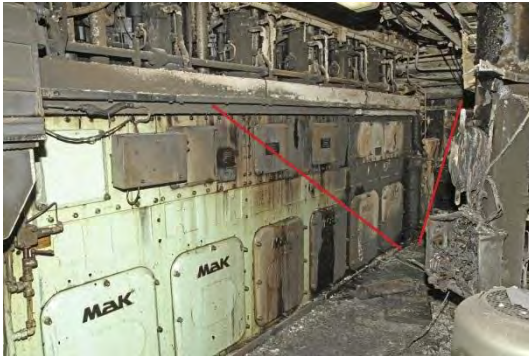
have been by the lowest leakage point (the ball valve), which was at the forward end of the starboard side of the engine on the same level as the floor plates on the tank top. The fire had deposited a 'fire fan' (a V-shaped mark) from that point and up along the starboard side of the engine; see Figure 42. Corresponding deposits were also found on the workshop bulkhead opposite the engine on deck 1; see Figure 43.

*Figure 42: Looking forward along the starboard side of the starboard main engine at tank-top level. The fire has left a V-shaped mark from the floor upwards ('fire fan'). Photo: The police.*

As mentioned, the lowest 'fire fan' starts at the lowest leakage point (the ball valve), while the upper 'fire fan' seems to start at the highest leakage point (fuel injector pump no 5). In other words, both leakages seem to have contributed during the fire.

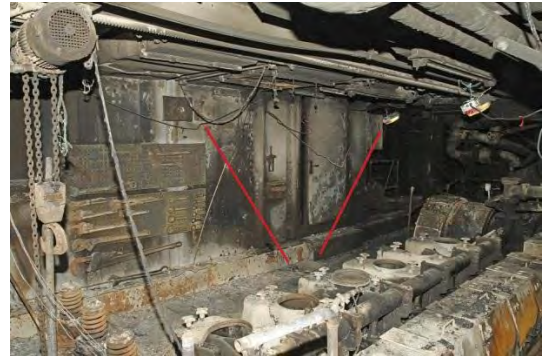
*Figure 43: The top of the starboard engine looking aft at an angle. The bulkhead with the aft door to the workshop can be seen in the background. The fire has left an upward V-shaped mark. Photo: The police.*

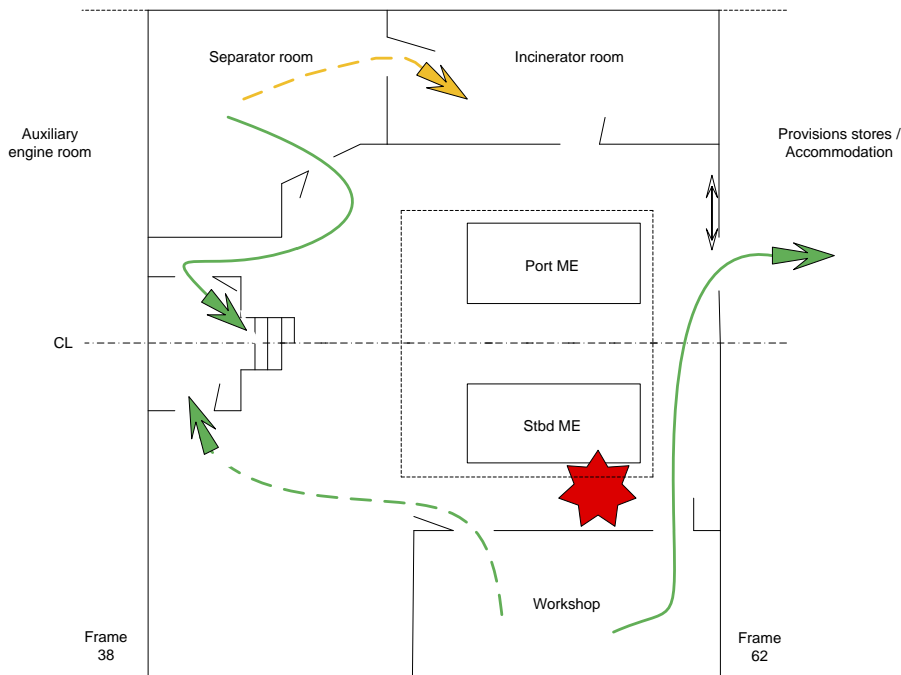
The chief engineer and the motorman were in the separator room when the fire started. When interviewed by the AIBN, the motorman explained that the chief engineer moved out into the incinerator room when they realised that smoke was emanating from that room. At some point, he must have turned back, as his body was found in the separator room. The AIBN cannot say for certain whether he moved out into the incinerator room with the intention of evacuating the engine room through the watertight door at the forward end of the engine room, or whether he intended to investigate what was wrong. The AIBN assumes that he turned back because of the smoke. The motorman escaped through the exit in the aft end of the engine room; see Figure 48.

The first engineer, the repairman and the apprentice engineer were in the workshop on the starboard side of deck 1 when the fire started. From there, they had two alternative escape routes: either through the aft door in the workshop and then through the exit at the aft end of the workshop, or through the forward door of the workshop and then through the watertight door at the forward end of the engine room. Both alternatives meant that they would have to pass close by the fire. The first engineer and the repairman have explained to the AIBN that they chose the latter alternative, and then made their way up to deck 3. Both sustained major burn injuries and had to receive treatment at Haukeland Hospital after the accident. The apprentice engineer, whose body was found next to the stairwell on deck 4, has probably followed the same escape route as the first engineer and the repairman.

Figure 48: Sketch showing the alternative escape routes from the workshop, which both entailed passing the fire at close range. The solid green line shows the escape route chosen by the first engineer, the repairman and probably the apprentice. The dotted green line shows the alternative escape route. The motorman's escape route from the separator room is marked with a solid green line, and the likely movement of the chief engineer from the separator room is marked with an orange dotted line.

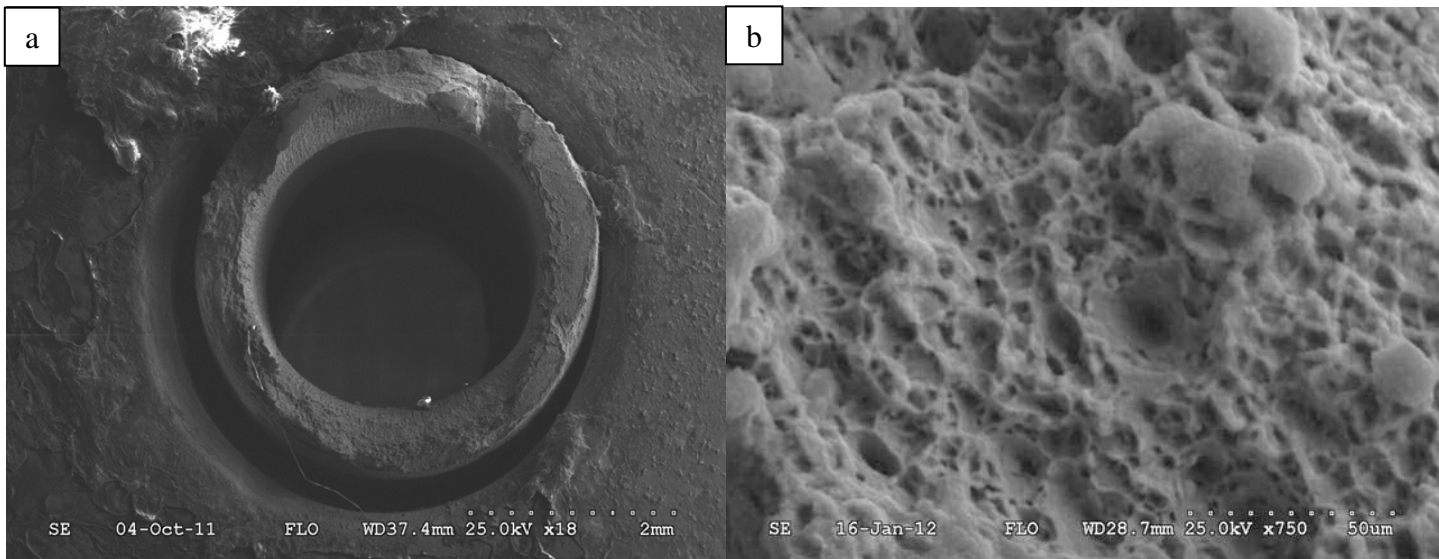
Et oversiktsbilde av bruddflaten er vist i Figur 5a. Som det fremgår av fraktografibildet vist i Figur 5b bestod bruddflaten av dimpler hvilket viser at røret for smøring av drivstoffpumpe 5 har røket som følge av duktil overbelastning.

Figur 5a: Oversiktsbilde i SEM av bruddflaten til rør ved innfeste. b: Representativt fraktografibilde i SEM av bruddflaten viser dimpler forenlig med duktil overbelastning.

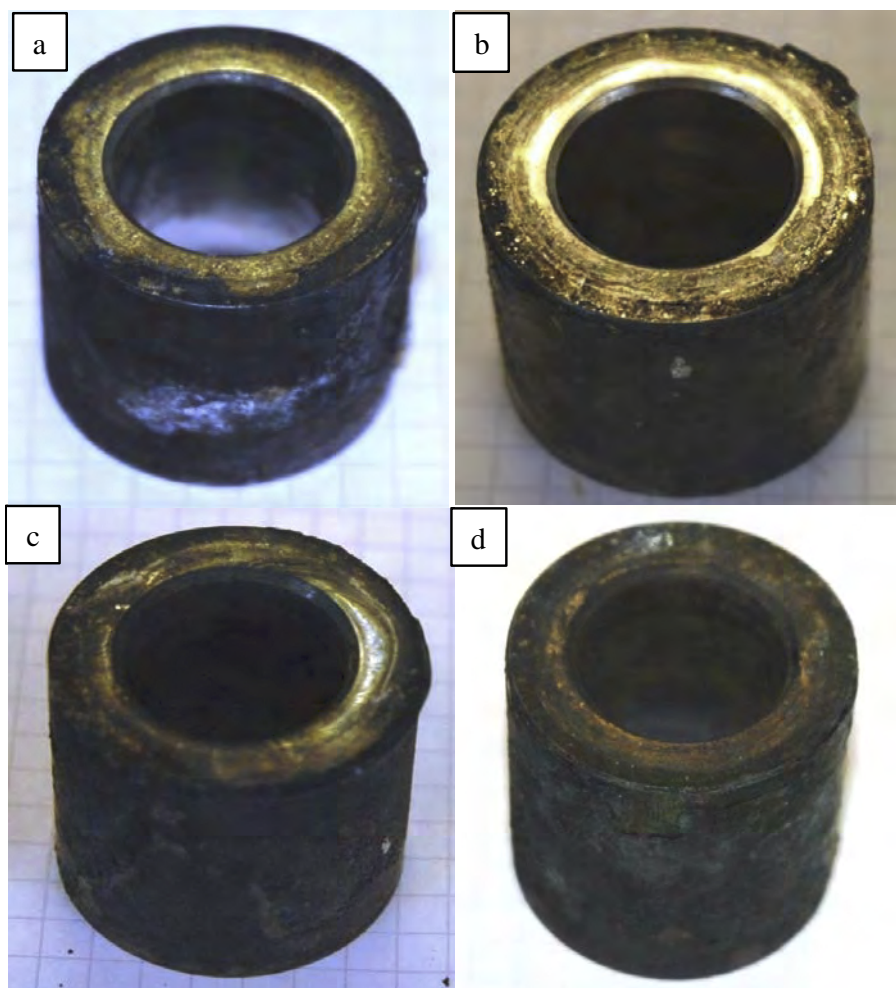
Det har vært et sentralt spørsmål å avklare hvorvidt drivstoffpumpen var festet tilstrekkelig eller ikke, basert på observasjonene ovenfor virker det sannsynlig at boltene ikke har vært tilskrudd med moment av betydning. Deformasjon/klining av foringsoverflatene kan ikke observeres hvilket skulle forventes når boltene skrues inn mot den mykere foringen med moment. Dette støttes videre av at sot er avsatt på overflatene hvilket tyder på avstand mellom bolt og foring.

Figur 6 Oversiktsbilder av foringer til bolter til drivstoffpumpe til sylinder 5, a: C57, b: C58, c: C59 og d: C60. Bildene viser den siden som møter bolthodet.

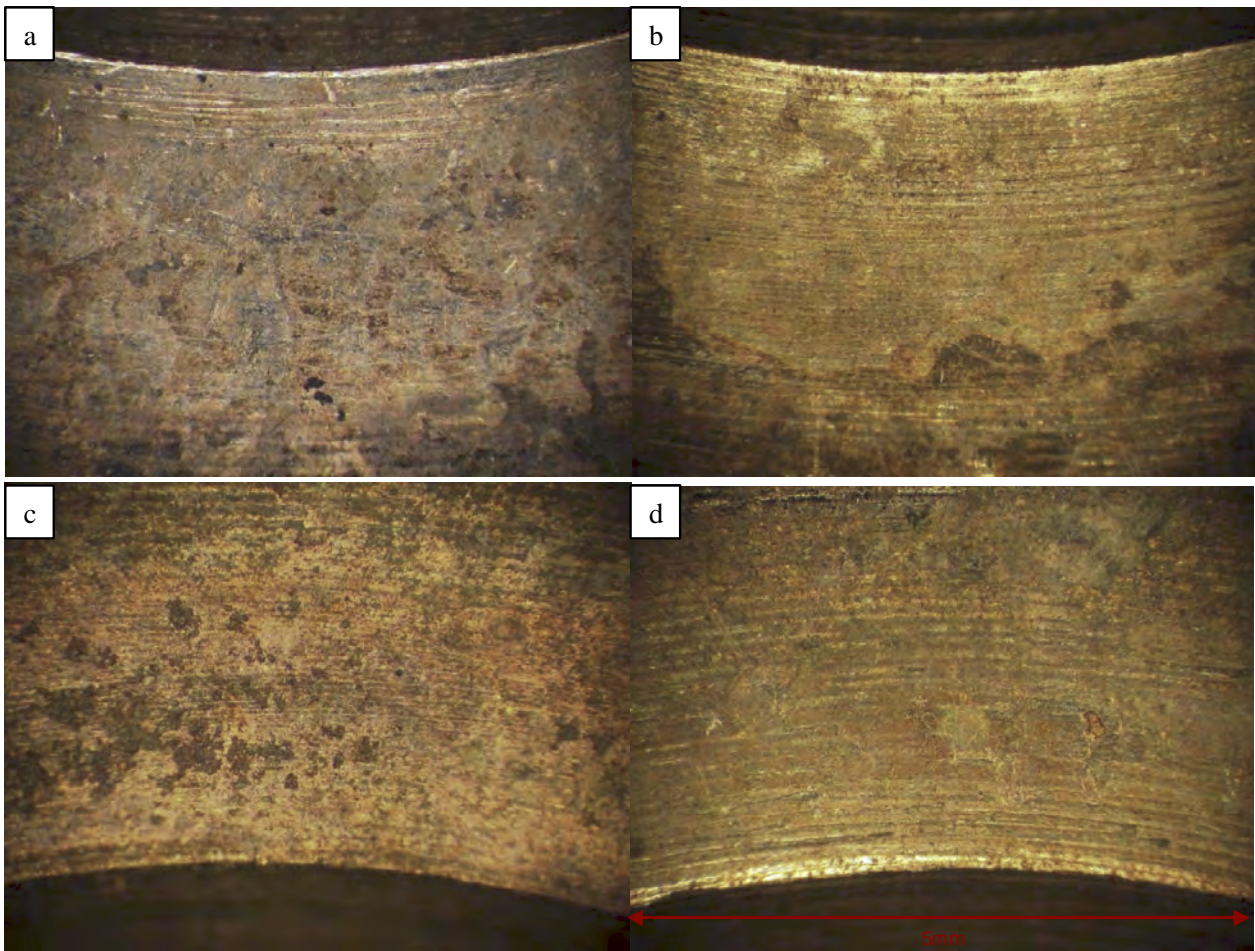
Figur 7 Bilder i stereolysmikroskop av maskineringspor i overflaten til foringer til bolter til drivstoffpumpe til sylinder 5 som vist i Figur 6a-d, (a: C57, b: C58, c: C59 og d: C60). Bildebredden utgjør ca. 5mm.

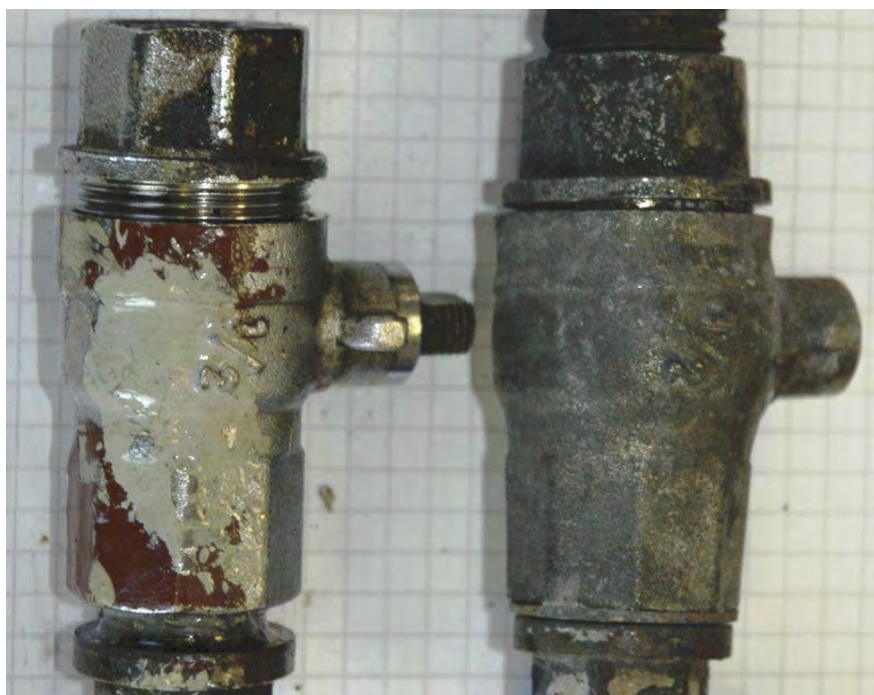
Figur 9 Sammenstilling for å illustrere forskjell i inngrepspunkt mellom referanseventil (C40) t.v. og separat ventil (C1 og C39) t.h.
