# REPORT

## Sjø 2013/02

## REPORT ON THE INVESTIGATION OF A MARINE ACCIDENT NORDLYS LHCW - FIRE ON BOARD DURING APPROACH TO ÅLESUND 15 SEPTEMBER 2011

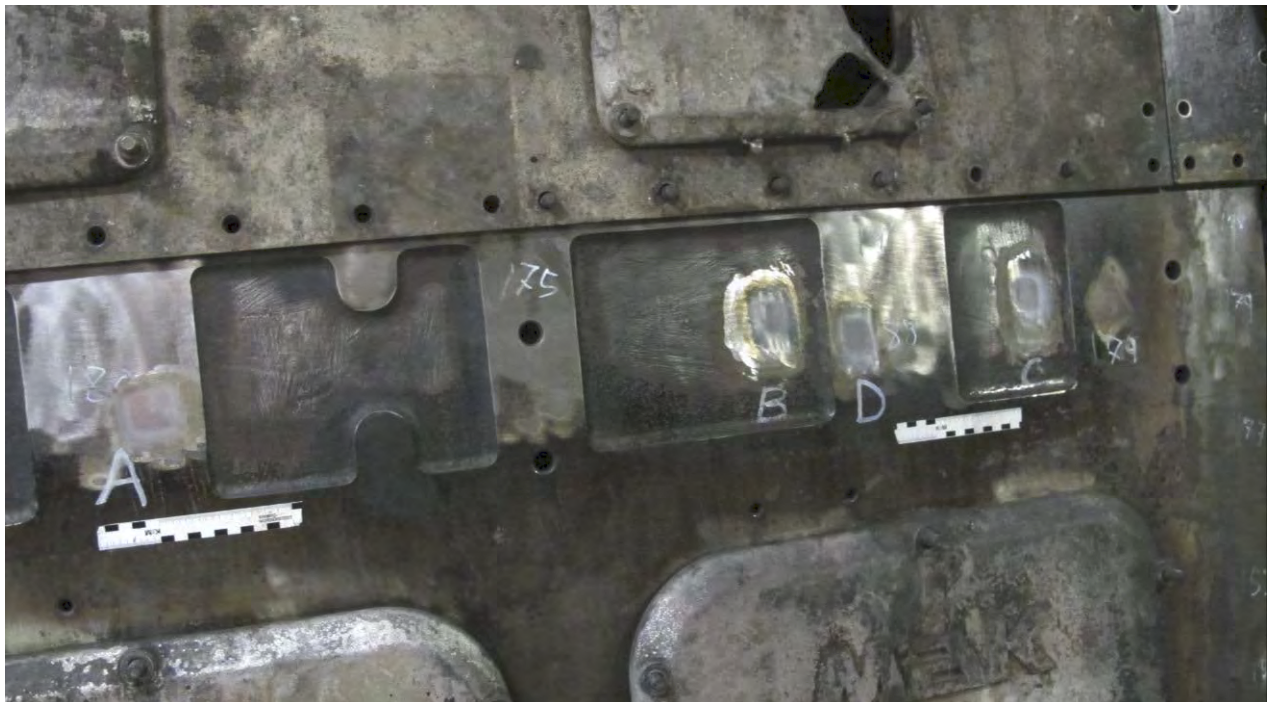
In order to examine the microstructure four different areas labelled by DNV as A, B, C and D were selected within the heat affected area, see Fig. 3. In addition, a reference area for comparison the microstructure and hardness was chosen at the same level as the heat affected area, ref. Fig. 1. Sample A and D including the reference area were selected within an original machined surface carried out by the manufacturing of the engine. The samples B and C were selected in areas where the original casting surface was visible. These two areas were initially rough grinded by use of an angle grinder to approximately 2 mm below surface. All areas were metallographically prepared and finally the microstructure examined in a portable light microscope at magnification 100 X to 400 X. A regular microstructure characteristic for nodular cast iron was observed in all areas, Fig.7 – Fig. 10. However, the areas B and C contain somewhat more ferrite most likely due to shallow grinding into the material.

Fig. 4 Overview of the prepared areas for examination the microstructure and hardness measurements.

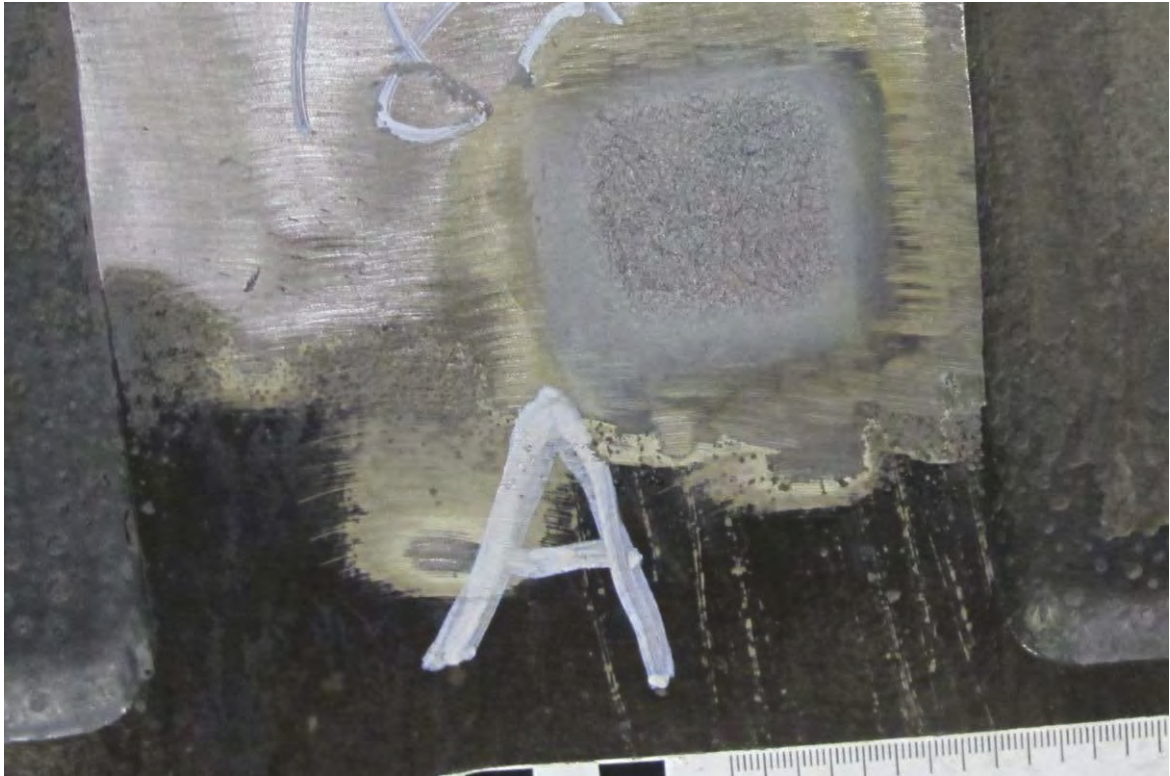
Fig. 5 Close-up of area A prepared and etched for examination in the portable microscope and finally hardness measurements. The area is representative for the areas Ref., B, C and D.

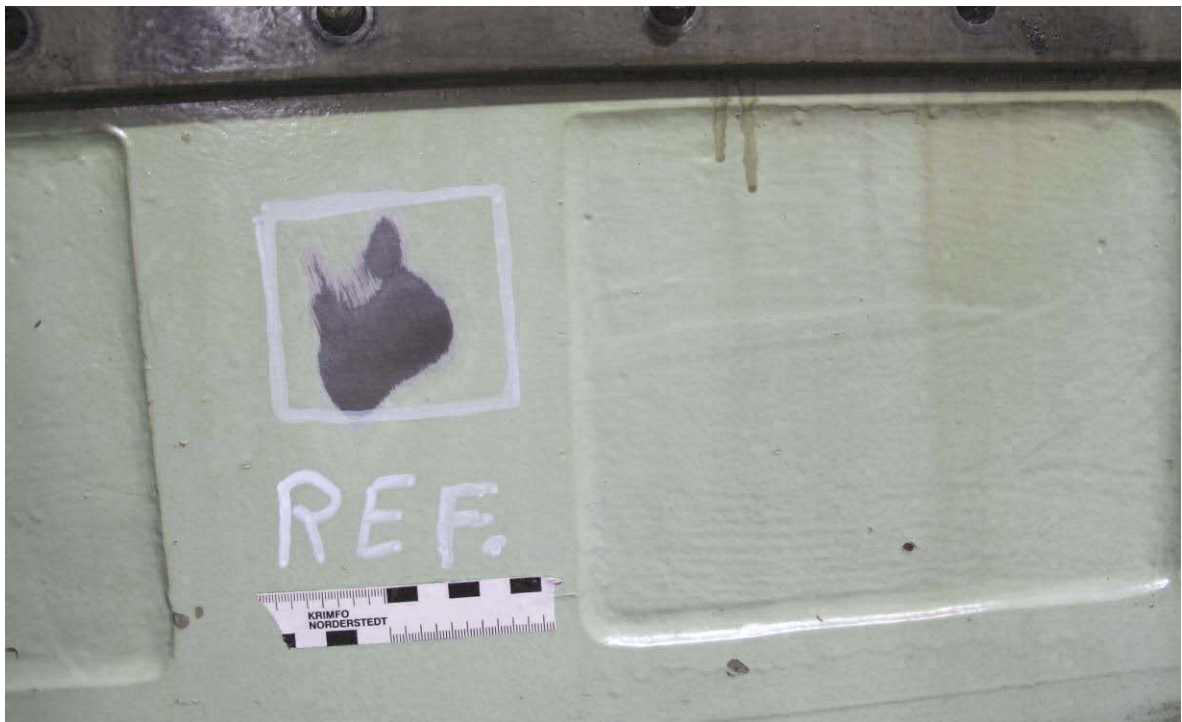
Fig. 6 Close-up of the reference area (ref. to Fig. 1) used for comparison of the microstructure and hardness values.

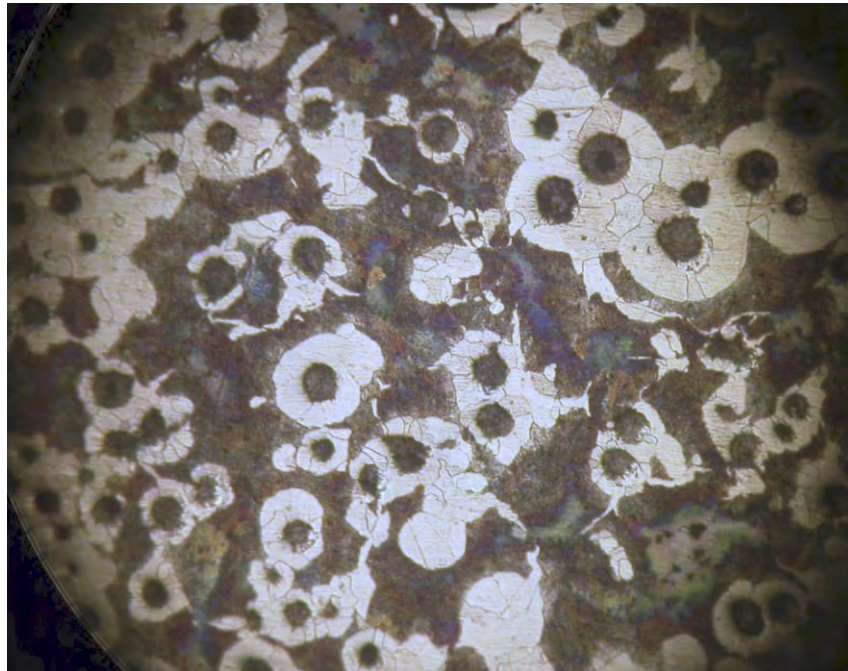
Fig. 7 Reference area. Metallographically prepared area shows a microstructure characteristic for nodular cast iron as expected. The microstructure consists of ferrite and pearlite with spheroidal graphite. Magnification 100 X.

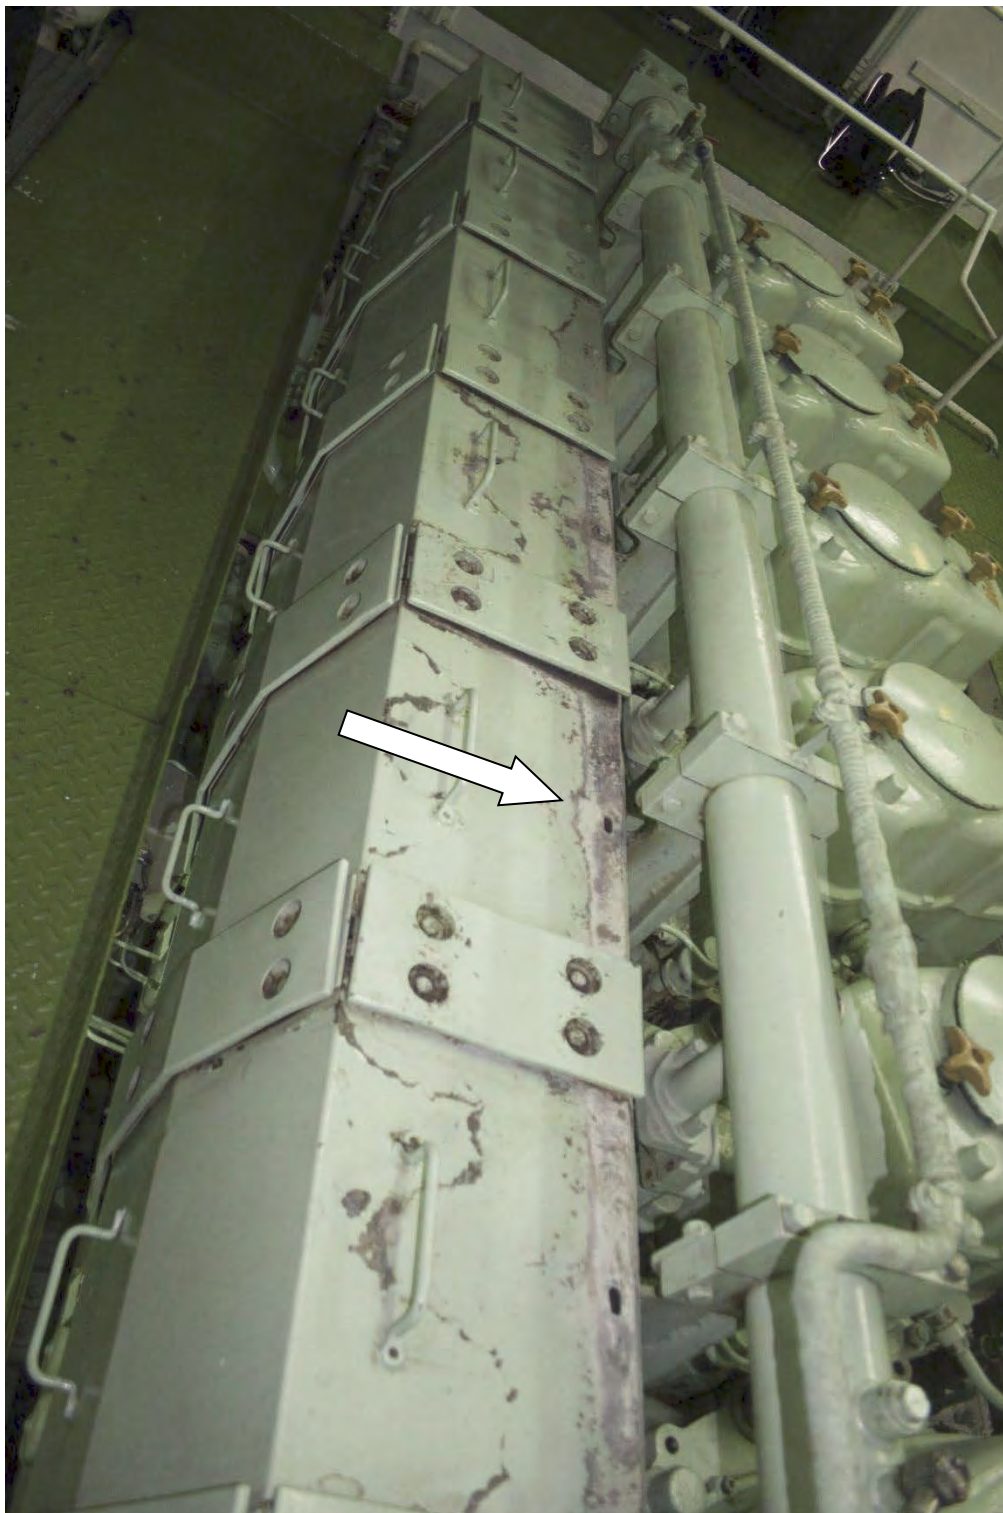
**Foto 3**

**Deksel rundt eksosmanifold. Lakken ser ut til å være varmpåvirket på aktre halvdel av dekselet, nærmest motorens senterlinje. Pilen peker på punktet som er referert til som "eksosmanifold topp" i temperaturtabellene.**

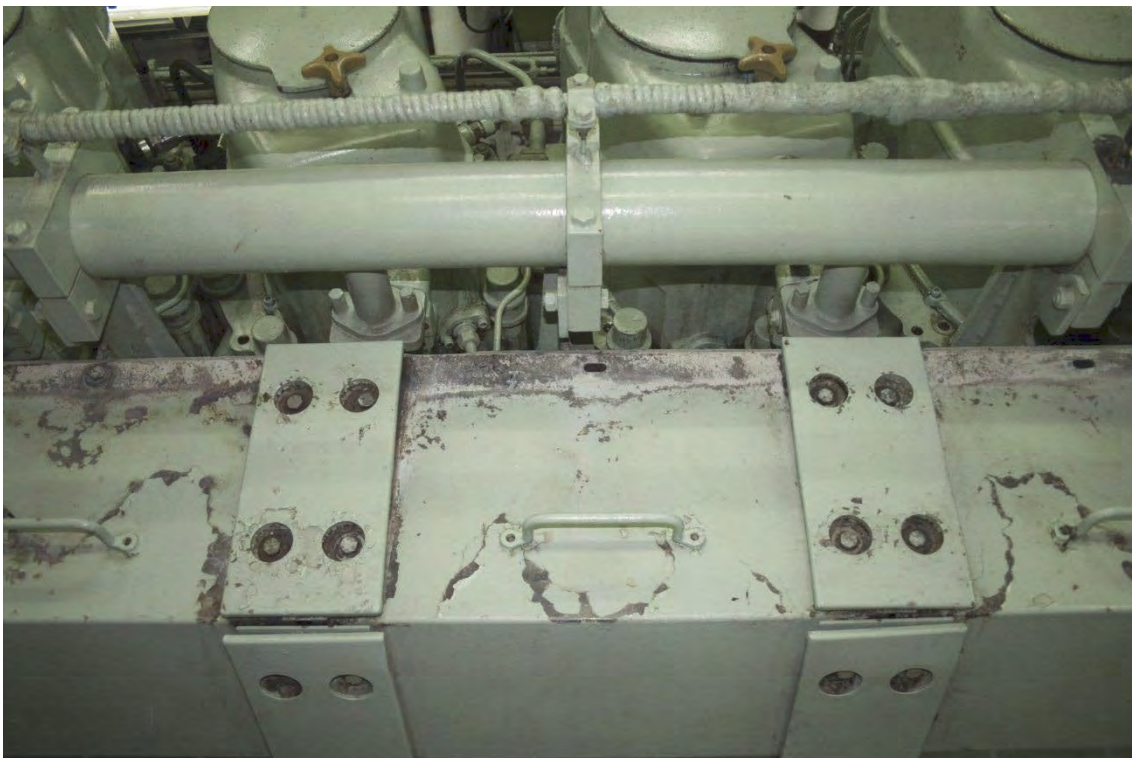
**Foto 4** Deksel rundt eksosmanifold. Lakken ser ut til å være varmepåvirket.

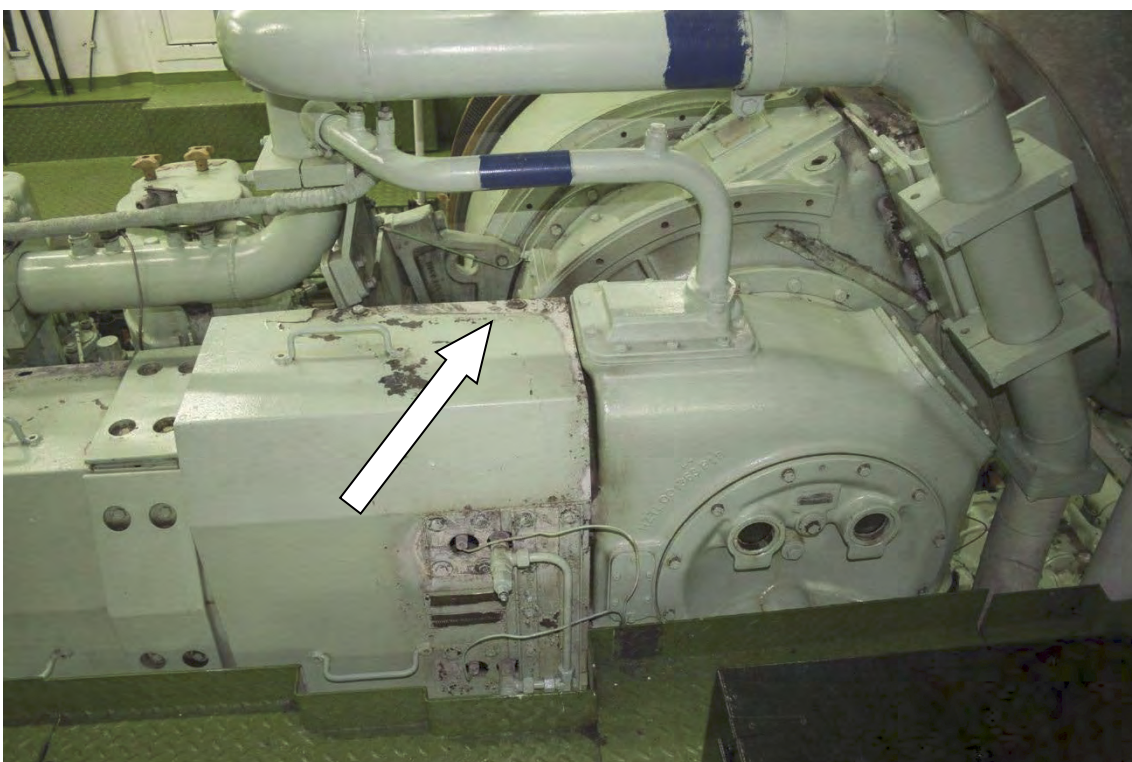
**Foto 5** Overgangen fra eksosmanifolden til turboladeren. Ser tendenser til varmepåvirket lakk.

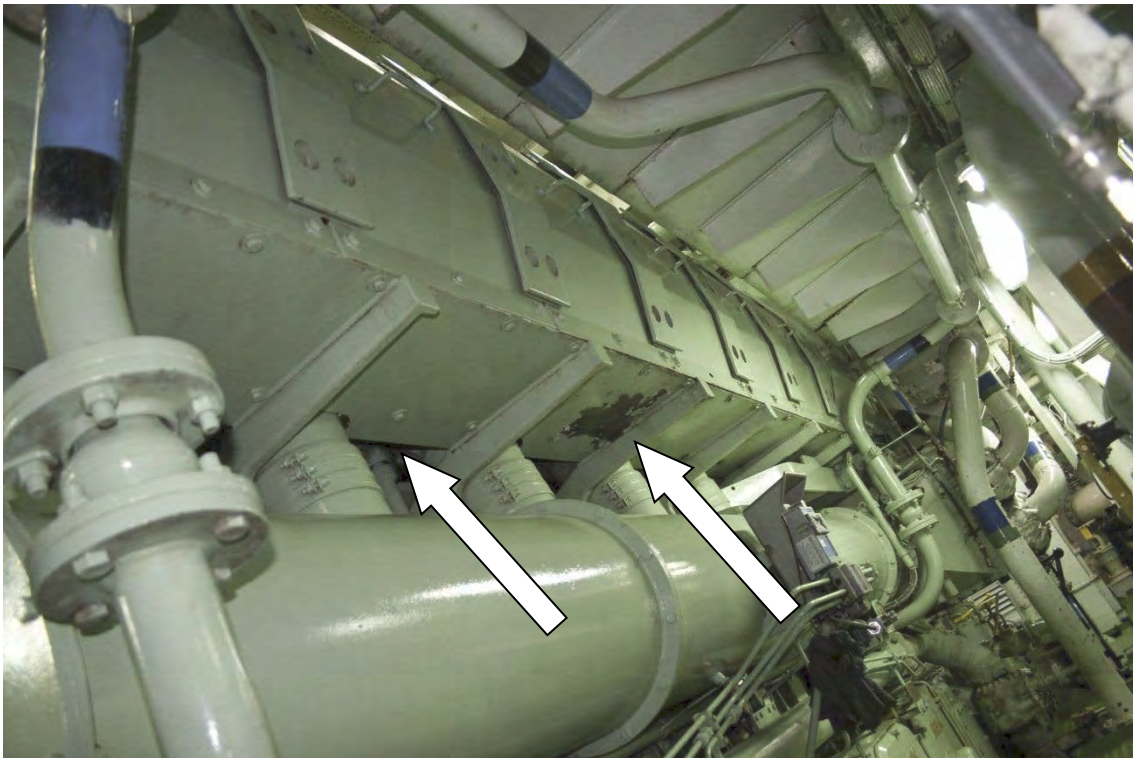
**Foto 10** Bildet viser avskalling av lakk oppunder babord side av styrbord hovedmotor (høyre pil). Venstre pil peker på punktet hvor sylindertemperaturen for hver sylinder ble målt.

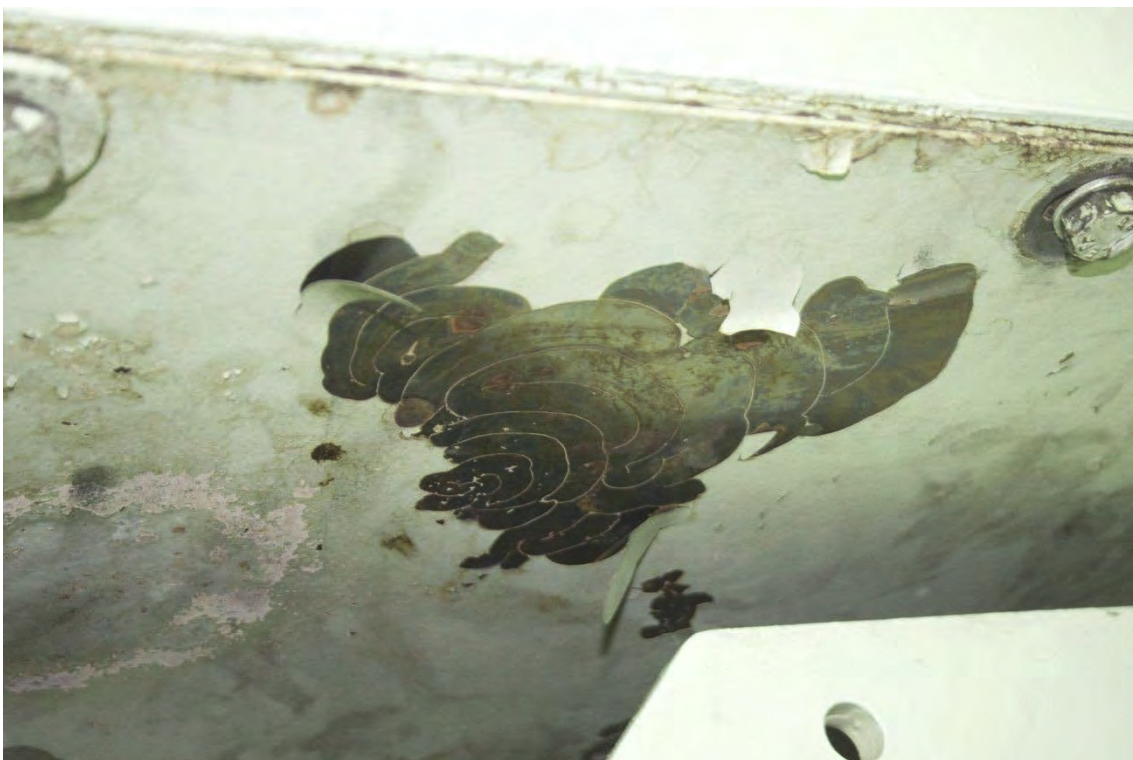
**Foto 11** Detalj av avskalling av lakk oppunder babord side av styrbord hovedmotor.

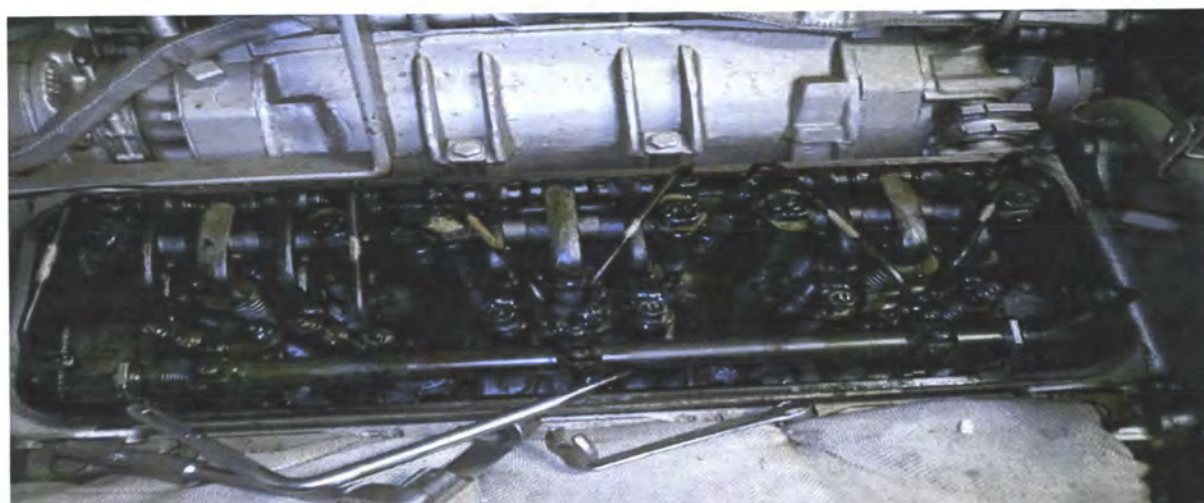
Ser godt at det har hvert veldig varmt.

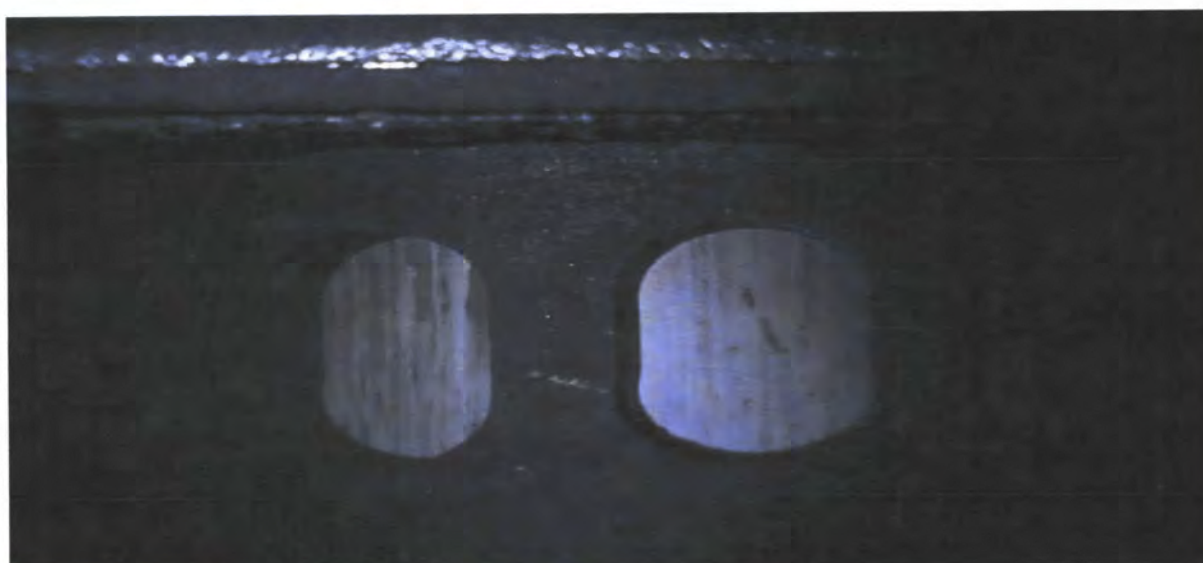
Ser rivninger på stempel.

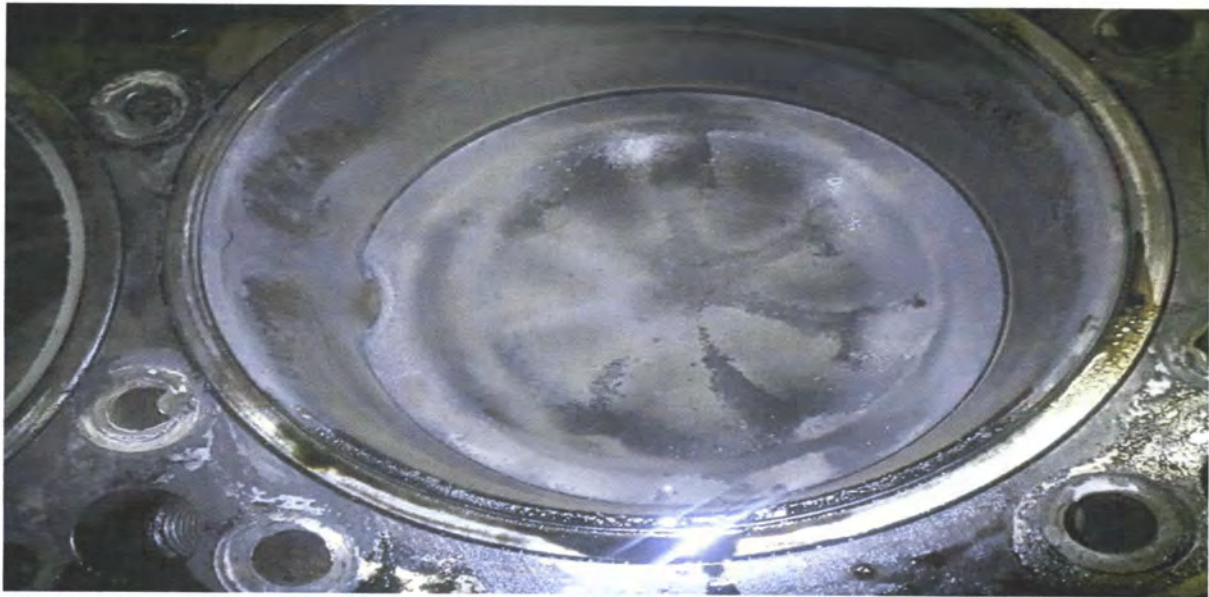
Når jeg fikk av toppene var det klart at det hadde revet seg på flere sylindere. Slutt 20.30

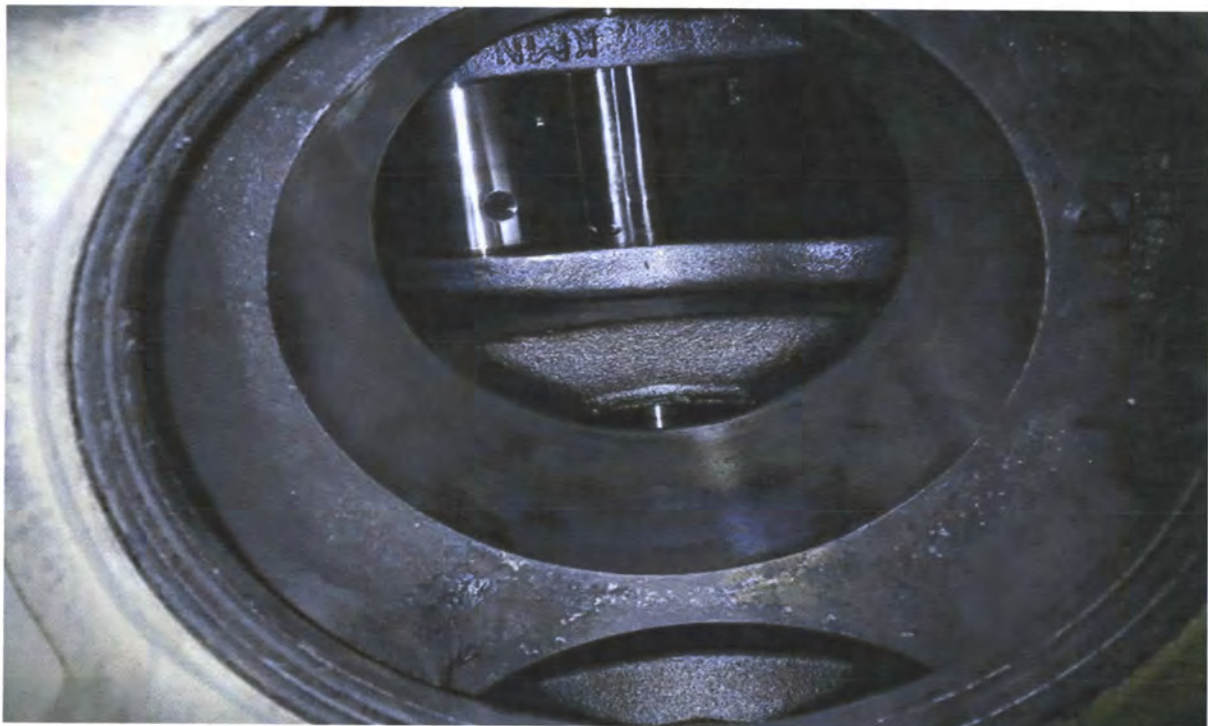
Startet dagen på verkstedet til Maritim Motor AS 07.00, reiste til Vigra for å hente Thor Hermansen fra Bergen Diesel Contact. Ankom verftet og gikk i gang med å dra stempler, så da at alle måtte byttes. Da vi dro foringene så vi at blokken hadde fått blåfarge pga varmen.

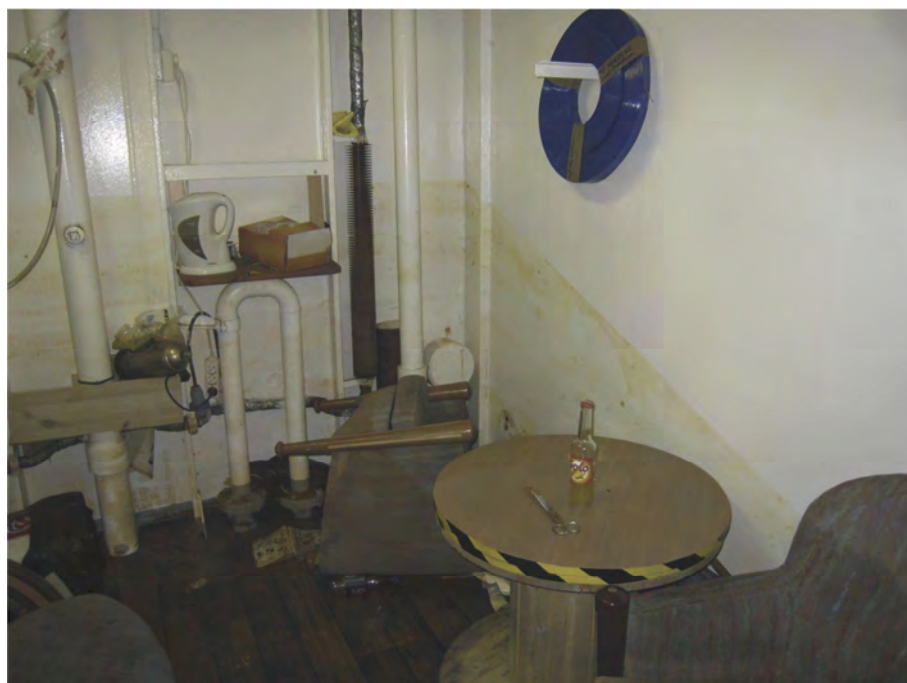
**Figure 4-1**

An overview was needed of what compartments were flooded and how much water there was in each compartment. In most compartments this was quite easy to read by the marks left on the bulkheads like in the photo below.

Picture of lashing room on car deck (#55 to #62) port side, aft of cargo lifts.

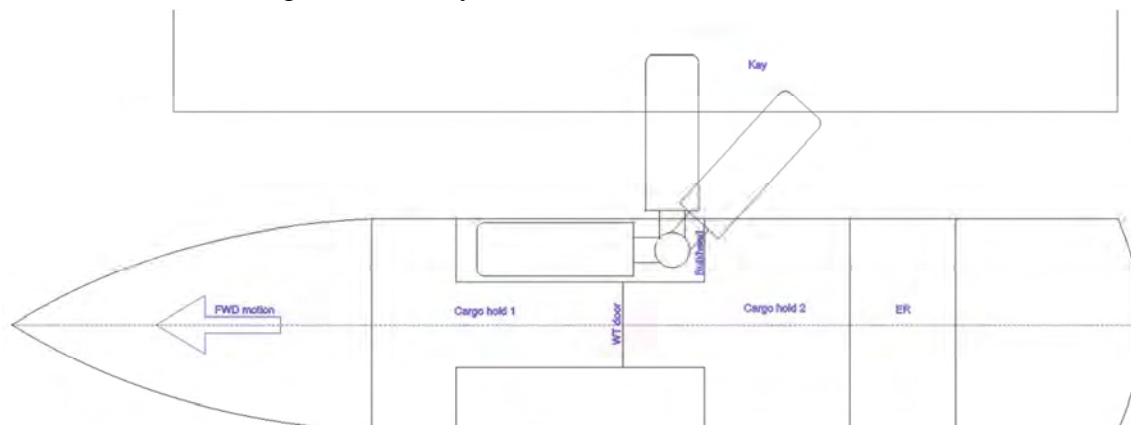
**Figure 5-1**

Above is a sketch of how the damage occurred. The stabilizer fin was bent backwards causing the trailing edge (Figure 5-2) to cut open the side shell of cargo hold 2.

The size of the hole was reported to be about 30 cm long and 8 to 10 cm high.

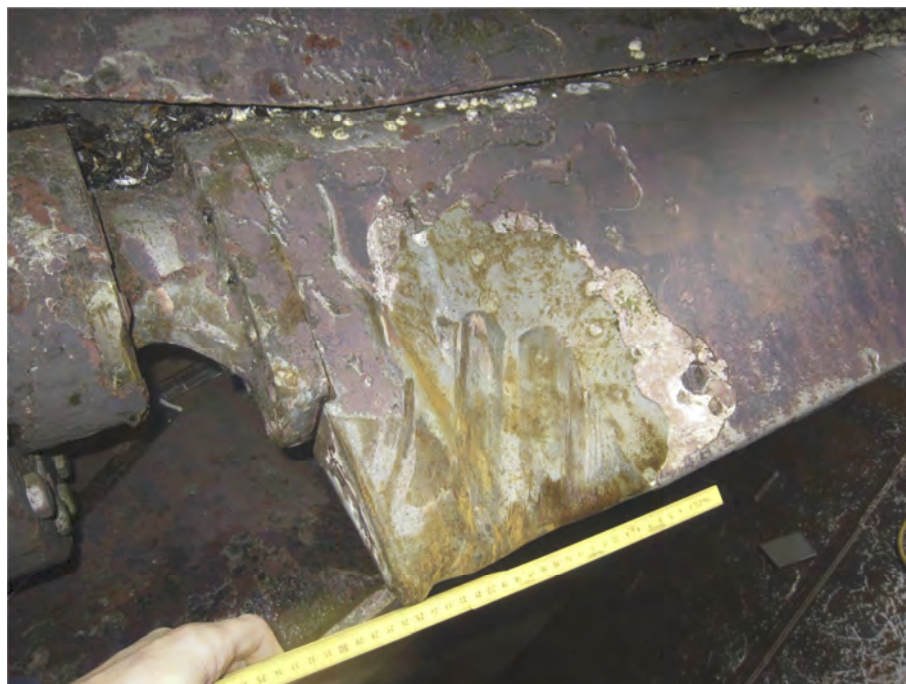
**Figure 5-2**

Trailing edge of stabilizer fin.

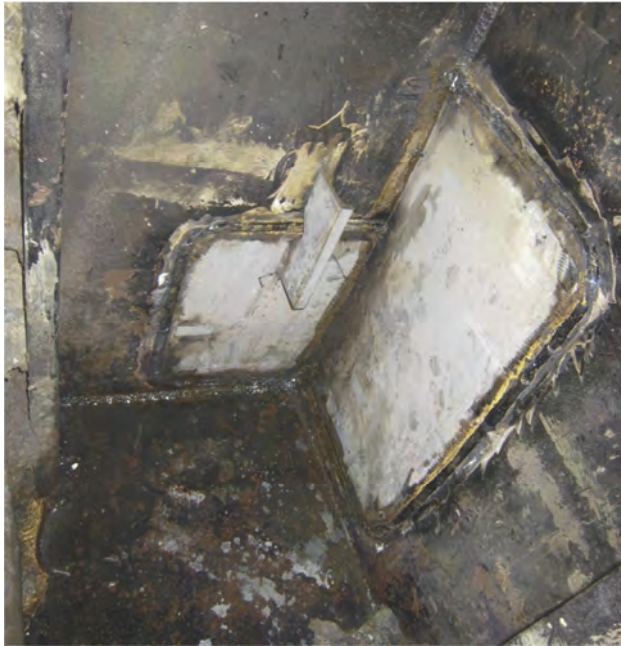
**Figure 5-3**

A repair had been carried out before the inspection, replacing the damaged area with new plating. The exact position of the damage was therefore not attainable. The bottom plating seen on the picture is the tank top.

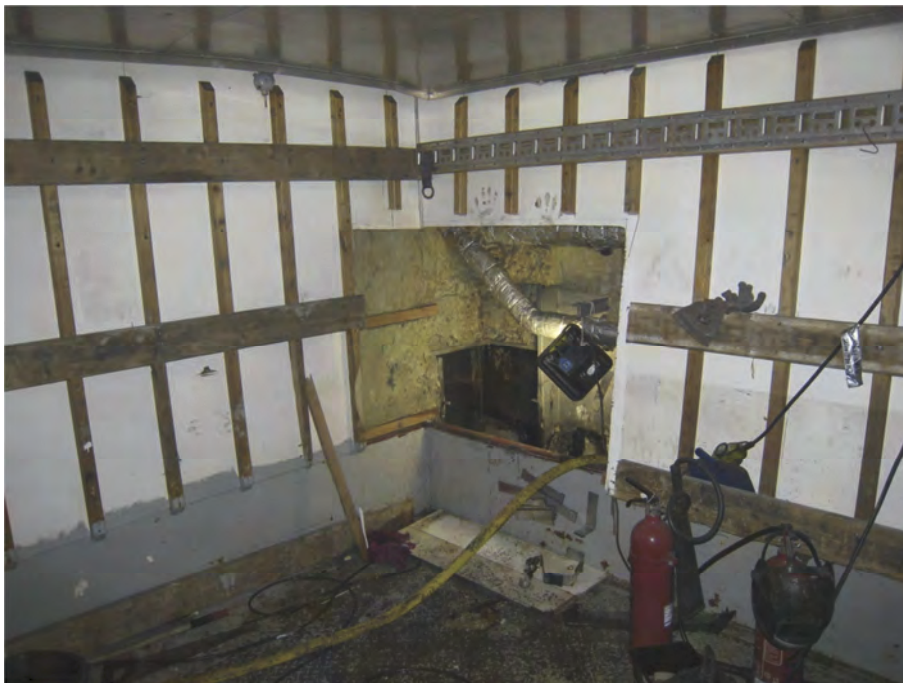
**Figure 5-4**

The damage was behind a thick layer of insulation. The water flooded through the damage on the starboard side over to the port side since the vessel had a slight list to port side before the damage.

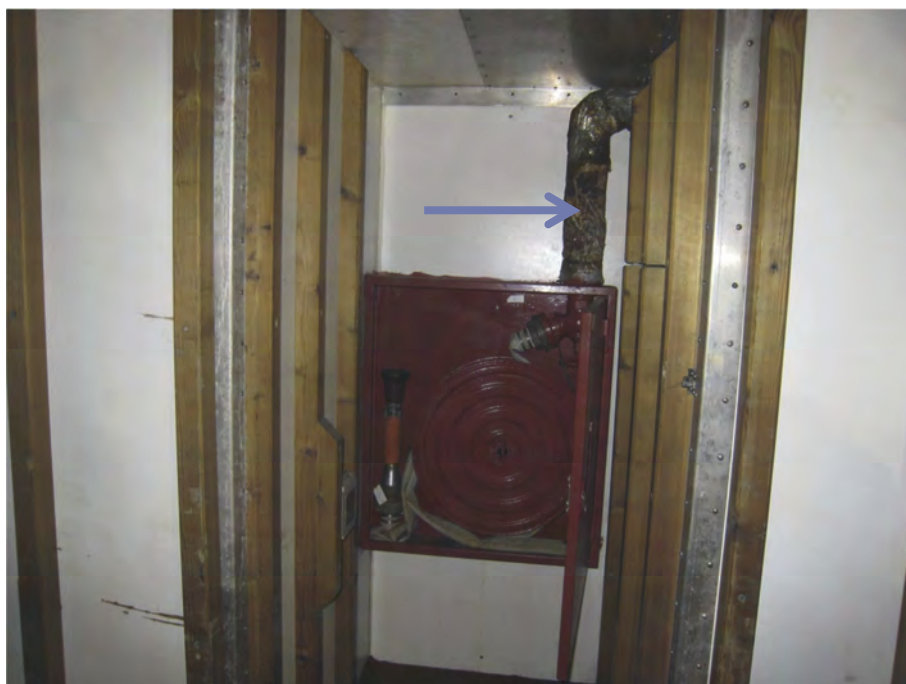
**Figure 6-4**

The arrow shows the level of water. The insulation was dry above the arrow and wet below.

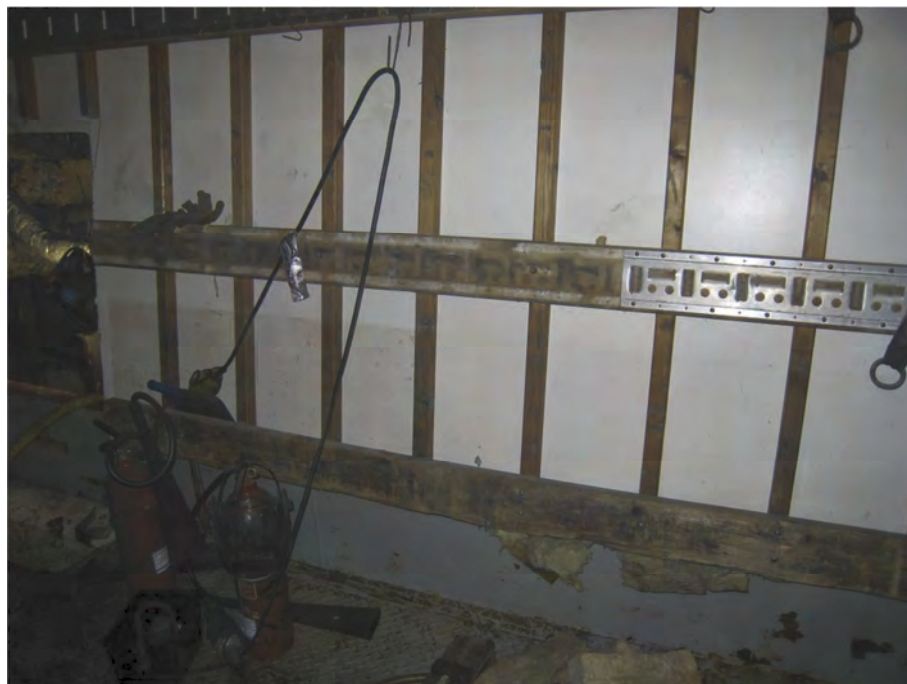
**Figure 6-5**

Trace of water is clearly seen on the bulkhead on starboard side of cargo hold 2.

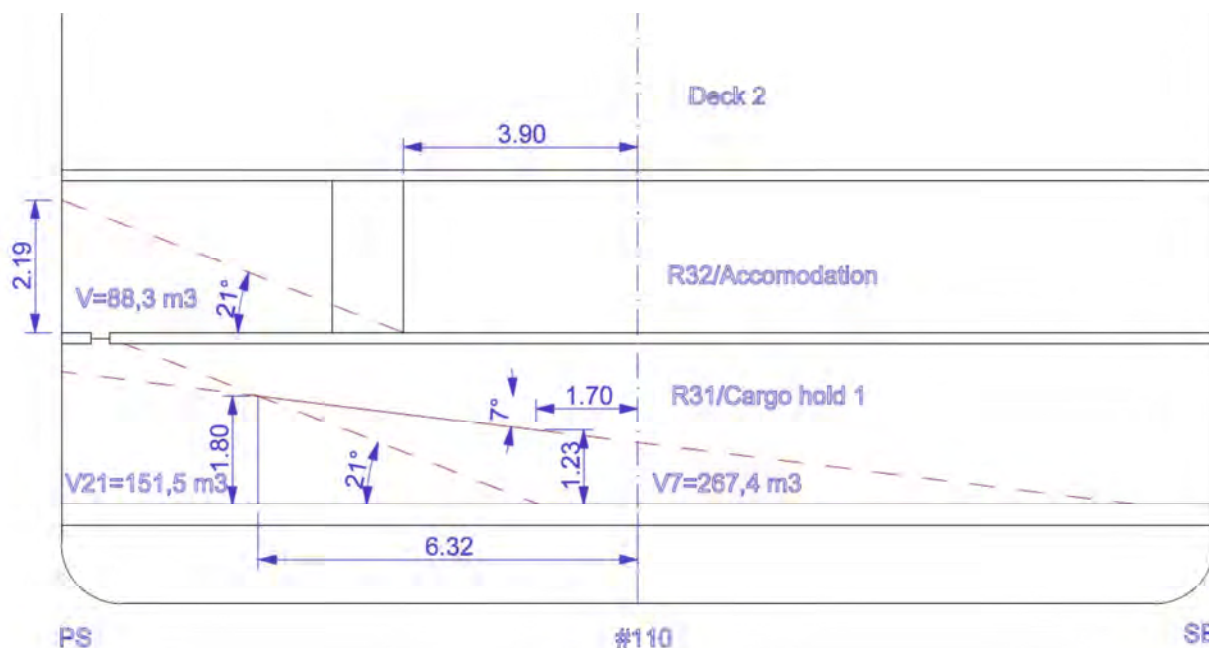
**Figure 6-8**

In cargo hold 1 were two marks of water detected. As seen on the sketch above, the angle of heel made by the two positions gave a heel of 7 degrees. The port position was an insulated pipe where the insulation was dry above a certain level (see Figure 6-4). It is therefore presumed that this give the highest possible water level at maximum heel.

On deck 1 was water detected on the starboard side of the port corridor in the accommodation. The angle is presumed to be 21 degrees.

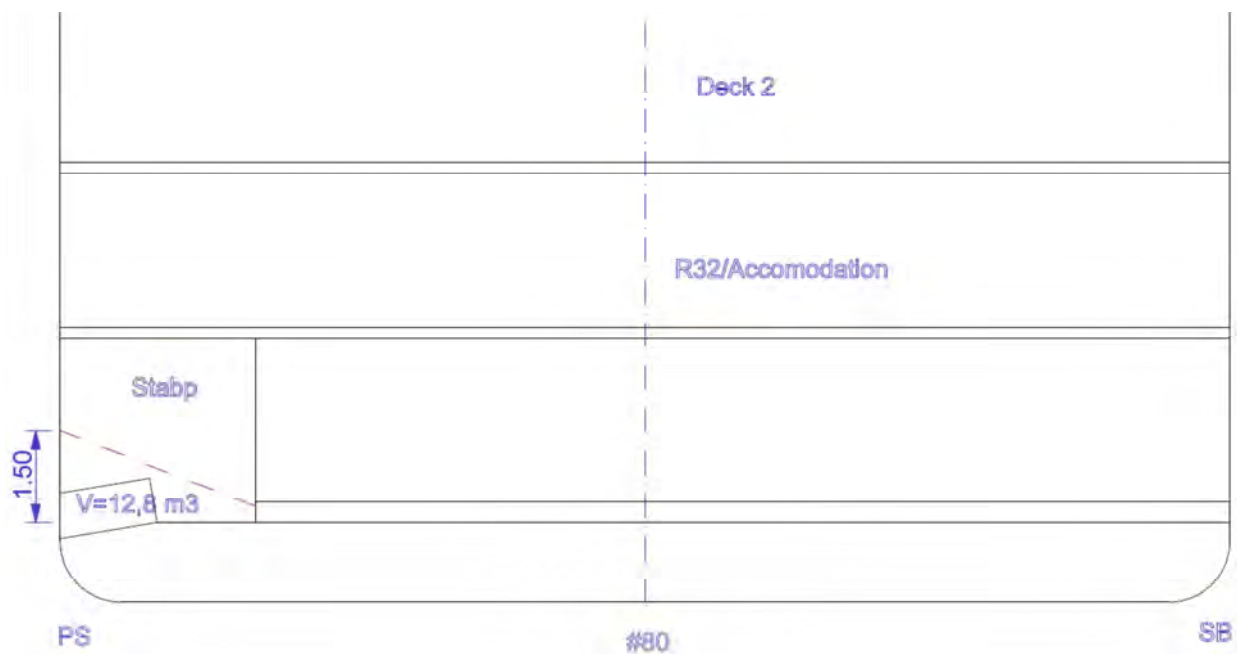
**Figure 6-9**

Marks on the side shell gave the maximum water level. The angle is presumed to be 21 degrees.

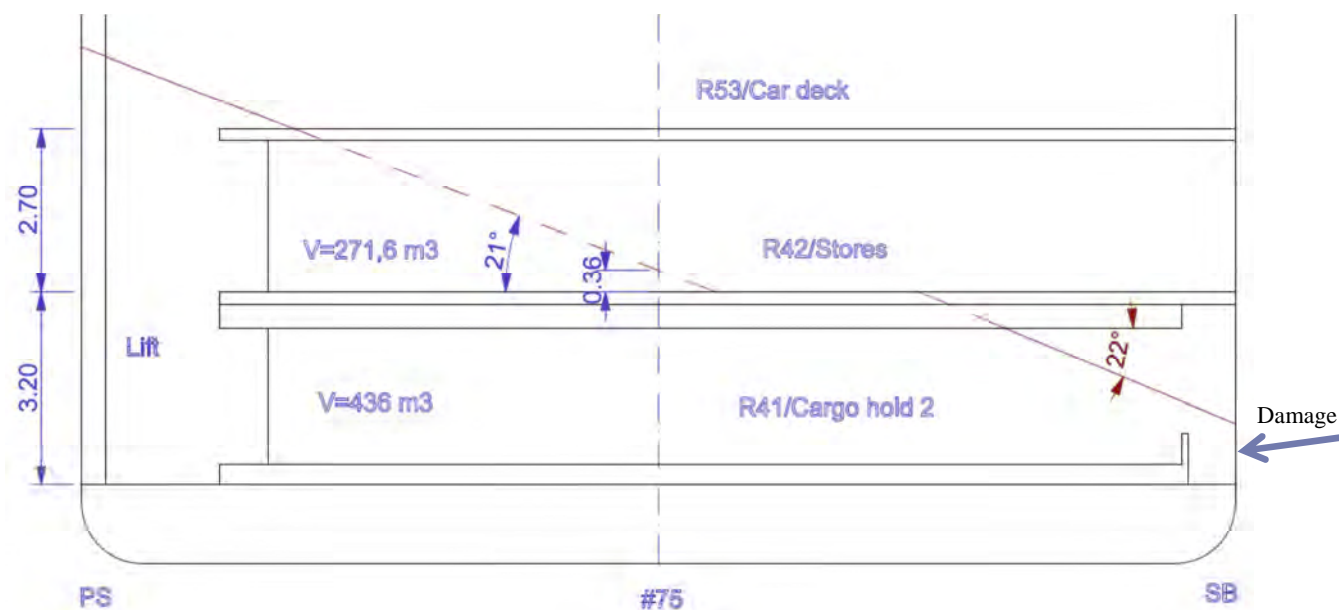
**Figure 6-10**

Clear traces of water were found on the longitudinal bulkhead in cargo hold 2 (see Figure 6-5). Traces were also found in the ceiling. There was not possible to find any traces in the store room on deck 1 due to a lot of soot. The level is therefore estimated based on the water level above on the car deck.

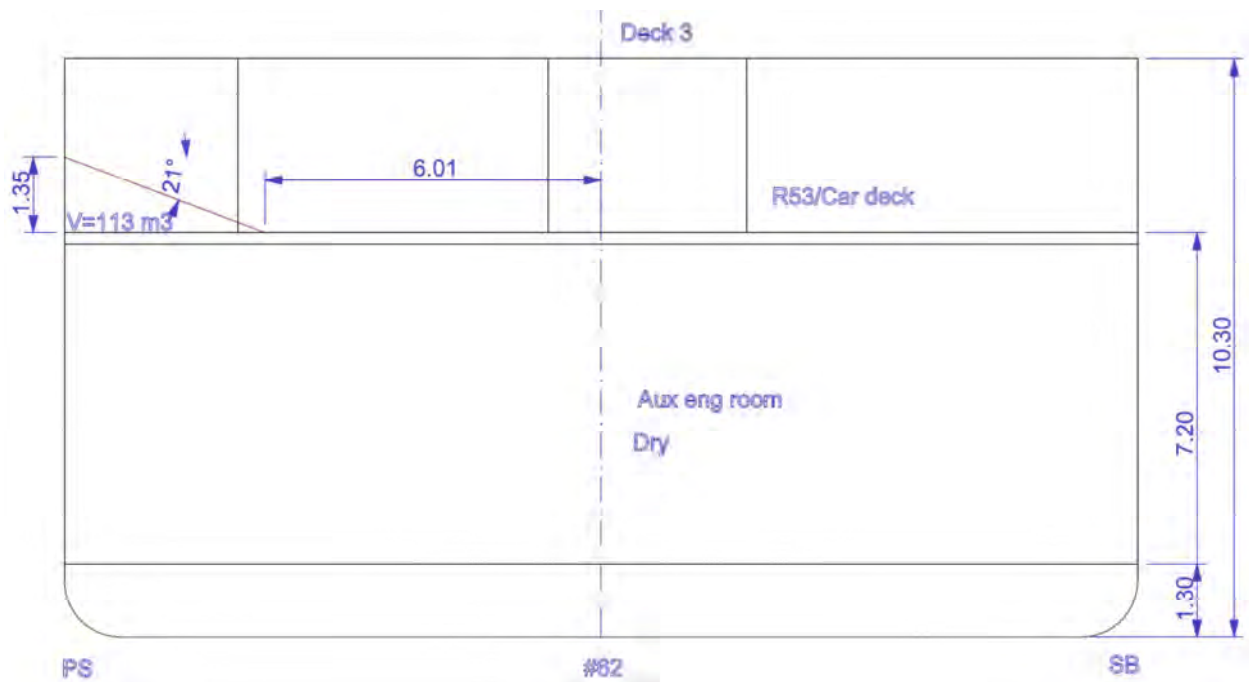
**Figure 6-11**

Several marks was made by the water on the car deck (see Figure 4-1, 6-6 and 6-7).

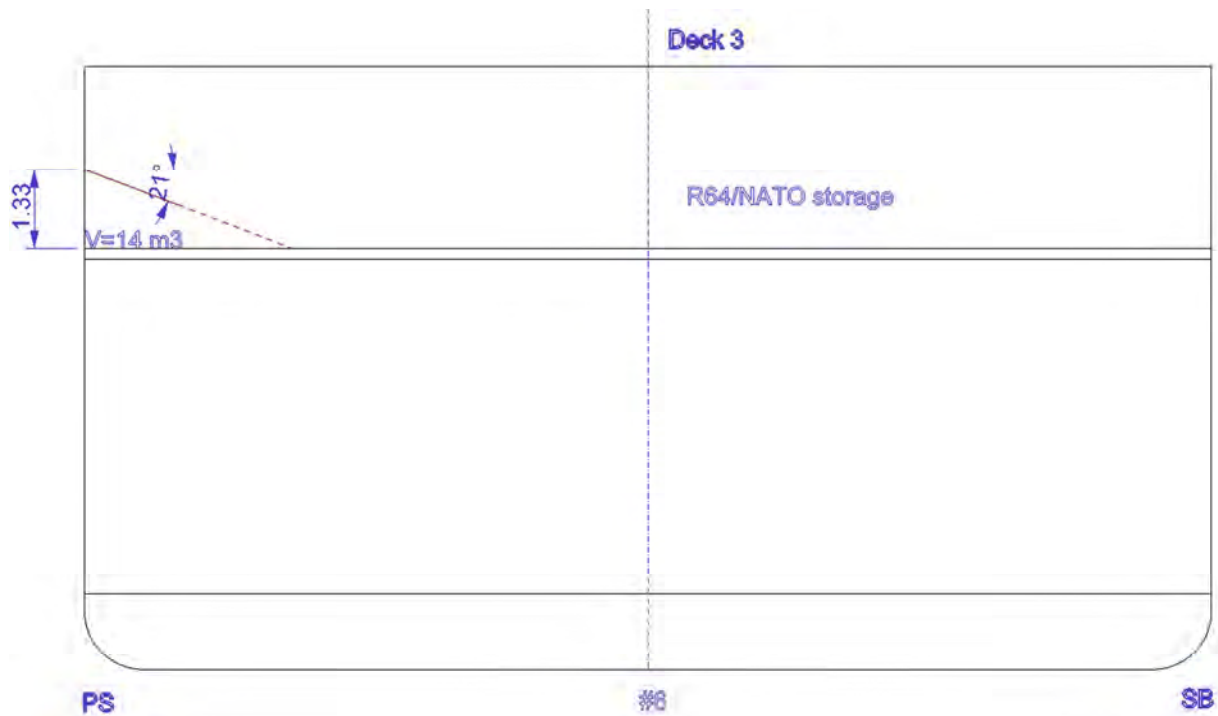
**Figure 6-12**

Some water was found in the NATO storage aft of the car deck.
