# REPORT

## Sjø 2014/05

## REPORT ON MARINE ACCIDENT ON BOARD THE MOTOR FERRY MF RØST - LDWE, NEAR SKROVA ON 18 MAY 2013

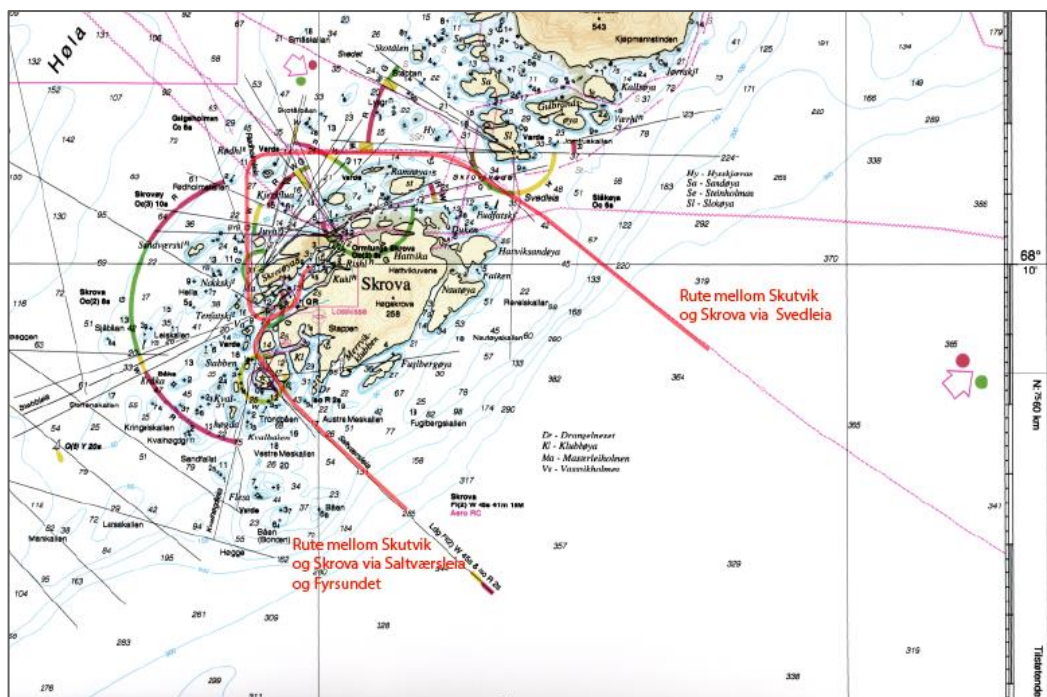
The shipping company's representatives told the AIBN that sailing through Fyrsundet reduced the travel time between Skrova and Skutvik (Figure 8) by 10 minutes in both directions. It was also stated that Fyrsundet and Saltværsleia inlet were the most favourable starting point for setting course across the Vestfjord. Furthermore, under unfavourable weather conditions, this could also make the passage more comfortable for the passengers on board.

Figure 8: Map section with the route via Svedleia and the alternative route via Saltværsleia and Fyrsundet drawn in. Source: Nautical Chart No 73 from the Norwegian Hydrographic Service

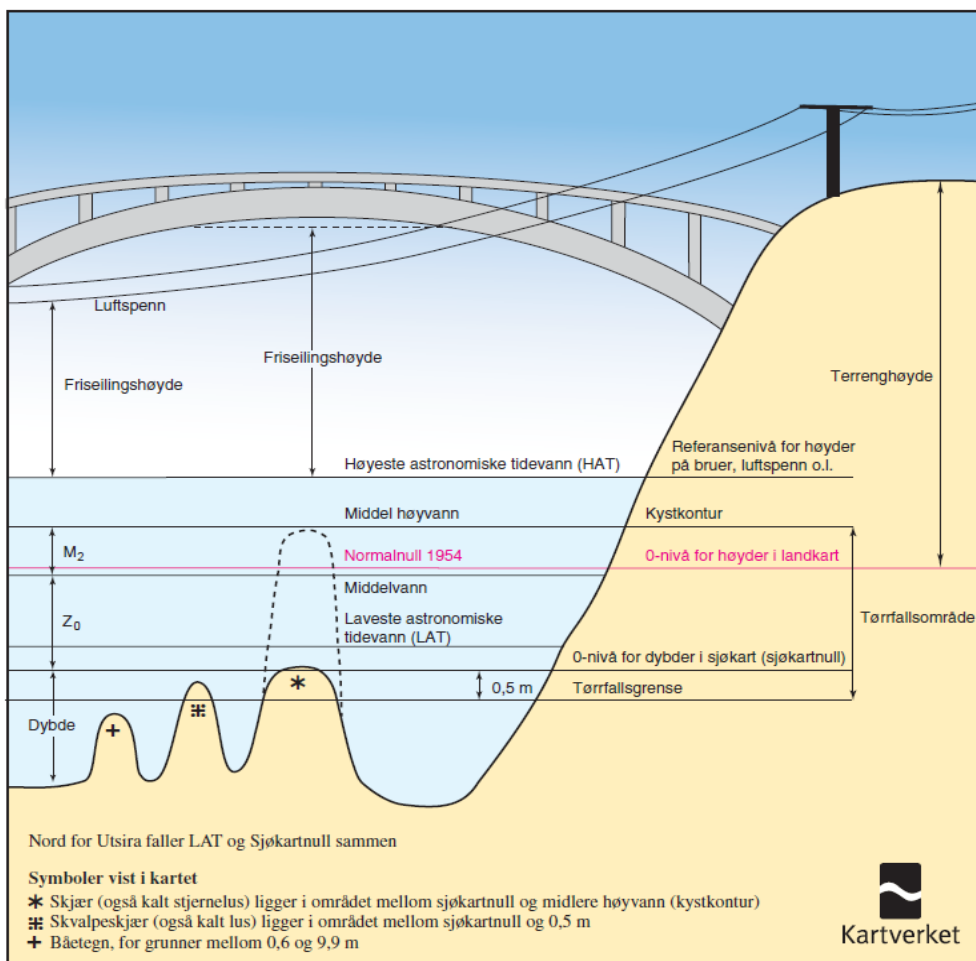
Figure 9: Illustration of navigational limitations. Source: the Norwegian Hydrographic Service

Neither the illustration in Figure 9 nor the legends on the 143 nautical charts in the Norwegian Hydrographic Service's main series, which covers the Norwegian coast in the scale 1:50 000, state that a safety margin has been added to the safe vertical clearances under overhead cables carrying high voltage.

It is pointed out in *Den norske los* that overhead cables can carry high voltage, and that seafarers must exercise great caution when navigating in their proximity. However, *Den norske los* does not describe the safety margin that is taken into consideration in the given safe vertical clearance under overhead cables carrying high voltage. Nor is any explanation given of what the magenta colour signifies. The illustration in Figure 9 shows that HAT is to be used as the reference level for safe vertical clearances.

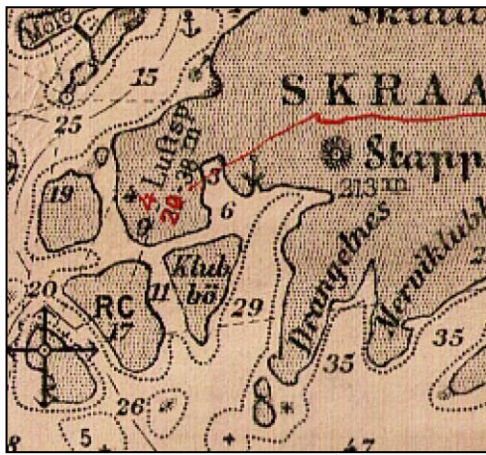
Figure 11: Section of Nautical Chart No 73, 1951-59 Source: the Norwegian Hydrographic Service

The most recently updated list of cables crossing fairways (*'farvannskryssliste'*) from 2003, which Lofotkraft claims to have sent to the Norwegian Hydrographic Service, shows a minimum safe vertical clearance of 22 metres, which is the height indicated on the two signs ashore on either side of the sound. The nautical charts, however, show a clearance of 20 m both before and after the overhead cables were raised in 1993 (Figures 11 and 12).

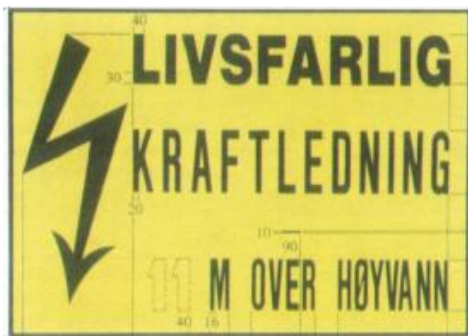
The Regulations do not specify whether the figures stated on such signs shall be understood to signify safe vertical clearances or whether seafarers are expected to add a safety margin. However, the power company's calculations show that a safety margin must have been reckoned with (see section 1.7.3). The margin of 2 metres is in accordance with the letter from the NC Authority in 1982.

Figure 14: Warning sign where overhead cables span the fairway. Source: Regulations relating to beacons, seamarks etc. Annex A4

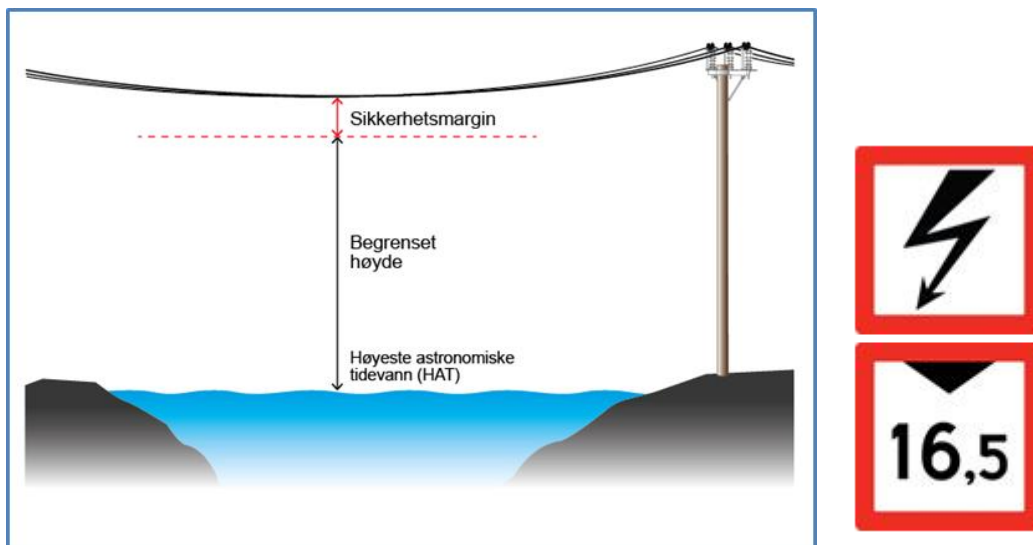
As far as overhead cables are concerned, it is specified in Section 7.2.1 of the above-mentioned Annex 1 to the Regulations that the 'limited height' is calculated as the vertical distance to the lowest point within the navigable breadth of the fairway, with the deduction of a safety margin depending on the voltage carried by the cable in question. For the voltage carried by the cables across Fyrsundet, the margin is stated to be 1.5 m, see Table 8. This safety margin comes in addition to what is described in the previous

Figure 15: Limited height under overhead cables and signage. The signs indicate 'Life-threatening danger, electric cable' (above) and 'limited height' (below). Reproduced from the Regulations relating to Fairway Signs etc. Annex 1 Chapters 7 and 8
