REPORT

Marine 2018/06

REPORT ON WORK ACCIDENT ON BOARD THE NORMAND MAXIMUS OFF THE COAST OF BRAZIL ON 21 FEBRUARY 2017

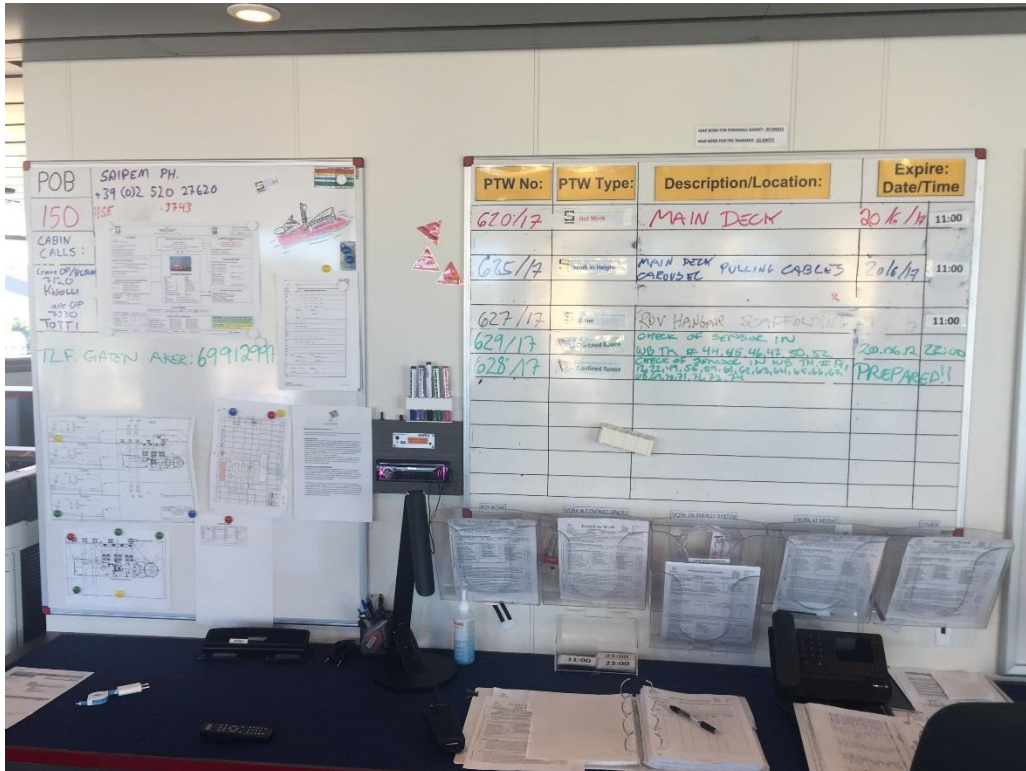
Figure 7: The photo shows the area on the bridge of the CSV Normand Maximus dedicated to handling the permit to work system. This photo was taken in June 2017 and shows entries and notes from another project that has nothing to do with the accident in February 2017. Photo: AIBN

The change made in the PTW system at the request of Saipem entailed changes to the procedure that leads up to the final approval of a PTW. Previously, it was the person who was to carry out the work (Baker Hughes) who submitted to the shipboard management 'checklists and procedures relevant to the work to be carried out'. The function of the shipboard management was not to approve the job as such, but to verify that the submitted procedures and checklists in the system had been observed.

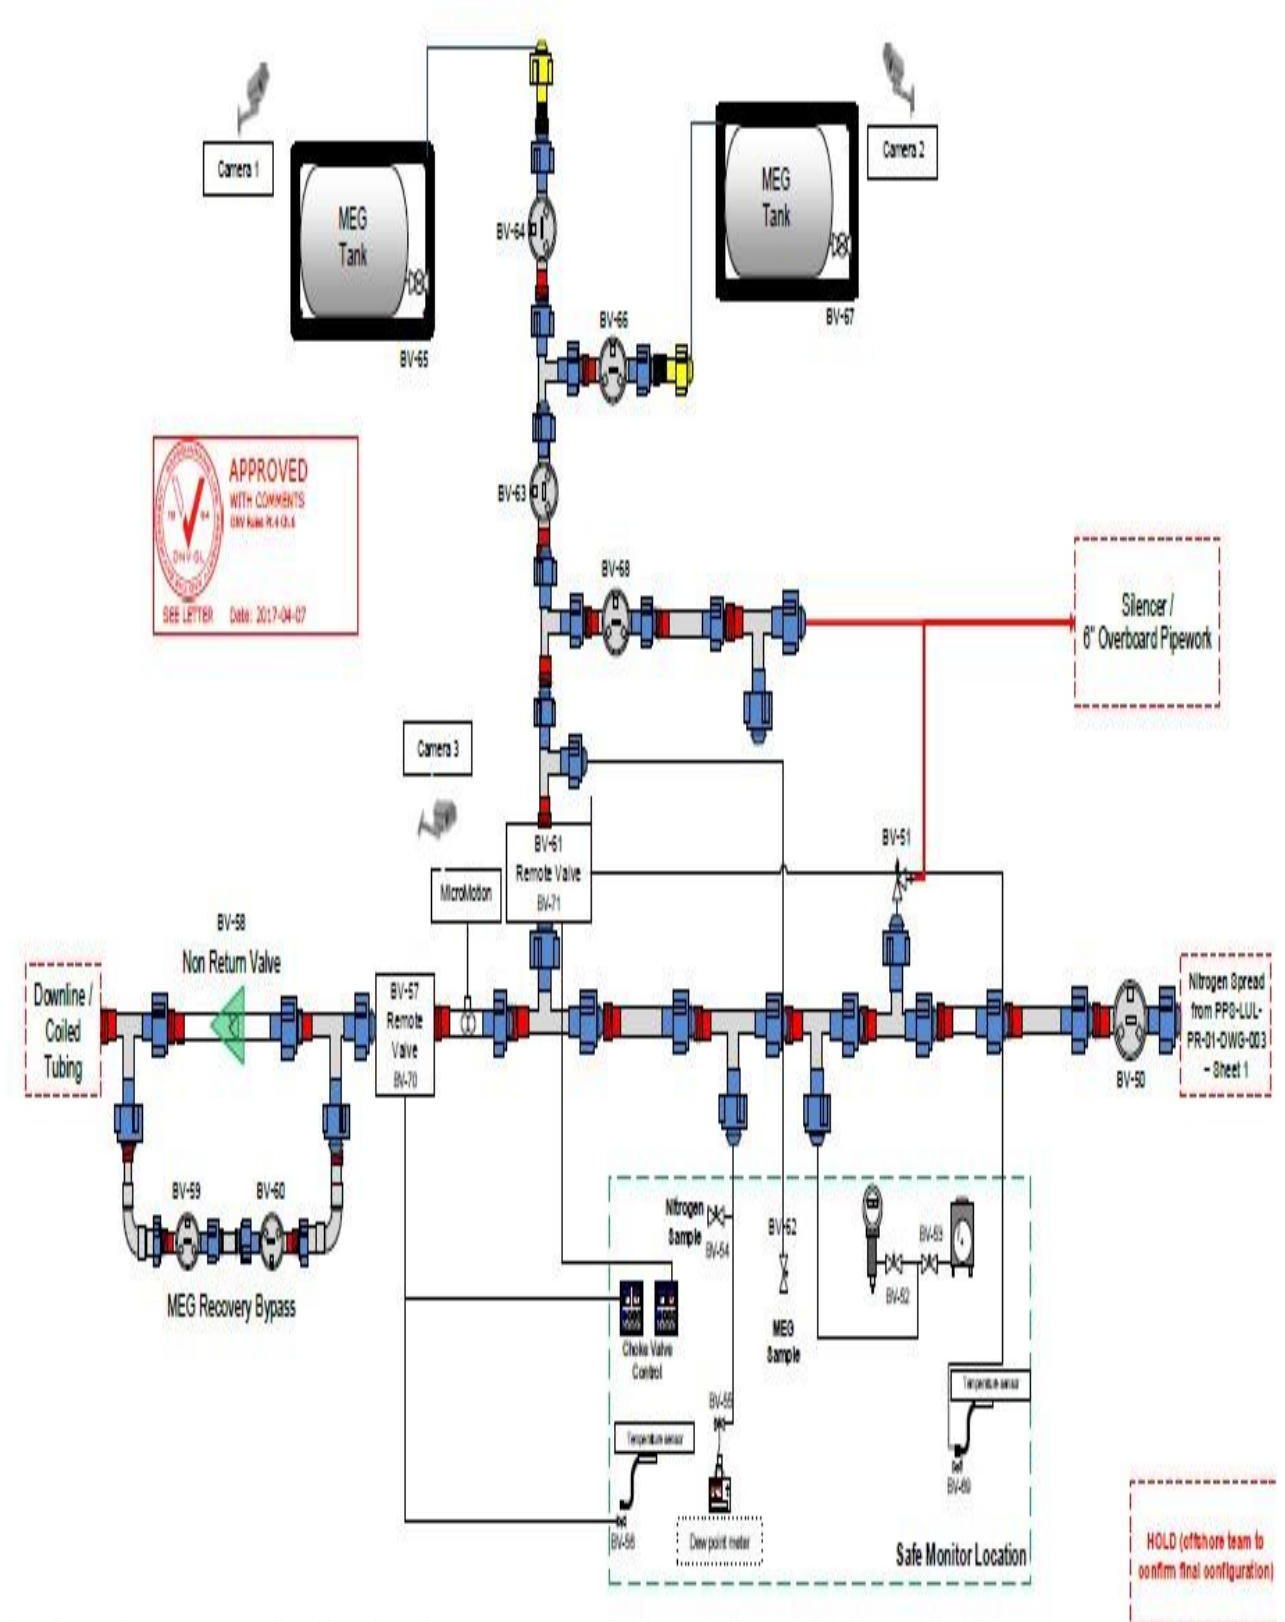
Photo 8: Installation diagram.
