Statens
Havarikommisjon
for Transport

Sjø 2018/06

RAPPORT OM ARBEIDSULYKKE OM BORD I NORMAND MAXIMUS UTENFOR KYSTEN AV BRASIL 21. FEBRUAR 2017

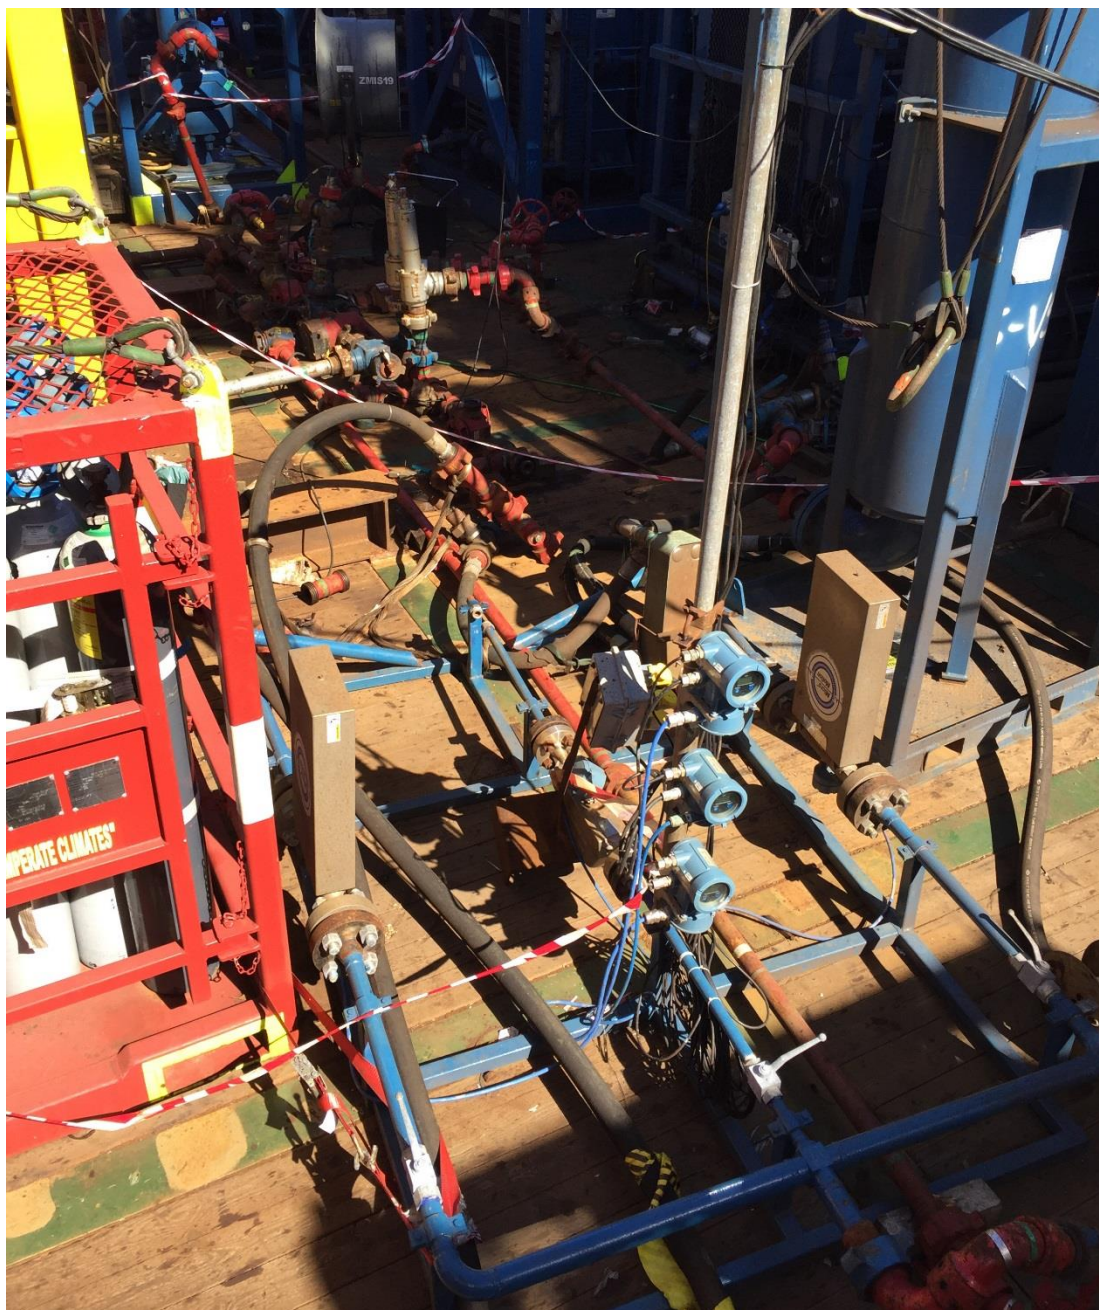
Saipem var ansvarlig for montering og klargjøring av installasjonen som skulle benyttes om bord i CSV Normand Maximus for å gjennomføre pre-commissioning jobben. Den tekniske operasjonen skulle foregå på det utvendige dekket akterut. Hele akterdekket var fylt med forskjellige komponenter som var sammenkoblet med rør, slanger og ventiler. Mange av ventilene og enkeltkomponentene var sertifisert av klasseselskap, men det forelå ingen ekstern godkjenning eller sertifisering av den komplette installasjonen.

Figur 4: Rør, slanger og ventiler var plassert mellom komponentene på det utvendige dekket.
Foto: Brazilian Navy

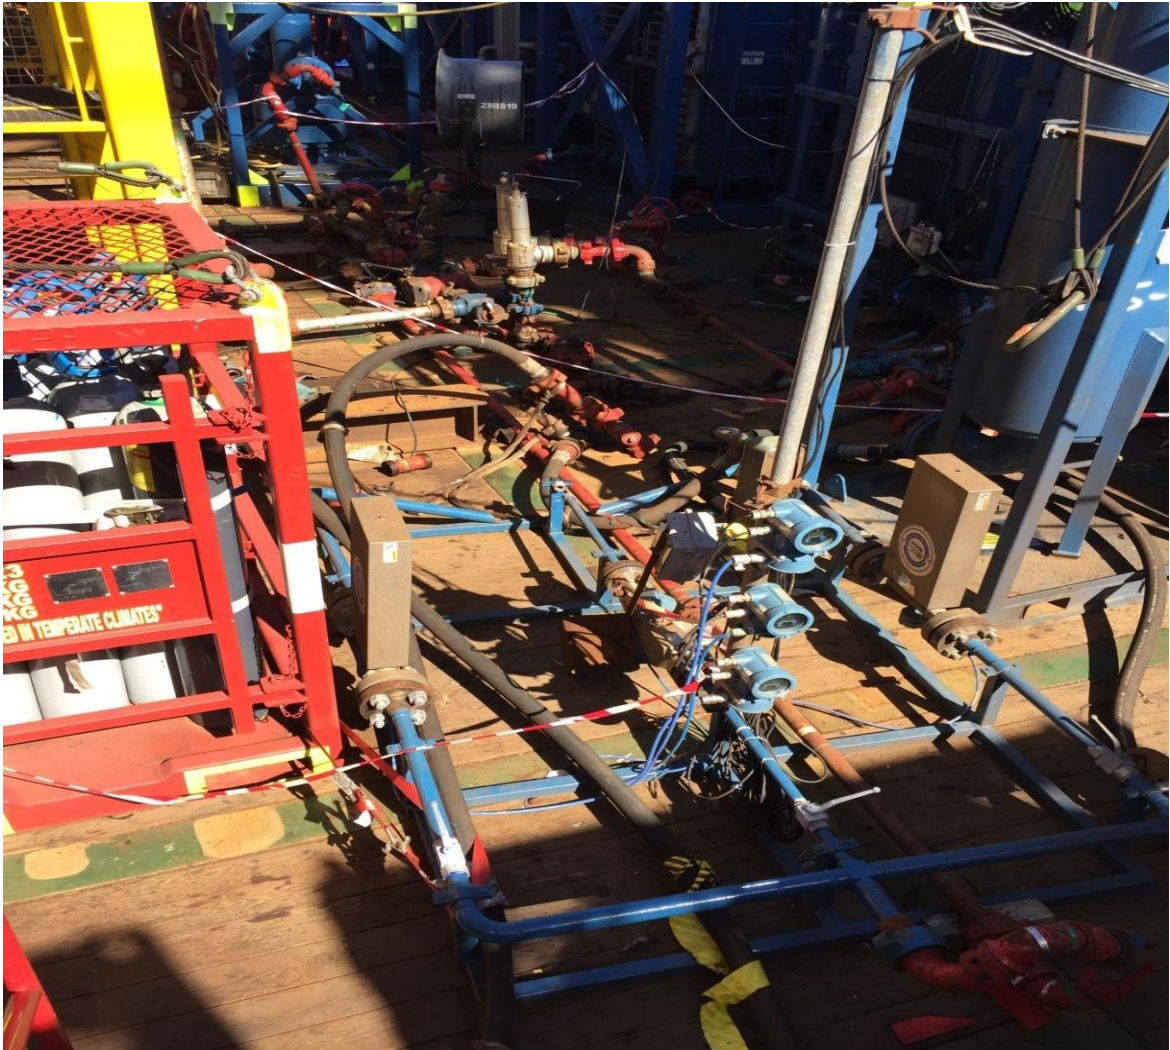
Photo 2: Installation overview

a) Several material broken and broken steel pipes; faulty locking and relief valves; high pressure hoses (2,500 psi capacity), belonging to the pre-commissioning system, were torn and with broken steel mesh;

b) installation was without supports; the structures had no fixation and were loose, as well as pipes, valves and connections belonging to the system presented corrosion on their surfaces; two pressure and temperature loggers, members of the project scope (according to the approved procedure), were positioned on the main deck and not installed;

f) the existence of residues of oily product already absorbed by the wooden deck, close to the damaged valves.

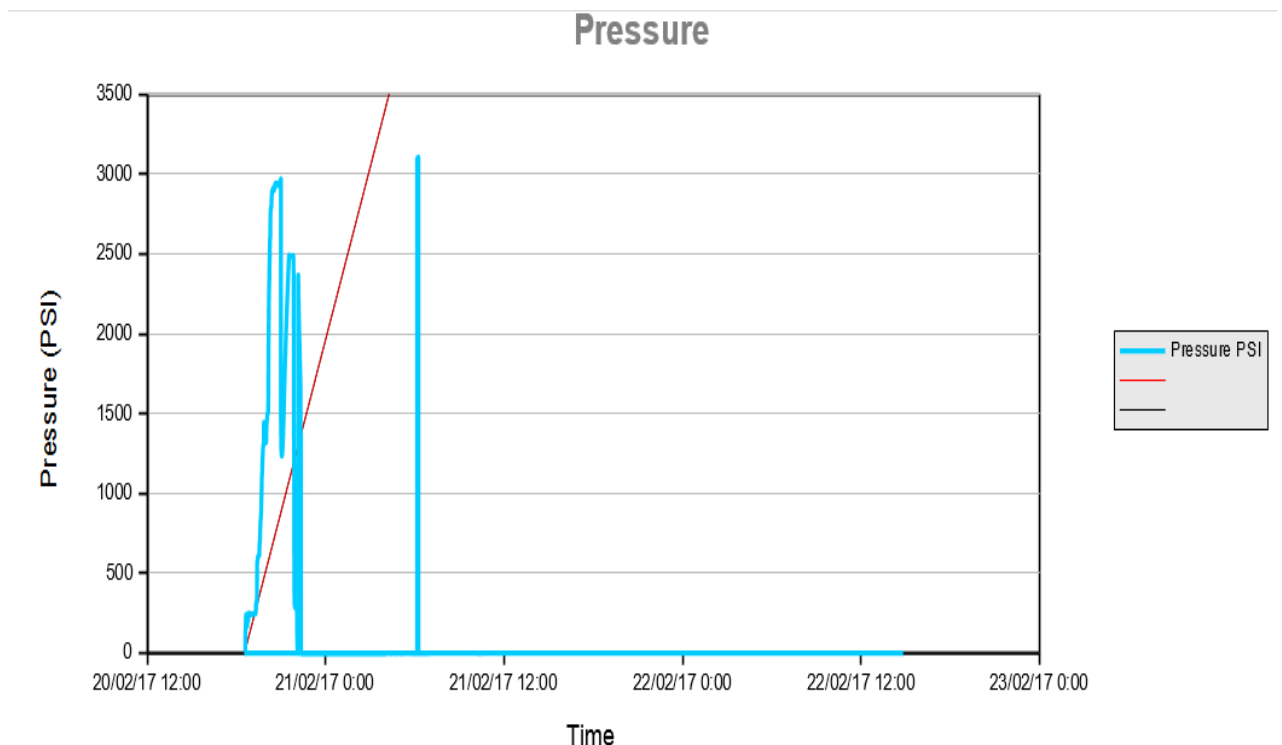
Photo 7: Diagram Pressure (PSI) X time

The control room monitored the conditions of operation and the launch / arrival of the pigs to the deck. The General Supervisor ("Senior Supervisor"), guided by the Control Room, manually depressurized the deck by means of valves. The network operated at local pressure up to 3,916 psi (270 bar). At the time of the accident the system operated at a pressure of 3,188 psi (215 bar).

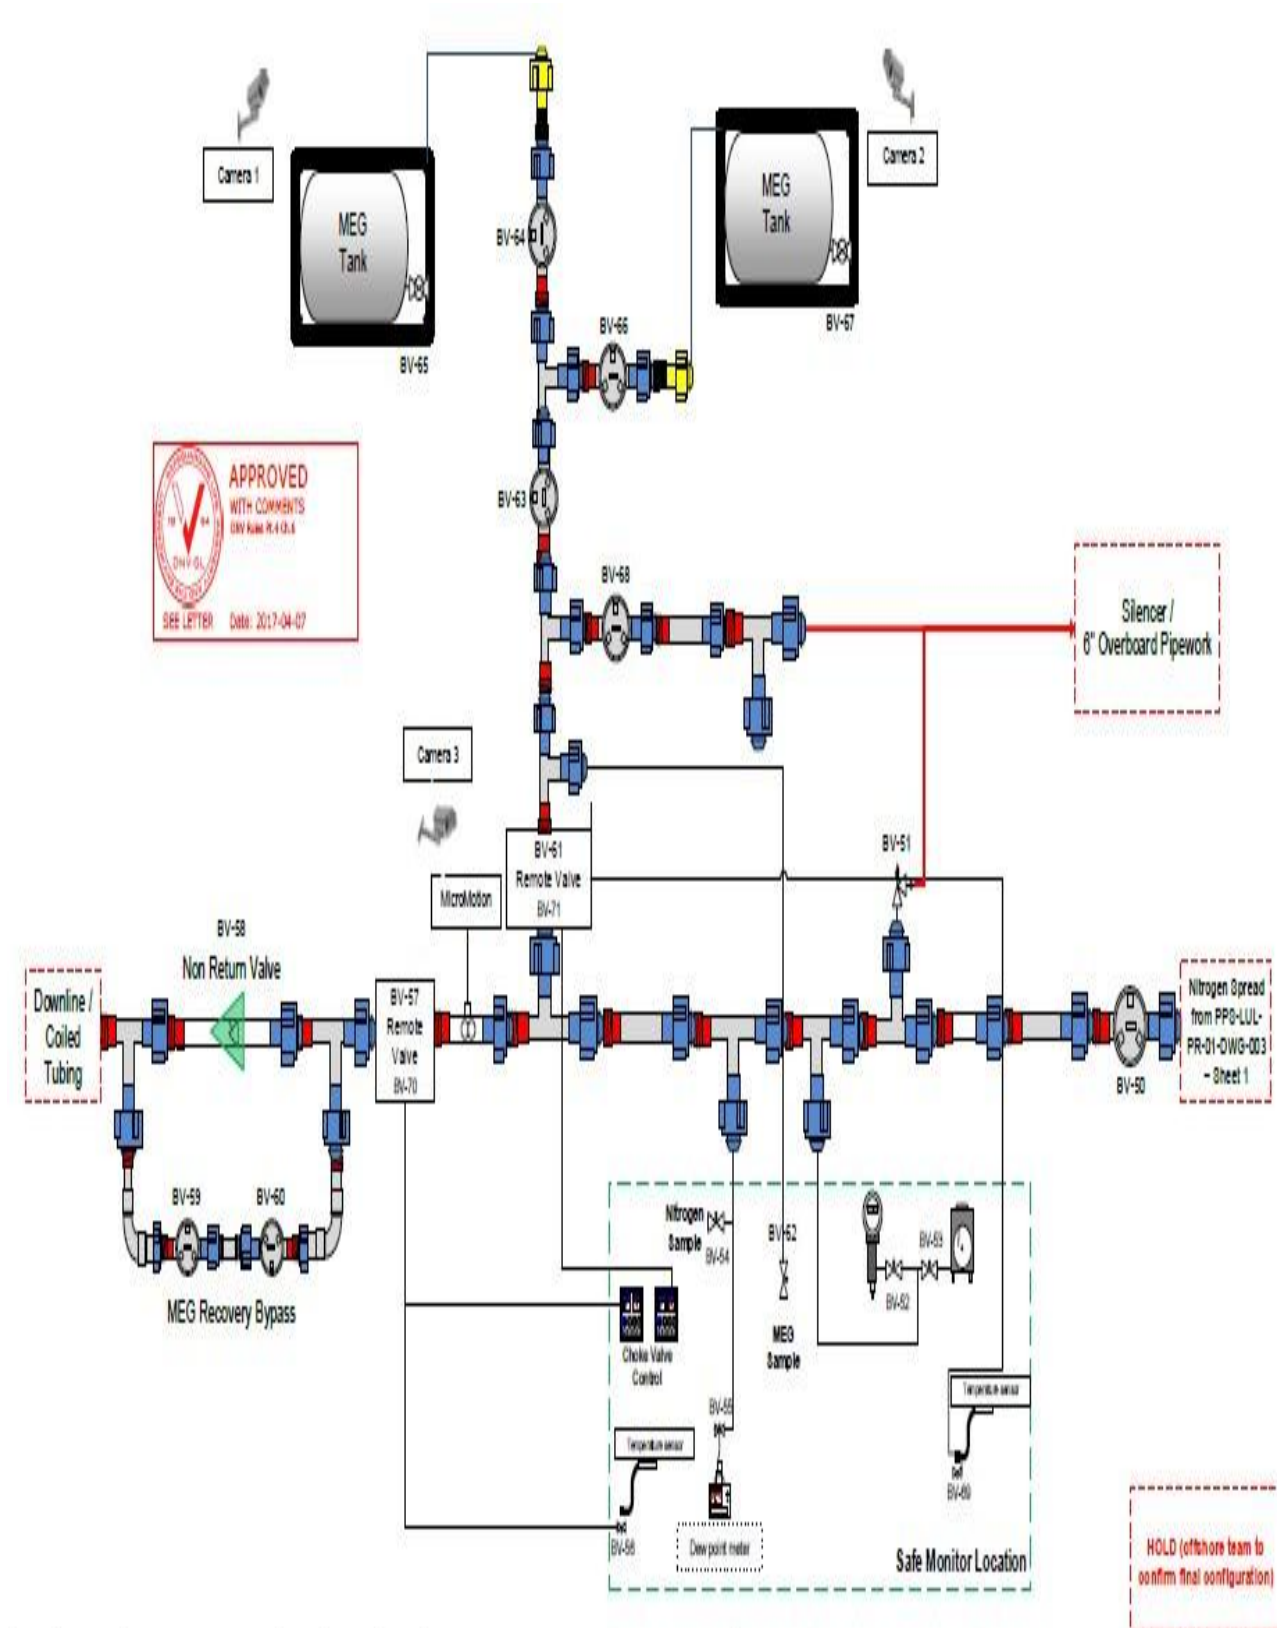
The operation of the system was performed by the General Supervisor, manually, through valves, starting with the local pressure of the order of 3,916 psi (270 Bar). The Process Engineer, positioned in the Control Room, monitored the pressures and flows, guiding the actions to be taken.

Photo 8: Installation diagram.
