# REPORT

## Road 2015/05

## REPORT ON HEAD-ON COLLISION BETWEEN TWO HEAVY GOODS VEHICLES ON THE E39 ROAD BY THE LAVOLL TUNNEL IN FLEKKEFJORD ON WEDNESDAY 22 OCTOBER 2014

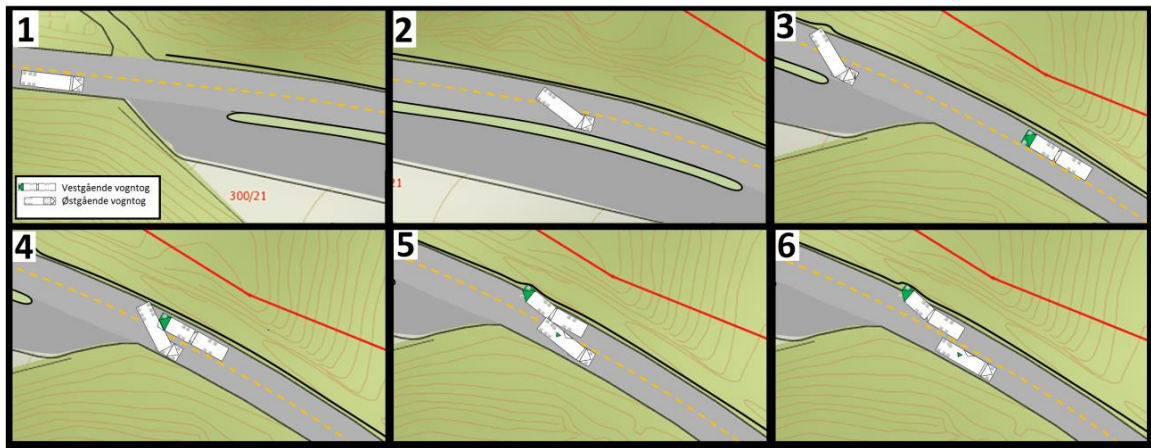
At the same time, a westbound heavy goods vehicle, belonging to Alex Andersen Ølund AS and consisting of a tractor and centre-axle trailer, was approaching in the opposite lane. This vehicle entered what, from its perspective, was a left-hand bend below the Lavoll tunnel, and ran into the skidding semi-trailer. The point of impact with the westbound heavy goods vehicle was the left part of the driver's cab. The westbound vehicle was pushed into the crash barrier on the right-hand side of the westbound lane. Under the impact of the collision, the eastbound vehicle's semi-trailer was pushed back into the eastbound lane, hit the crash barrier in that lane and stopped as illustrated in Figure 2.

Figure 2: The sequence of events. Source: © The Norwegian Mapping Authority/AIBN

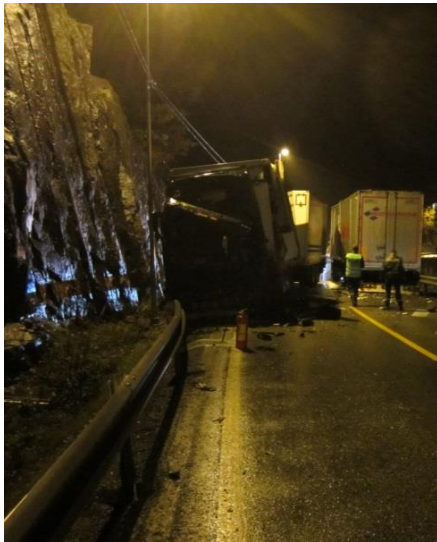
The crash barrier on the right-hand side of the westbound lane was damaged when the accident occurred. The barrier posts in Figure 8 mark the westbound heavy goods vehicle's final position, while the barrier posts seen in the distance (approximately 30 m behind) mark the point of impact with the eastbound vehicle's semi-trailer. Tyre marks were also found on the edge line, indicating that the westbound vehicle may have been pushed back towards the right. Figure 9 and Figure 10 show the heavy good vehicles' final positions after the collision.

Figure 9: Final positions looking eastwards. Photo: NPRA

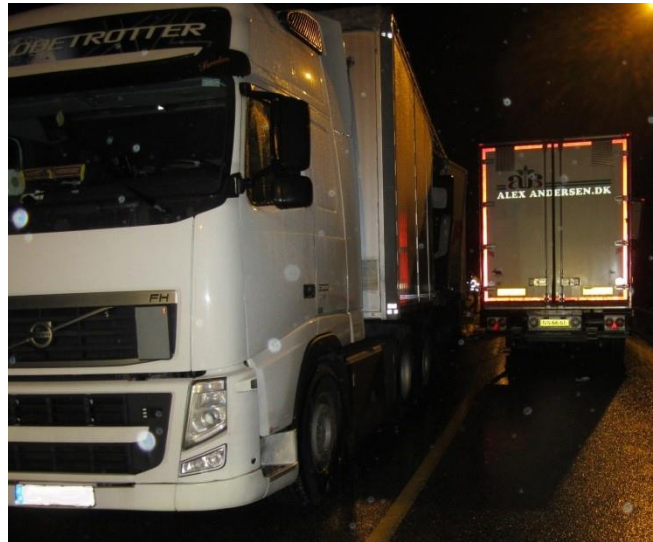
Figure 10: Final positions looking westwards. Photo: NPRA

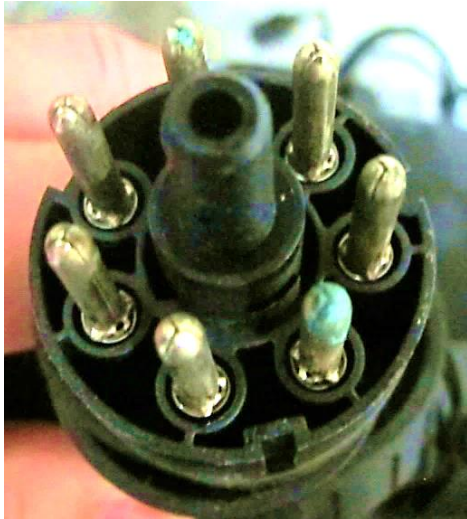
A yellow ABS-1 fault (fault signal for semi-trailer) was observed on the dashboard when the ignition was turned on. An EBS fault was also indicated on the dashboard when the fuse was installed.

Figure 11: 7-pin ABS plug for semi-trailer. Photo: AIBN

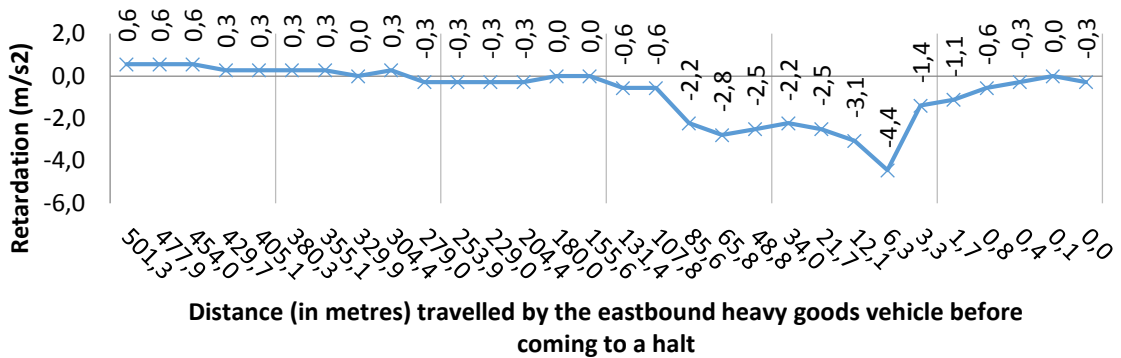
Tachograph data were downloaded for the eastbound heavy goods vehicle after the accident. Among other things, the tachograph records speed data<sup>3</sup>. The vehicle's retardation can be calculated on the basis of these data. From 500 to 100 m before the place where the vehicle came to a halt, the vehicle speed was recorded as between 84 and 92 km/h. A short distance before the bend, approximately 100 m before coming to a halt in its final position, the driver applied the brakes to slow down in the normal manner from a speed of 84 km/h. Figure 22 and Figure 23 show the calculated retardation and speed of the heavy goods vehicle.

Figure 22: The eastbound heavy goods vehicle's retardation over the final 500 metres or so before coming to a halt. Source: AIBN

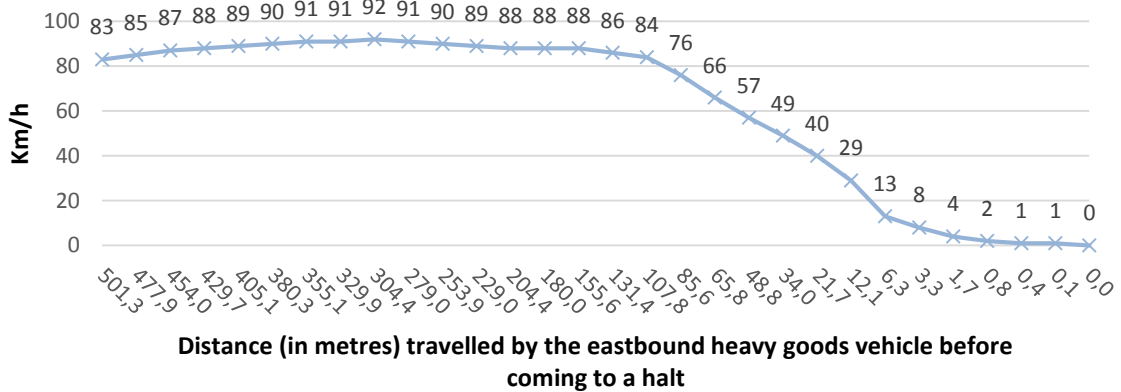
Figure 23: Speed of the eastbound heavy goods vehicle over the final 500 metres or so before coming to a halt. Source: AIBN

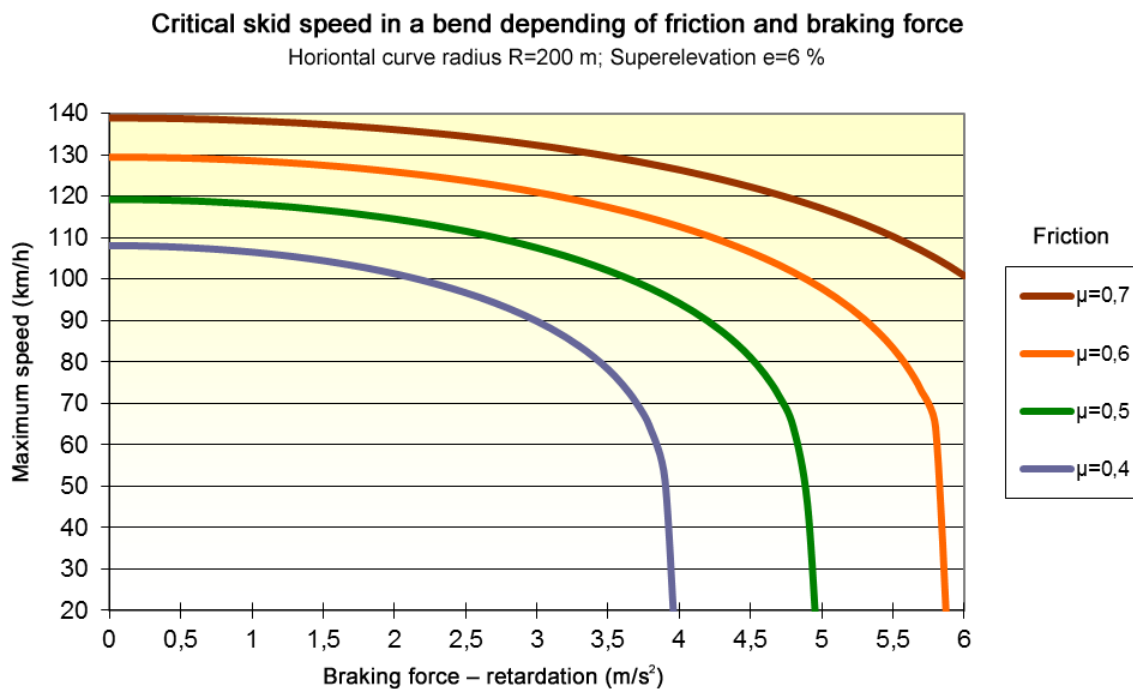
Figure 24 shows the theoretical maximum speed before skidding at different speeds in a bend, under the application of braking forces and subject to different friction values. The figure has been conservatively adapted to the bend where the accident occurred, in that it describes a bend with a radius of 200 m, a superelevation of 6% and different friction curves that can be measured in the roadway.

Figure 24: Critical skid speed in a bend depending of friction and braking force. Source: AIBN

In principle, a vehicle could theoretically pass through this bend at a speed of approximately 110 km/h without skidding on a wet road surface ( $\mu=0.4$ ). When braking ( $3\text{m/s}^2$ ), the vehicle could reach a critical skid speed at 90 km/h, given the same friction value of  $\mu=0.4$ . This is based on the assumption that the vehicle's brakes have a correct braking force distribution.
