REPORT

Road 2017/04

REPORT ON FIRES IN GAS-POWERED BUSES IN HORGVEGEN, RANHEIM, TRONDHEIM ON 17 DECEMBER 2016 AND AT FLATÅSTOPPEN, TRONDHEIM ON 23 NOVEMBER 2016

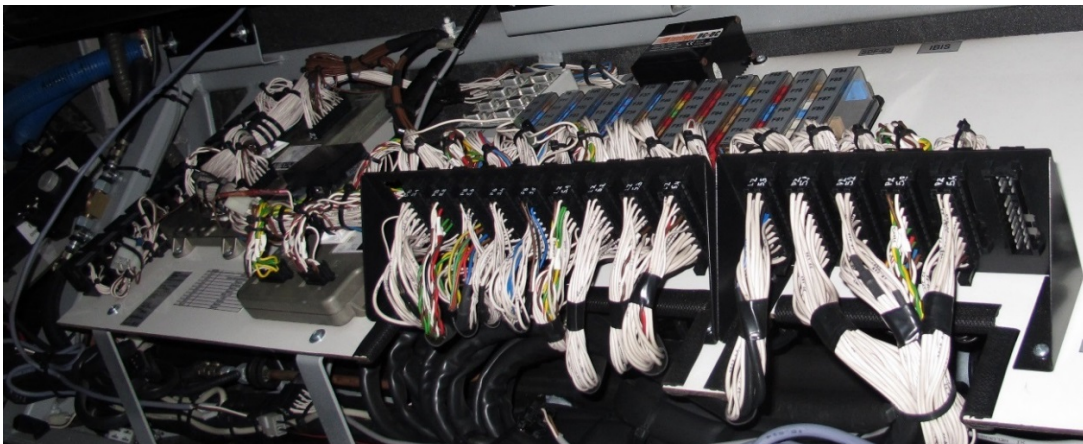
Figure 12: Fuse box, multiplexers and wiring in the buses in question. Photo: AIBN

The input circuit for the multiplexer was protected by a 15 A fuse and the power was distributed to a group of six outgoing circuits in the multiplexer. The six outgoing circuits in the group had a wire cross section of 0.75 mm² and were dimensioned for 3 A each, and were only protected by the 15 A fuse on the input circuit and the multiplexer's internal earth-fault protection.²

The incoming circuit for this group would not be broken by turning off the main power switch, but would be broken by disconnecting the earthing for the entire electrical system.

The multiplexer would nevertheless have delivered voltage as soon as the earth-fault protection had cooled down, provided that the 15 A fuse had not blown or broken. The
