REPORT

Road 2018/01

REPORT ON TRAFFIC ACCIDENT IN KRISTIANSAND 7 MARCH 2017 INVOLVING A MOBILE CRANE

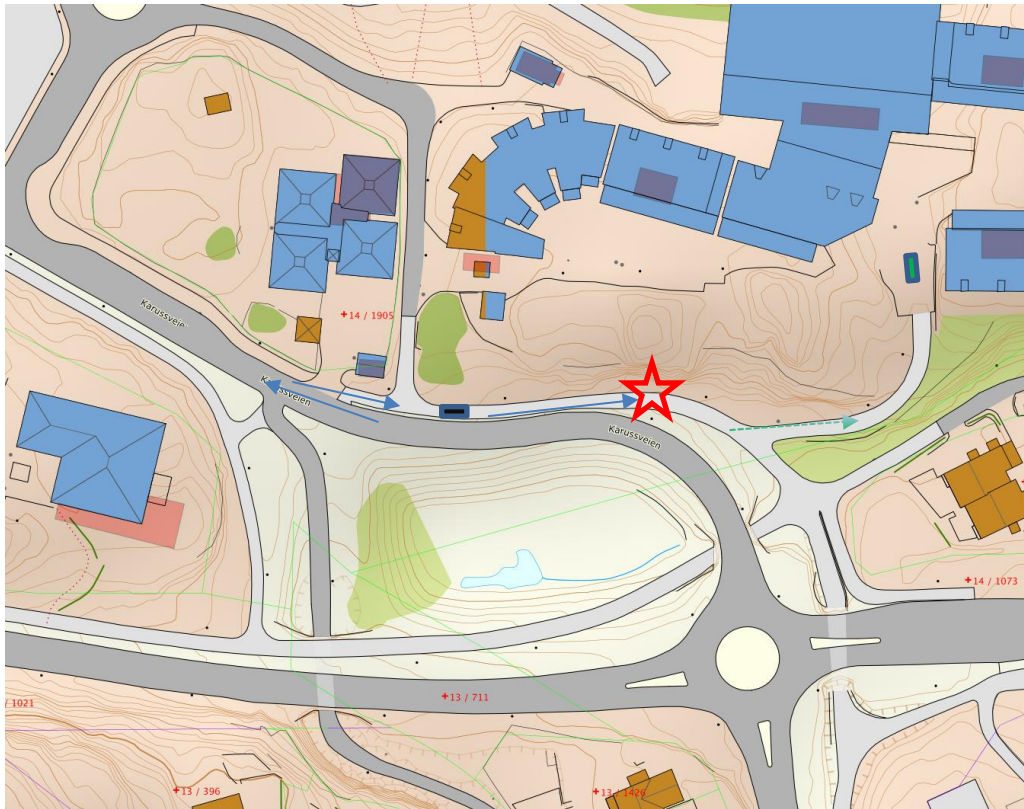
The accident occurred on a pedestrian walkway⁵ that formed part of a more extensive walkway/cycleway network owned by Kristiansand Municipality; see figure 12. The mobile crane reversed onto the walkway with Karuss Kindergarten one side of the walkway and railings forming a barrier against Karussveien road on the other.

The walkway functioned as a temporary access route to the building site at Karuss School and was used for some parts of the development project. The walkway was not regulated by any signs, such as for example sign no 518 'Walkway' or sign no 521 'Walkway and cycleway'. Nor had any work notification signs been posted or barrier put in place to prevent pedestrians/cyclists from using the walkway while the mobile crane was being driven onto the building site. The walkway is not used as an access road to properties in the area.

Figure 12: The accident site and surrounding walkway network. The arrows indicate the driving/reversing direction. Illustration: AIBN. Map: © Norwegian Mapping Authority
