SL 2008/18

## RAPPORT OM LUFTFARTSULYKKE PÅ RUDSKOGEN I ØSTFOLD 29. OKTOBER 2007 MED ROBINSON HELICOPTER R44, LN-OCA

Avgitt dato: 13.10.2008  
SL Rapport: 2008/18

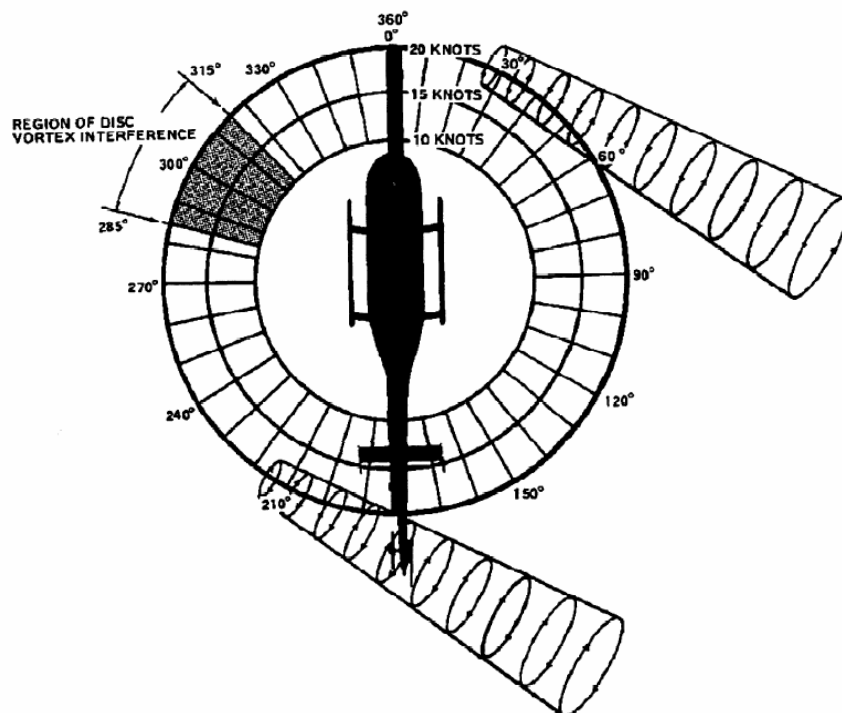
FIGURE 1. MAIN ROTOR DISC VORTEX INTERFERENCE

(1) Main rotor disc vortex interference (285° to 315°). (See figure 1.)

(a) Winds at velocities of about 10 to 30 knots from the left front will cause the main rotor vortex to be blown into the tail rotor by the relative wind. The effect of this main rotor disc vortex is to cause the tail rotor to operate in an extremely turbulent environment.

(d) As the main rotor vortex passes the tail rotor, the tail rotor angle of attack is reduced. The reduction in the angle of attack causes a reduction in thrust and a right yaw acceleration begins. This acceleration can be surprising, since the pilot was previously adding right pedal to maintain the right turn rate.

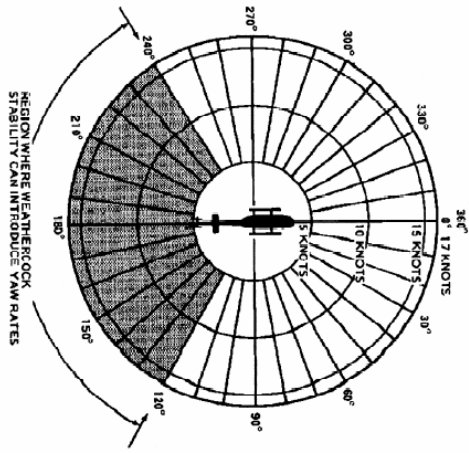
FIGURE 2. WEATHERCOCK STABILITY

(2) Weathercock stability (120° to 240°). (See figure 2.)

(c) If the pilot allows a right yaw rate to develop and the tail of the helicopter moves into this region, the yaw rate can accelerate rapidly. It is imperative that the pilot maintain positive control of the yaw rate and devote full attention to flying the aircraft when operating in a downwind condition.

(d) The helicopter can be operated safely in the above relative wind regions if proper attention is given to maintaining control. If the pilot is inattentive for some reason and a right yaw rate is initiated in one of the above relative wind regions, the yaw rate may increase.

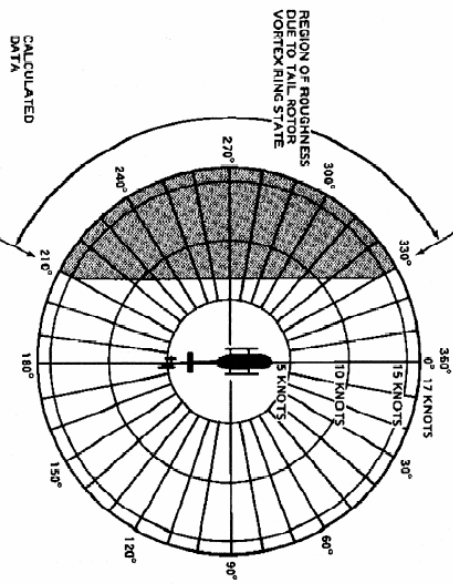
FIGURE 3. TAIL ROTOR VORTEX RING STATE

(3) Tail rotor vortex ring state (210° to 330°). (See figure 3.)

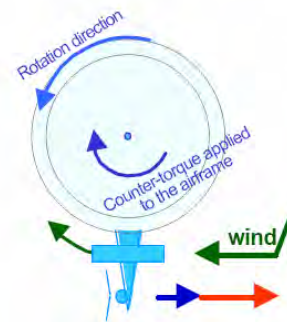
#### When adding a light unfavourable wind,

never forget that a rightward rotation departure can result in the aircraft's initiating a high rotation rate, if no adequate and additional action is immediately applied to the yaw pedals.

Remember that a tail wind component upon departure would worsen the problem.

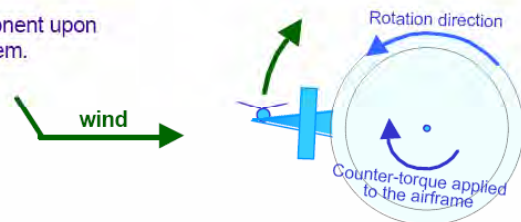
In a quick rightward rotation, if the Pilot attempts to counteract this rotation by applying the LEFT yaw pedal up to a position corresponding to that of hover flight, the aircraft will not decelerate significantly!

In this situation, immediate action of significant amplitude applied to the LEFT yaw pedal must be initiated and maintained to stop rightward rotation. Never hesitate to go up to the LEFT stop.

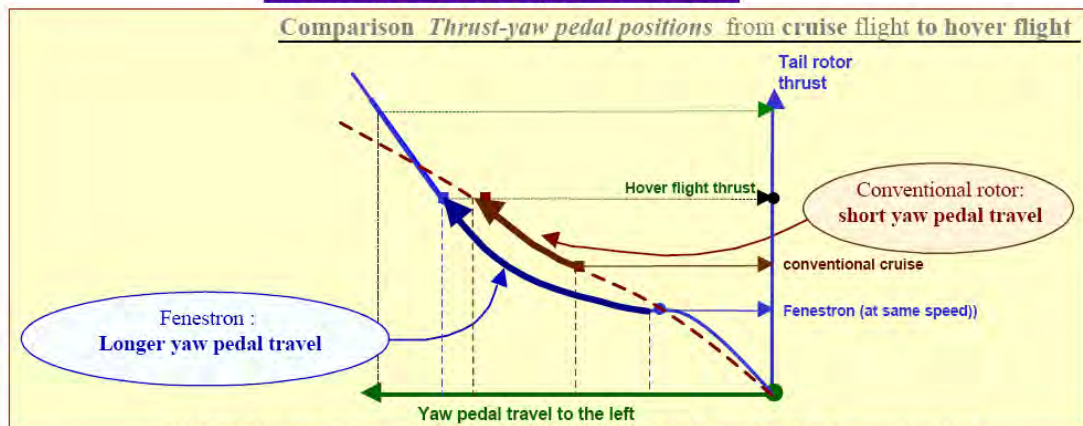
#### Transition from cruise flight to hover flight

With a Fenestron, when changing from cruise flight to hover flight, be prepared for a **significant movement of the foot to the left**.

Insufficient application of pedal would result in a rightward rotation of the aircraft during the transition to hover.

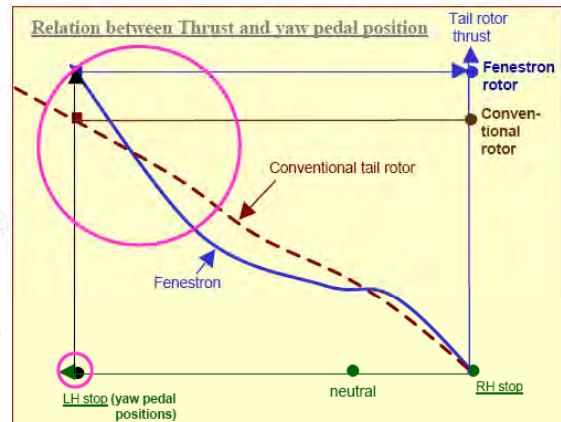
*It can be noticed that near the LEFT stop, the Fenestron efficiency is very high (curve slope).*

To stop rotation to the right, whether it is intentional or not, never hesitate to go up to the yaw pedal LEFT stop!
