**REPORT ON SERIOUS AVIATION INCIDENT, 19 MAY 2004 APPROX.  
20 NM WEST-NORTHWEST OF SANDEFJORD AIRPORT TORP, NORWAY,  
INVOLVING BOMBARDIER DHC-8-402, LN-WDA, OPERATED BY  
WIDERØES FLYVESELSKAP ASA**

Issued  
November 2007

Aircraft type: Bombardier Aerospace Inc. DHC-8-402  
Registration: LN-WDA  
Owner: HPA Leasing Limited, Don Street, St. Helier  
Jersey, UK  
Operator: Widerøe Flyveselskap ASA, Post Office Box 247,  
8001 Bodø  
Crew: 2 + 2  
Passengers: 27  
Incident location: Approx. 20 NM west-northwest of Sandefjord Airport Torp,  
Norway (ENTO)  
Date/time of incident: Wednesday 19 May 2004, at 0739

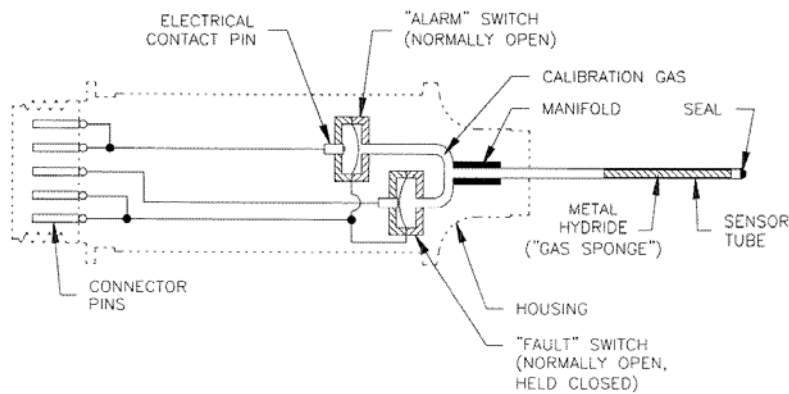
Figure 2: Outline drawing of heat detector (sensor).

1.16.2.4 It was evident that the sensitivity of the switch actuating the alarm function had changed. The pressure switch was cut open to allow access to the electrical contact side of the diaphragm (see figure 2). The diaphragm proved to be intact, but it exhibited a small dimple that was offset to one side that had arisen at some stage after manufacture. The diaphragm consequently did not have the same curve as a new diaphragm would have.

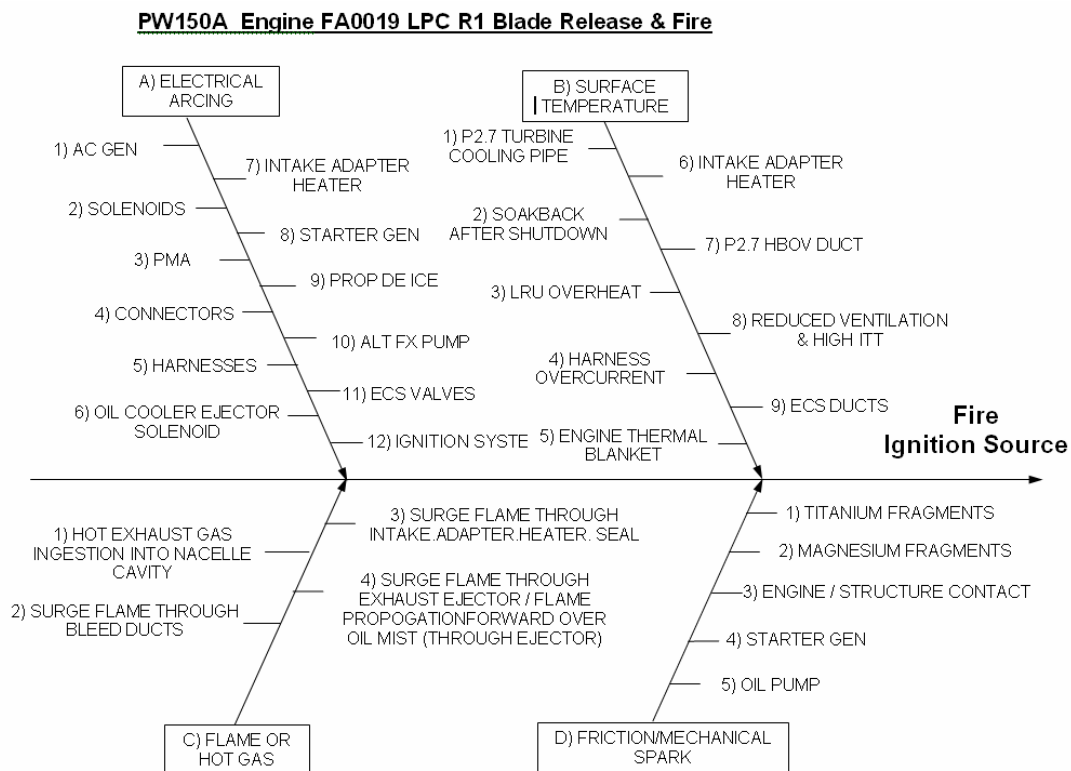
1.14.2.2 A series of experiments and calculations were carried out. Each possible ignition source was then categorised as: Non, Very Low, Low, Medium and High. Quotation from the working party's conclusion:

*“The team concluded that the most likely ignition source was the surge flame from the engine exhaust nozzle associated with the blade-off event / sudden engine stoppage. The actual mechanism of ignition would either be: (i) exhaust nozzle choking and surge flames passing through the exhaust ejector into the nacelle, igniting the oil spray from the cracked fuel to oil heat exchanger, or (ii) oil spray from the cracked fuel to oil heat exchanger being pumped out trough the exhaust ejector where it ignited by the surge flame and the flame subsequently propagated forward into the nacelle through the ejector, over the oil mist. The second potential ignition source, substantially less likely, was identified as surge flames trough the P2.2 handling bleed duct.”*

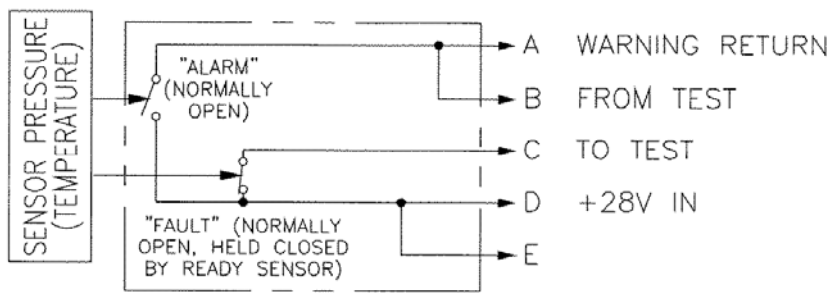
Figure 24: Electrical diagram of sensor.

Initially, the two sensors were examined by measuring the continuity between pins A and C, and between C and D (see figure 24).
