REP 19/2003

**REPORT ON  
AIRCRAFT ACCIDENT AT LÅGHELLERNUTEN ON THE  
HARDANGER PLAIN IN THE MUNICIPALITY OF  
ULLENSVANG, HORDALAND ON NOVEMBER 6 1999,  
INVOLVING EUROCOPTER AS 350-B2, LN-OCF  
OPERATED BY AIRLIFT AS**

**ISSUED MARCH 2003**

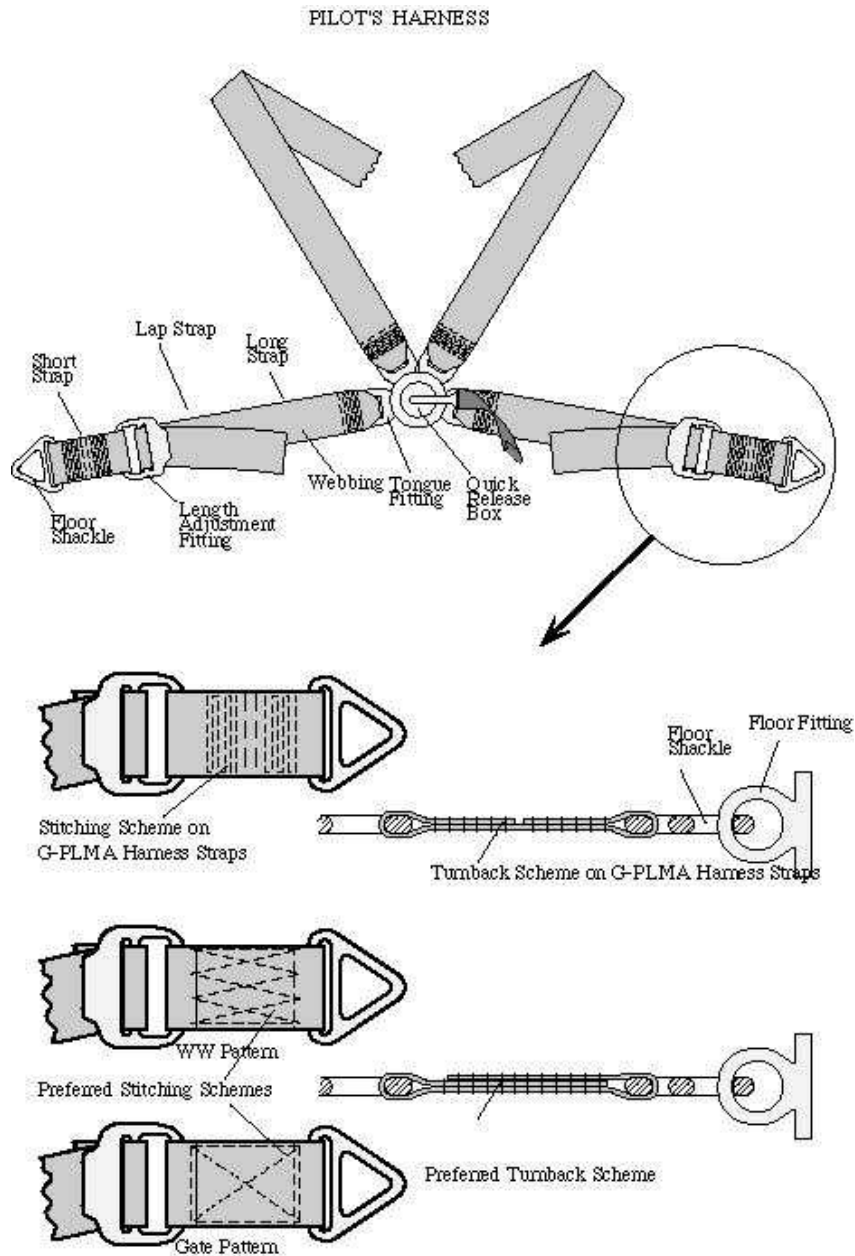
### Seatbelts, details

The front seats were fitted with both lap and shoulder belts, while the 4 seats behind were only fitted with lap belts. The front-seat belts were sewn with 6 seams at the buckle attachment, while the back ones were sewn with 4 or 5 seams. The seatbelts were of an approved make (Autoflug BAGU FAG 7B-27 / 09/90 in the front and Anjou Aeronautique SA type 343 1 / 47/90 in the back). The belts had a limited life (10 years) and were scheduled to be changed on September 1 2000.

The top part of the lap belts on the front seats had no individual identification. Only the part of the belt secured to the helicopter structure was marked. The lap belt is installed by using carabin hooks.
